# THE ATLANTIC EMPRESS SINKING—A LARGE SPILL WITHOUT ENVIRONMENTAL DISASTER

Stuart A. Horn and Captain Phillip Neal  
Mobil Oil Corporation  
150 East 42nd Street  
New York, N.Y. 10017

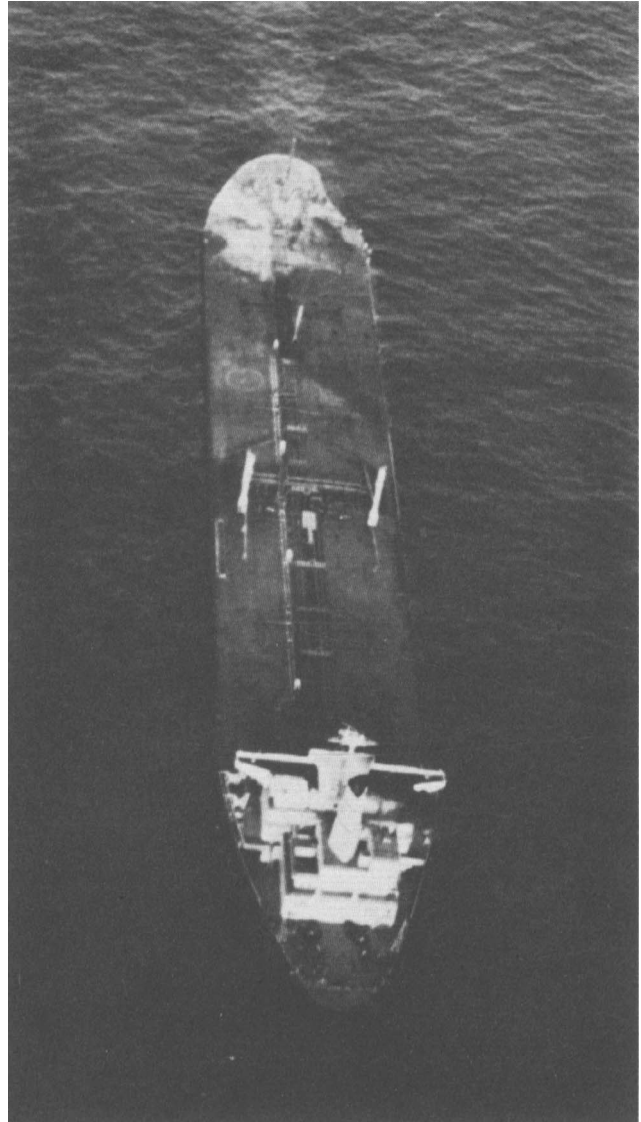
At first light on July 21, an overflight was made of both vessels and the general collision scene. The *Aegean Captain* (Figure 2) was located at approximately 11°30'N, 60°32'W under tow of the tug *Oceanic*. The fire had been extinguished, damage appeared confined to the starboard bow area, and a light-to-medium thickness slick about 10 mi in length and 2 mi wide was observed. The *Atlantic Empress* (Figure 3) was lying at about 11°30'N, 60°48'W, on fire along the entire starboard side of the main deck and with a list of about 10° to starboard. The slick in this area was also light to medium and covered an area

Figure 2. *Aegean Captain* following collision.

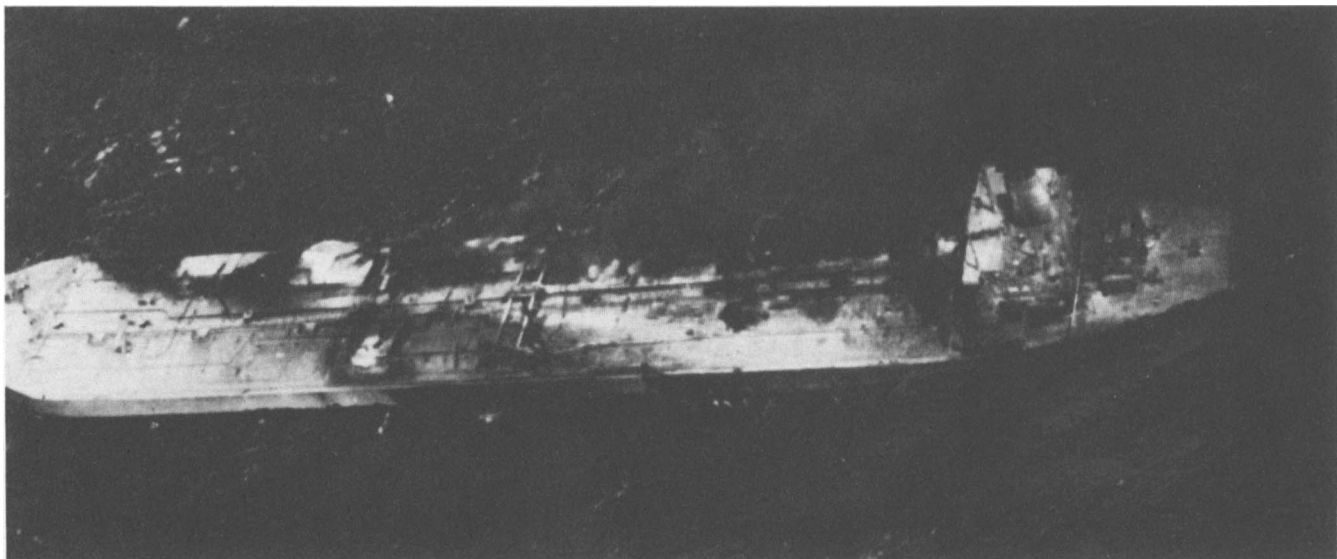
Figure 3. *Atlantic Empress* following collision.

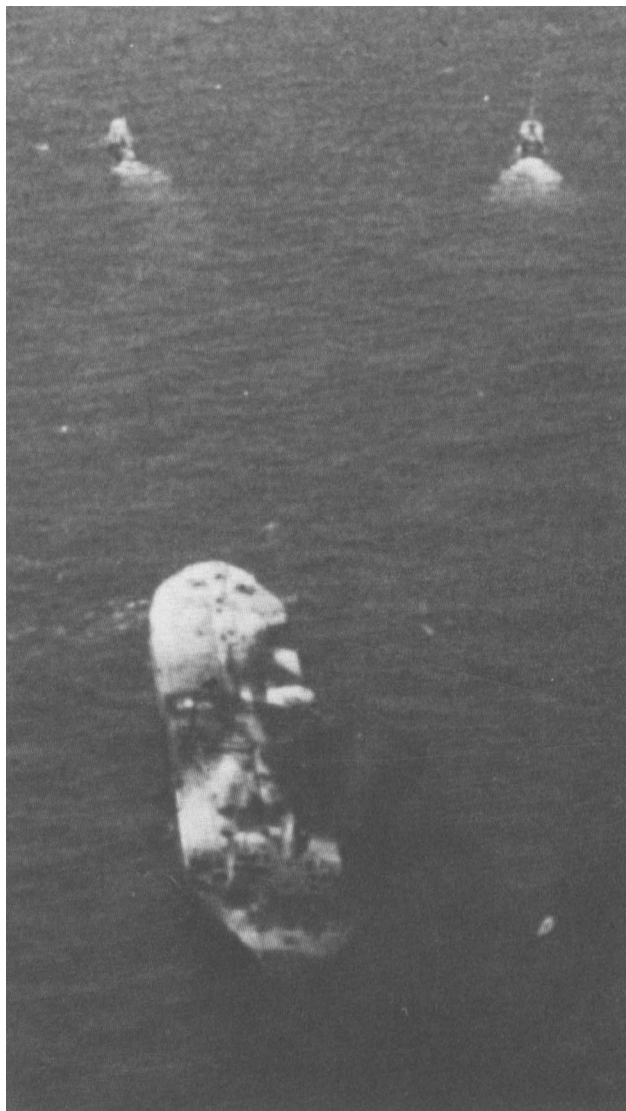
A second overflight of the *Atlantic Empress*, late in the day on July 21, determined that the fire extended from the Number 2 tank to the after maindeck on the starboard side and across the maindeck. Accommodations were totally gutted. The tugs *Zwarte Zee* and *Smit Lloyd 114* had arrived and were starting to tow the ship in a northerly direction (Figure 4).

Figure 4. *Atlantic Empress*—starting to be towed.

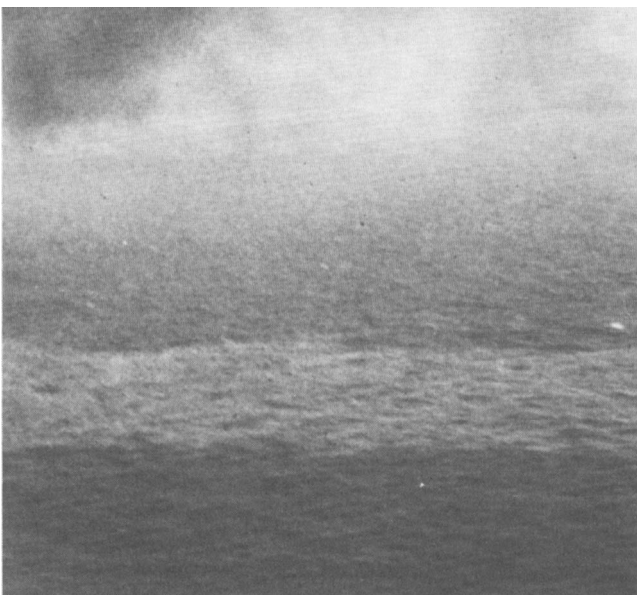
The slick from the *Atlantic Empress* (Figure 5) started out near the ship as light brown oil about the width of the vessel and was observable for 50 mi, at which point it was about 0.5 mi wide and just barely visible. The slick did not come closer than 10 mi to any land mass and was not heading toward any land.

Figure 5. Slick while towing the *Atlantic Empress*.

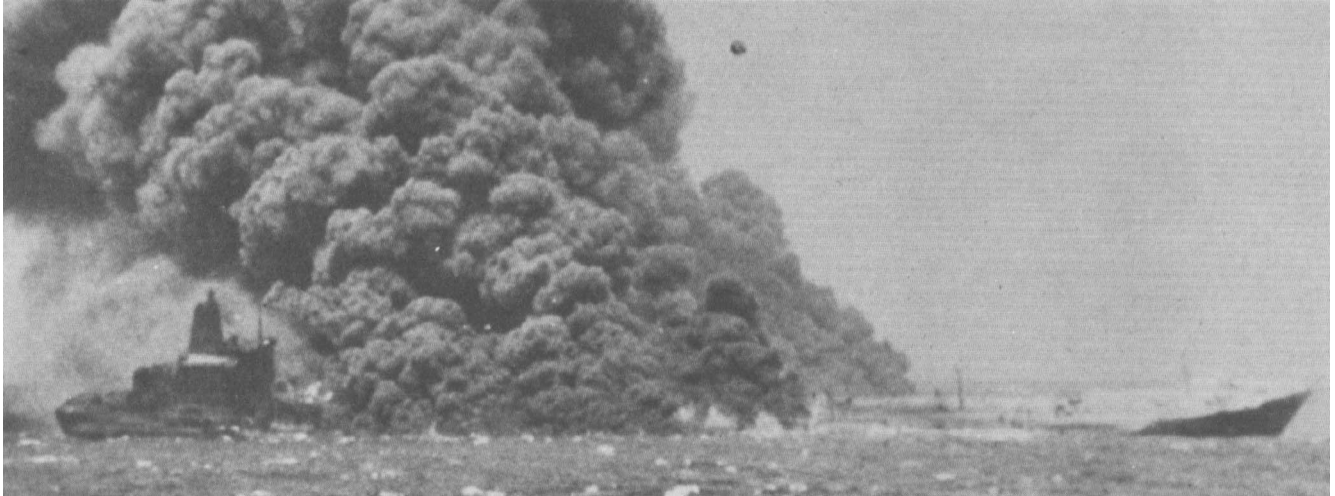
**Monday, July 30.** At dawn, the damage aboard the *Atlantic Empress* was found to be extensive. The deck of the ship was blown open for 35 to 70 ft, starting at Number 4 starboard tank and extending to Number 5 port tank. The steel at the edges was curled upward 10 to 15 ft. Much of the firefighting equipment on-board was lost. Later, low-level overflights confirmed the damage and the generally continuing increased level of fire in those tanks now open (Figure 11). Pollution levels continued low as the oil continued to burn both on the water and in the whole aft section of the vessel.

Figure 11. Condition of *Atlantic Empress* on July 30 after explosions.

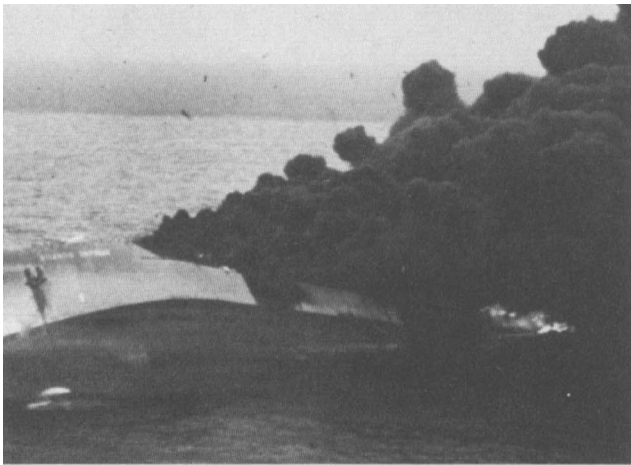
Figure 12. Sinking of *Atlantic Empress*.

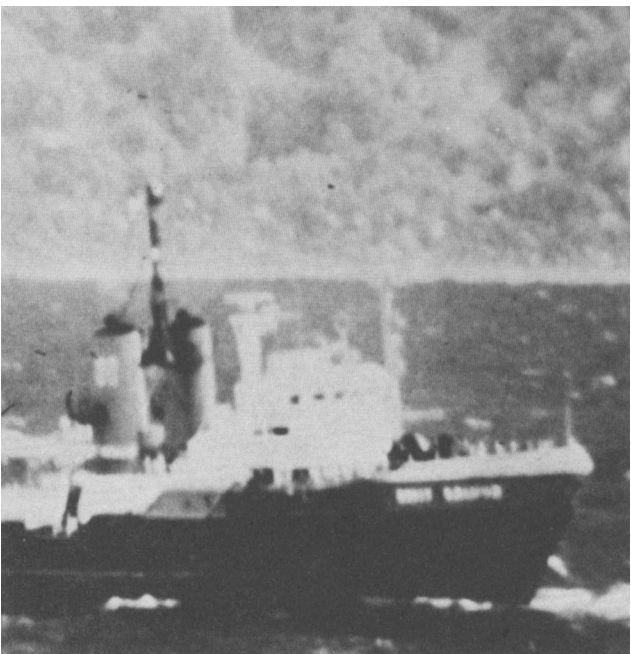
Figure 13. Fire following sinking.
