Isle of Man Ship Registry

2010

Summary Report of Casualties, Accidents and
Incidents on Isle of Man Registered Vessels

Published April 2011

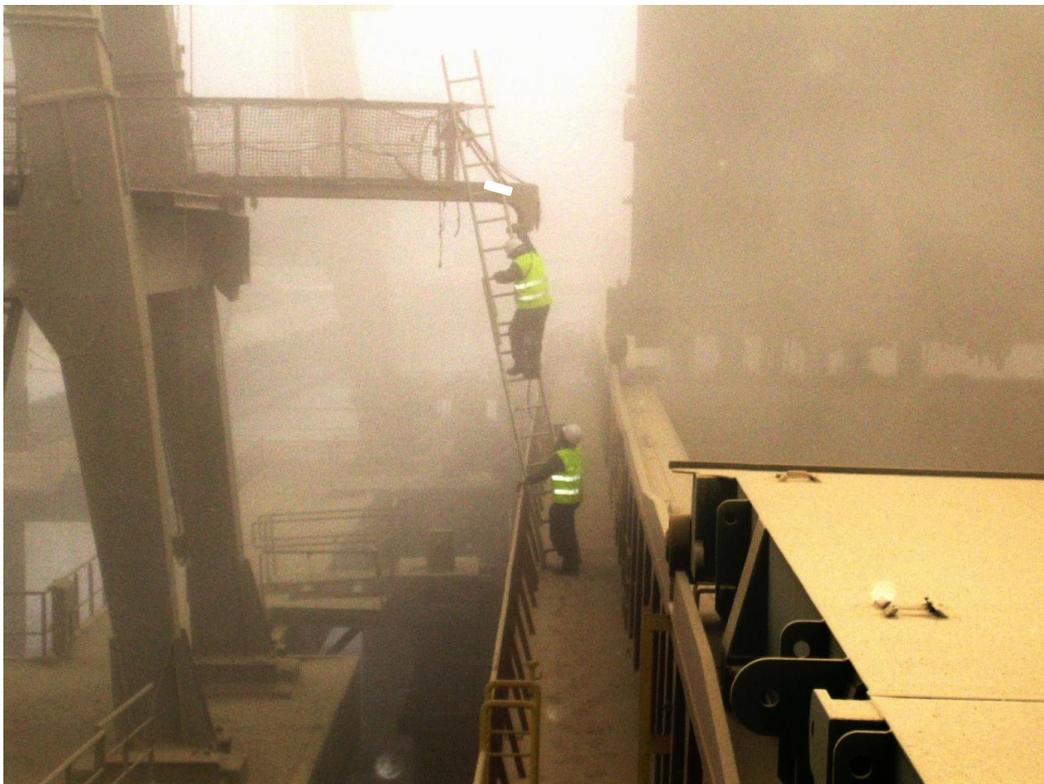
Front cover picture taken by an IOM Surveyor during an ISM Audit. Would you allow this as the safe means of access to your vessel?
