Fatal man overboard from the lone-operated creel fishing vessel *Nista* (LK121) north of Belnahua, north-west Scotland on 13 December 2023

SUMMARY

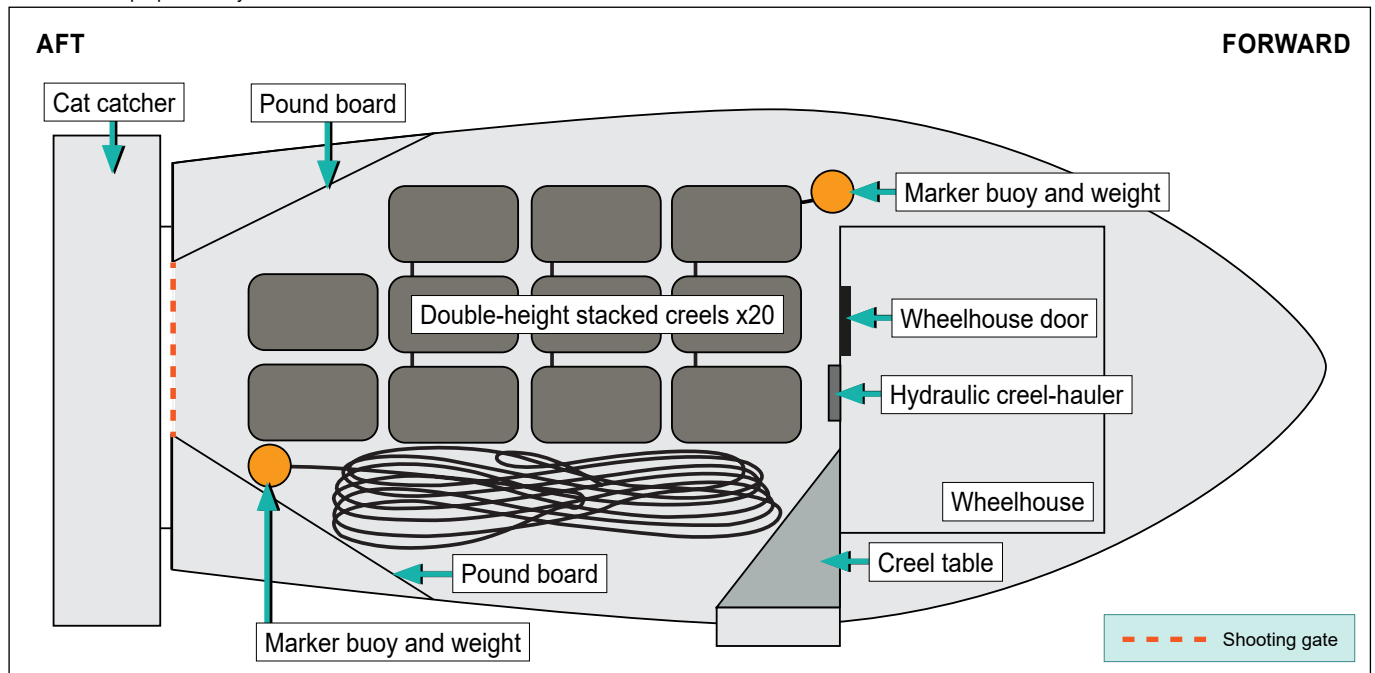
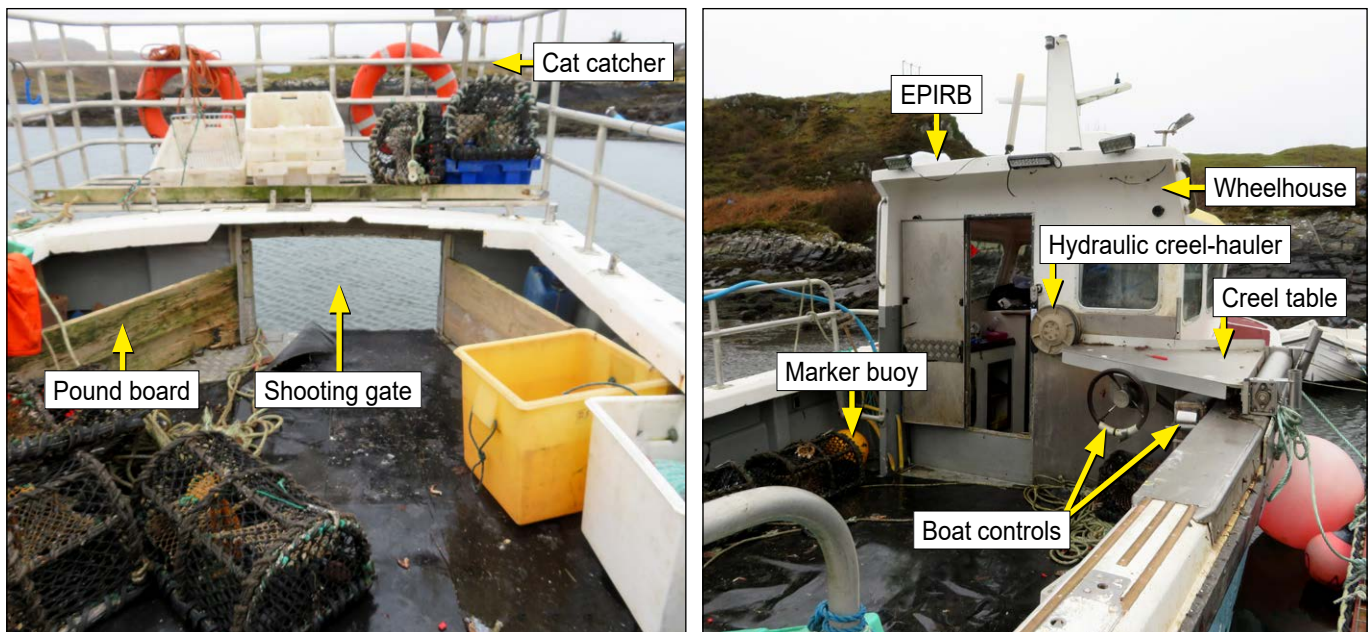
Figure 3: Nista's deck arrangement

Nista (Figure 3) was a 7.78m commercial fishing vessel built in 1990. It was constructed of fibreglass and had a 0.9m draught. In 2020, the skipper had added an aluminium cat catcher and two low pound boards to the vessel's stern.

The vessel had a 153-kilowatt engine below deck and could be driven from a helm in the wheelhouse or from next to the hydraulic creel-hauler that was mounted outside on its starboard aft bulkhead. The shooting gate opening in the transom measured 53cm by 108cm and was enclosed by a top rail. There was no means to close the shooting gate. The aluminium working deck was covered with an antislip rubber mat. Knives were found on the creel table next to the hauler and at the baiting station just aft of midships; no knives were found near the shooting gate.

The skipper's desire to work 20 creels on each fleet and the limited size of *Nista's* working deck resulted in him stacking the creels in two layers before shooting. This increased the risk that the creels would topple, become entangled, and that two or more would be pulled to the shooting gate at the same time. The skipper had fitted pound boards to funnel the shooting creels towards the shooting gate, and spare gear was stowed behind the pound boards to keep the deck as clear as possible. However, despite these mitigations, as this accident has demonstrated, creels could still become jammed by the shooting gate.

If the shooting sequence was disrupted, for example by creels becoming jammed at the shooting gate, the only way the skipper could clear the problem was by walking over the back rope. Even if the skipper had put the engine in neutral before going on deck, the back rope would have been under tension from both the weight of the creels in the water and their anchoring effect on the vessel that would have been subjected to any wind or current.

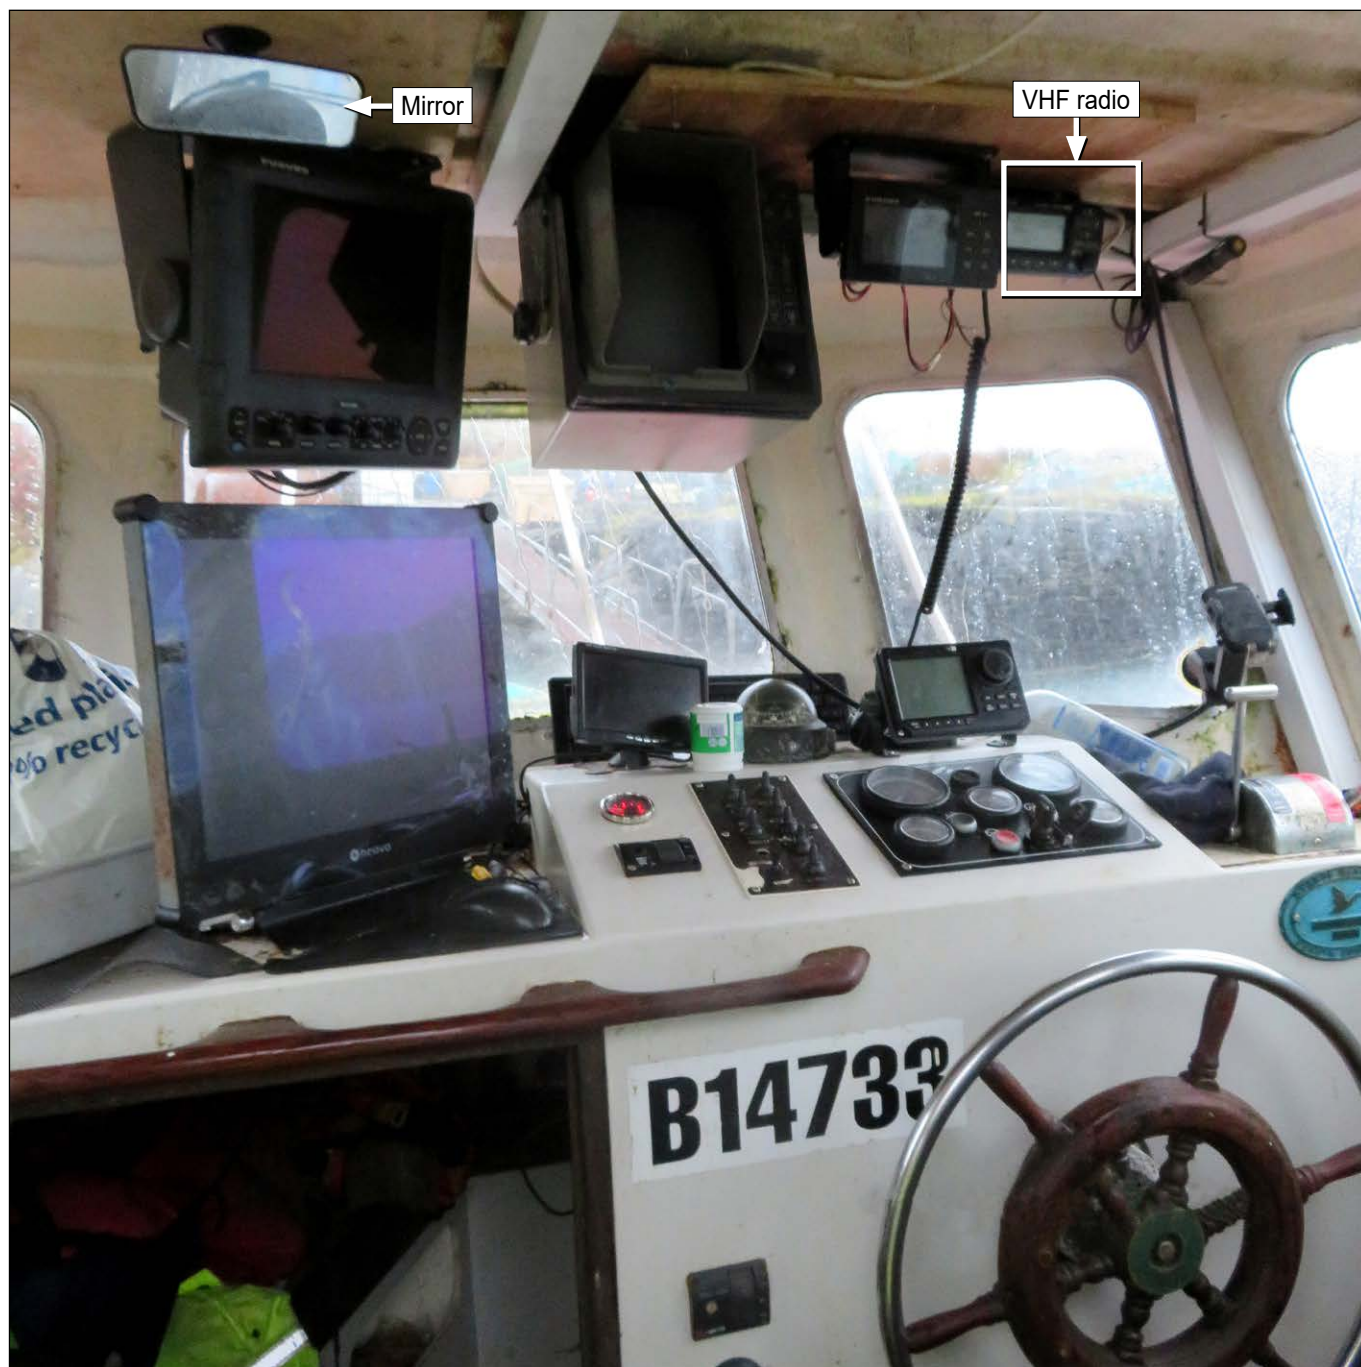
Figure 4: *Nista's* wheelhouse

A mirror mounted to the deckhead in the wheelhouse (**Figure 4**) provided a view of the shooting gate from the helm position. The wheelhouse was equipped with a very high frequency (VHF) radio.

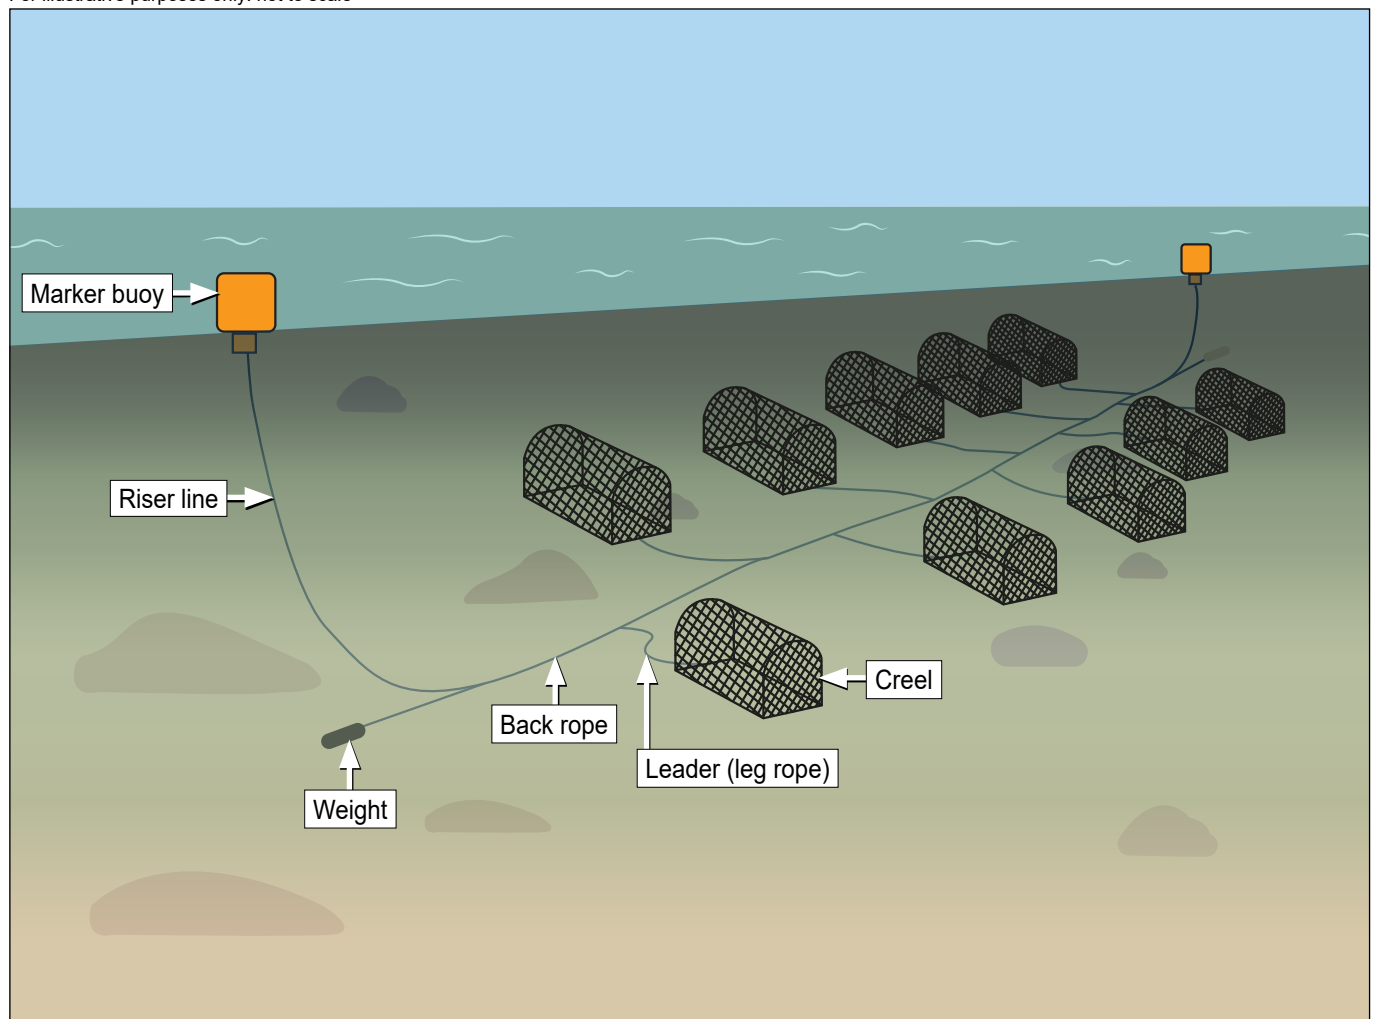
Figure 5: *Nista's* fishing arrangement

Once a new row of creels had been placed on the deck a second row would be placed on top, slightly overhanging the creels on the deck. The back rope was flaked on the deck next to the stacked creels. This positioning allowed the creels to be pulled out of the shooting gate in order and was intended to minimise the chance of the creels, leaders and back rope becoming entangled.

Shooting a fleet of creels from the deck was started by throwing the buoy, riser line, and weight from the end of the fleet nearest the stern and then driving *Nista* ahead at a speed of about 4kts to 6kts. This usually allowed the creels to shoot independently, one by one through the shooting gate.

If the back rope, leaders, and creels became entangled it was normal practice for the skipper to let the knotted creels shoot overboard and once the whole fleet had deployed to rehaul and shoot again. There were low pound boards on the starboard side where an additional crew member could stand clear of the shooting creels, but it was usual for the skipper to operate alone.
