Report on the investigation of
the capsize and foundering of the fishing vessel

***Njord* (SH 90)**

resulting in one fatality

on 6 March 2022

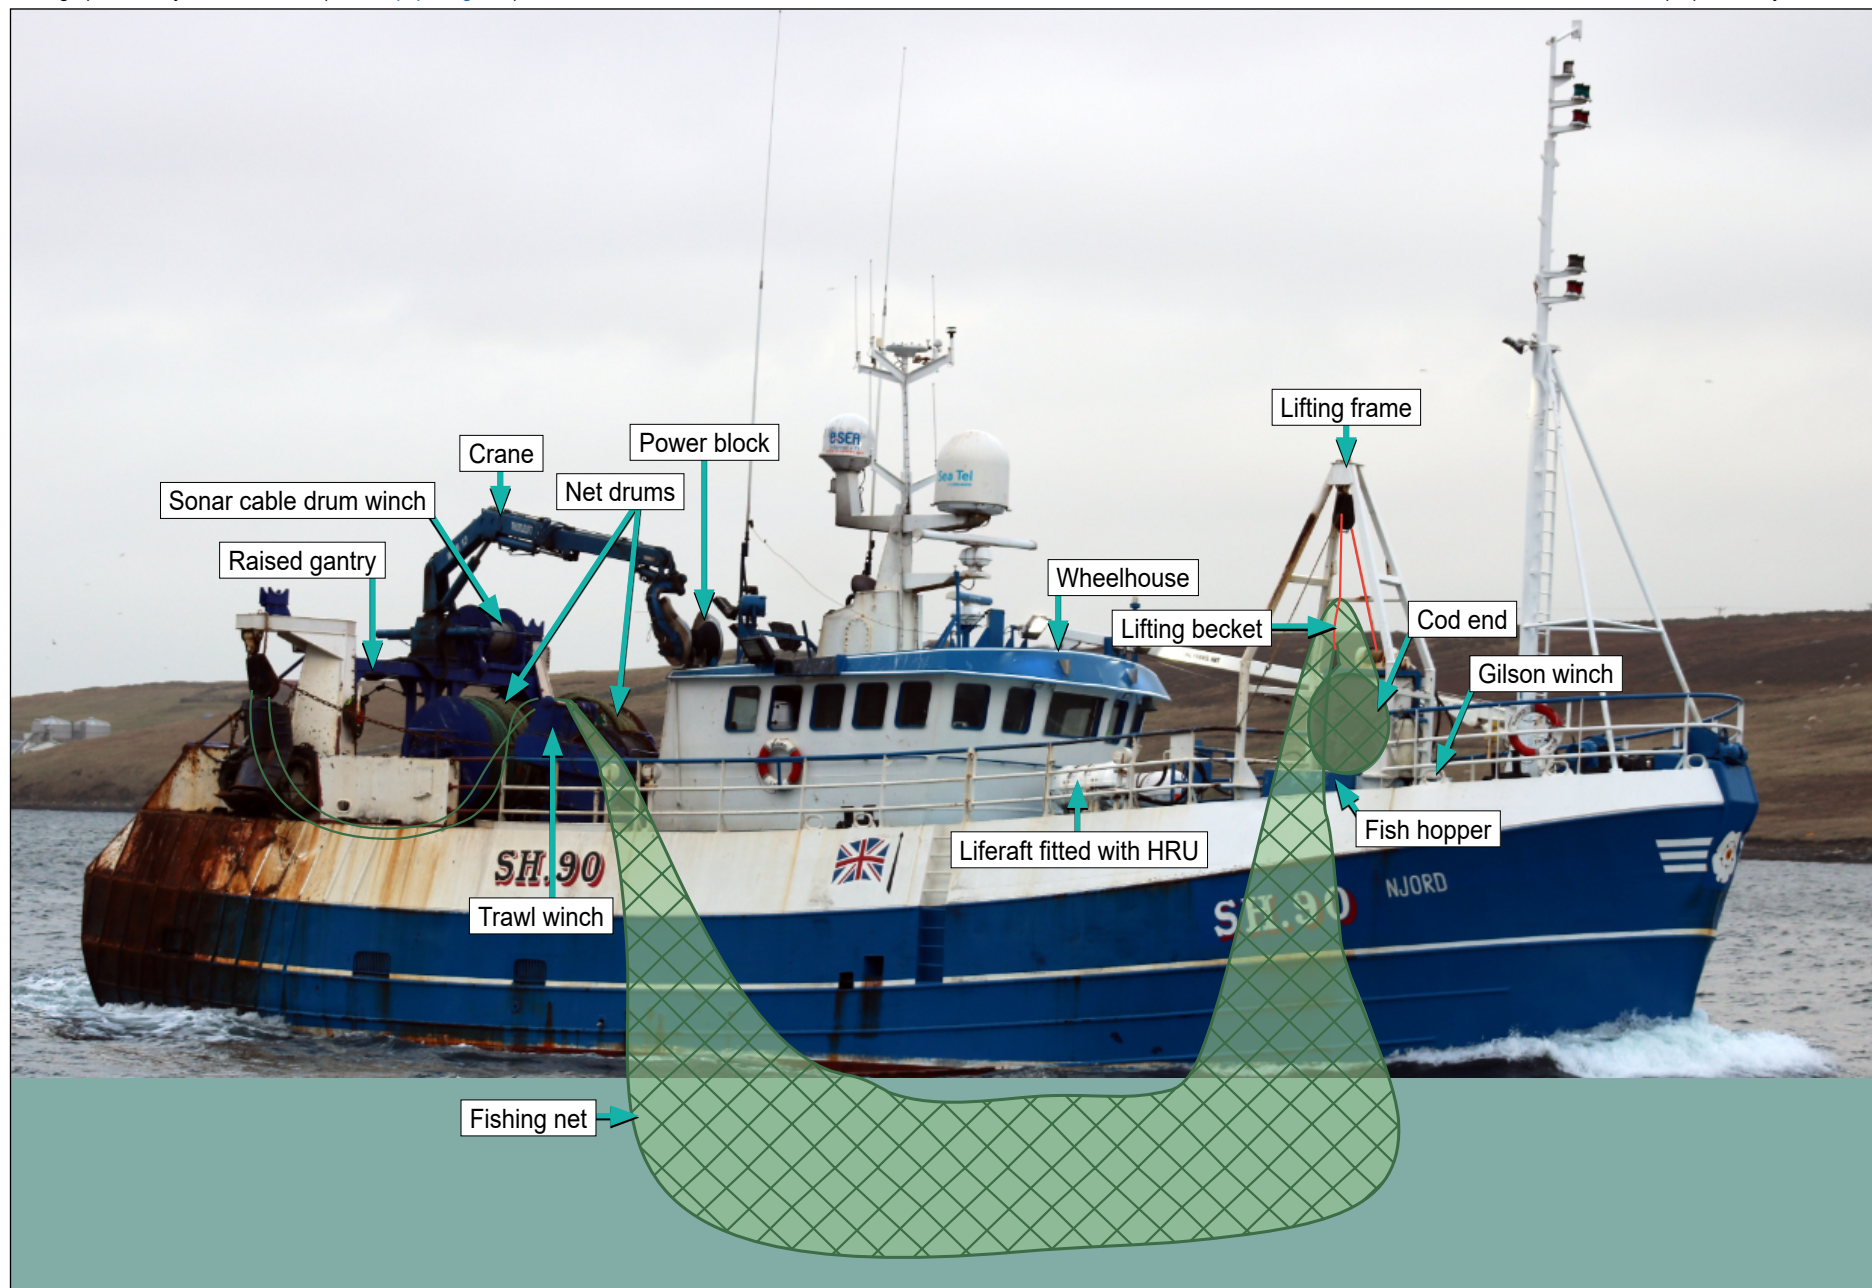
The investigation found that the net had been secured to the starboard trawl winch and the weight of the catch then acted on a handrail high up on the vessel's starboard side. As the remaining fish in the net started to sink, along with the vessel's hopper being overloaded, a substantial list developed to the point that downflooding could occur.

Figure 2: *Njord* net indicative lashing and general layout

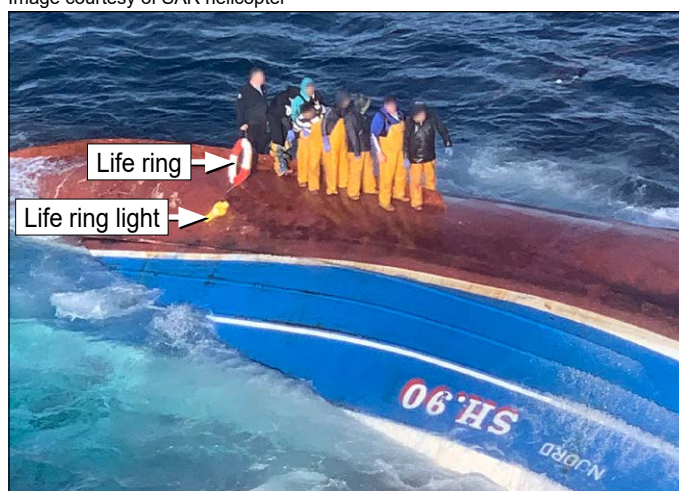
Figure 4: The crew standing on the upturned hull of *Njord*

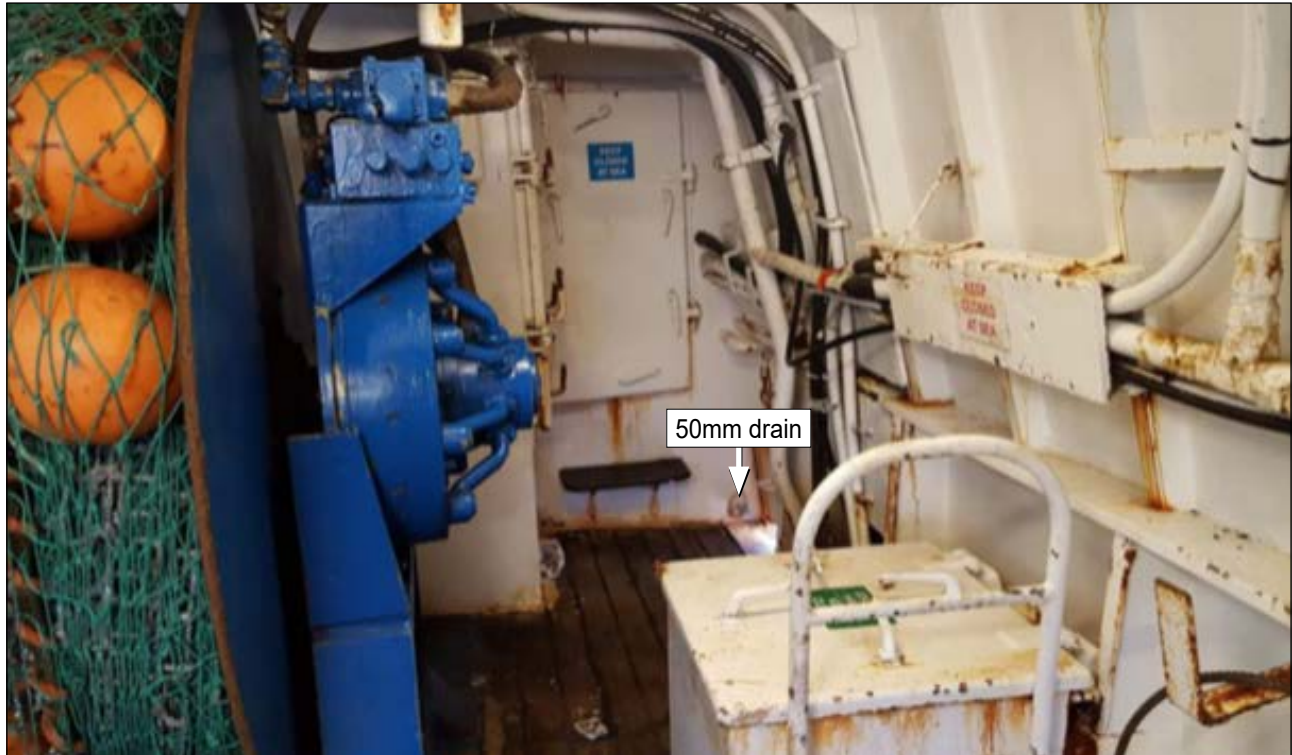
A 50mm drain was cut into the lower starboard corner of the aft bulkhead of the starboard passageway (**Figure 6**) and fitted with a stub pipe, to which a valve was fitted on the inside of the bulkhead. The drain allowed accumulated water in the starboard passageway to flow to the outside deck. The MAIB investigation found that the drain had been in situ for some years before the skipper had purchased the vessel. The drain was neither referenced on the general arrangement plans nor in the vessel's stability book, and there was no record of it in any MCA documentation to indicate that it had been reported to the organisation for approval.

Figure 6: Position of the drain from the starboard passageway

The reason for the installation of the drain hole in the aft bulkhead of the starboard passageway is unknown; its purpose might have been to drain water from periodic cleaning of the space. The downflooding angle reduced from 46° to around 17° when the vessel was assessed in its pre-accident loading condition (scenario A) if the valve was left open. It is likely that *Njord* would not have capsized had the valve on the drain been closed, as it should have been, while the vessel was at sea.

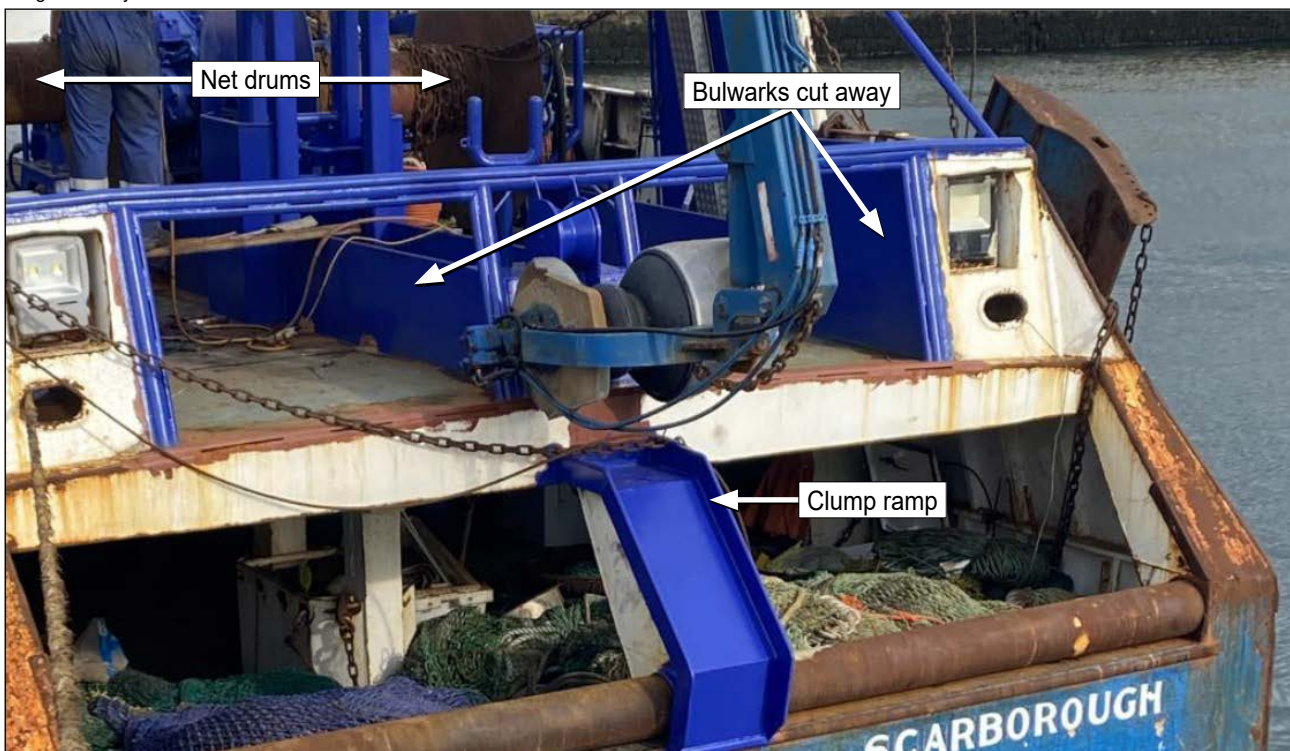
Sections of the top deck's aft bulwark were also removed to enable the shooting of prawn nets through the stern. Additionally, a gantry was constructed between the towing gallows to raise the power block crane from the deck, and to allow the shooting of the prawn nets. A sonar cable drum was also installed on this raised gantry. Various other modifications were made to the top deck, including the removal of storage pounds, relocation of a capstan and its base, removal of other steel structures, and the addition of steel net running tracks to the deck.

Figure 8: Clump ramp and cut away bulwarks on *Njord*'s stern

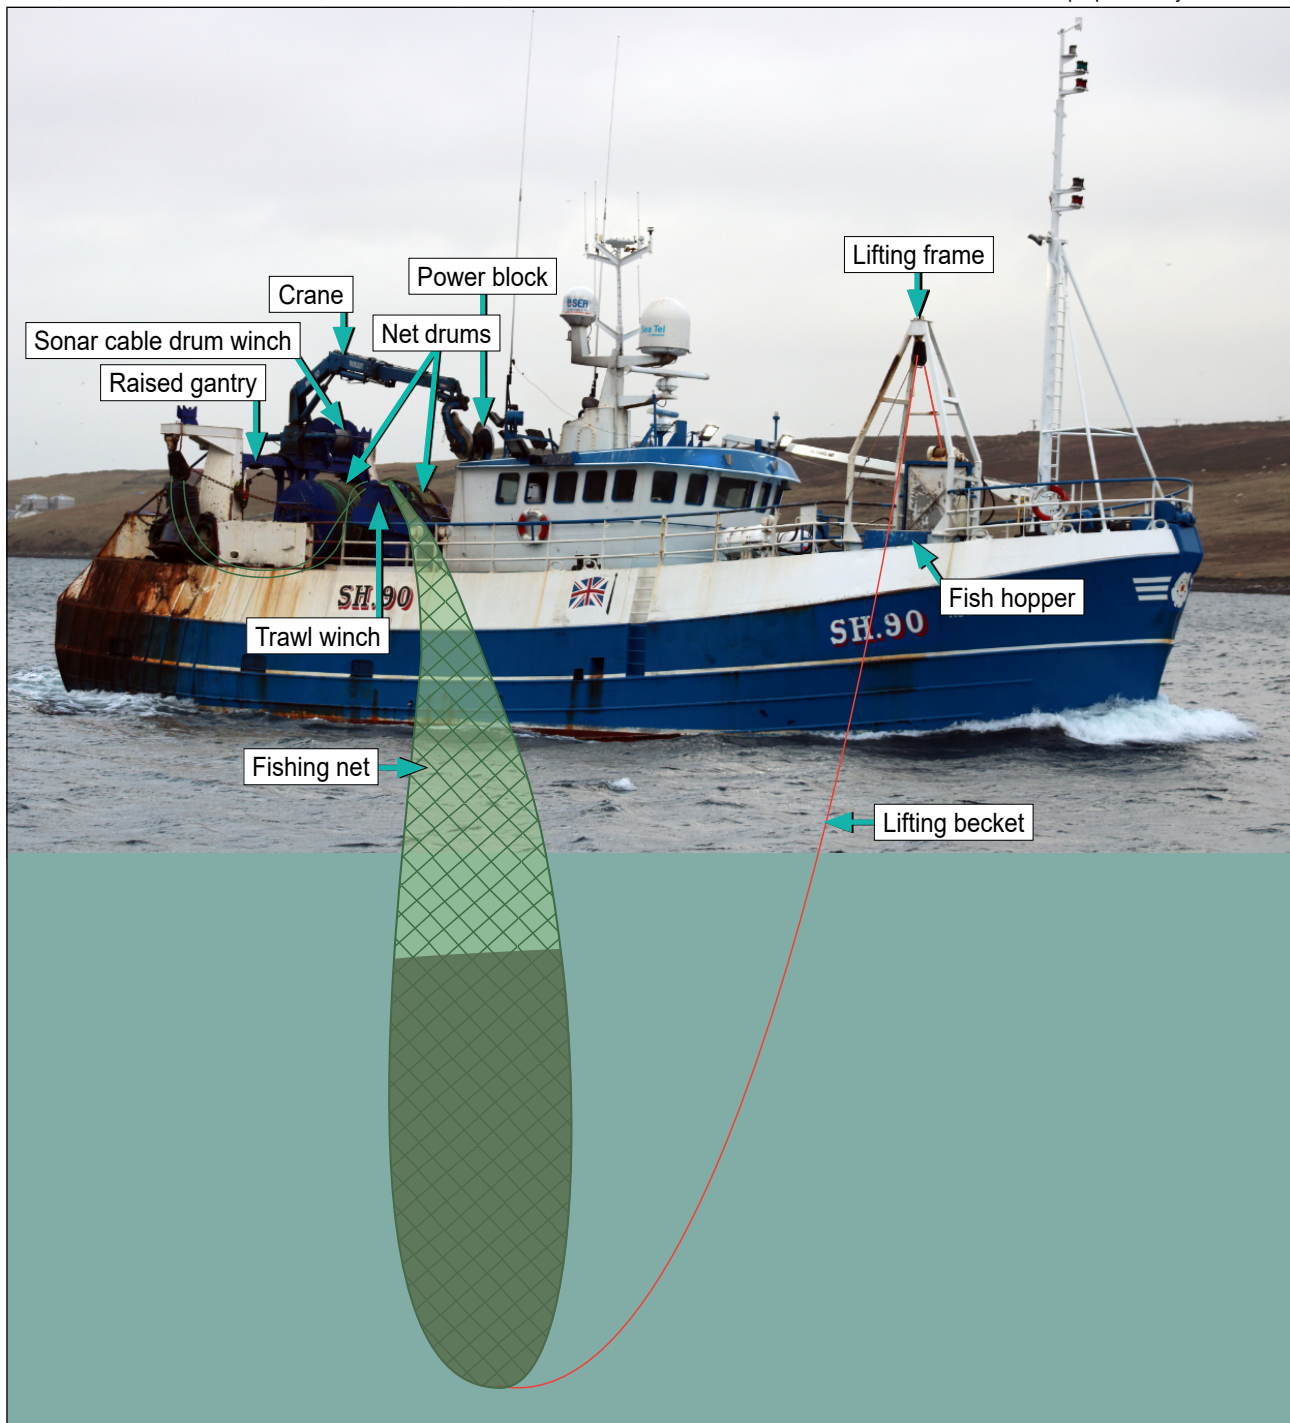
Figure 10: Position of net during loss scenario

Scenario	Lightship weight (year)	Load in net (t)	Downflooding angle (°)
A	2021	3.10	17.2
B	2021	9.90	Capsize
C	2018	4.40	17.8
D	2021	7.40	16.4

The results of the scenario A loading condition indicated that 3.10t was required to act at the net lashing position for progressive flooding to immerse the starboard passageway drain hole (downflooding point 2) and begin flooding the passageway. The digital model demonstrated that a list of 46.6° would capsize the vessel before flooding of the lower accommodation through an internal door (internal downflooding point 4) would occur (**Figure 11**).

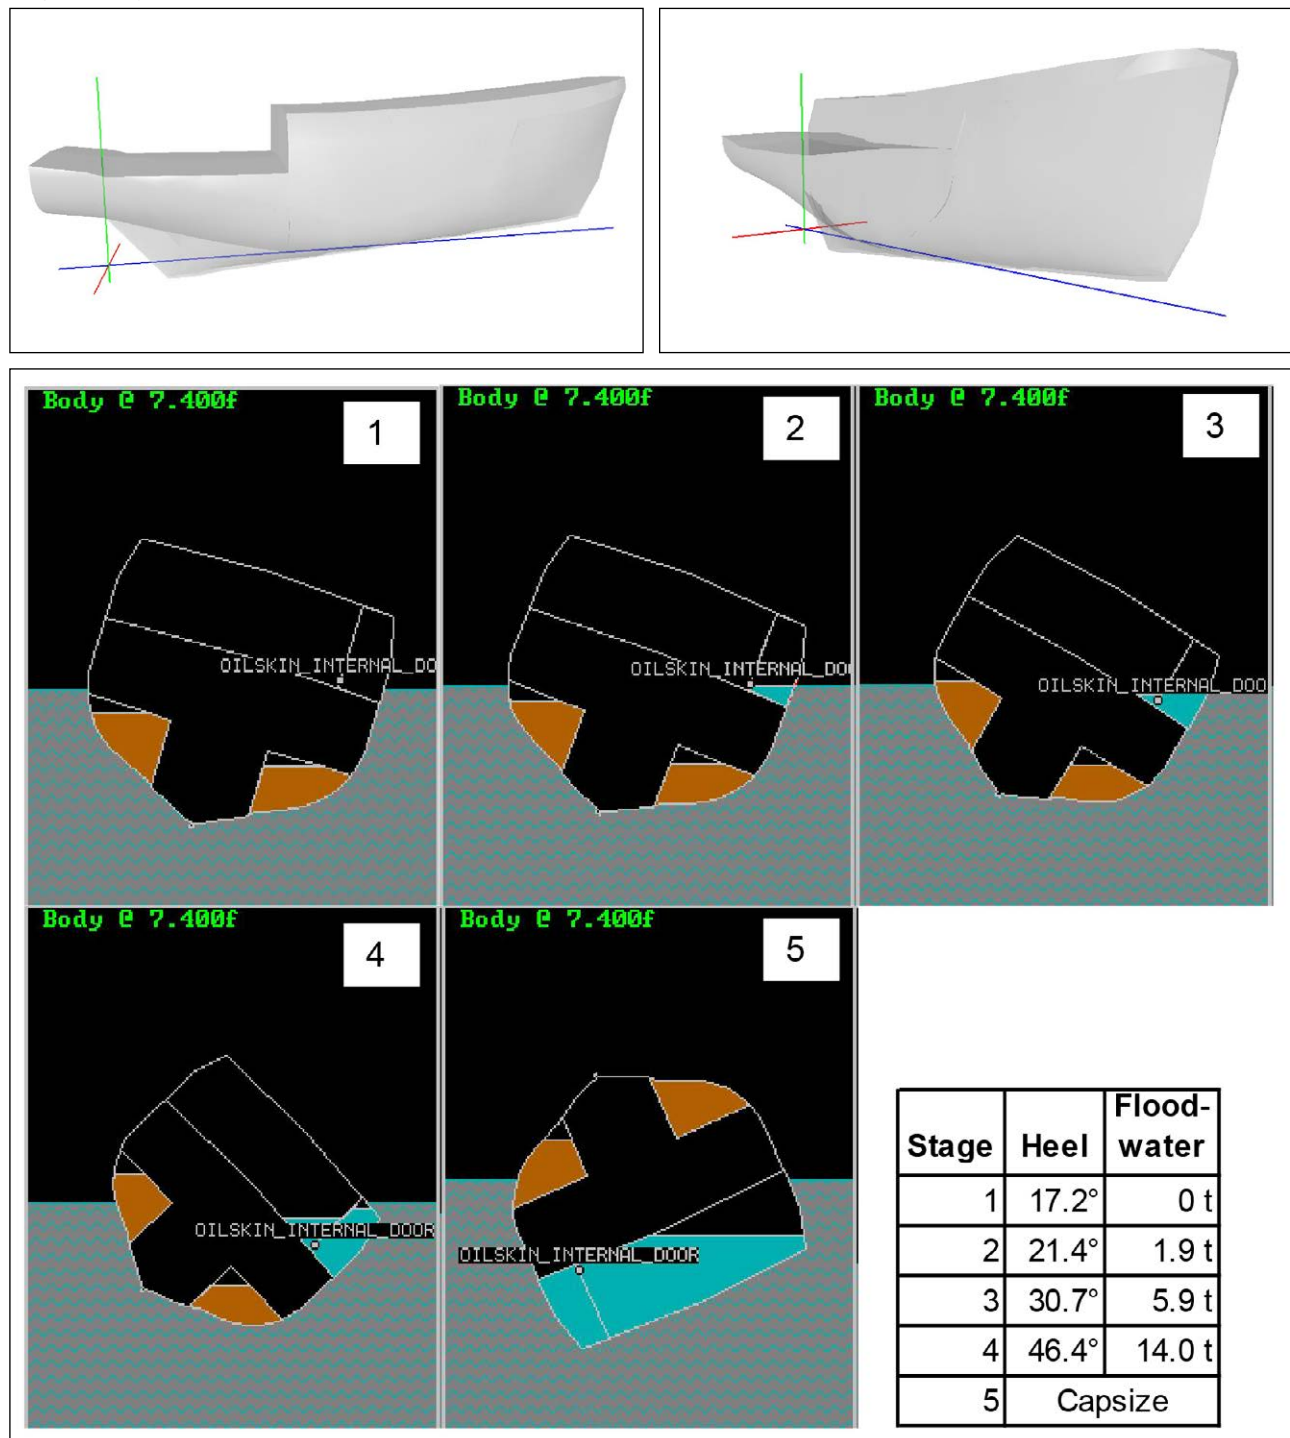
The results of the scenario B loading condition indicated that *Njord* would have immediately capsized without downflooding if a load of 9.9t or more had been applied to the net lashing position. It would not have been possible to apply sufficient net load to submerge the fish landing hatch (downflooding point 1) before capsize occurred.

Figure 11: *Njord*'s likely flooding sequence
