Failure of chain link investigation on board *Cornishman* report no. 2021-5360

FAILURE OF CHAIN LINK ONBOARD CORNISHMAN

Failure investigation

Report No.: 2021-5360, Rev. 0

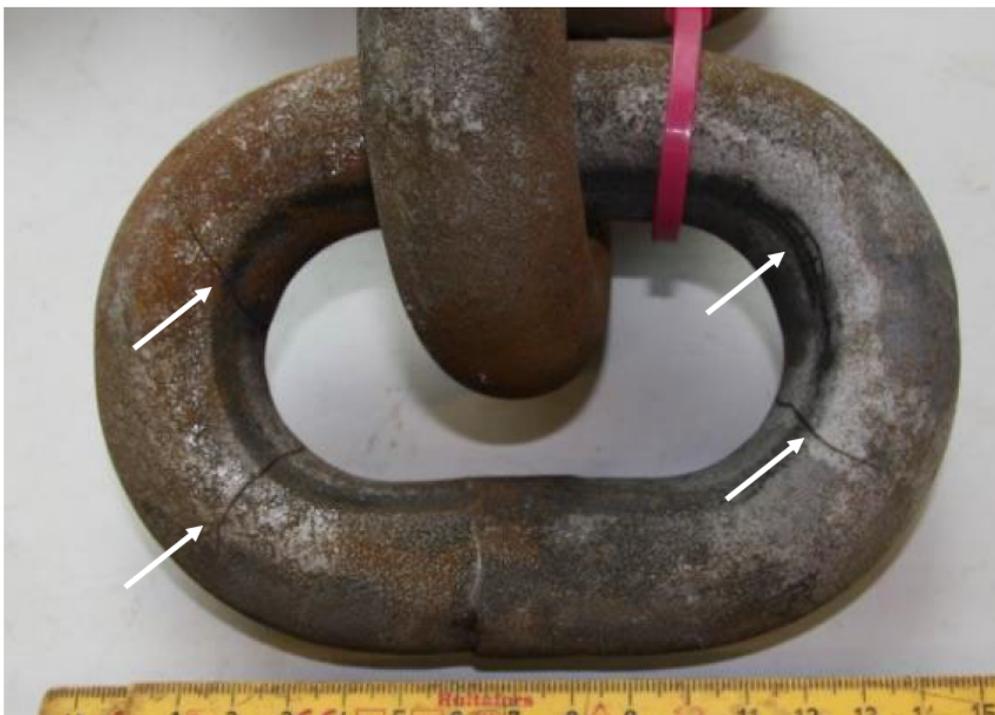
Part ID	Description	Link no.	Observations
Part BJC/1	Part of portside chain, connected to steel wire rope	1	<ul style="list-style-type: none"> - Crack-like indications in both ends of the link - The larger crack extends approximately 180° around the chain link circumference. - Uneven surface in connection to the weld - No significant wear/deformation marks - See Figure 4-11
		2	<ul style="list-style-type: none"> - No crack-like indications from visual inspection - Uneven surface in connection to the weld - No significant wear/deformation marks. - See Figure 4-12
		3	<ul style="list-style-type: none"> - No crack-like indications from visual inspection - Uneven surface in connection to the weld - No significant wear/deformation marks. - See Figure 4-13
		4	<ul style="list-style-type: none"> - No crack-like indications from visual inspection - Uneven surface in connection to the weld - Some increased interlink wear towards link 5 is seen - See Figure 4-14

Figure 4-11 BJC/1 – Link 1 after cleaning. Cracks are seen in four areas, indicated by arrows.

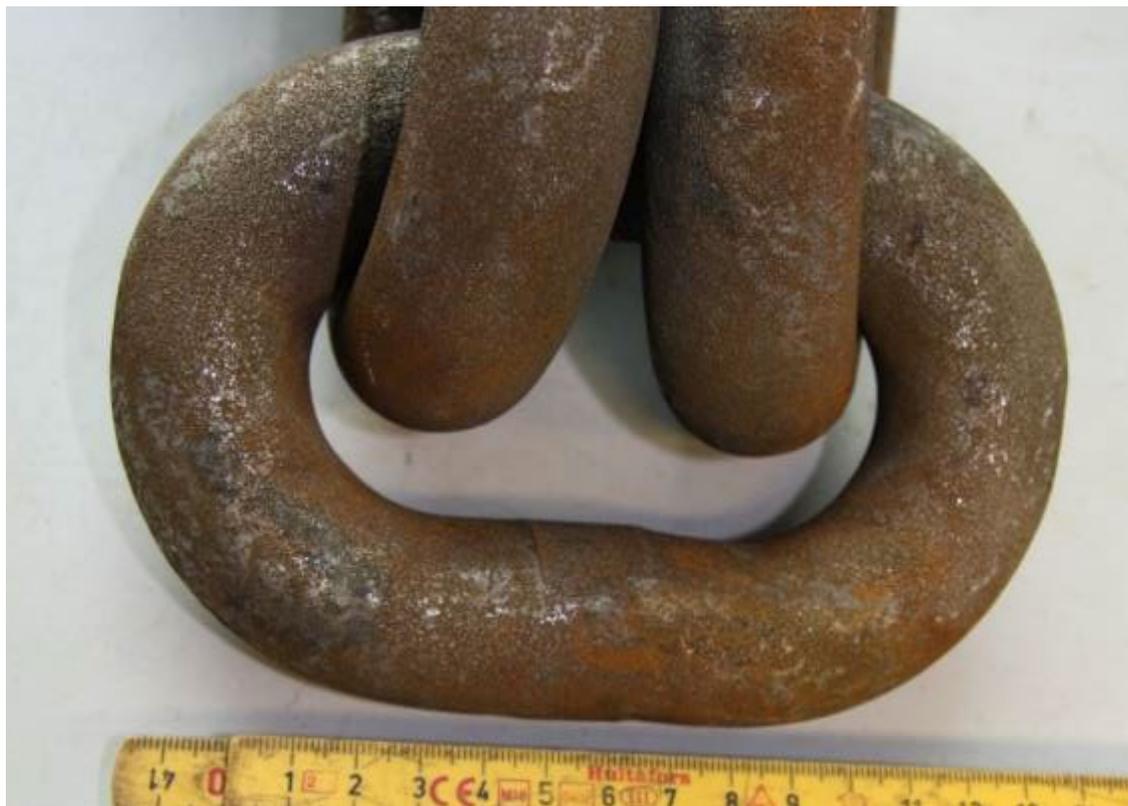
Figure 4-12 BJC/1 – Link 2 after cleaning. No crack-like indications.

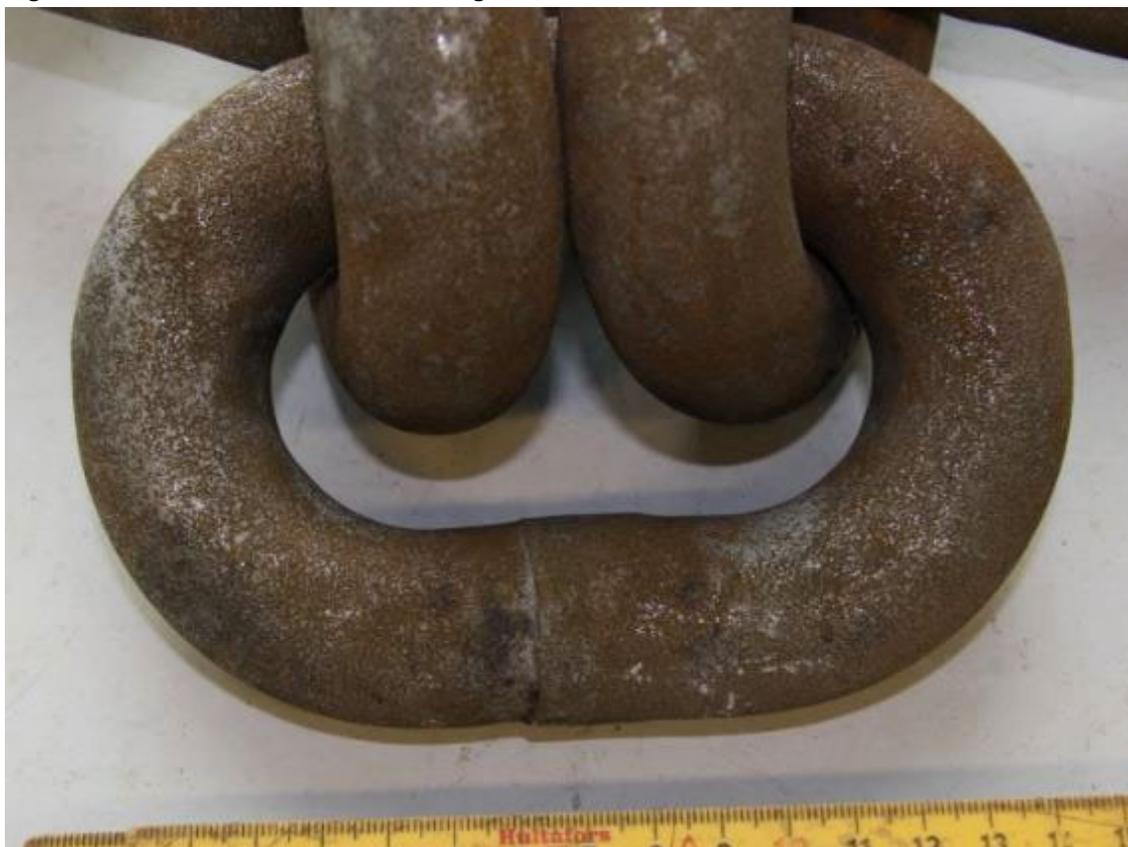
Figure 4-13 BJC/1 – Link 3 after cleaning. No crack-like indications.

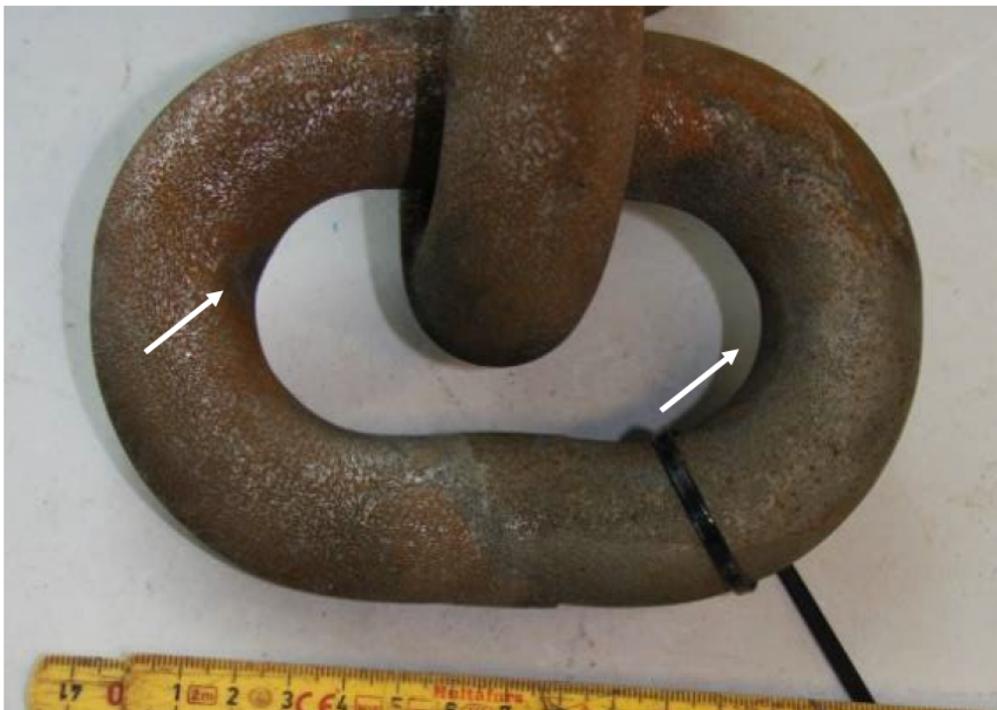
Part ID	Description	Link no.	Observations
		5	<ul style="list-style-type: none"> - No crack-like indications from visual inspection - Uneven surface in connection to the weld - Some increased interlink wear is seen - See Figure 4-15
Part BJC/2	Unused section of chain*	1-9	<ul style="list-style-type: none"> - No crack-like indications from visual inspection - Uneven surface in connection to the weld - Some asymmetric geometry - Marking: "3/19" and "H52-8", see Figure 4-16. This corresponds to the information about marking given in the certificate (Appendix A).
Part BJC/3	Starboard chain	1	<ul style="list-style-type: none"> - No crack-like indications from visual inspection - Uneven surface in connection to the weld - No significant wear/deformation marks. - See Figure 4-17
		2	<ul style="list-style-type: none"> - Crack-like indication towards link 3 - Uneven surface in connection to the weld - No significant wear/deformation marks. - See Figure 4-18

Figure 4-15 BJC/1 – Link 5 after cleaning. No crack-like indications. Some interlink wear, indicated by arrows.

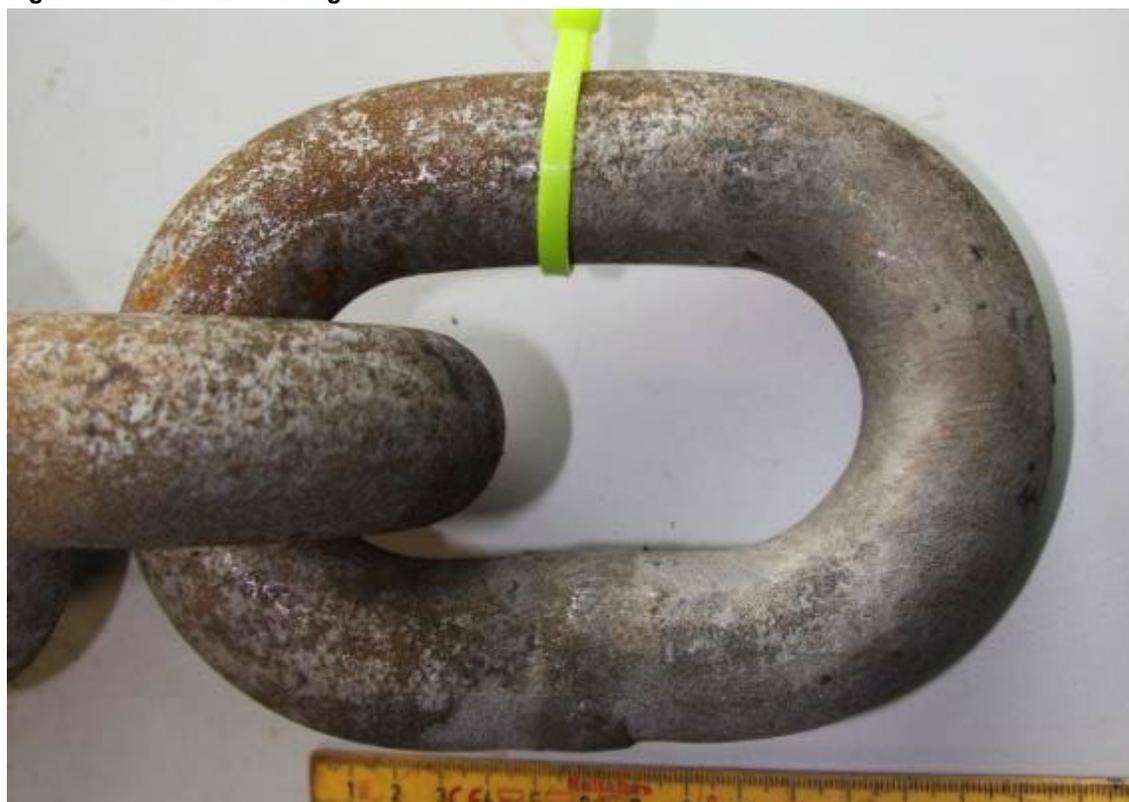
Figure 4-17 BJC/3 – Link 1 after cleaning. No crack-like indications.

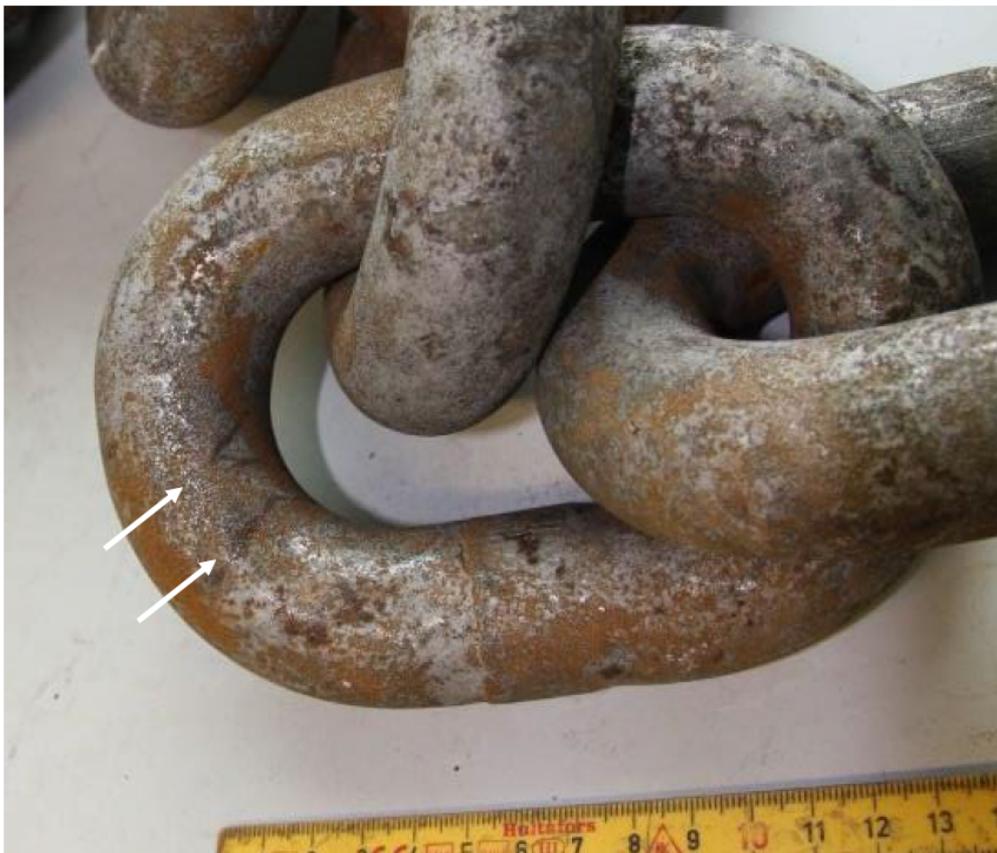
Figure 4-18 BJC/3 – Link 2 after cleaning. Possible crack-like indications, indicated by arrows.

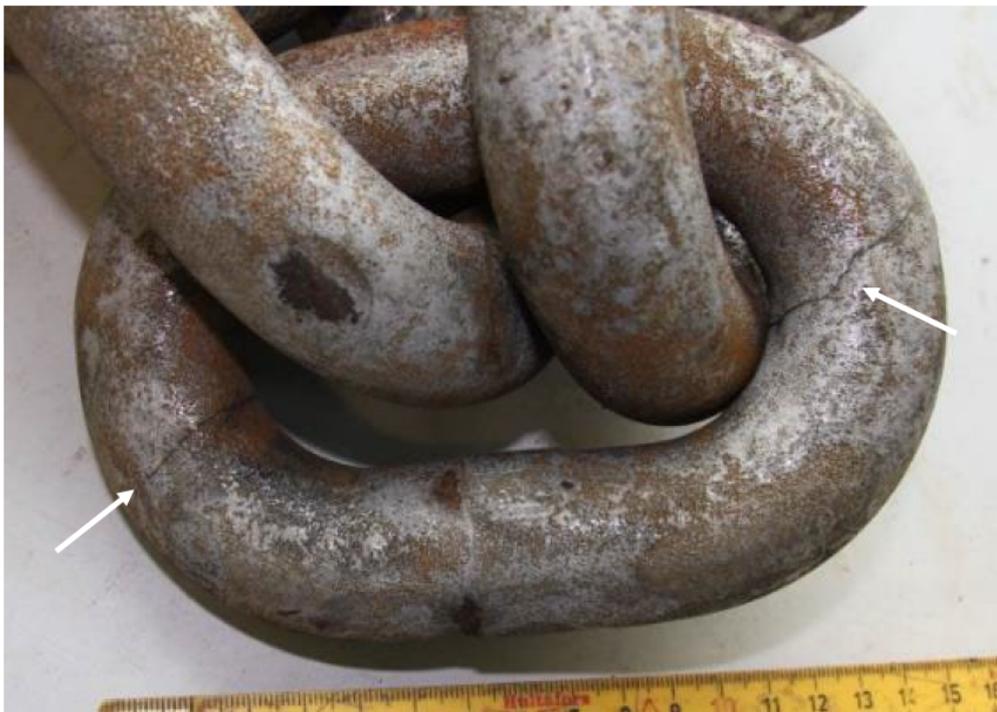
Figure 4-19 BJC/3 – Link 3 after cleaning. Crack-like indications observed, indicated by arrows.

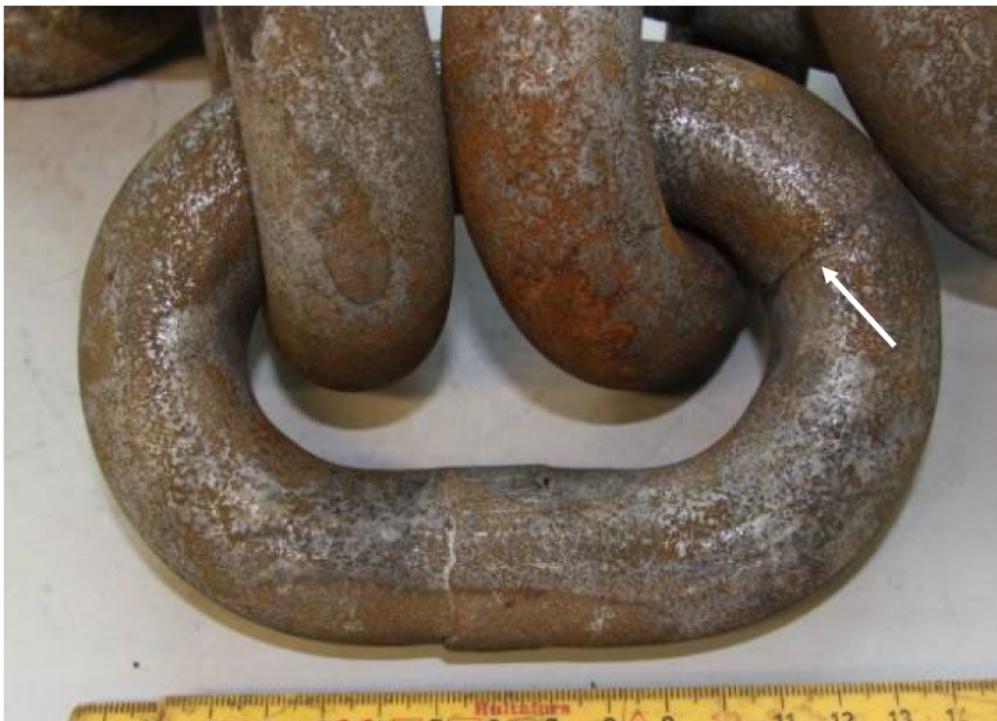
Figure 4-21 BJC/3 – Link 5 after cleaning. Crack-like indication towards link 4 is indicated by arrows.

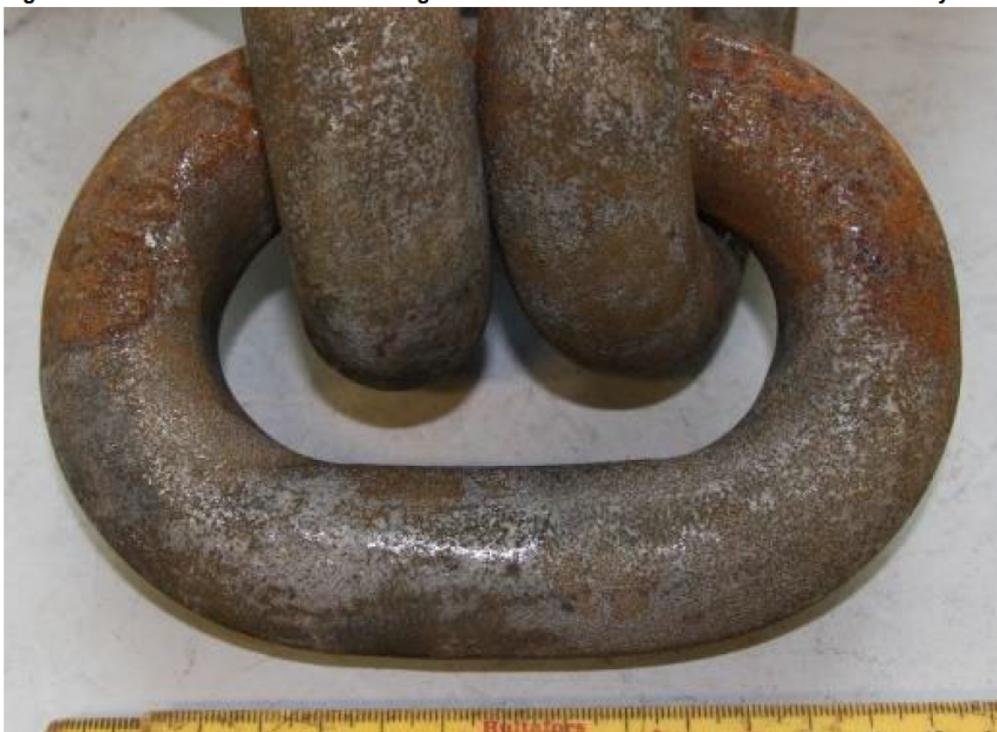
3	<ul style="list-style-type: none"> - Crack-like indications in both ends of the link. - The larger crack extends approximately 270° around the chain link circumference. - Uneven surface in connection to the weld - No significant wear/deformation marks. - See Figure 4-19
		4	<ul style="list-style-type: none"> - Crack-like indications in both ends of the link, also one crack close to the weld. - The larger crack extends approximately 360° around the chain link circumference. - Uneven surface in connection to the weld - No significant wear/deformation marks. - See Figure 4-20
		5	<ul style="list-style-type: none"> - Crack-like indication towards link 4 - The larger crack extends approximately 180° around the chain link circumference. - Uneven surface in connection to the weld - No significant wear/deformation marks. - See Figure 4-21
		6	<ul style="list-style-type: none"> - No crack-like indications from visual inspection - Uneven surface in connection to the weld - No significant wear/deformation marks, however an asymmetric geometry is seen. - See Figure 4-22

Figure 4-22 BJC/3 – Link 6 after cleaning. No crack-like indications, however some asymmetric geometry.

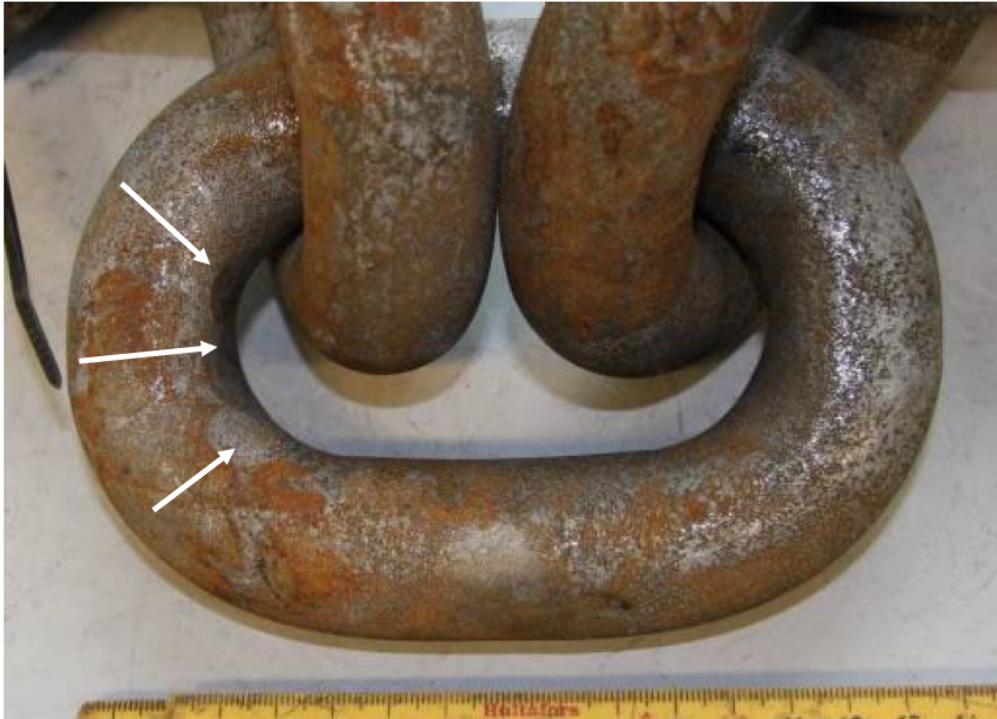
7	<ul style="list-style-type: none"> - No crack-like indications from visual inspection - Uneven surface in connection to the weld - Wear marks towards link 8, mainly on one side, towards both shoulders - See Figure 4-23
		8	<ul style="list-style-type: none"> - No crack-like indications from visual inspection - Uneven surface in connection to the weld - Wear marks towards both sides, towards both shoulders - See Figure 4-24
		9	<ul style="list-style-type: none"> - No crack-like indications from visual inspection - Uneven surface in connection to the weld - Significant wear marks towards both ends. Towards link 8, marks towards both shoulders, towards link 10, one main mark - See Figure 4-25
		10	<ul style="list-style-type: none"> - Visual crack-like indications in one end of the link and on one leg - Uneven surface in connection to the weld - Significant wear mark in one end of the link - Wear marks on side/shoulders - See Figure 4-26

Figure 4-23 BJC/3 – Link 7 after cleaning. No crack-like indications, however wear/deformation marks towards link 8, indicated by arrows.

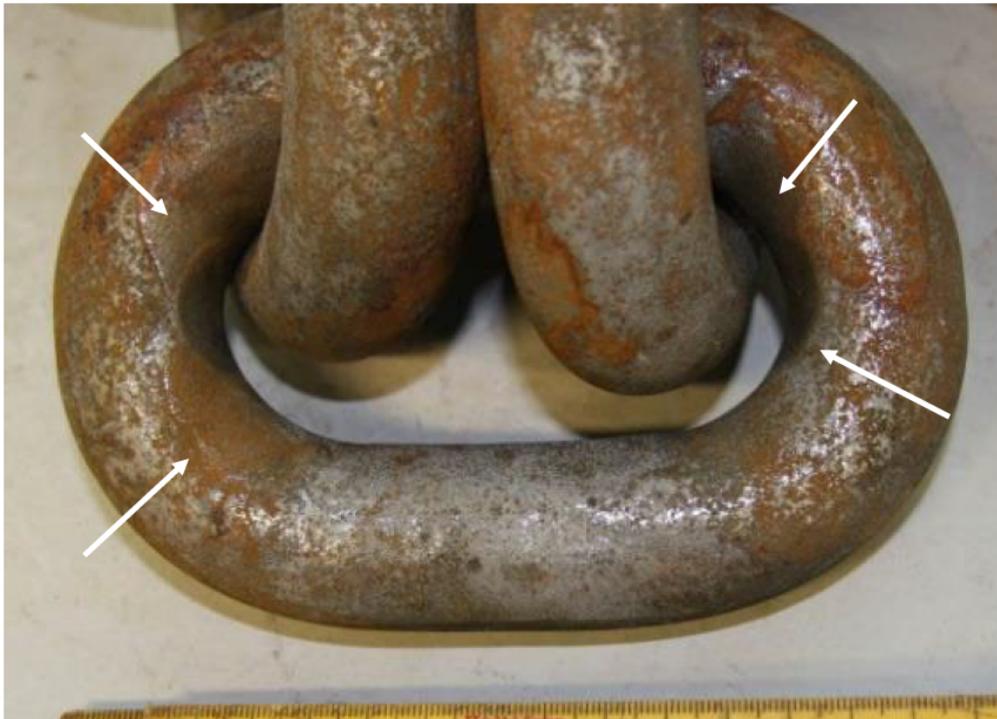
Figure 4-24 BJC/3 – Link 8 after cleaning. No crack-like indications, however significant wear/deformation in both the interlink areas.

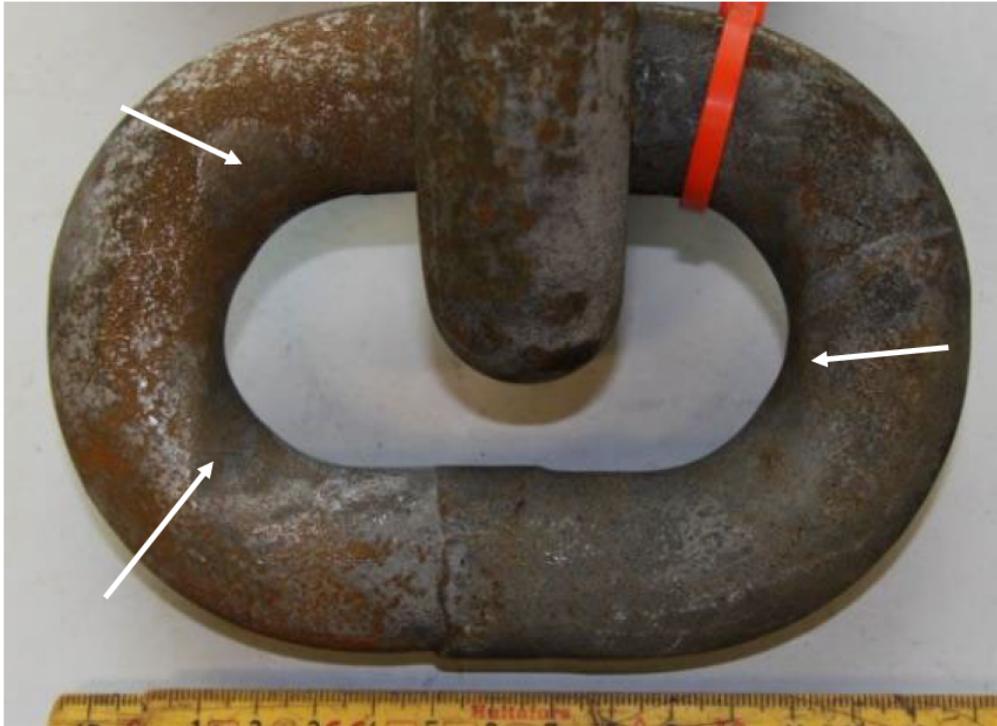
Part BJC/4	Part of fractured link, portside chain	6	See Paragraph 5.1 for visual examination
Part BJC/5	Part of portside chain, towards trawl	7	<ul style="list-style-type: none"> - No crack-like indications from visual inspection - Uneven surface in connection to the weld - Wear mark in both ends of the link. Against link 8, there are wear marks towards both shoulders. - See Figure 4-27

Figure 4-27 BJC/5 – Link 7 after cleaning. No crack-like indications, however significant wear/deformation of the interlink areas.

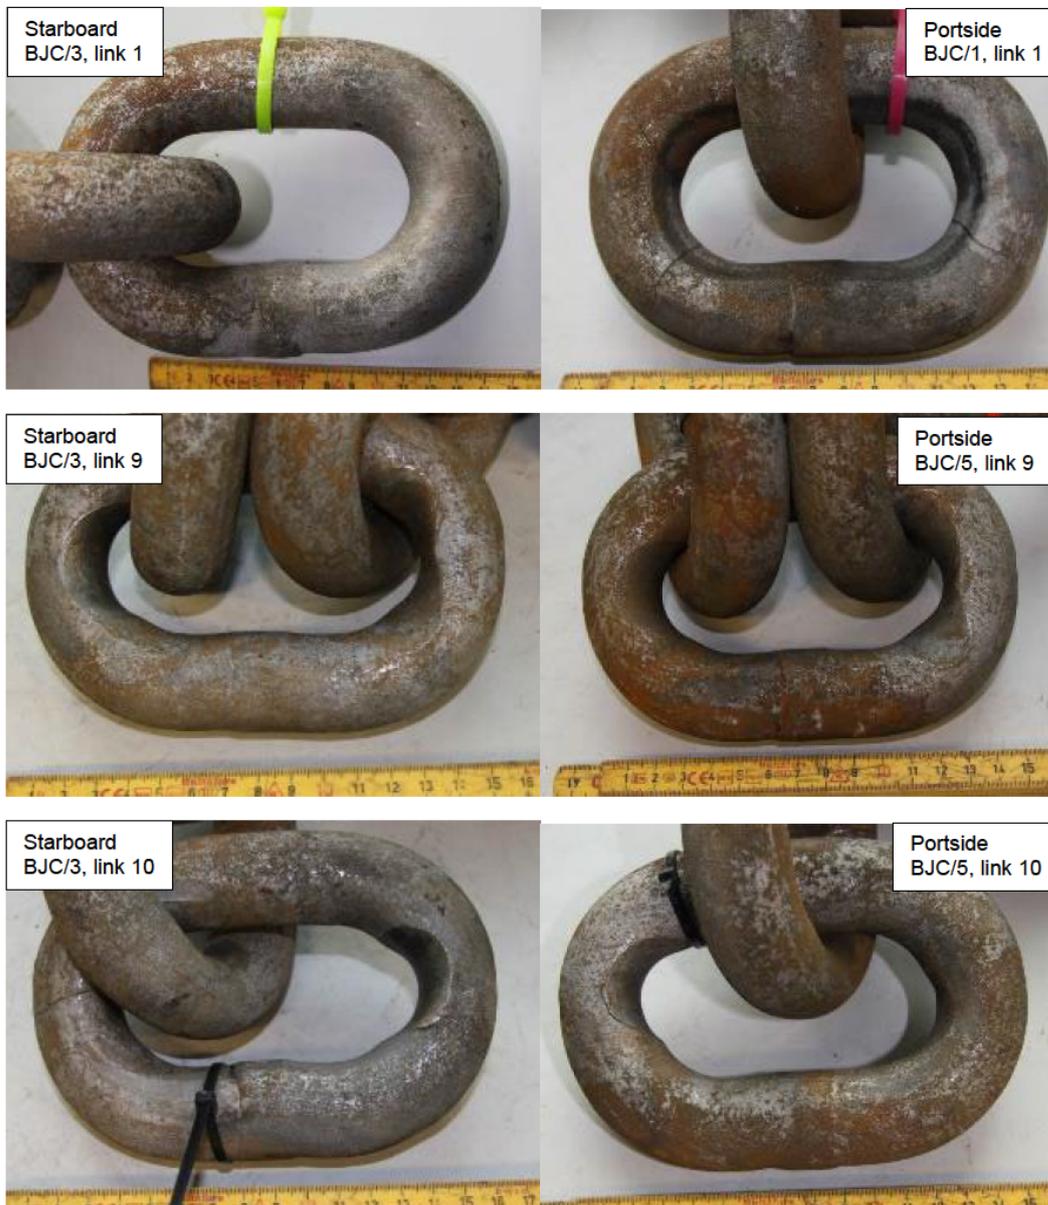
Figure 4-32 Comparison of wear pattern on links in corresponding position, between starboard and portside chain.

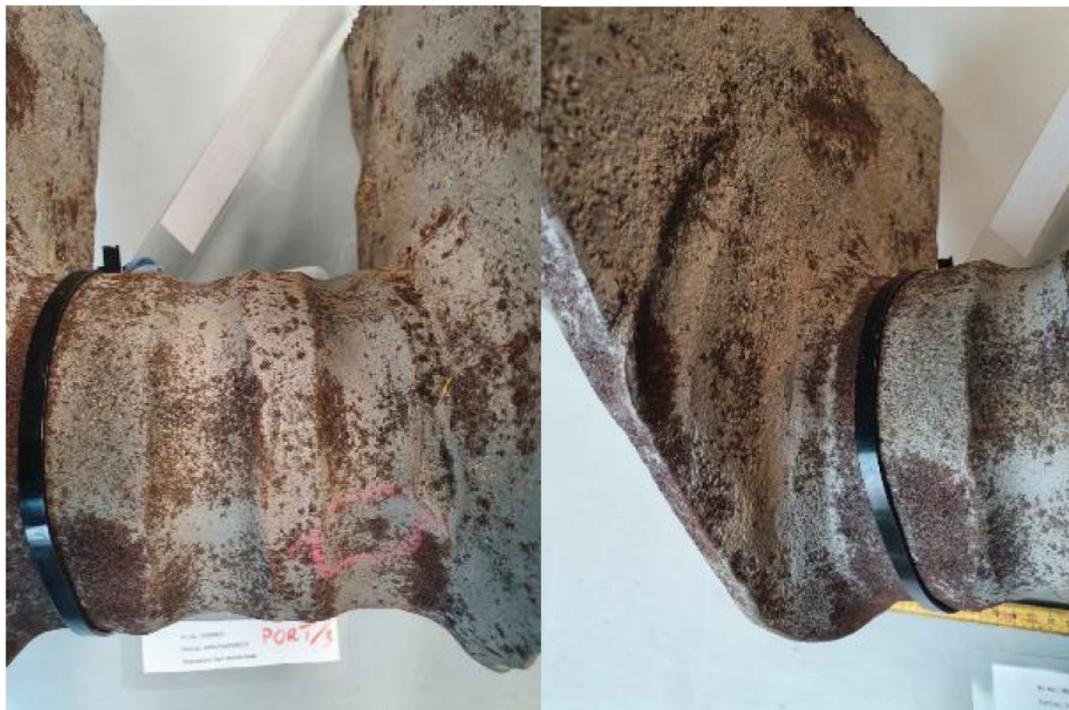
Figure 4-36 Portside derrick head. Wear on both pin (left image) and cheek plates (right image).

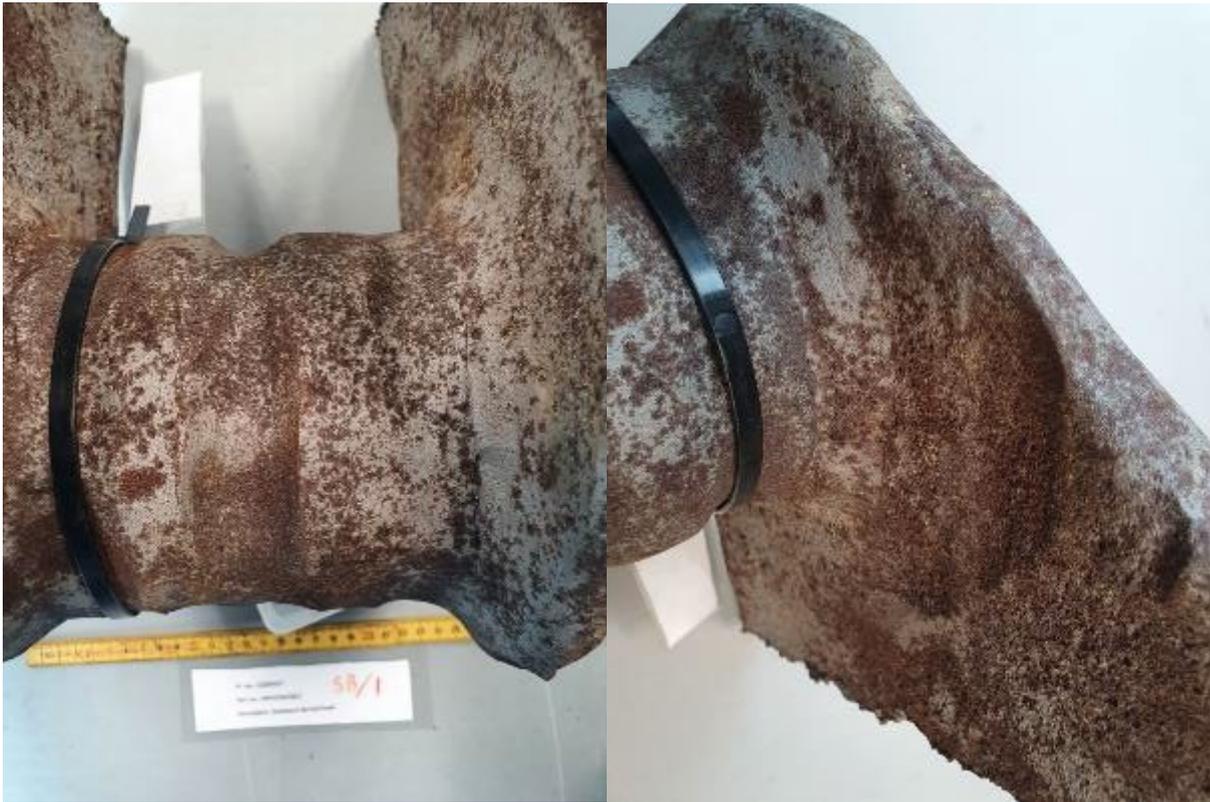
Figure 4-37 Starboard derrick head. Wear on both pin (left image) and cheek plates (right image).

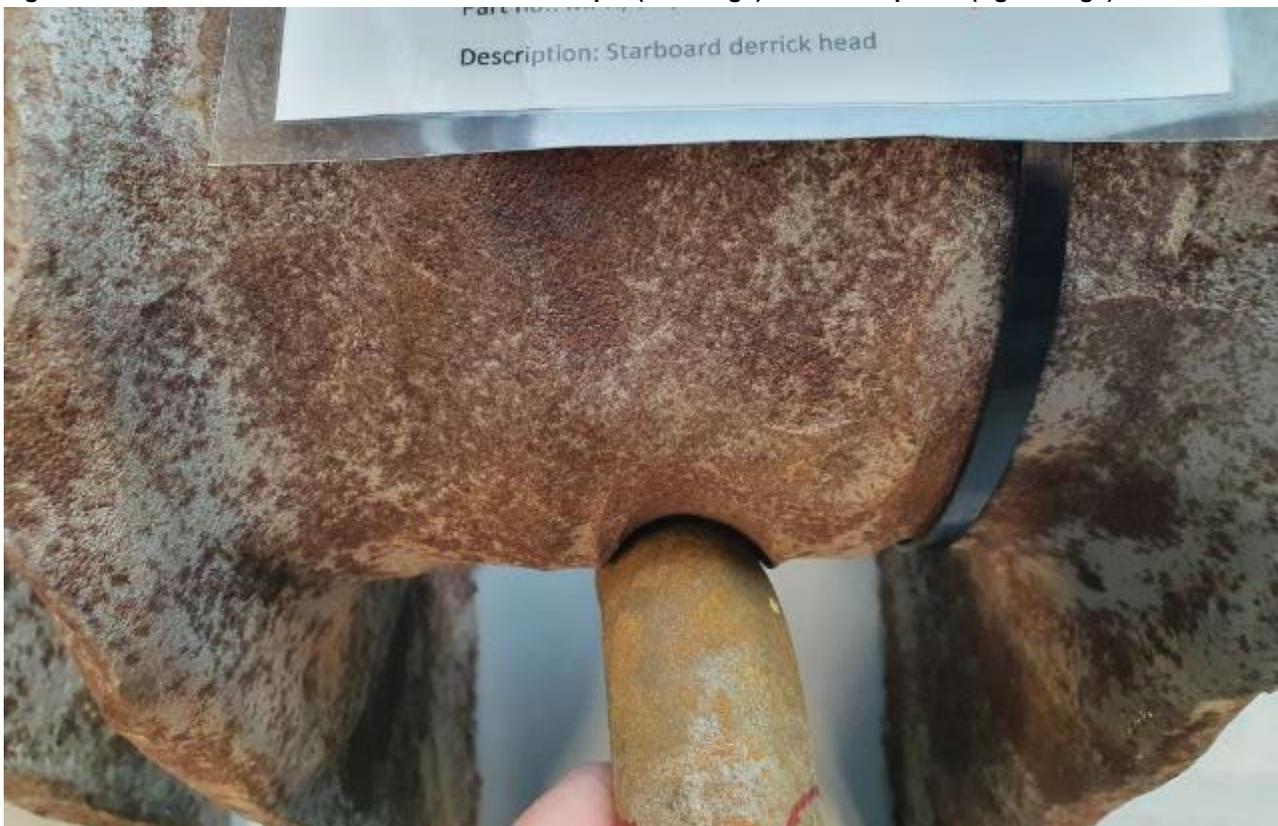
Figure 4-38 Starboard derrick head. Comparison between wear marks and chain.

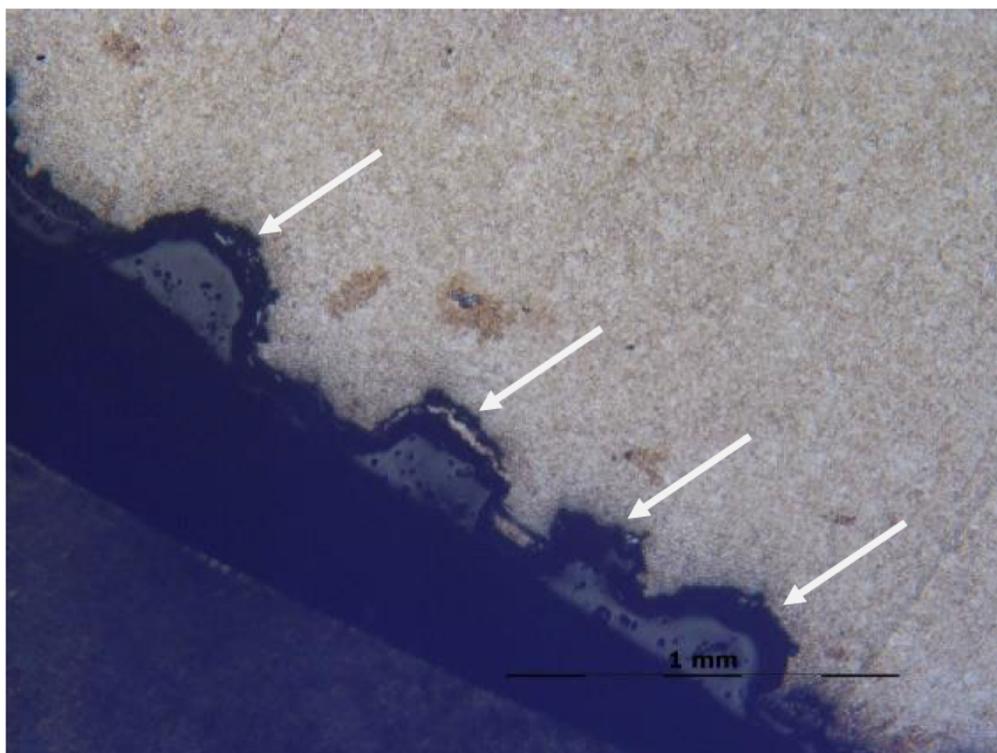
The cross sections also show examples of corrosion pits on the chain surface, see Figure 4-40.

Figure 4-40 Typical examples of corrosion pits on the link surfaces, sample 1-5. Four major pits are indicated by arrows.

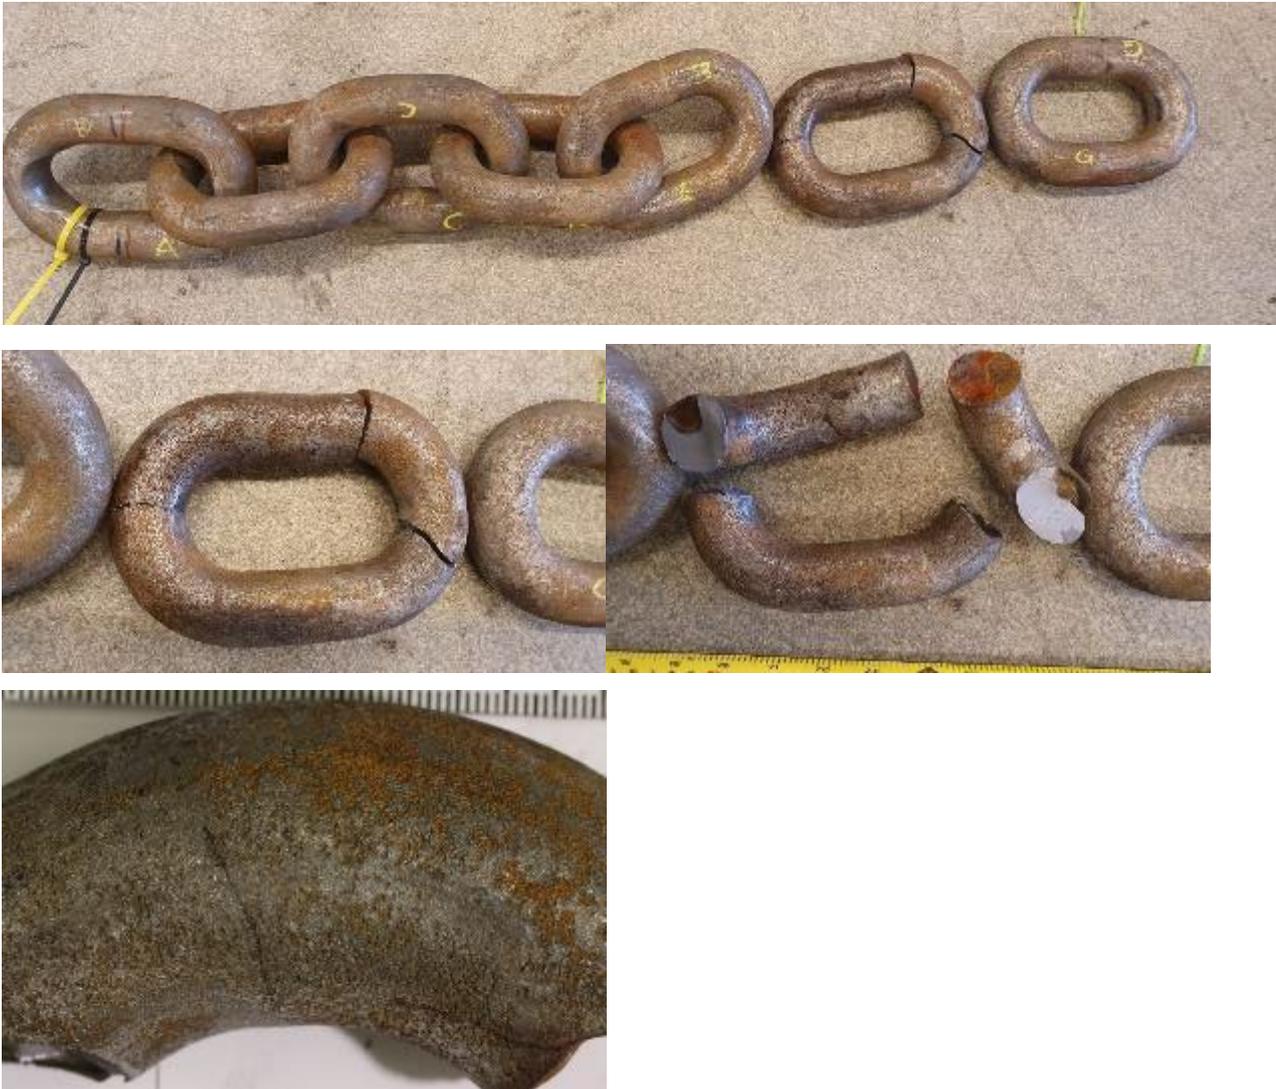
thickness of the link in service, meaning that the chain link has worked more or less like a C-hook during the last time in service. No significant plastic deformation is seen for the fractured link. The fractures correspond to the crack-like indications seen prior to testing, see Figure 4-20.

Figure 4-48 Break load testing of starboard chain. The upper image shows the whole length after break load testing, the lower images show the fractured link. The letters on the chain links are for internal use only. The strips used for marking are shifted to the end links after cutting, to ensure that the orientation is kept. The yellow strip on link 3 (link to the right) was loosened during testing, however, is included in the images.

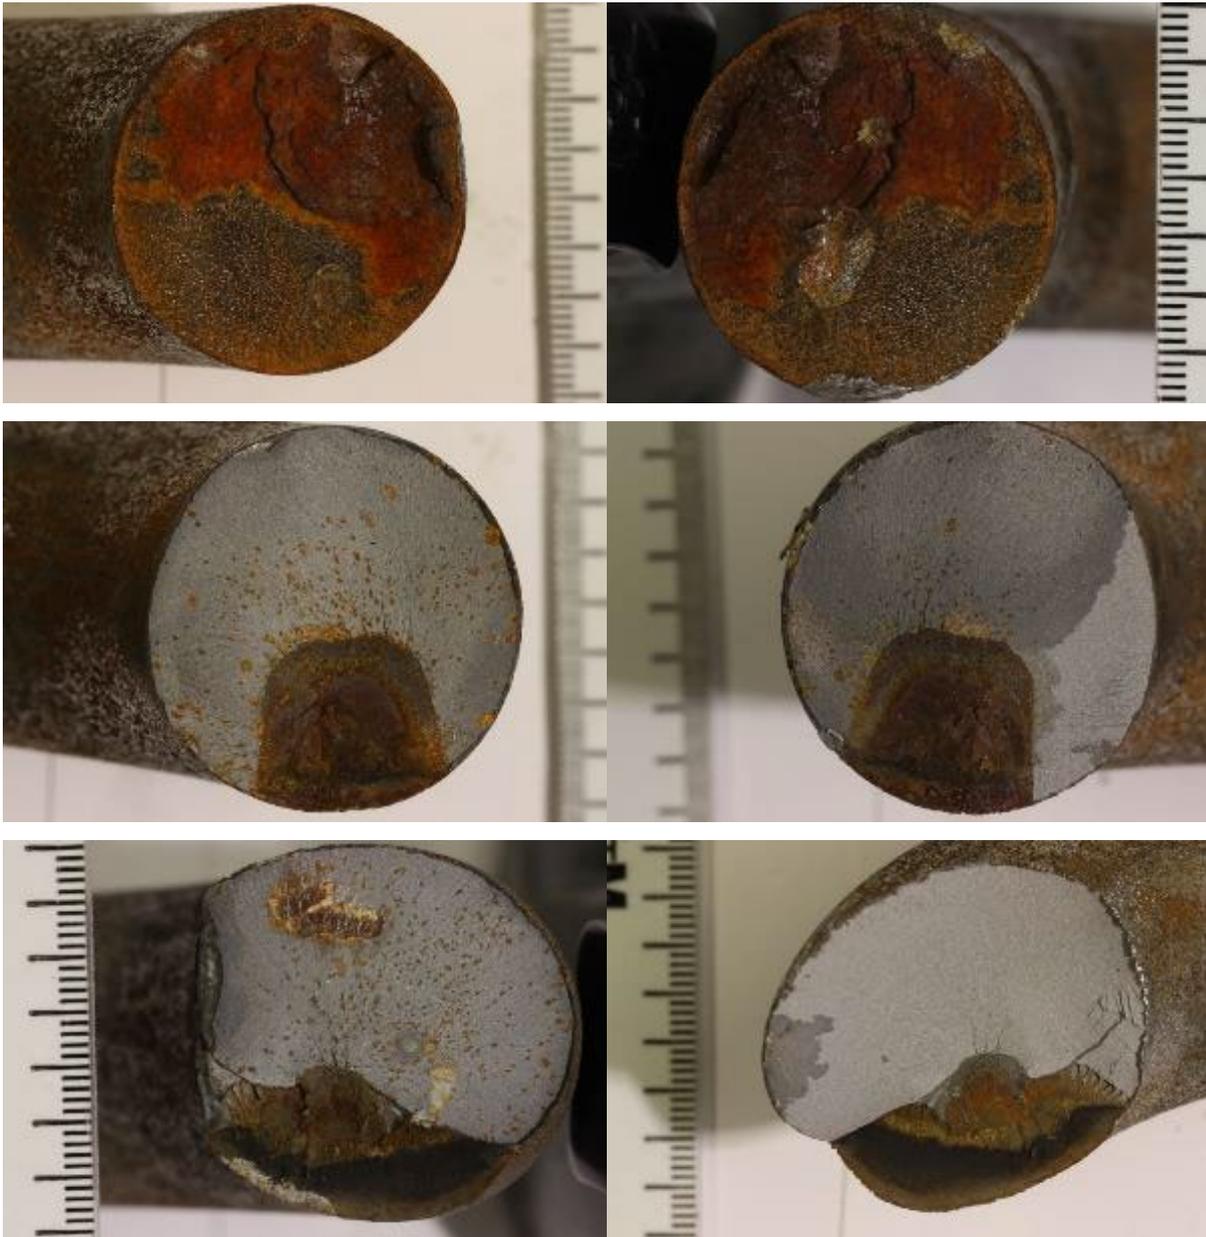
Figure 4-49 Break load testing of starboard chain. All three fracture surfaces have areas of cracks present in the chain prior to testing, seen as rust-coloured area.

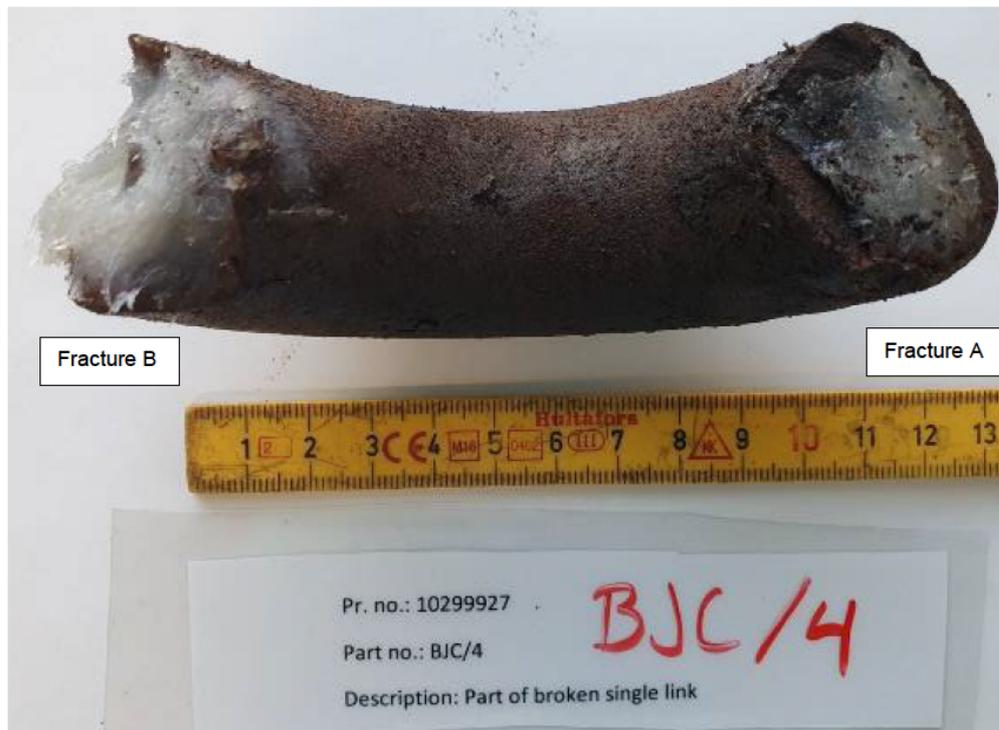
Corrosion is observed on both fracture surfaces.

Figure 5-1 BJC/4 – Fractured link: As received. The fracture surfaces were protected using grease.

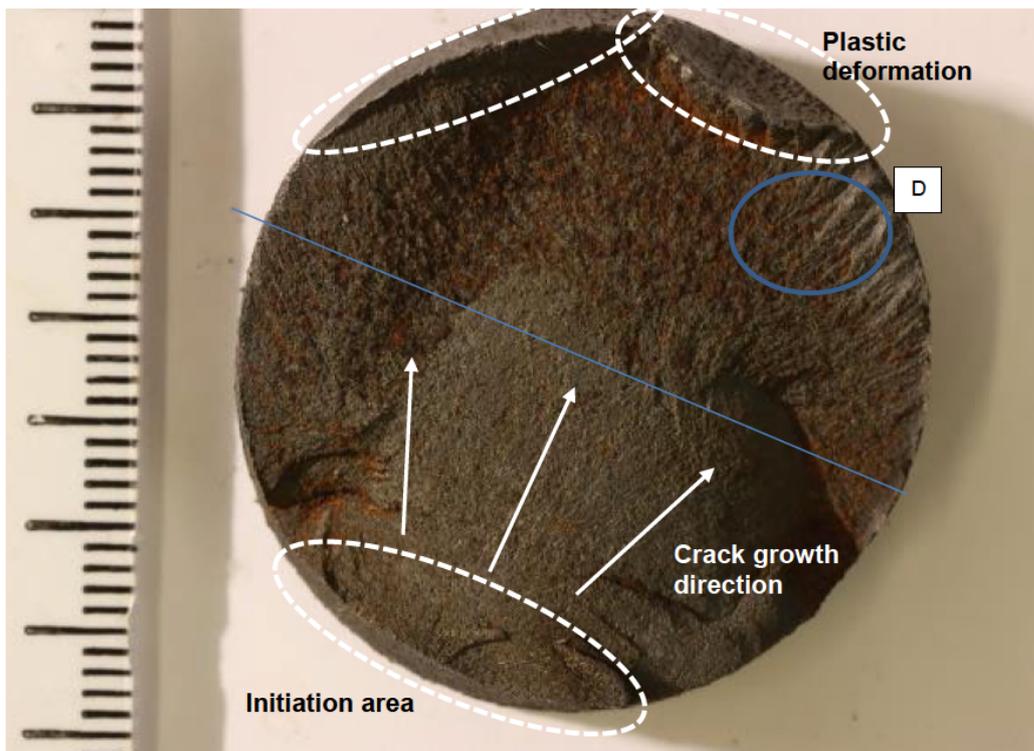
Figure 5-5 Overview image showing fracture surface A after careful chemical cleaning. The marked Area D refers to the SEM image given in Figure 5-16. The approximate position of the line between the intrados and the extrados (inner and outer curve) is included as a blue line, as the curvature of the link cannot be seen. Fracture initiation area and crack growth direction (white arrows) are included in the lower part of the figure. The latter shown by the white arrows. Plastic deformation is shown in the upper part of the image.

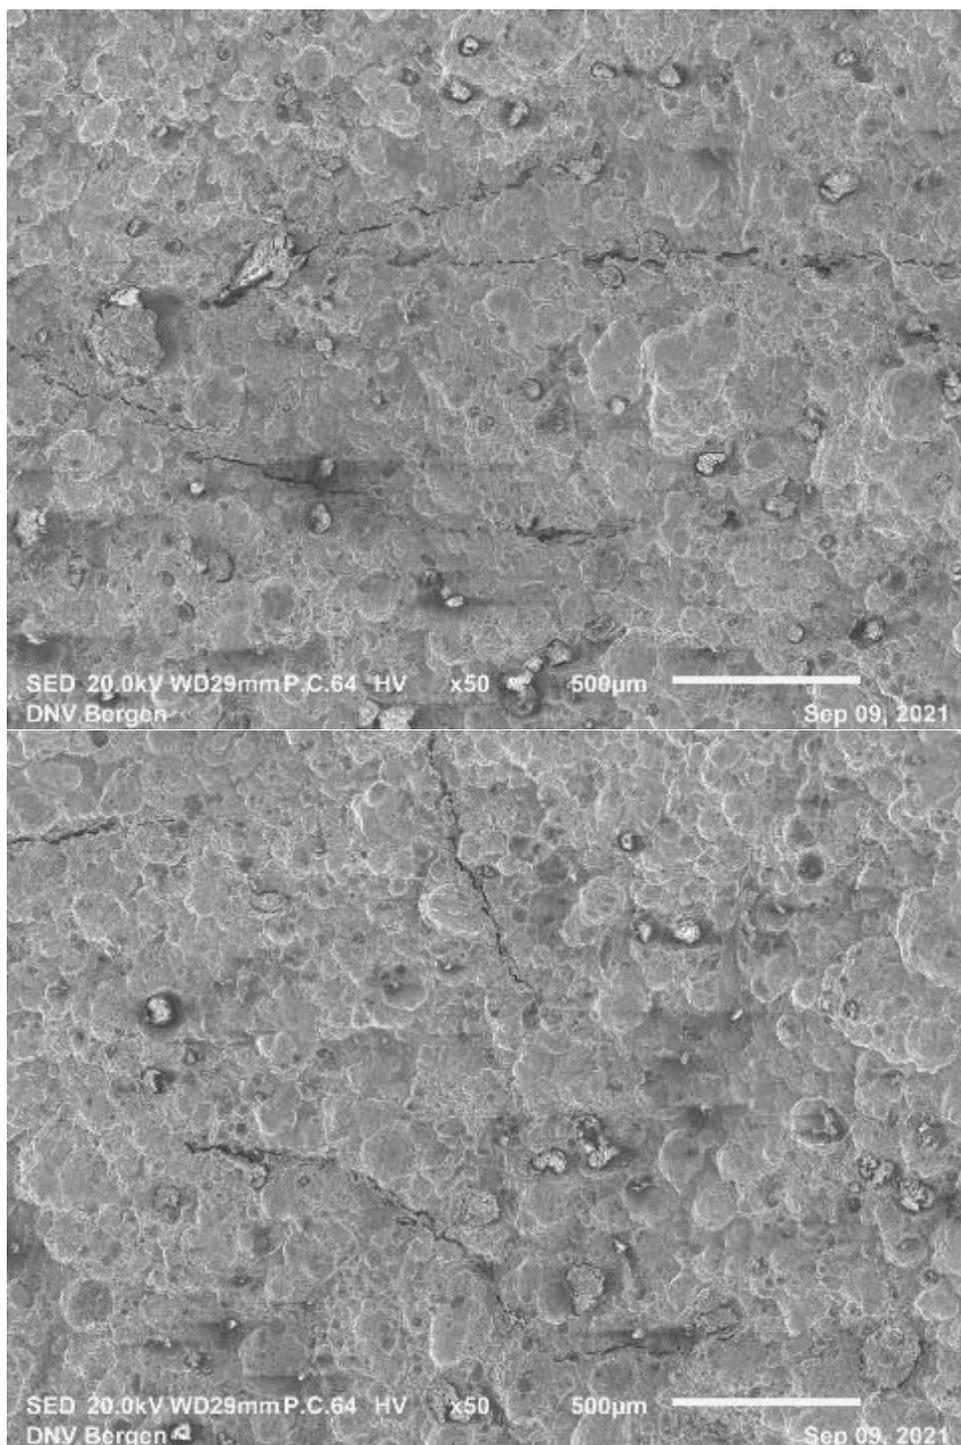
As shown in Figure 5-9, an area of multiple cracking is found on the chain link surface, close to the fracture initiation area. It is noted that most of the cracks are parallel to the fracture surface, however a crack nearly perpendicular to the fracture is also found. The cracks have a jagged appearance on the link surface, indicating to intergranular cracking.

Figure 5-9 Fracture A: Cracks in the chain link surface, below the crack initiation area.
