Failure of chain link investigation on board *Cornishman* report no. 2021-5360

FAILURE OF CHAIN LINK ONBOARD CORNISHMAN

Failure investigation

Report No.: 2021-5360, Rev. 0

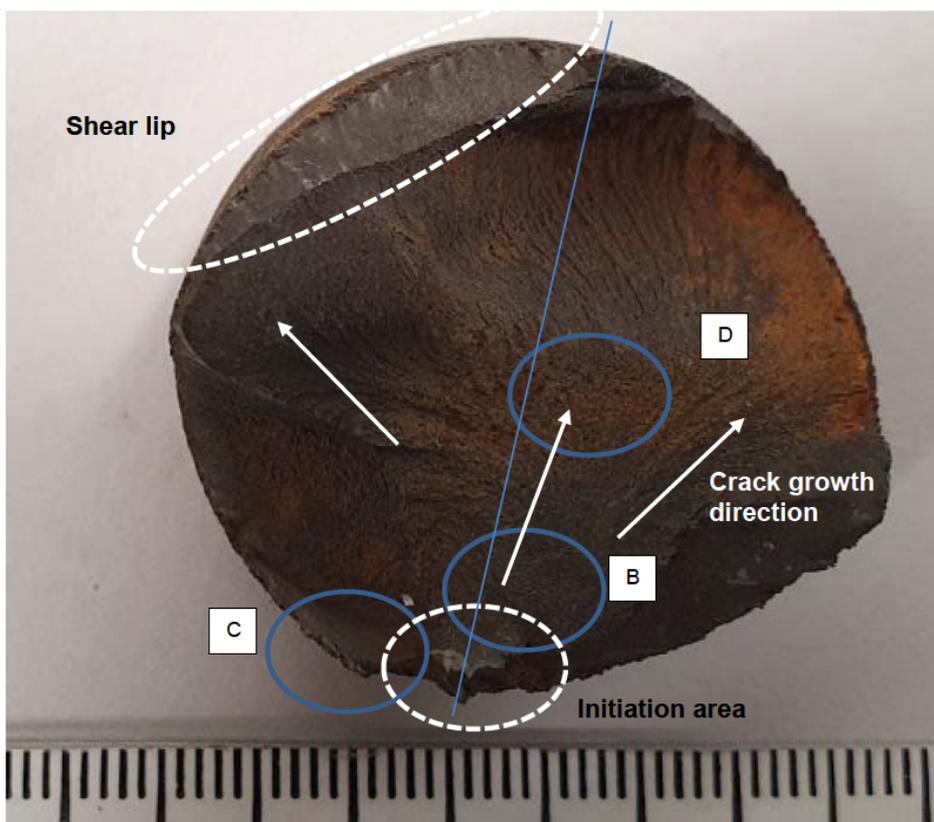
An overview image showing fracture B after careful cleaning using inhibited hydrochloric acid, is shown in Figure 5-17. This fracture surface has a rather rough initiation area, as is indicated in Figure 5-17 and at higher magnification in Figure 5-18. The main part of the fracture surface has a typical river-pattern, as is shown at higher magnification in Figure 5-19. This crack has initiated approximately from the intrados (inner curve) of the chain. A shear lip is observed ca 90-180° from the initiation area, see Figure 5-20, and this is the last part of the chain link to have fractured.

Figure 5-17 Overview image showing fracture surface B after careful chemical cleaning. Fracture initiation area, crack growth direction and shear lip are included in the figure. The marked areas B, C and D refers to a SEM image. The approximate position of the line between the intrados and the extrados is included as a blue line, as the curvature of the link cannot be seen in the image.

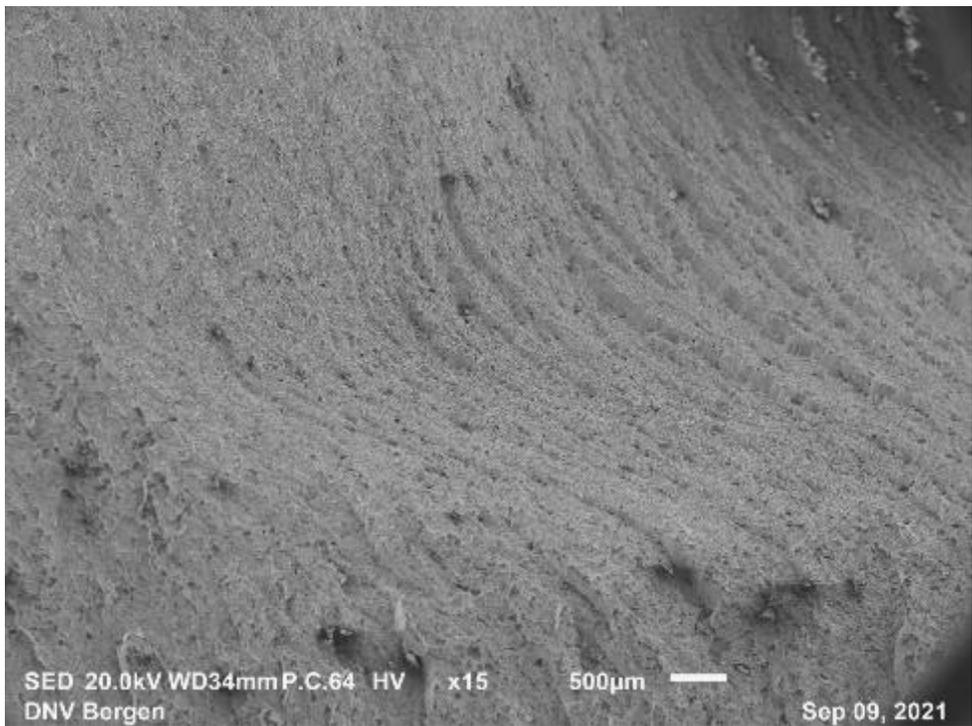
Figure 5-22 Fracture B, area D: Main part of fracture surface, river pattern.

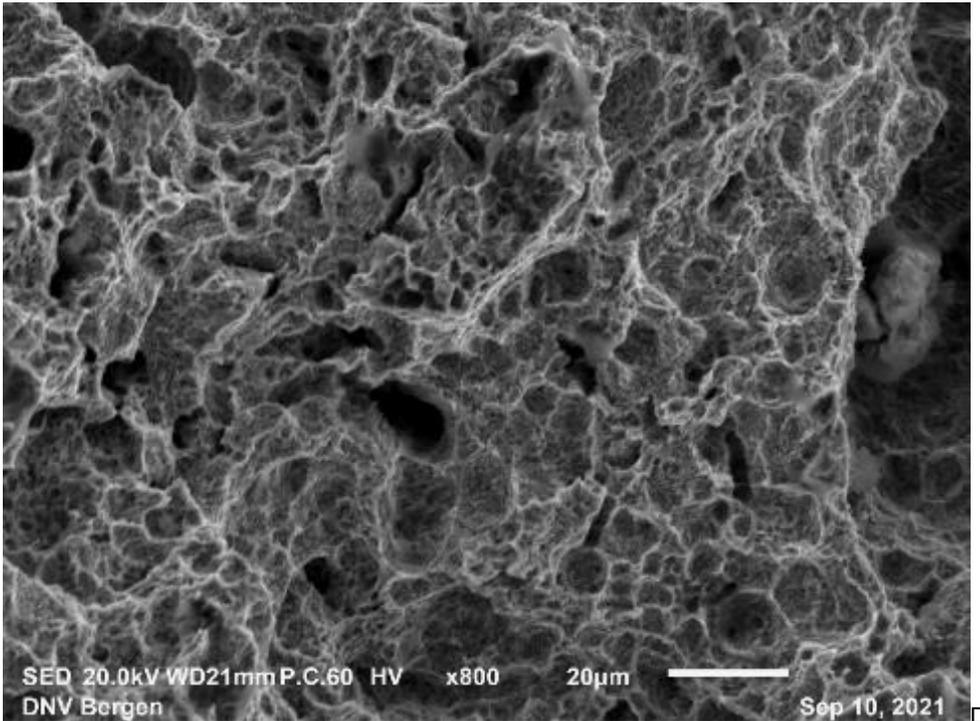
Figure 5-27 Fracture B, area D: Main part of fracture surface. Corrosion and/or dimple fracture topography.

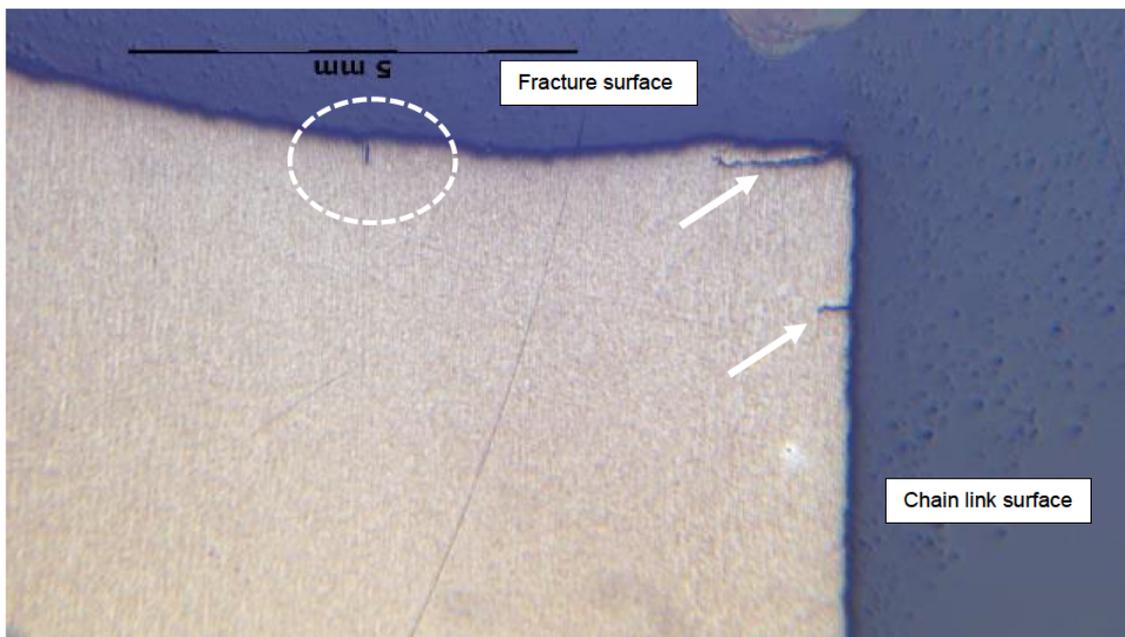
Figure 5-28 Overview image showing the cross section through the initiation of fracture A. Two cracks parallel to the fracture surface (shown with arrows), as well as one inhomogeneity perpendicular to the fracture surface (marked by a dotted circle), is seen. The photo is rotated for more logical presentation.

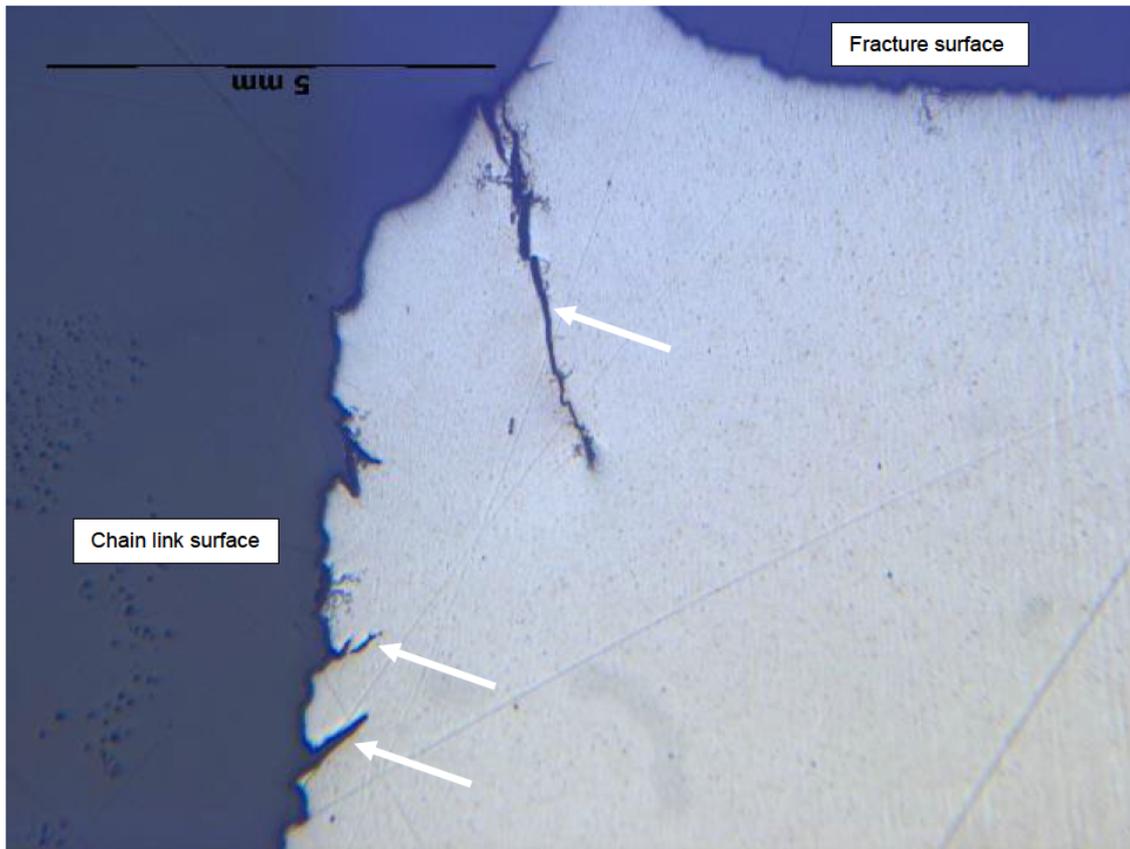
Figure 5-29 Overview image showing the cross section through the initiation of fracture B. Several cracks (shown with arrows) close to the initiation area are seen. The photo is rotated for more logical presentation.

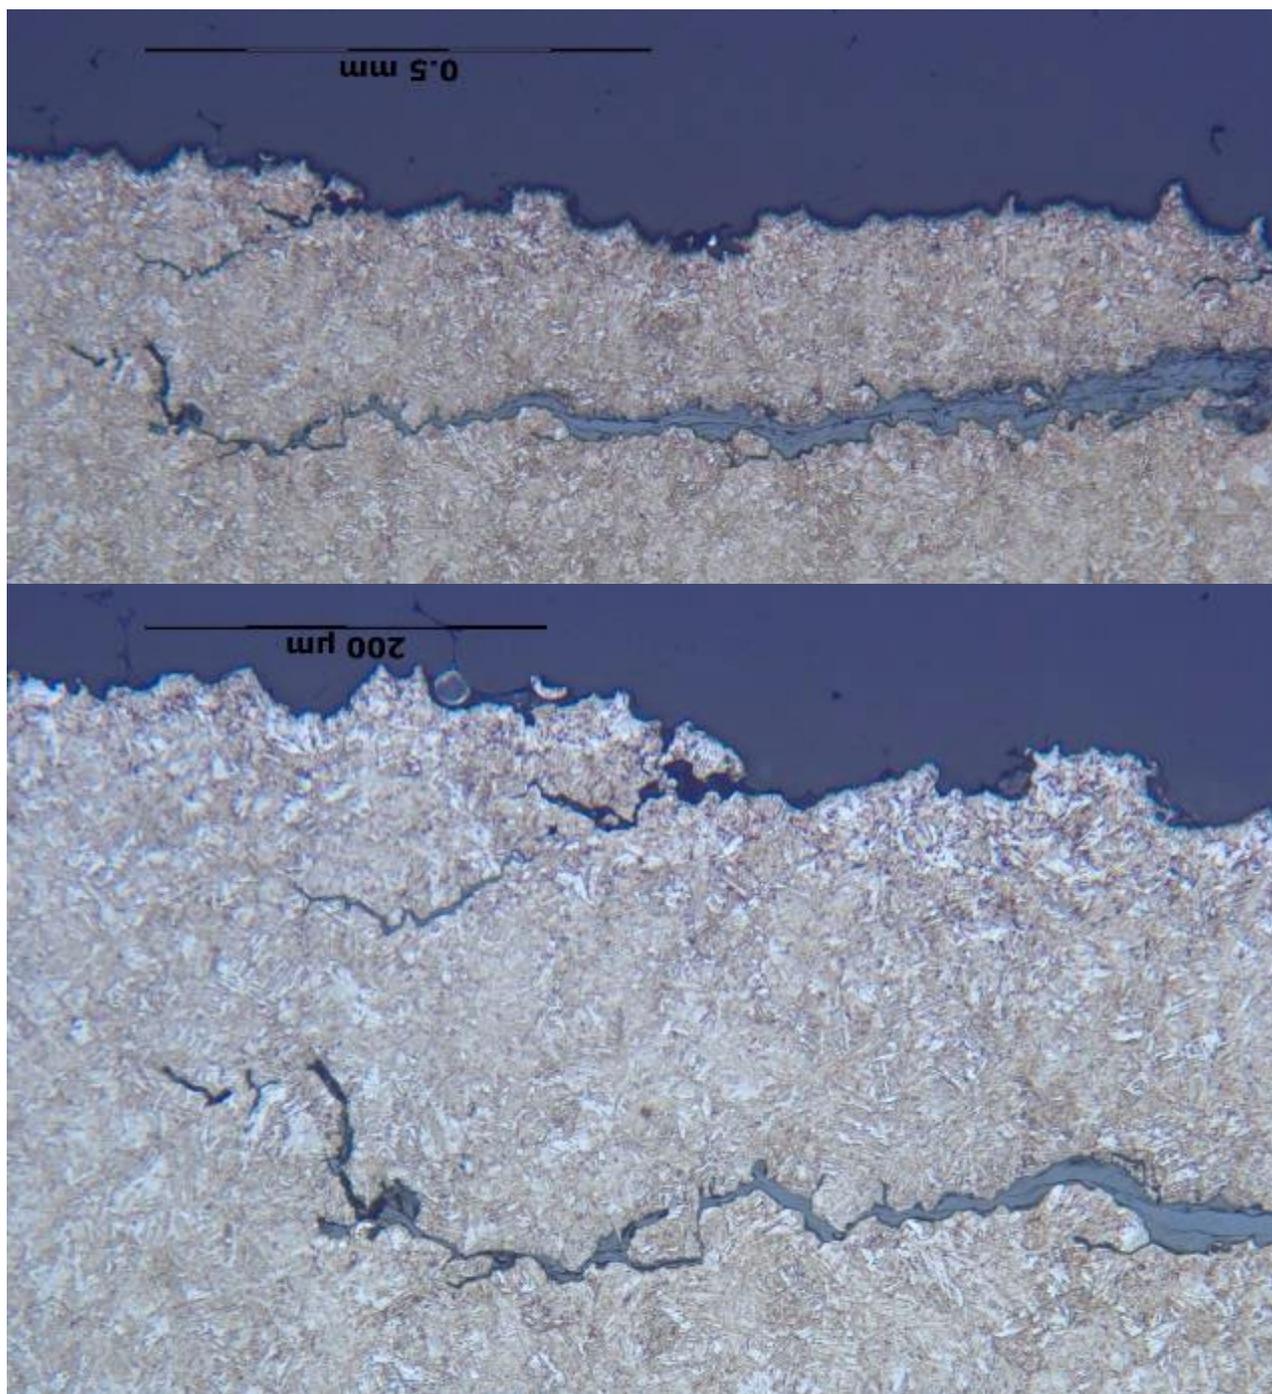
Figure 5-30 Fracture surface A: Crack close to fracture initiation area. The photos are rotated for more logical presentation

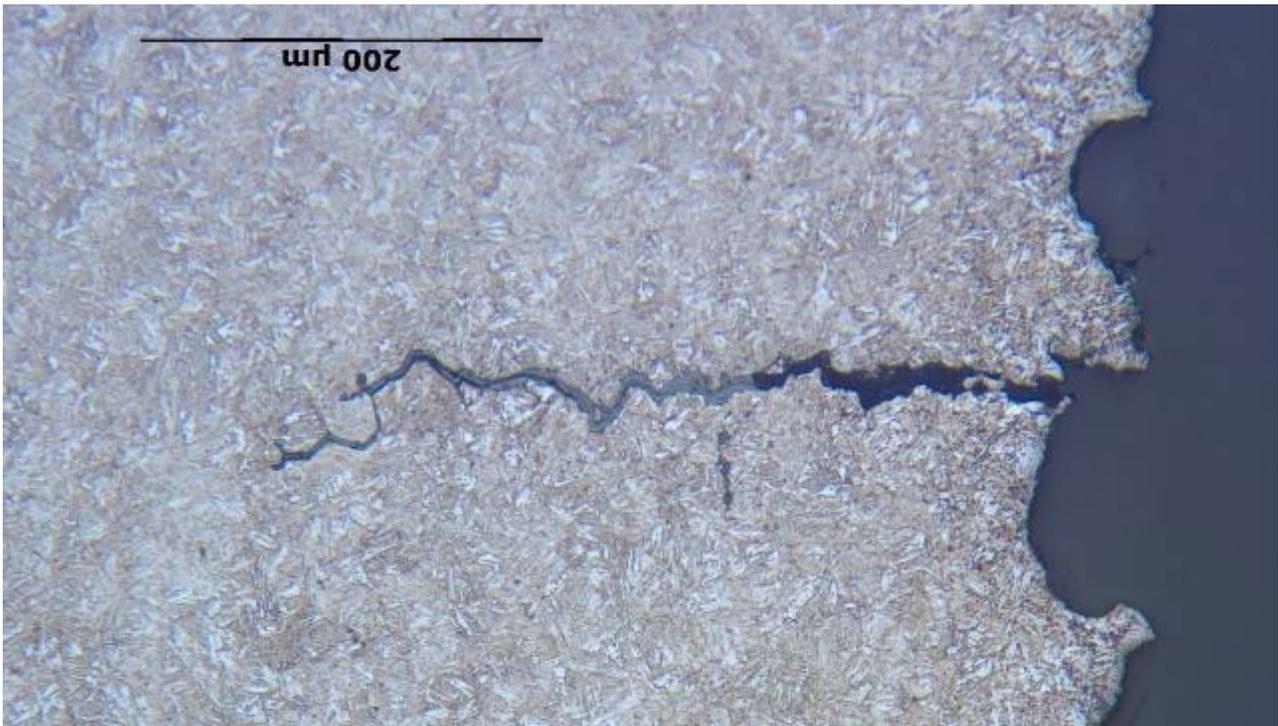
Figure 5-31 Fracture surface A: Smaller crack close to fracture initiation area. The photo is rotated for more logical presentation

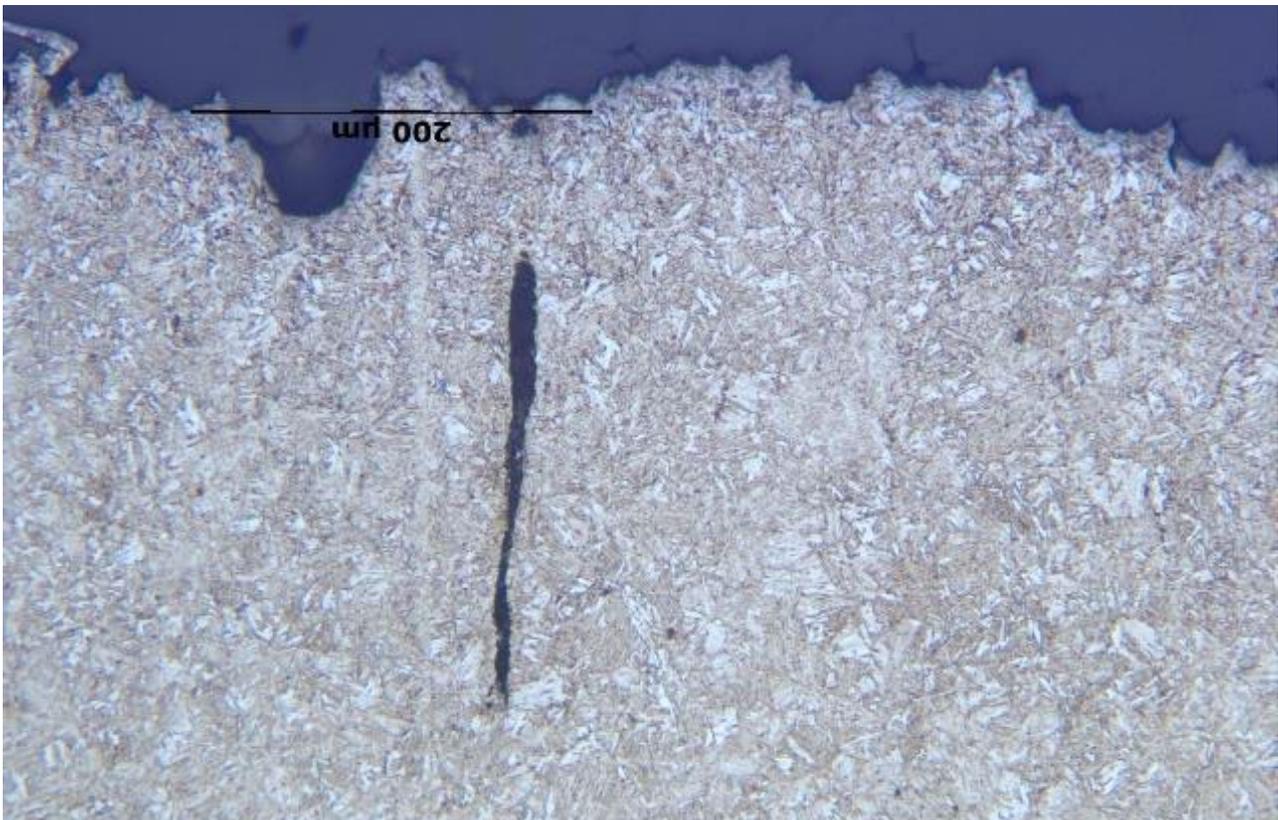
Figure 5-32 Fracture surface A: Longitudinal void close to fracture surface. The photo is rotated for more logical presentation

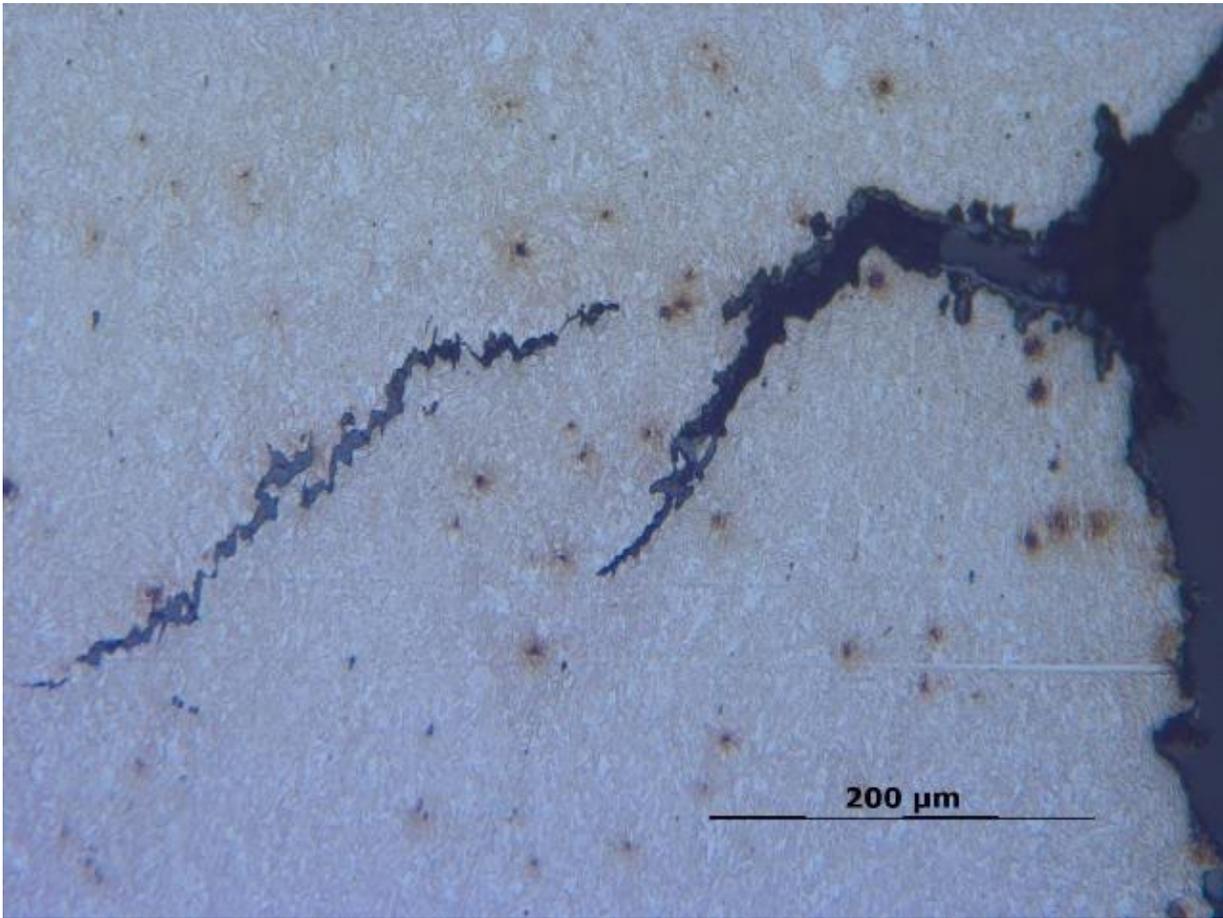
Figure 5-33 Fracture surface B: Large crack close to fracture initiation area.

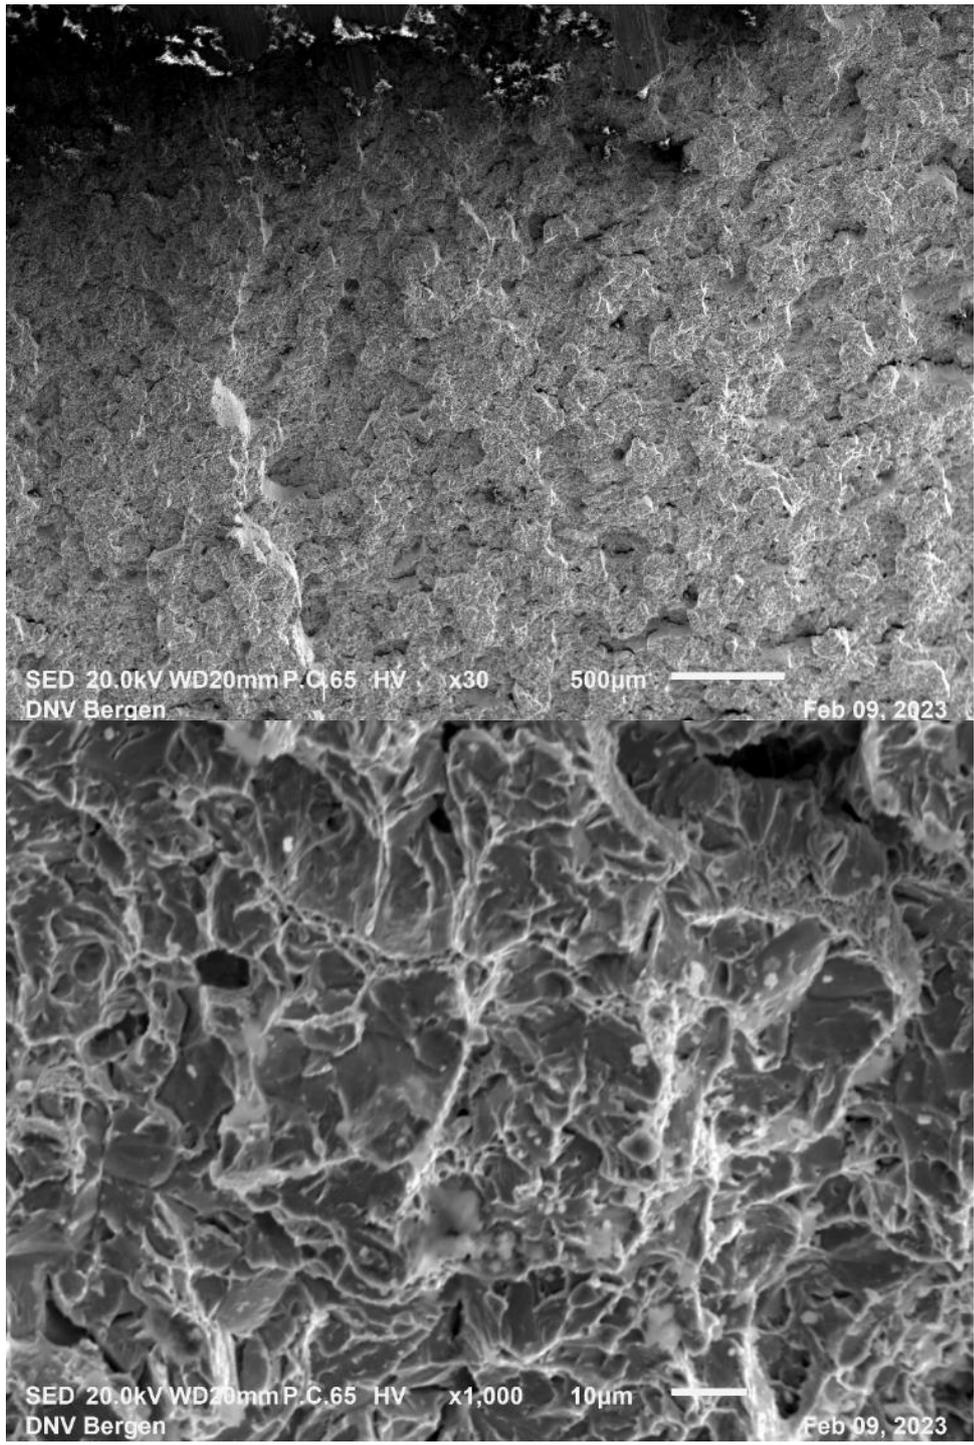
Figure 3-27 Part MJA/4, area 4: Mixture of intergranular cracking and cleavage fracture.

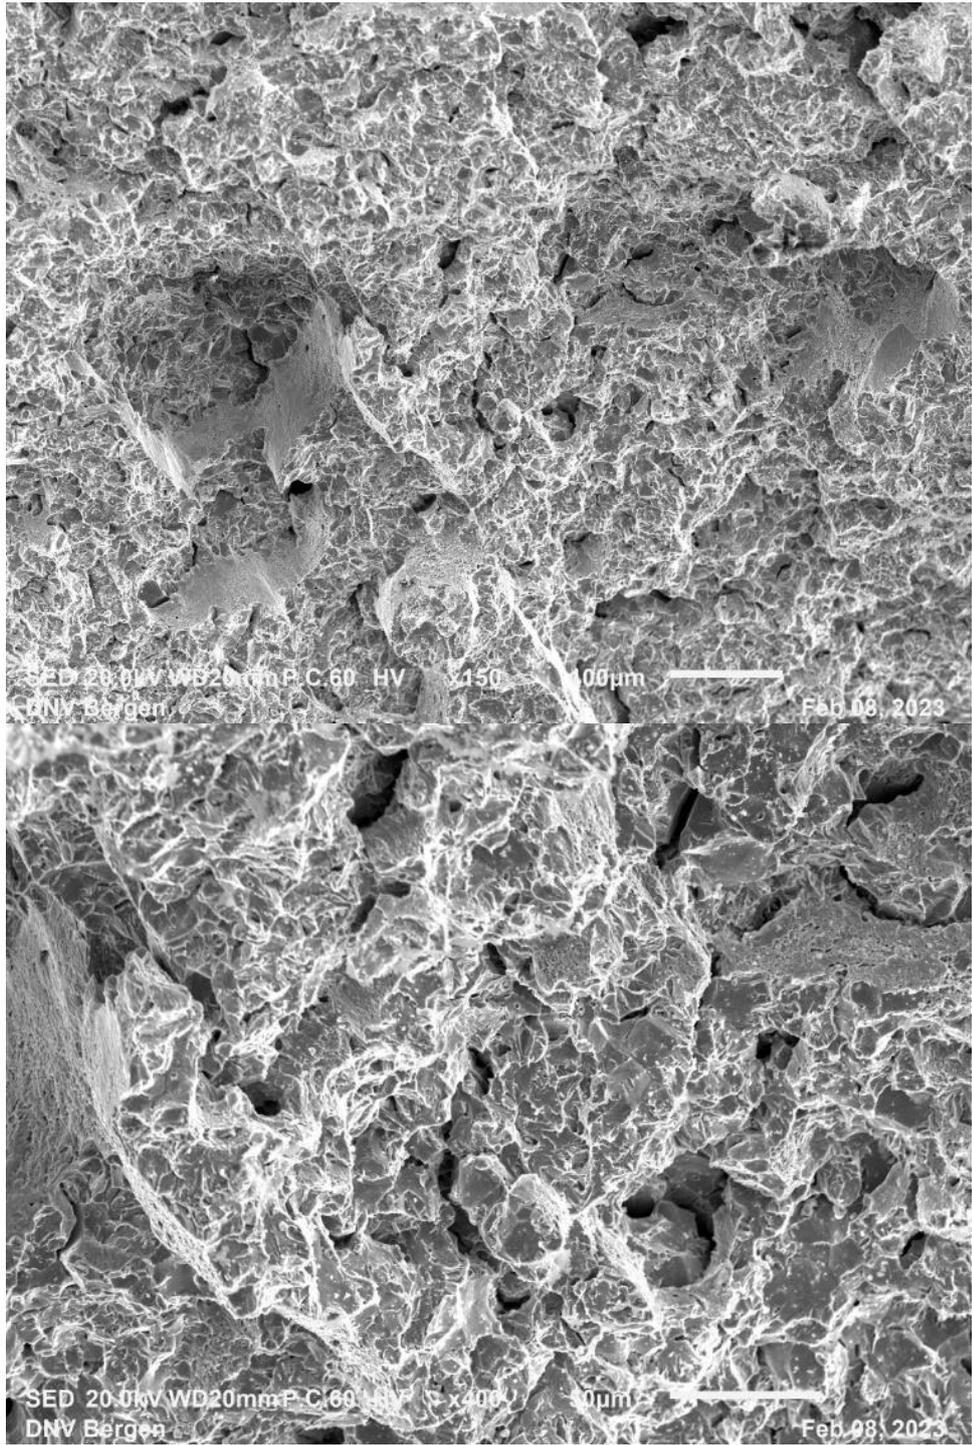
Figure 3-30 Part MJA/4, area 7: Mixture of intergranular cracking and cleavage fracture.

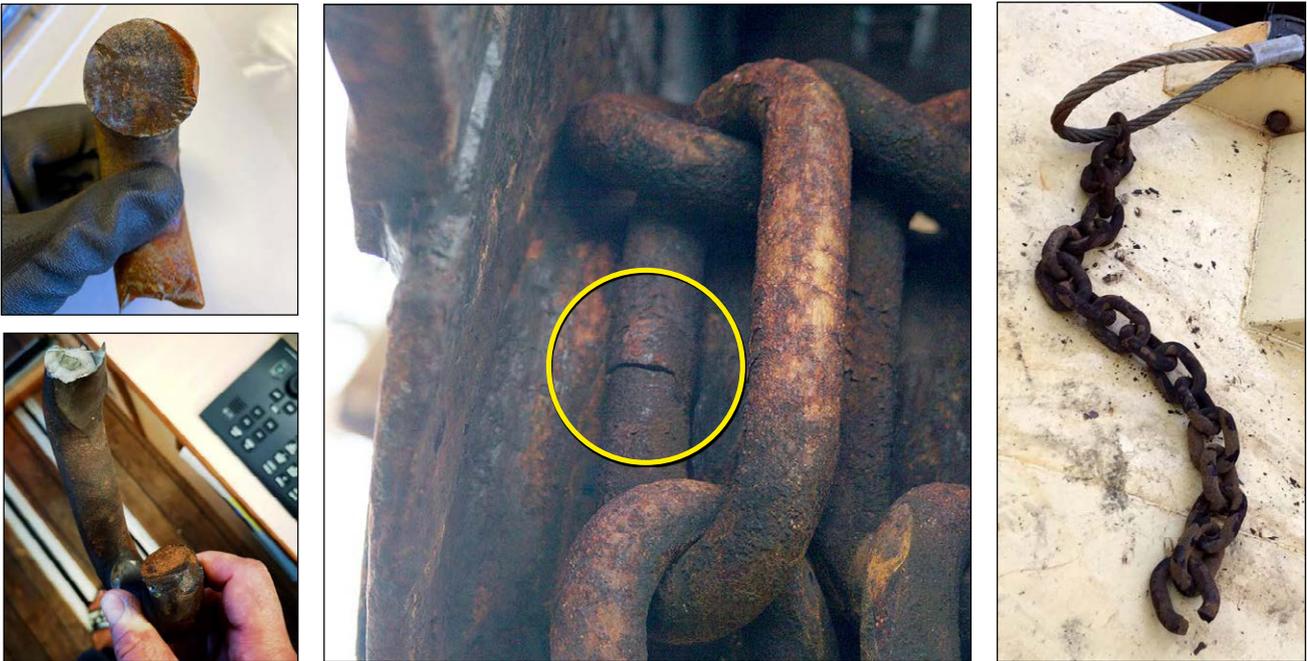
Figure 3: Identified chain defects in static pin arrangements

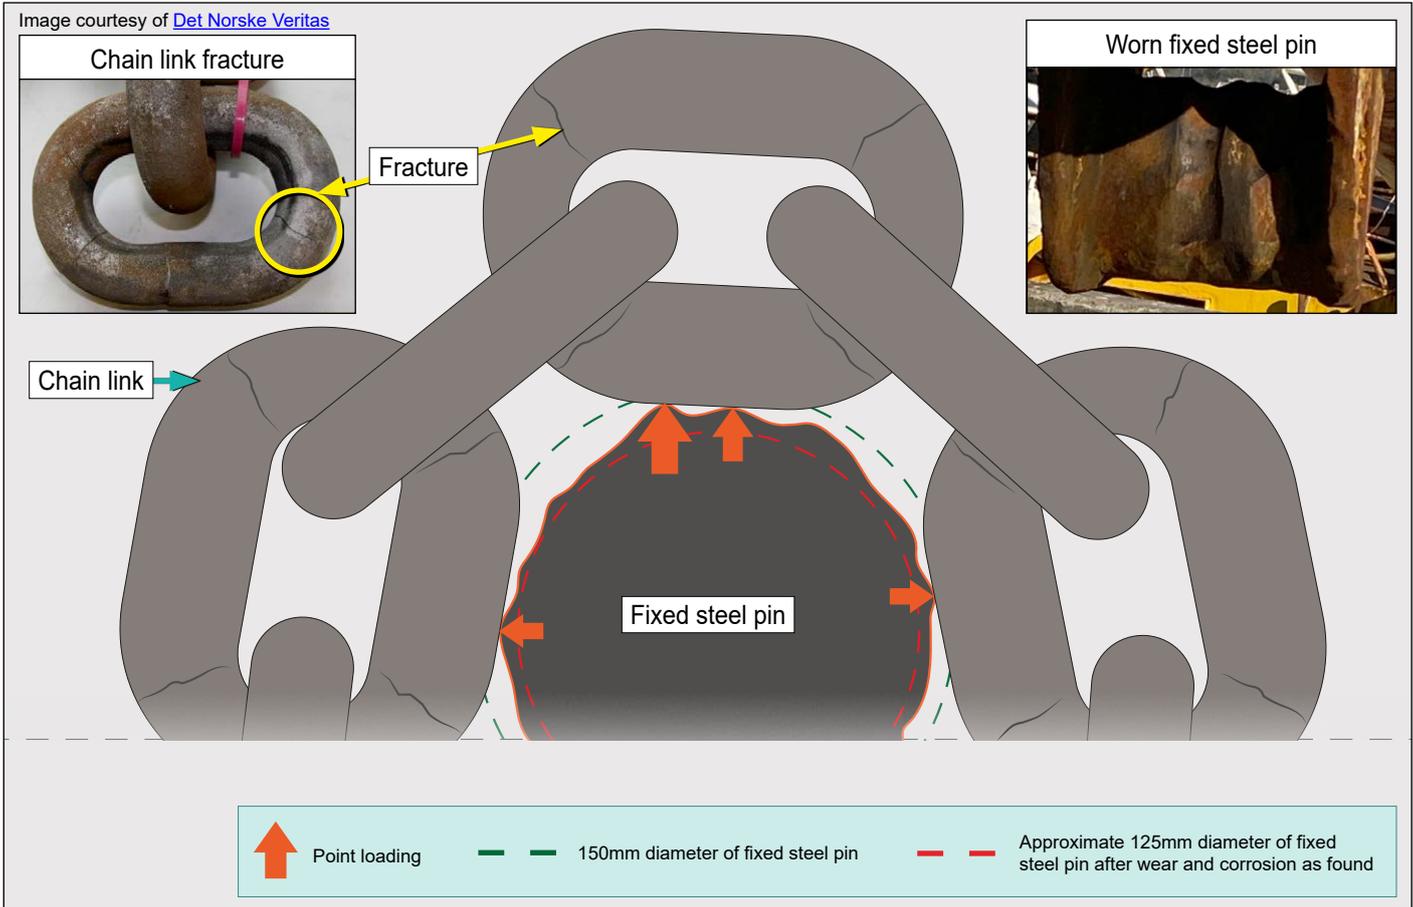
Figure 2: Representation of chain loading over fixed steel pin, showing links subjected to out of plane bending stress point loads
