Report on the investigation of  
the fatal accident to a deckhand on board the  
beam trawler

***Cornishman (PZ 512)***

44 nautical miles south-south-west of the Isles of  
Scilly, England

on 6 February 2021

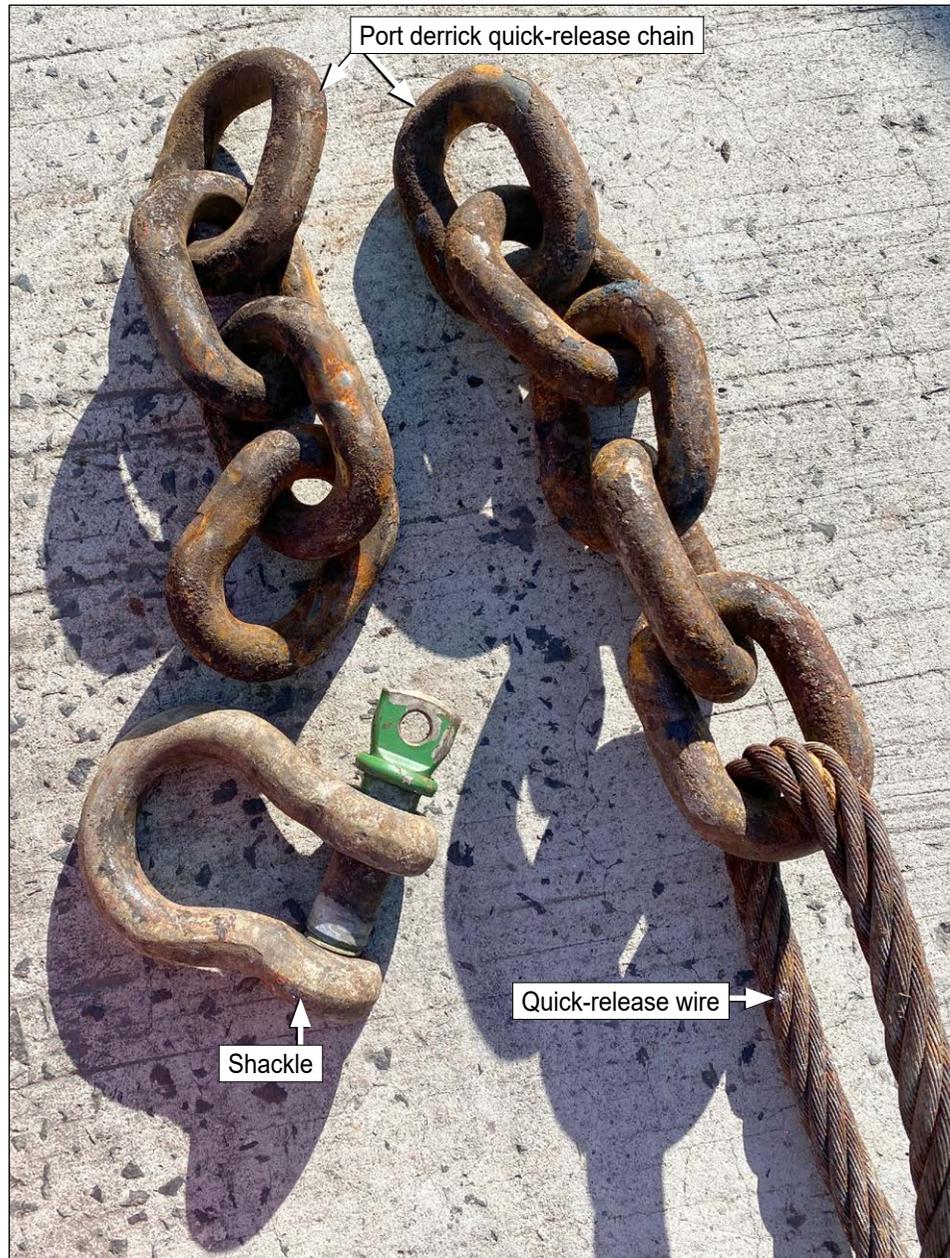
At around 0630, and without warning, the quick-release chain supporting the port trawl beam failed (**Figure 5**) and the beam fell, striking deckhand 1 and landing inboard (**Figure 6**) with the net and remaining trawl gear overboard. The beam trapped deckhand 1 and injured one of the other two deckhands who had been assisting with the port trawl beam. The skipper was awoken by the sound of the beam hitting the deck and sent the mate down to help. The crew used the Gilson winch to lift the beam clear of the deck and pulled deckhand 1 out from beneath the fishing gear. After some initial difficulties with radio communication, the skipper contacted Falmouth coastguard via *Cornishman*'s satellite telephone to raise the alarm and was in turn connected to a doctor to discuss the extent of the injuries. The doctor requested immediate evacuation of deckhand 1 and advised the crew to start cardiopulmonary resuscitation (CPR). Deckhand 1 was bleeding heavily from his ears, nose and mouth, one of his legs was broken and his pulse was very faint. The crew moved him to the crew companionway and cut off his oilskins. They began CPR, attached a finger heart rate monitor, which initially gave an output, and prepared the vessel's defibrillator.

**Figure 5:** Port derrick broken quick-release chain

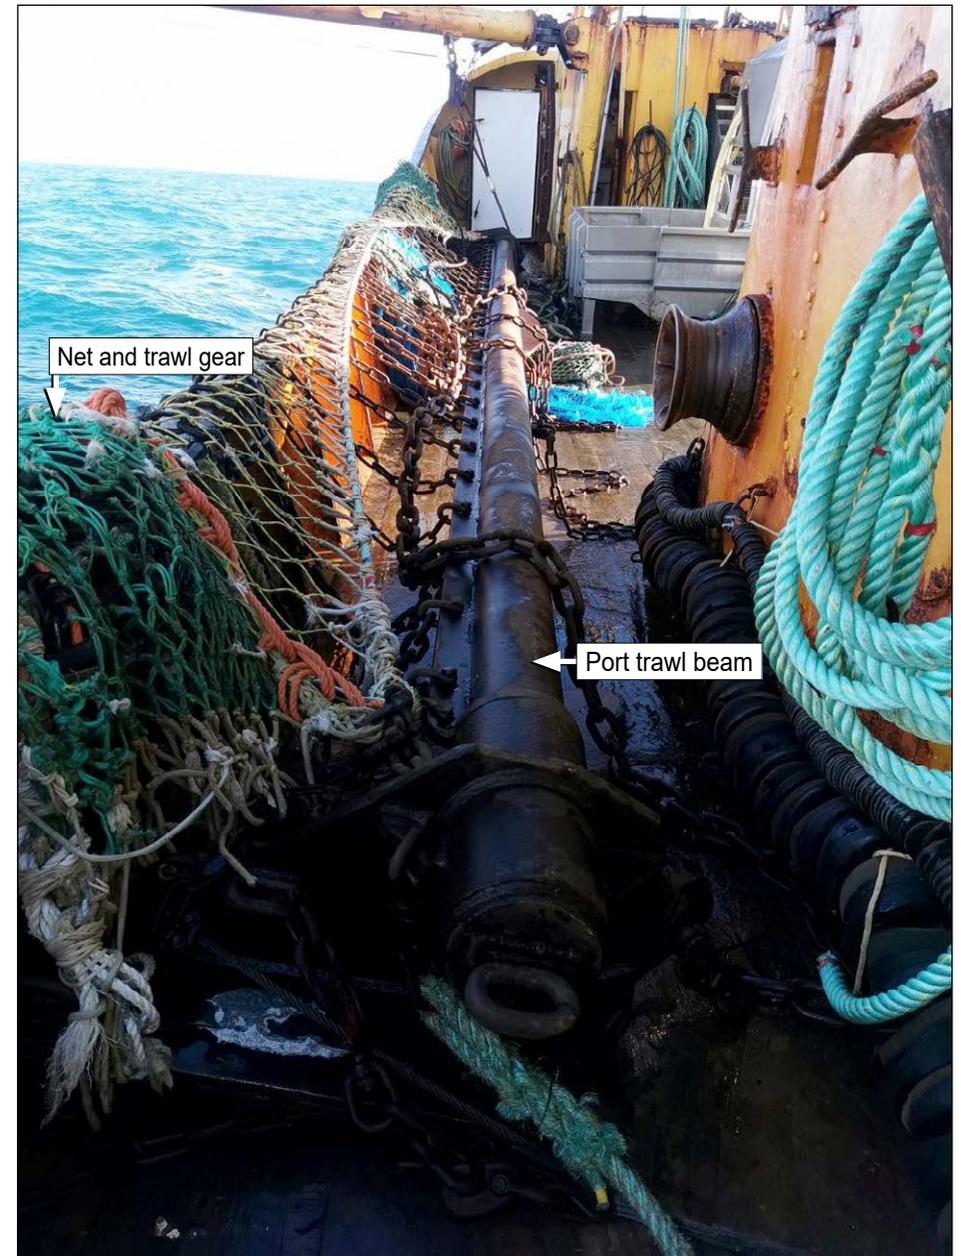
**Figure 6:** Port trawl beam on port deck after quick-release chain failure

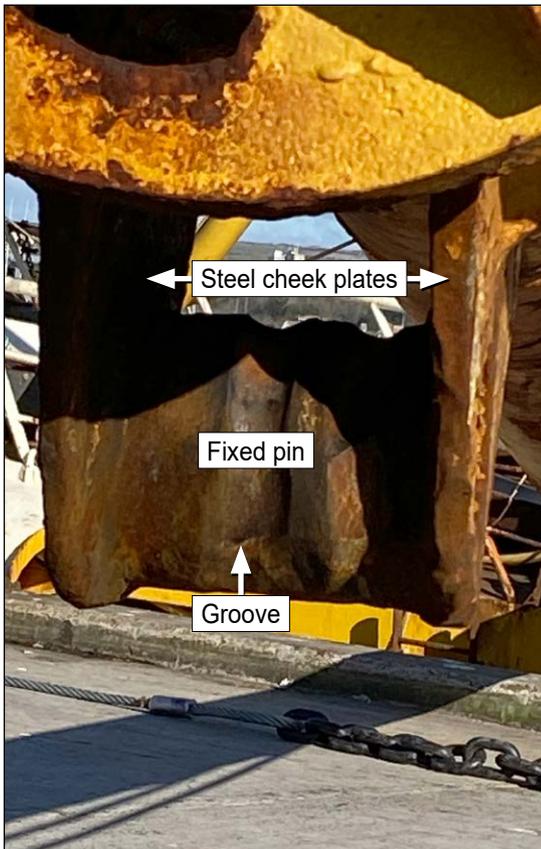
The fixed steel pin became grooved (**Figure 10**) during use by wear from the chain links as they laid at angles to the pin (**Figures 10** and **11**), alternately lying to one side and then the other, effectively reducing the D/d ratio to a measured value of between 3.0 to 3.5 to 1.

**Figure 10:** Derrick head quick-release fixed pin grooving

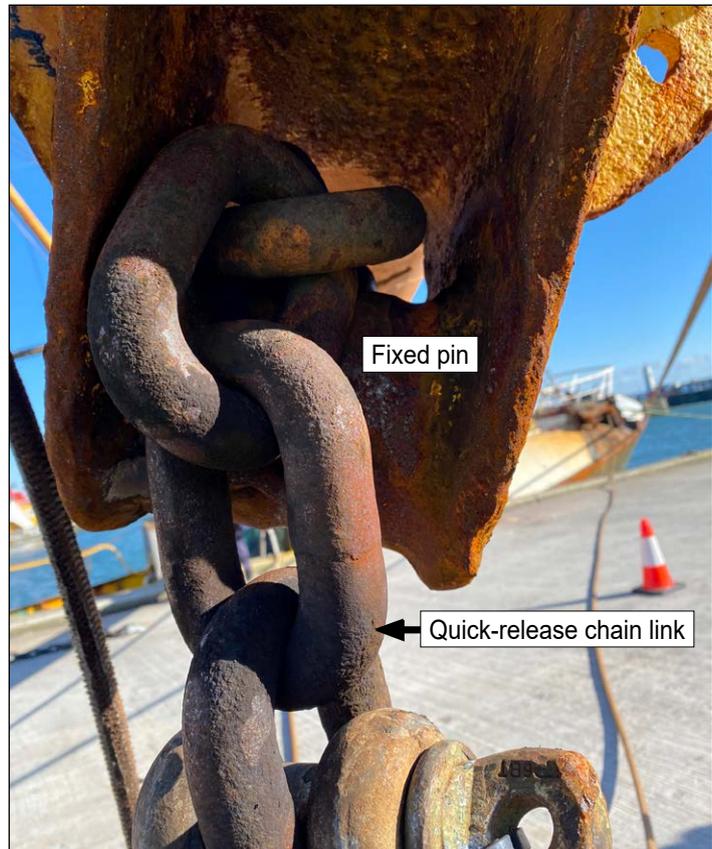
**Figure 11:** Quick-release chain links lying at alternating angles on the fixed pin

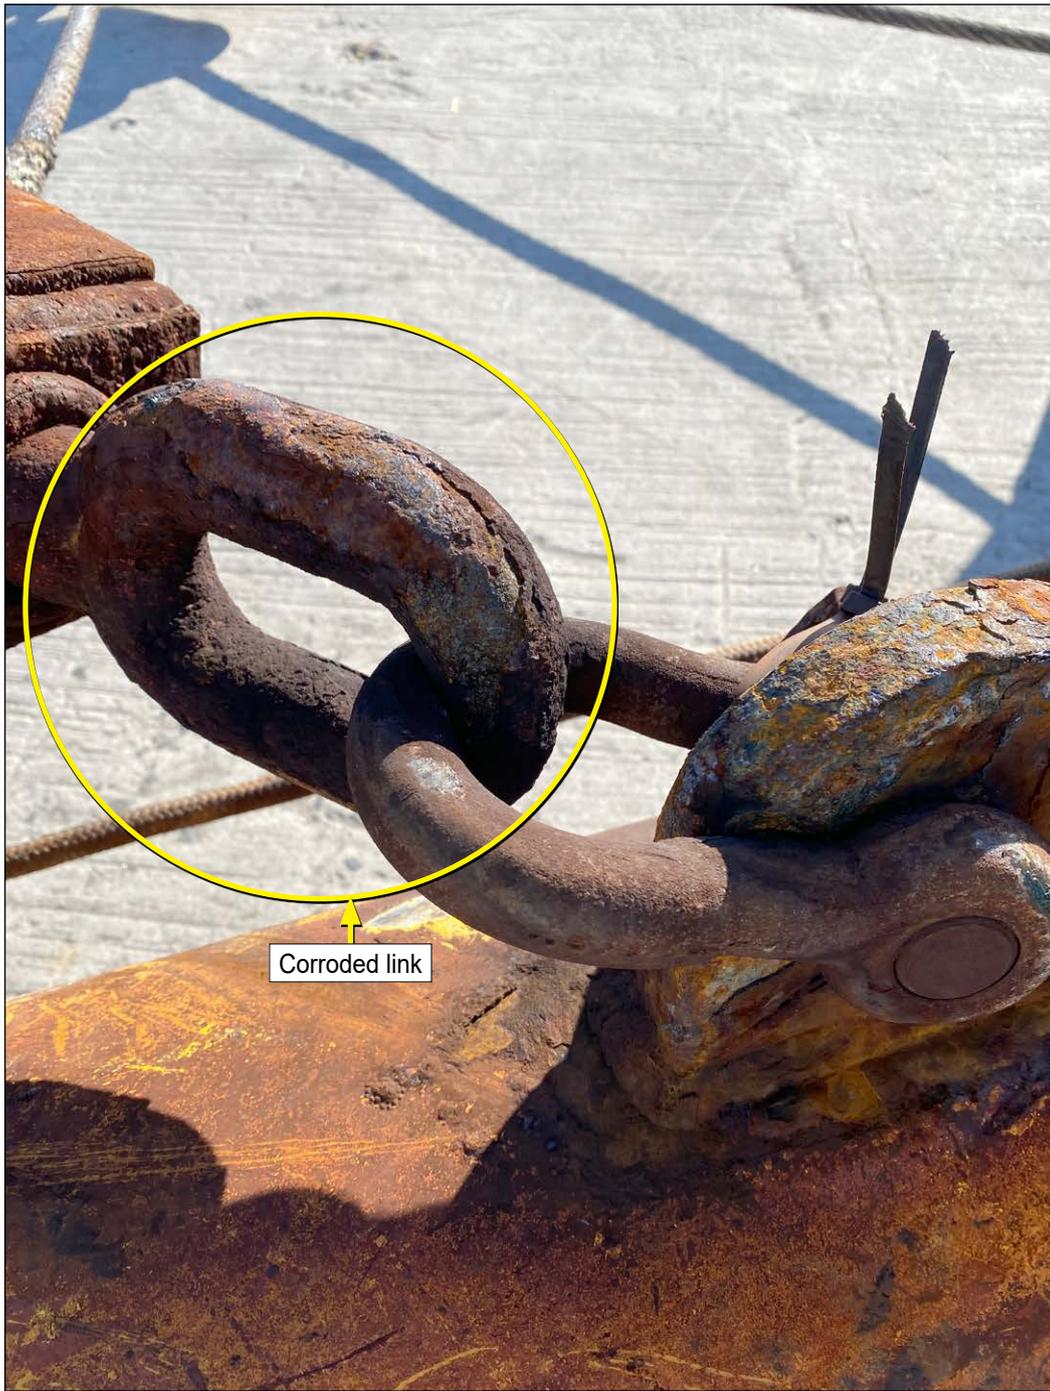
The effects of the harsh operating conditions required frequent running repairs to *Cornishman*, including the replacement of various components such as corroded links (**Figure 12**), to keep the gear in working order. Excessive grooves in the fixed steel pin were filled in with weld and then ground smooth by the shore-based maintenance team. The quick-release chain was replaced approximately annually. Previous failures while at sea had involved chains, wires and shackles on the quick-release gear and had usually resulted in the trawl gear falling overboard.

**Figure 12: Corroded chain**

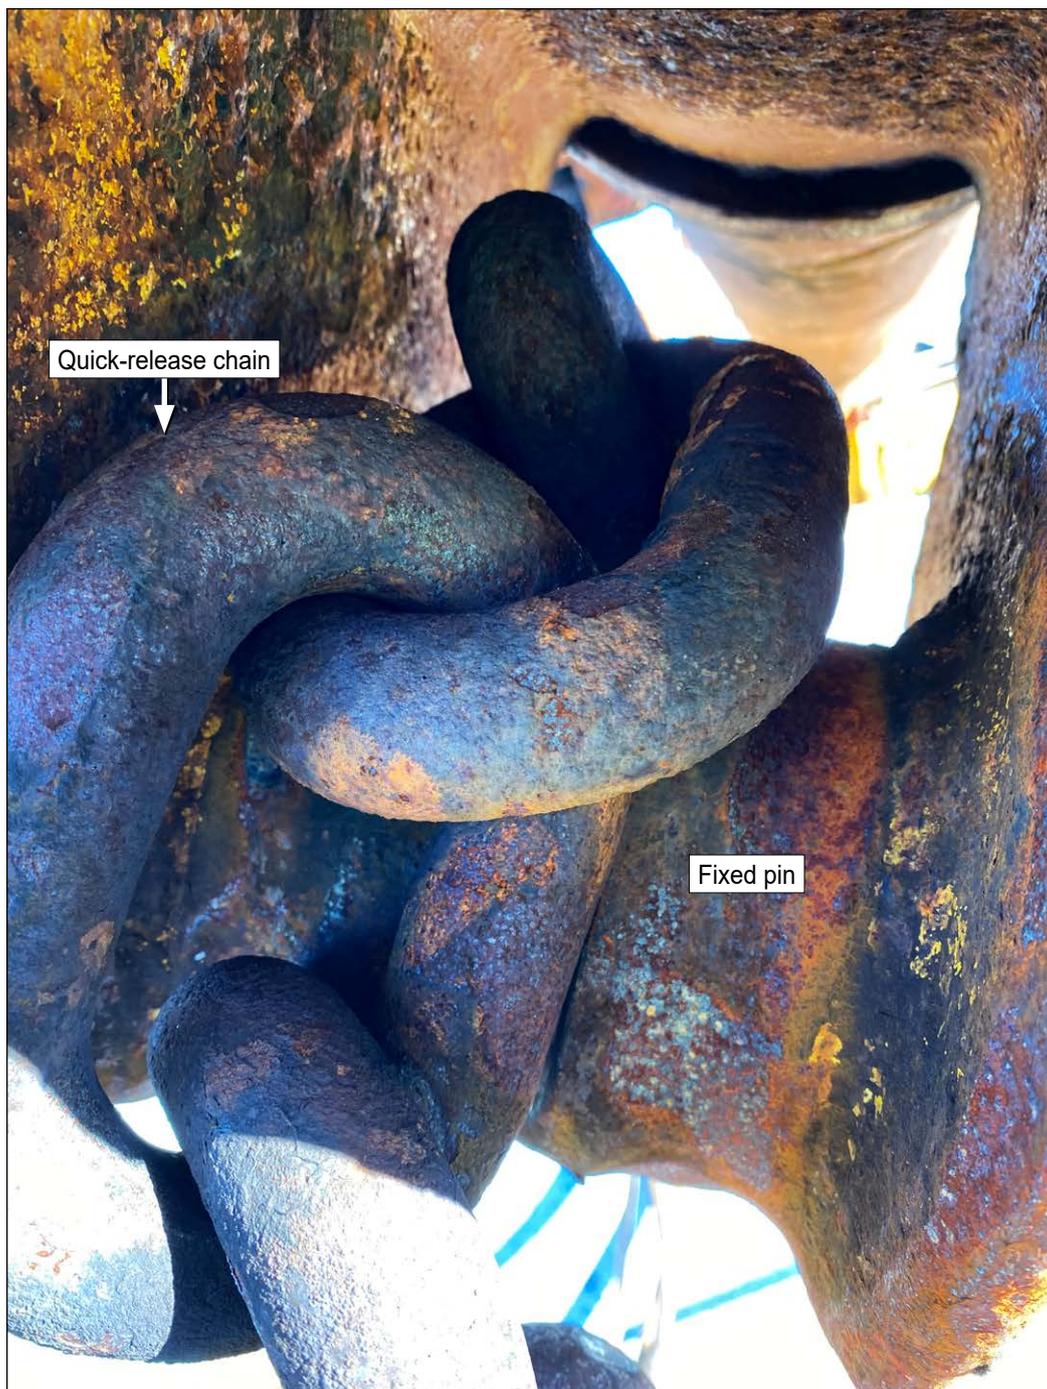
**Figure 14:** Limited access of quick-release chain and derrick head fixed pin

*The fractured link has been identified as the sixth link when counting from the steel wire rope end. According to the received images<sup>22</sup>, the fractured link is positioned close to the pin of the derrick head, most likely experiencing some bending moment against the pin. (see **Figure 14**)*

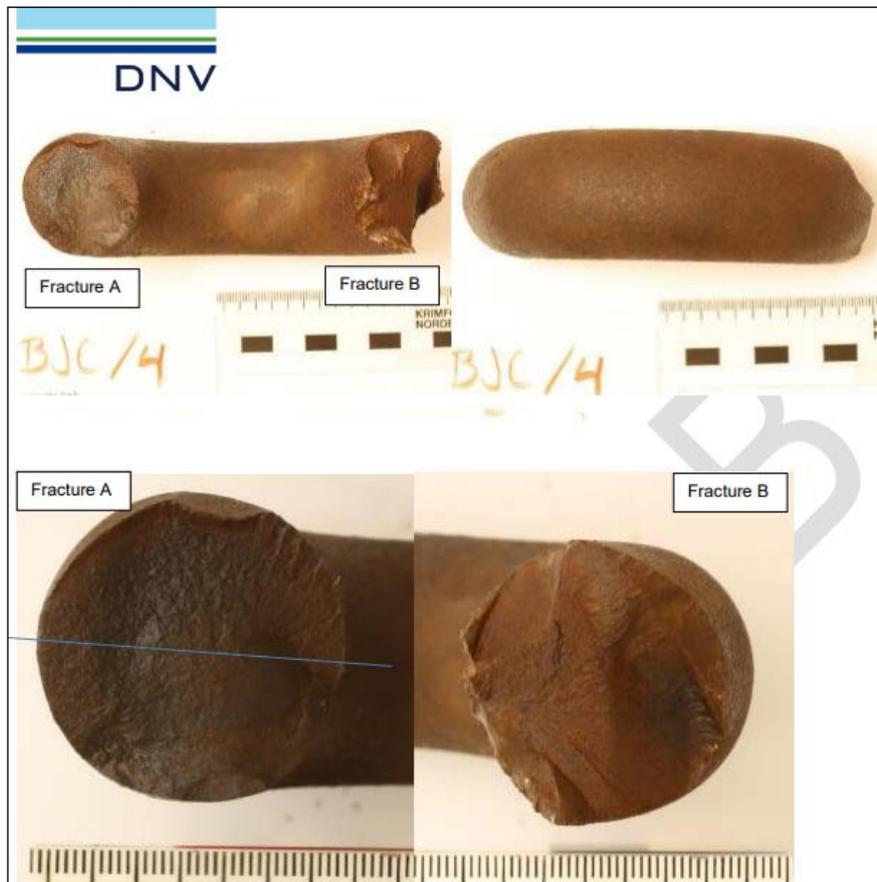
*A large number of cracks and crack-like indications have been detected, both in the portside chain that fractured, but also in the starboard chain used in parallel to the portside one. The large number of cracks are believed to be related to environmentally induced cracking, most likely related to hydrogen embrittlement. This has induced crack growth in multiple positions.*

*The underlying cause of fracture is a high hardness and low ductility<sup>23</sup> chain material in a corrosive environment, in combination with tensile stress. Hydrogen introduced during the steel chain manufacturing process may also have contributed to the material embrittlement. [sic]*

**Figure 16:** Extract from the DNV BJC report, showing part of the fractured number 6 link in the port side chain

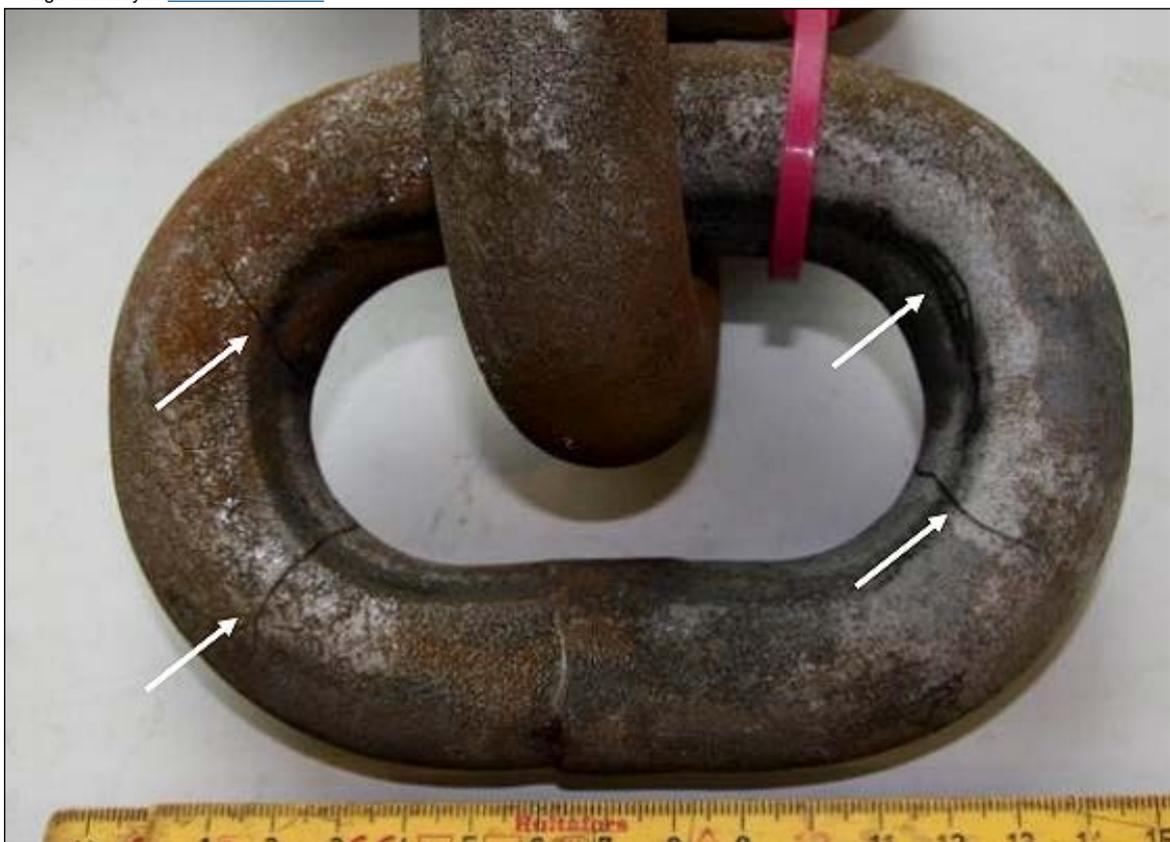
*Crack-like indications in a significant number of links is found, up to five cracks in one link. Cracks are found both in links that have been bent over the derrick heads and links that are considered to have been loaded along the main length direction. Examination of samples from break load testing showed that, in addition to the fractured chain link, at least one chain link has a crack that have propagated through the link thickness. [sic] (**Figure 17**)*

**Figure 17:** Extract from the DNV BJC report, showing cracks identified in one link of the port side chain

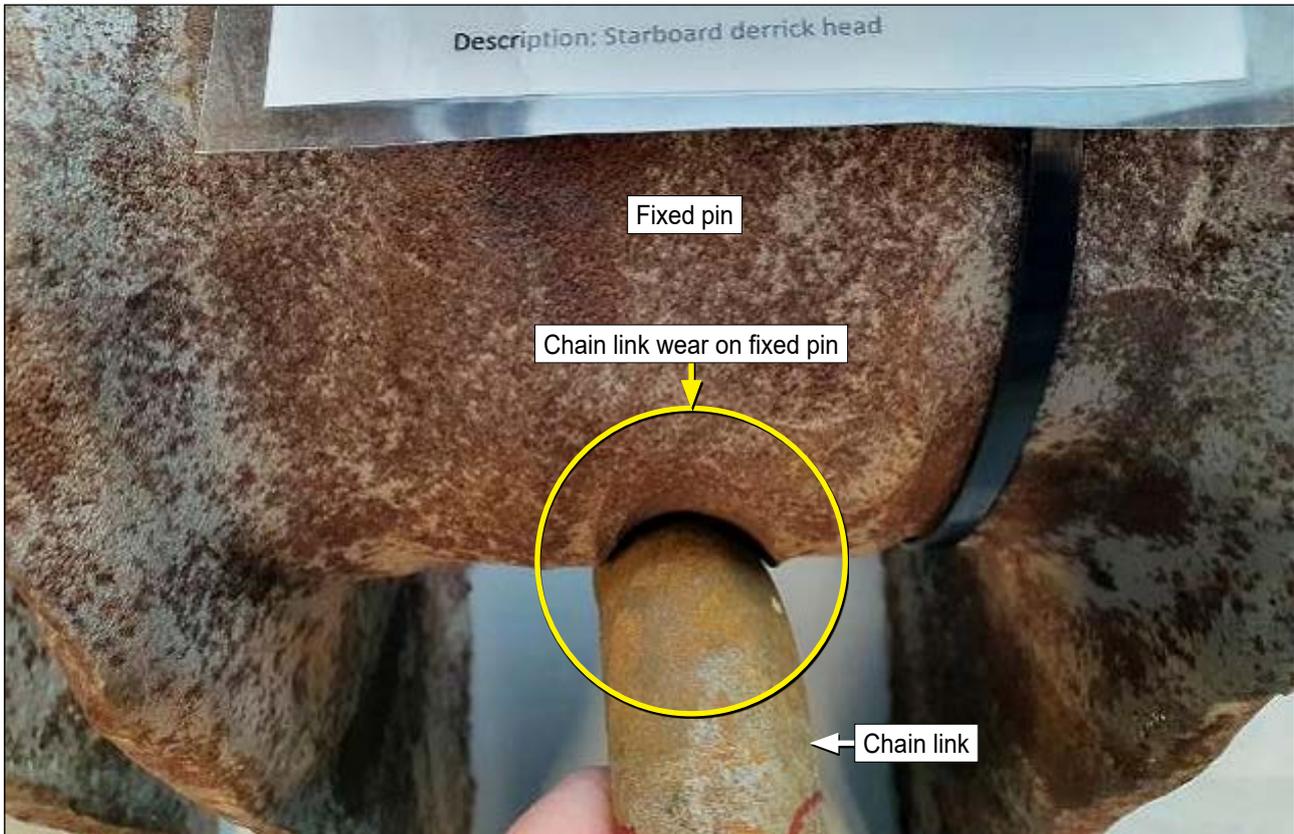
*The examination of the pins in the derrick heads shows severe deformation/wear, caused by the contact with a chain...It is however considered likely that the significant deformation/wear can influence on the load distribution in the chain,... [sic] (Figure 18)*

**Figure 18:** Extract from the DNV BJC report, showing chain link wear (grooving) on the fixed pin

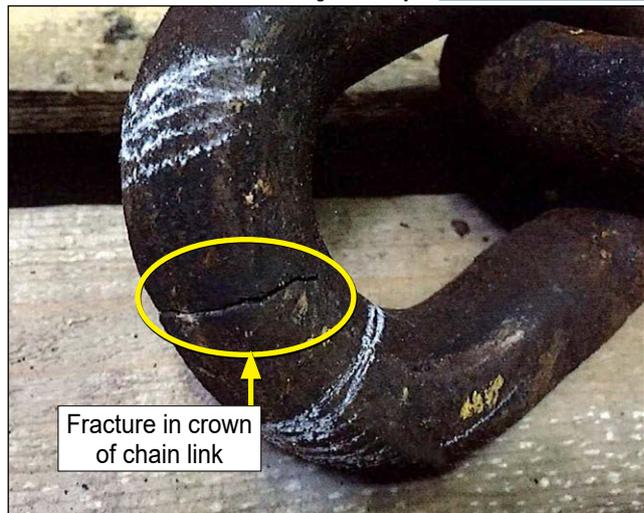
The failed link was not analysed to determine the cause of the cracks.

**Figure 20:** Previous Stevenson quick-release chain link fracture

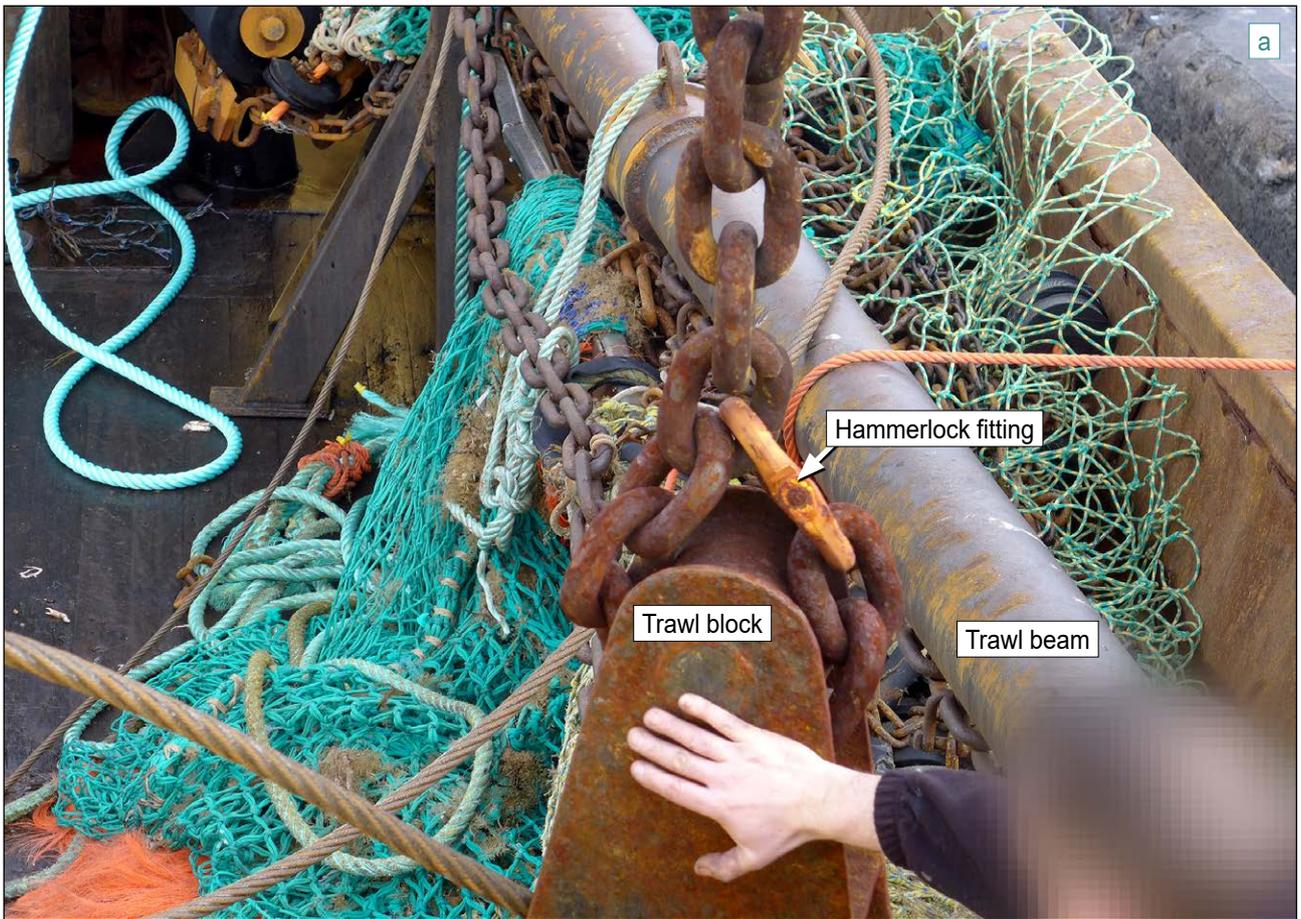
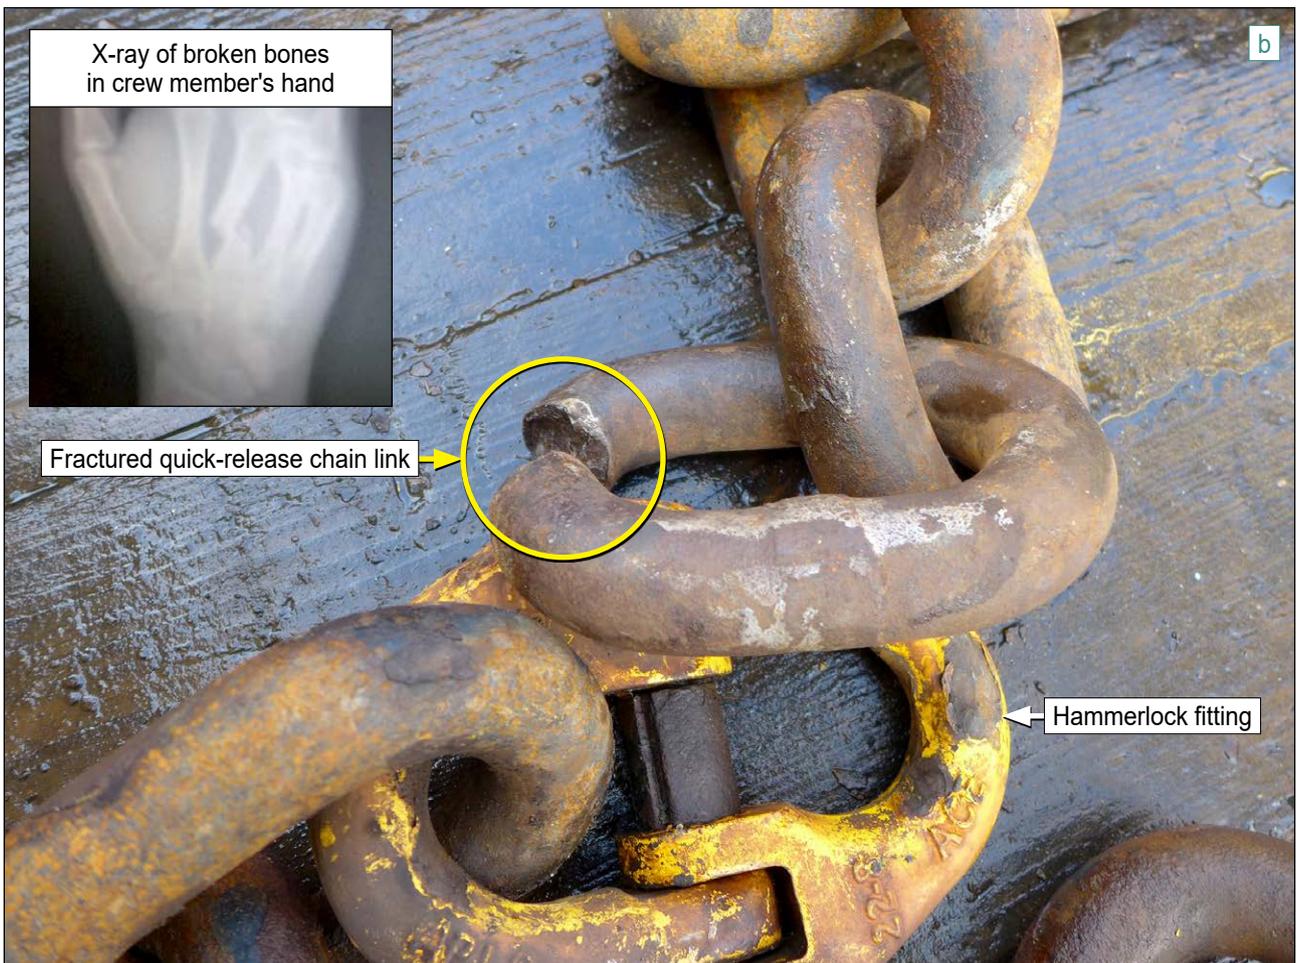
**Figure 21:** The fallen port side gear (a), quick-release chain connection failure (b) and (inset) X-ray of the crew member's broken hand
