**MARINE INVESTIGATION REPORT**  
**M06L0004**

**FIRE**

**GENERAL CARGO SHIP *SKALVA***  
**GASPÉ, QUEBEC**  
**04 JANUARY 2006**

Report Number M06L0004

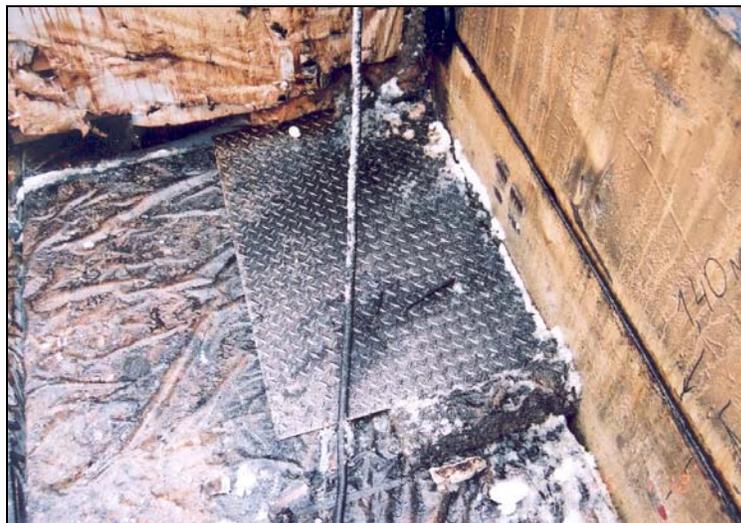
The welder placed an aluminum plate measuring 60 cm by 40 cm on the wood bundle beneath the welding area to protect the cargo (see Photo 2). Mineral wool batt insulation was used to fill void space between the bundles, and two fire hoses and a dry-chemical fire extinguisher were positioned nearby.

**Photo 2.** Hatch coaming and aluminum plate on top of a wood bundle adjacent to the welding area

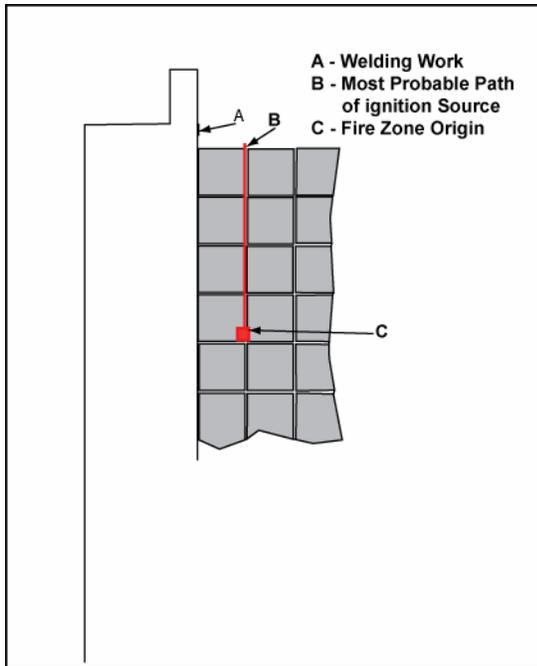
Figure 2. Cross-section view (not to scale)

When the hold was opened after the fire, an assessment showed that the wood bundles in the vicinity of the welding work had been destroyed by a smoldering, slow-burning yet intense fire. Burn patterns indicated that the fire originated from beneath the top bundles and inboard from the first row of bundles along the port side. Bundles were systematically lifted out of the cargo hold in an effort to determine the seat and cause of the fire. After four tiers of bundles were removed, burn patterns suggested that the seat of the fire had been near the gap between the first and second rows on the port side, four tiers down from the top (see Figure 2 and Photo 3). Carbonized wood and ashes were examined in that vicinity, but no indications were found as to the source of ignition.

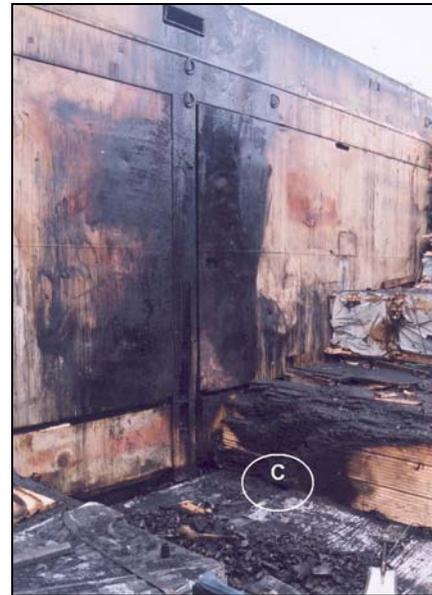
Photo 3. Fire zone origin

Ignition sources were present within the hold of the *Skalva*, which had been loaded with a combustible cargo of dry softwood lumber. The void space between the bundles that were inboard of the first row and adjacent to the hatch coaming was not blocked, and fire-retardant blankets were not used to cover the bulk wood cargo nearby. Both smoking and welding in the hold considerably increased the risk of fire. However, given the sequence of events, the proximity of the welding work to the fire zone origin, as well as the zone's depth (four bundle tiers down), there is a high probability that hot welding by-products ignited the fire.
