MIR-25-07

Contact of Small Passenger Vessel *Columbia Gorge* with Pedestrian Bridge and Tribal Fishing Platforms

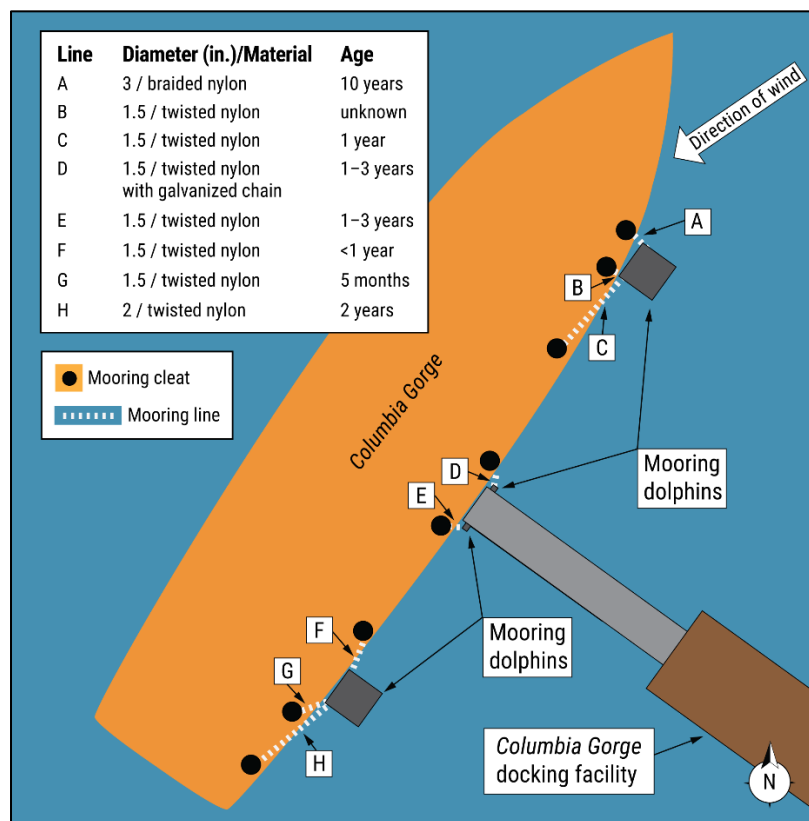
On January 11, 2024, crewmembers shifted the vessel from its typical mooring arrangement (port side to, with the bow facing downriver in a southwesterly direction) at its dock at mile 149.2 on the Columbia River in Cascade Locks to an upriver bow mooring (starboard side to, with the bow in a northeasterly direction) in anticipation of forecasted strong east winds, estimated to be 30–40 knots, with blizzard conditions possible. The vessel was secured against the mooring dolphins with eight nylon mooring lines and a galvanized chain (the usual mooring arrangement was six nylon mooring lines and no chain). The bow line was tight, and crewmembers estimated there was less than a foot of slack in the breast lines and the chain (see Figure 3). The vessel was uncrewed while docked, and, in the days before the breakaway, the crew checked the vessel's mooring a few times a day.

Figure 3. *Columbia Gorge* mooring arrangement on January 13, 2024, including the diameters of and materials comprising each mooring line (scale approximate).

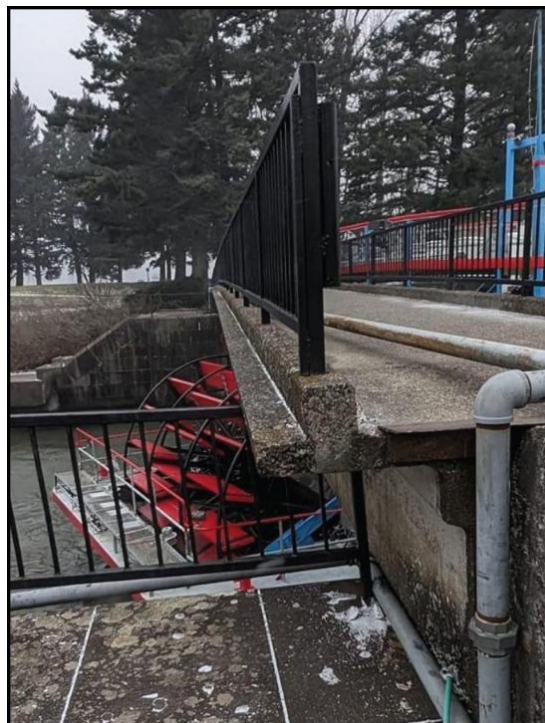
About 0822, the *Columbia Gorge*'s stern struck three tribal fishing platforms and then the Thunder Island pedestrian bridge—which spanned the historic lock channel at Cascade Locks Marina and connected Thunder Island to the mainland—halting the vessel's drift (see Figure 4).³ By 0831, the deckhand arrived at the pedestrian bridge, where he observed the vessel “banging around in the canal” at the entrance of the lock. The deckhand boarded the *Columbia Gorge* from the pedestrian bridge and started unlocking doors on the vessel, including in the engine room. About 0910, the vessel's captain arrived and boarded the vessel.

Figure 4. The stern of the *Columbia Gorge* under the Thunder Island pedestrian bridge as seen from the mainland. (Source: JettyLight LLC)

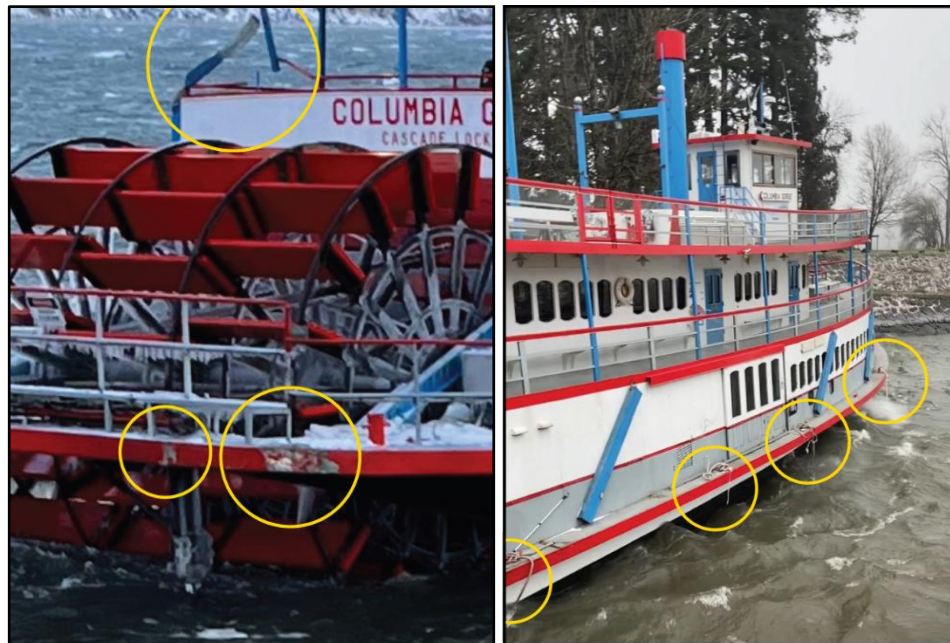
The *Columbia Gorge* sustained minor exterior damage, and the Thunder Island pedestrian bridge was displaced about 2 feet (see Figure 5 and Figure 6). Additionally, three of the four tribal fishing platforms mounted to the walls of the lock were damaged. One platform was destroyed, and two suffered lesser damage (see Figure 7).

The vessel's operator told investigators that he had examined the lines and chain after the casualty and found that all the mooring lines had parted and the chain had broken (see Figure 5). The vessel's operator was unable to locate documentation that identified the breaking strength of the lines and chain.

Figure 5. Left to right: Damage to the stern and the support columns for the upper deck of the *Columbia Gorge* (circled). The vessel in the lock with broken moorings visible (circled). (Background source: JettyLight LLC)

number of mooring lines and ran a chain out. However, while it was moored, the winds picked up (more than twice what was forecasted), increasing the wind load (force) acting on the *Columbia Gorge*. This force, just off the starboard bow, would have strained the mooring lines and chain holding the ship to its dock. As a result, all eight mooring lines and the chain failed.

The vessel operator had no plan in place for regularly examining the vessel's mooring lines or replacing them before failure, and the ages of the *Columbia Gorge*'s mooring lines ranged from less than 1 year to 10 years, with the age of some lines either unknown or not definitively known. The Cascade Locks Port Commission RCA Team investigated the breakaway and found that the mooring arrangement and nylon lines used would have been adequate to keep the vessel moored during the adverse weather conditions the morning of the casualty if the lines had been new or in good condition. Because none of the lines were new and the vessel operator did not have a life cycle management program to regularly examine the condition of the lines, it is possible that some of the mooring lines used to secure the *Columbia Gorge* during the adverse weather event had become degraded, which led to the mooring lines breaking.

As a result of the casualty, the operating company instituted two new safety measures: mooring lines are to be replaced annually, and the vessel will be crewed and/or moved when forecasted wind gusts exceed 70 knots.

As a result of the casualty, the operating company required mooring lines to be replaced annually.

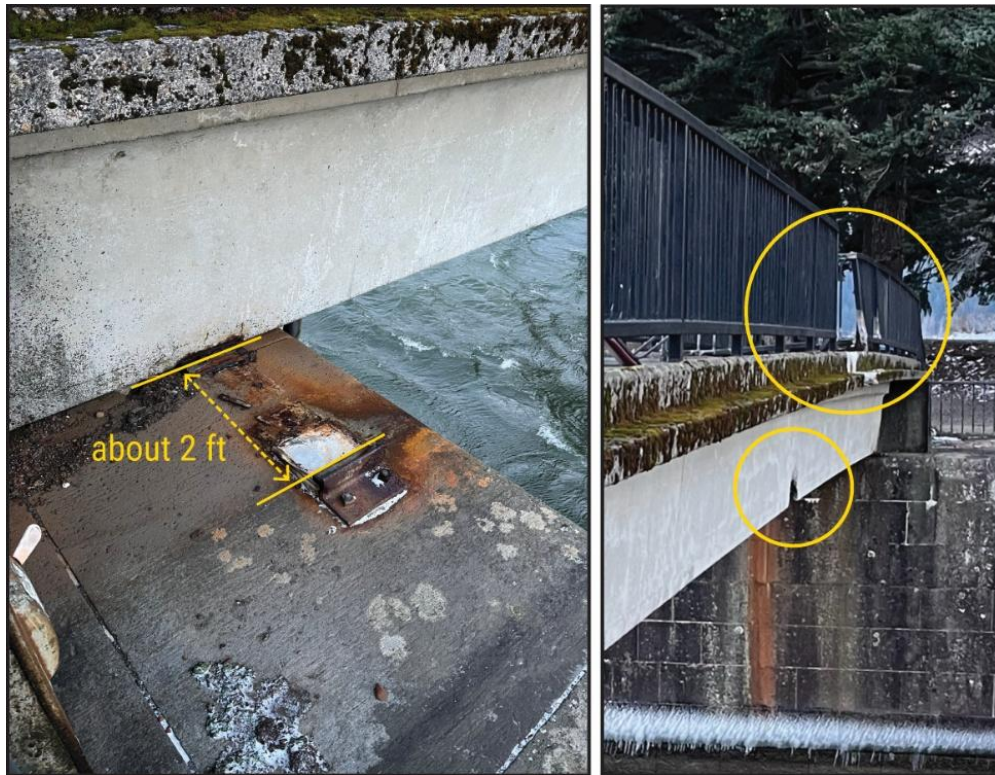
Figure 6. Left to right: Markings showing the displacement of the deck of the Thunder Island pedestrian bridge, and further damage to the deck and railing (circled). (Background source: Port of Cascade Locks Port Commission)

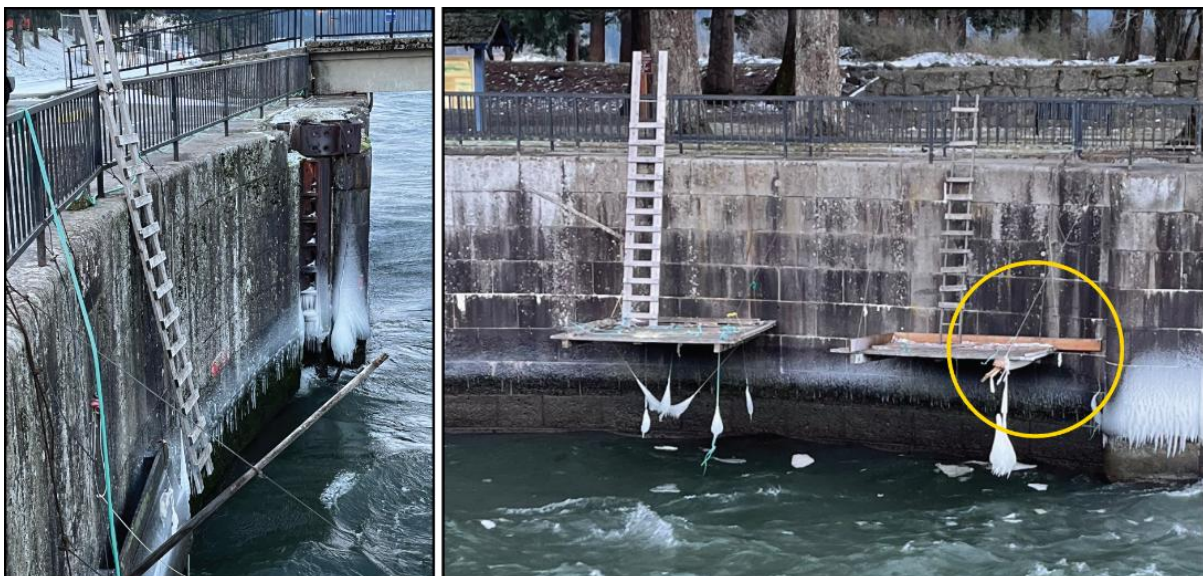
Figure 7. Left to right: The area where the destroyed fishing platform had been mounted, and damage to one of the platforms on the opposite side of the lock (circled). (Background source: Port of Cascade Locks Port Commission)
