February 6, 2025

MIR-25-08

# Collapse of Chalmette Refinery Dock Section During Docking of *Ovide J* Tow

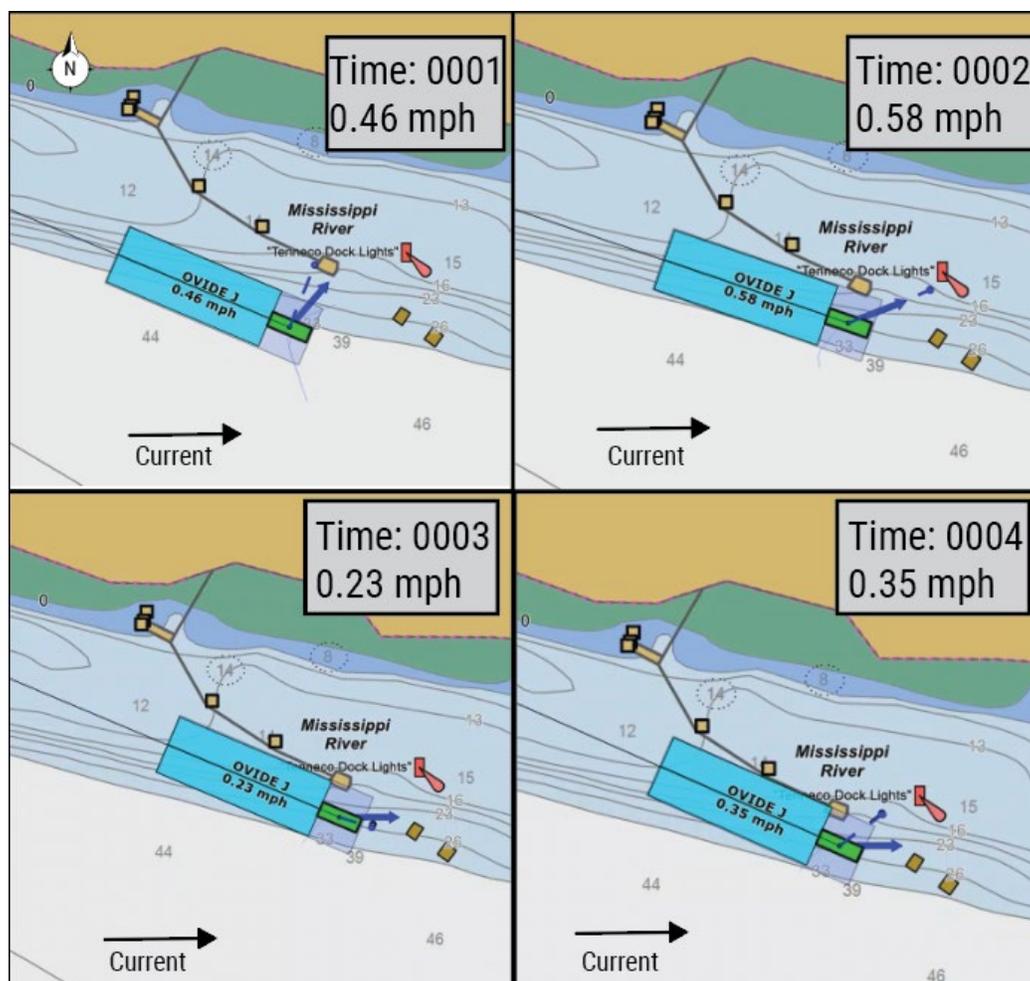
At 0002, the speed of the tow was 0.58 mph, and the onboard recording system showed the tow at an approach angle of 3-5° off the dock, with the starboard quarter of the starboard barge closest to the dock. At 0003, the speed of the tow was 0.23 mph, and the onboard recording system showed the tow traveling toward dolphin no. 3 with the head of the tow about 4° off the dock (see figure 5).

**Figure 5.** The *Ovide J* tow in the minutes before it contacted the Chalmette Refinery crude oil dock. Blue vector arrows indicate the tow's direction of motion. (Data source: *Ovide J* automatic identification system data in Rose Point software)

At 0004, as the tow moved downriver in the current (while still facing upriver), at a speed of 0.35 mph, the starboard quarter of the starboard barge (*EMS 348*) contacted the wooden fendering of the transfer platform at dolphin no. 3, and part of the dock collapsed into the river toward the shoreline (see figure 6). The onboard recording system captured the dock section falling into the water; the recording also showed that, in the wheelhouse, there were no signs of any movement from the contact (such as people getting jolted or VHF radio cables moving). The relief captain immediately placed the starboard engine in neutral to avoid entanglement of the starboard propeller with the fallen dock and floating hoses and lines on the submerged transfer platform.

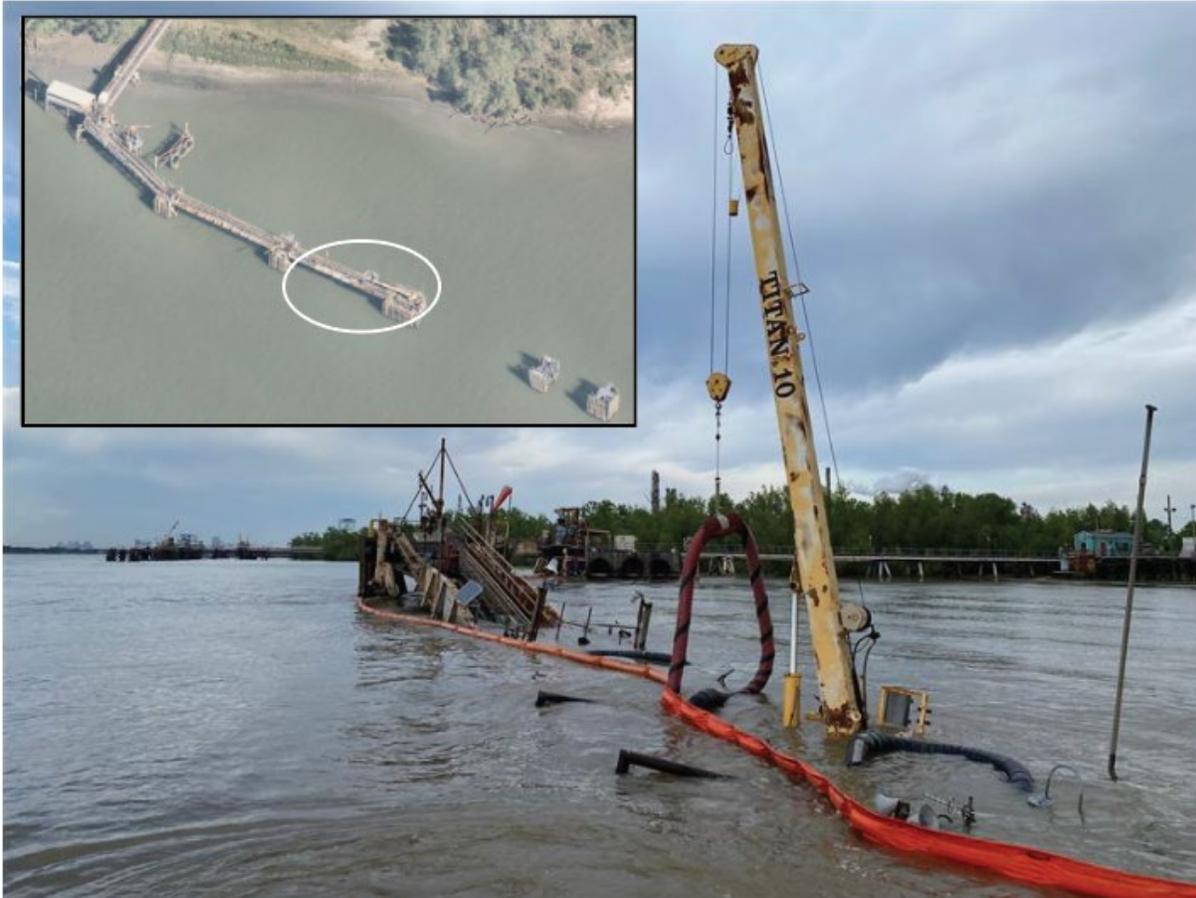
The contact caused 150 feet of the dock to collapse inshore (see figure 6). A postcasualty survey revealed shearing of dolphin no. 3 support pilings 5 to 20 feet below the waterline (see figure 7). The dock settled to the riverbed, 10 feet below the river height at the time of the casualty. The transfer platform moved about 30 feet toward the shoreline and had a 10° inshore list. The elevated bridge remained connected to dolphin no. 3 but was about 17° closer to the shoreline than its original position. The estimated cost to repair the damage to the crude oil dock was \$7 million.

**Figure 6.** The collapsed crude oil dock, looking upriver. Inset shows the area of the dock that collapsed (circled). (Sources: Coast Guard, Nearthmap).

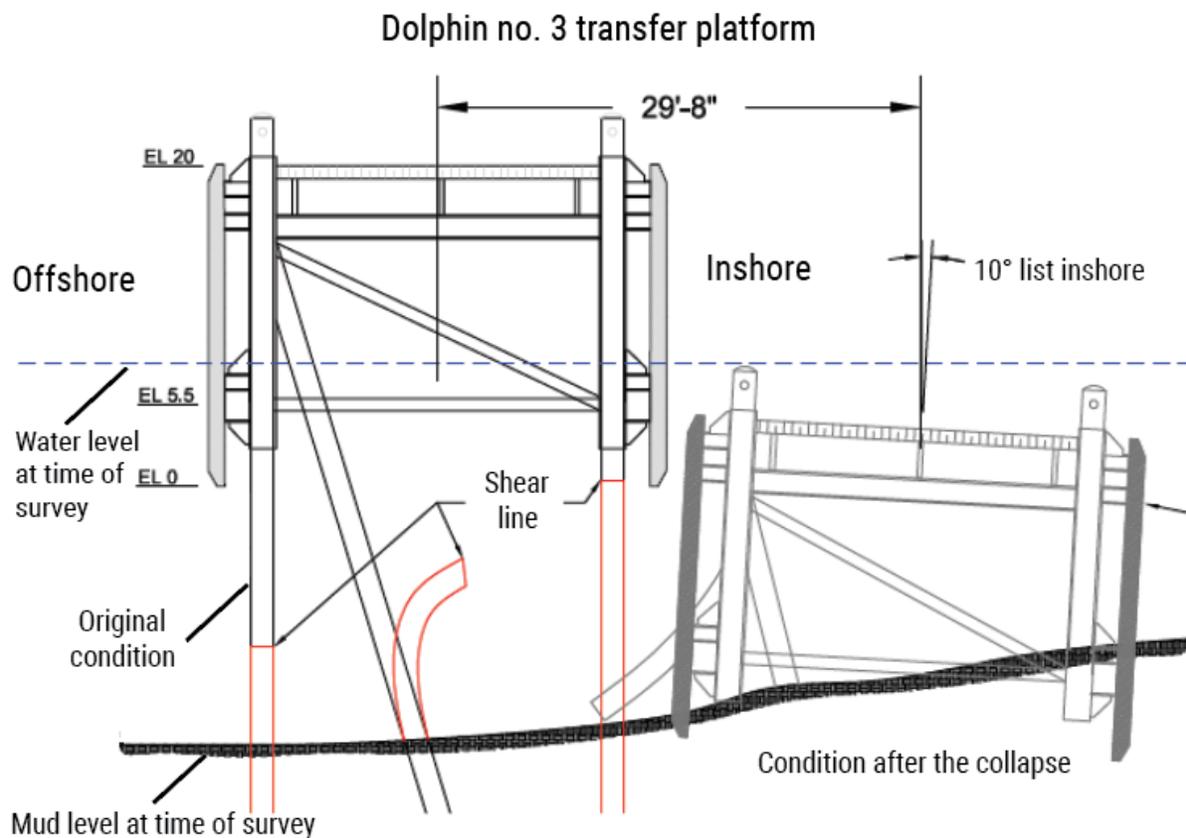
**Figure 7.** Postcasualty sketch of the dolphin no. 3 transfer platform at the Chalmette Refinery crude oil dock in its original condition and after the collapse. (Background source: Stewart Construction)

The observed deterioration to the dolphin no. 3 transfer platform before the collapse indicated that the dock's structural integrity was severely degraded. Because a portion of the dock collapsed from what appeared to be a low-impact contact during docking, it is likely that the dock's dolphin no. 3 transfer platform structure was compromised to the extent that it could not sustain the forces from a typical docking. The dock owner was aware that the dock had structural integrity issues before the collapse but had not yet taken steps to address them. Following the dock collapse, the dock owner has begun taking measures to more closely monitor dock integrity.

The National Transportation Safety Board determines that the probable cause of the collapse of a section of the Chalmette Refinery crude oil dock during the docking of the *Ovide J* tow was the degraded condition of the no. 3 dolphin transfer platform structure.

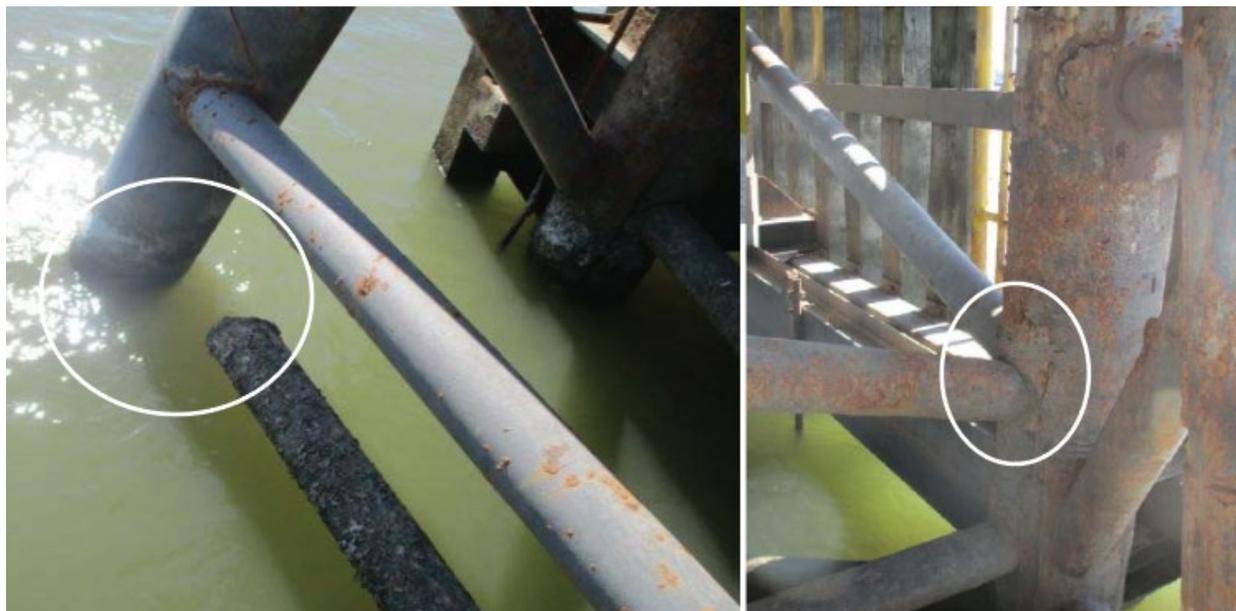
In October and November 2021, another engineering firm performed a visual above-water inspection of the Chalmette Refinery crude oil dock, including the dolphin no. 3 transfer platform. The structural inspection form for the dolphin no. 3 transfer platform listed seven findings corresponding to damage, including disconnected header joints, bent beams, and significant corrosion (see figure 8). The firm documented four priority one (highest urgency) categories of damage as a result of the inspection: The structure exhibited (1) visible damage to the longitudinal lateral force-resisting system, (2) visible damage to the transverse lateral

force-resisting system, (3) visible damage to the vertical gravity system, and (4) significant corrosion.

**Figure 8.** *Left to right:* Visual inspection photos from 2021 showing a lower header joint not connected to the other column and a joint starting to disconnect on the dolphin no. 3 transfer platform at the Chalmette Refinery crude oil dock. (Source: Hopper Engineering Associates)

A 2017 inspection report classified several horizontal braces between dolphin no. 3 pilings as having major deterioration. The report noted that two pilings were severely deteriorated, and all no. 3 dolphin pilings were shifted toward the shoreline. A 2021 visual structural inspection of the crude oil dock identified damage and deterioration, such as disconnected joints and corrosion at the dolphin no. 3 transfer platform. Although the company that completed the visual inspection recommended a complete inspection, according to the dock owner, as of the date the dock collapsed (which was about 1 year and 5 months after the 2021 inspection), the recommendations had "not been progressed."

The third-party engineering firm advised, as part of its inspection report, that the dock owner follow up this visual, above-water inspection with a structural assessment of the piles and the dock. According to the dock owner, the recommendations from this inspection report had “not been progressed” as of the date the dock collapsed.

The dock owner stated that actions they were taking after the dock collapse included: conducting a marine structure survey, integrating results from the most recent structural engineering review and inspections of marine facilities into the mechanical integrity program, reviewing dock procedures to reinforce expectations of the person in charge during vessel dockings, and developing an asset management system for dock integrity to ensure structural inspection of docks with specified frequencies for above water and below water, to include a workflow process for actionable items.
