March 24, 2025

MIR-25-11

## Contact of Tank Vessel *Hafnia Amessi* with Pier

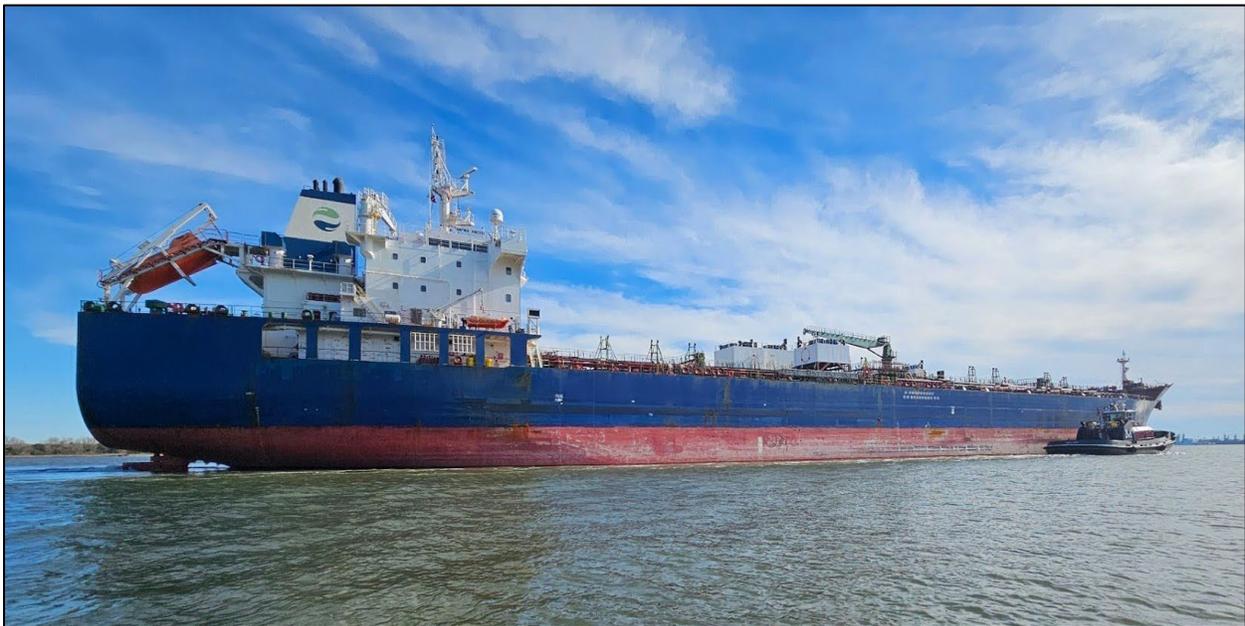
**Figure 1.** *Hafnia Amessi* underway following the contact with Pier B. (Source: US Coast Guard)

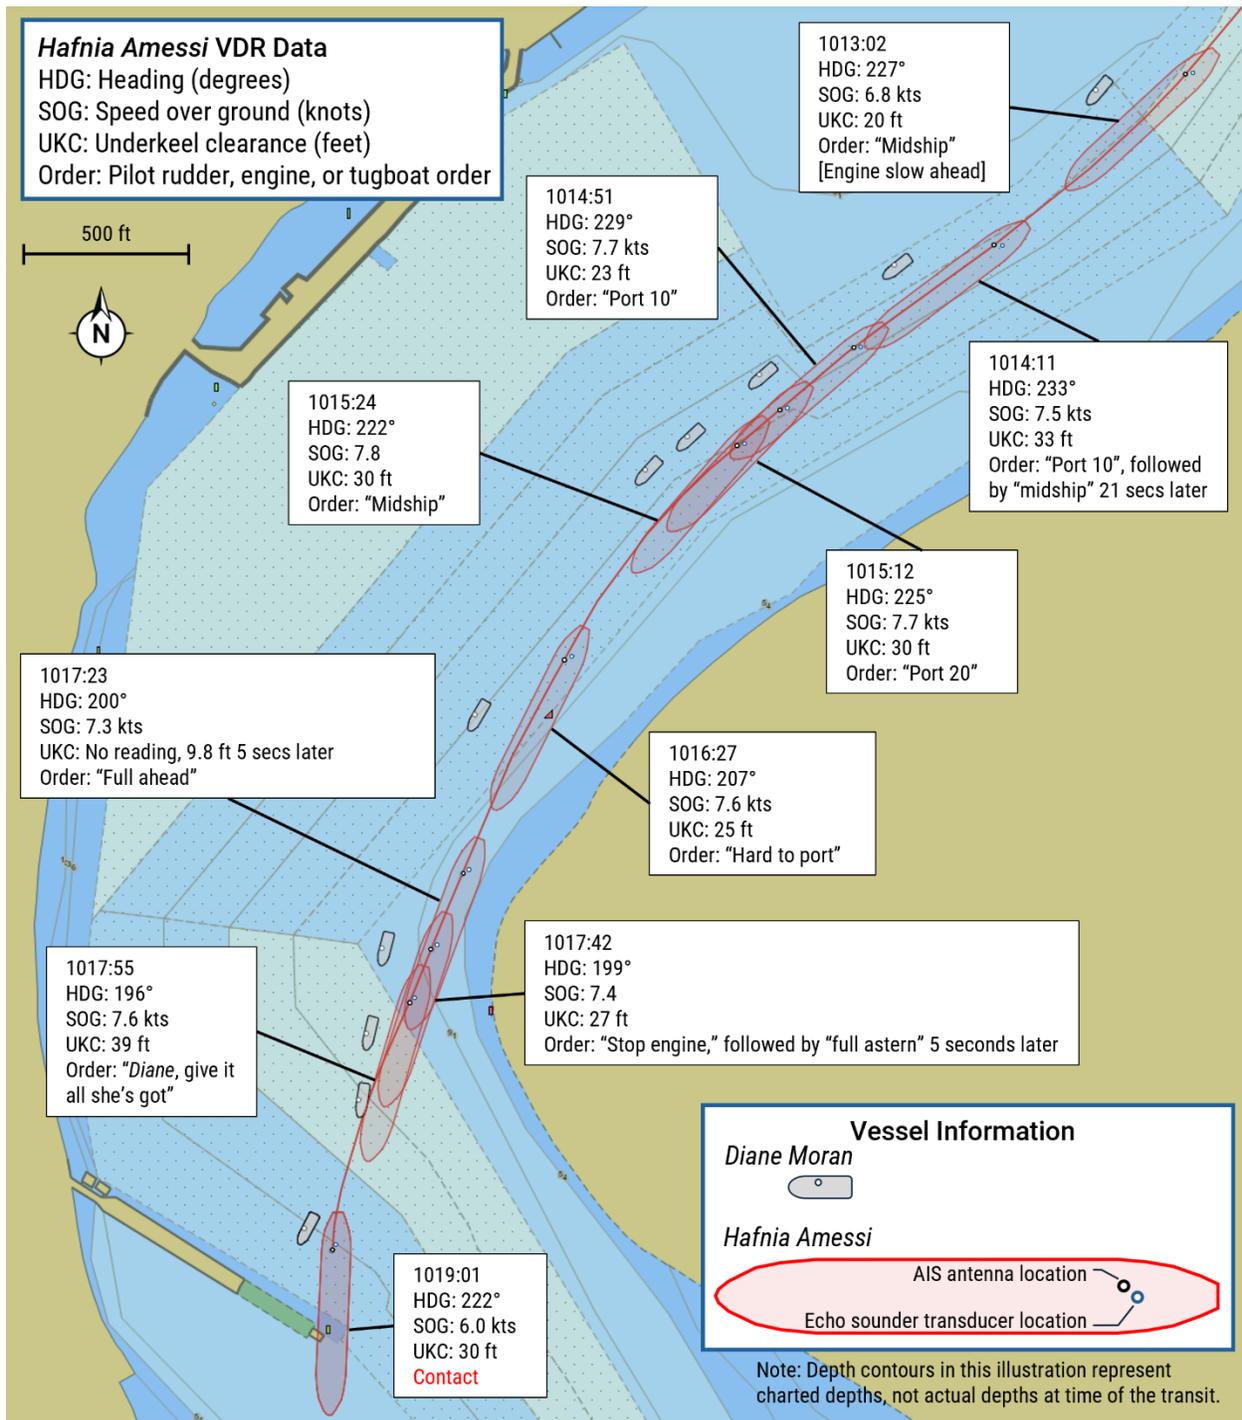
**Figure 4.** *Hafnia Amessi* automatic identification system (AIS) trackline. (Background source: NOAA ENC US5SC1LO as viewed on Made Smart)

The *Hafnia Amessi's* momentum carried it forward, with its bow moving to port and its stern swinging to starboard. At 1019:01, the starboard side of the vessel's hull pushed over a protective dolphin and contacted the northeast corner of the Pier B platform. The *Hafnia Amessi's* speed at the time it made contact was 6.0 knots.

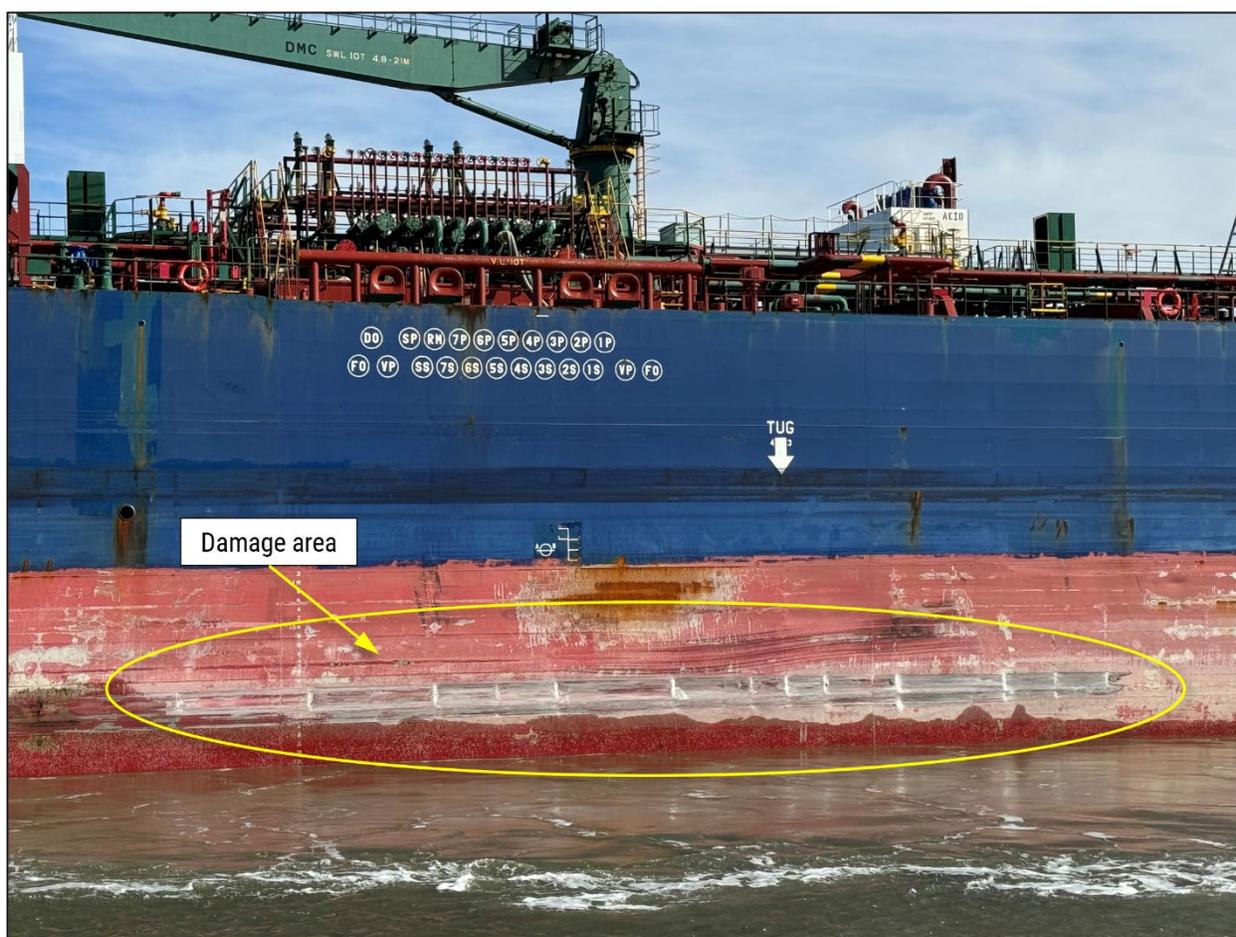
On the *Hafnia Amessi*, hull plating was inset up to 3 inches, and paint was scraped away along a 67-foot-long-by-3-foot-wide area of the vessel's starboard side above the waterline (see figure 5). Three transverse bulkheads that intersected the hull plating in the damaged area sustained buckling of about 1-2 inches. The estimated cost to repair the damage was \$30,000.

**Figure 5.** *Hafnia Amessi* starboard side after the contact, showing inset plating and scraped paint within circled area. (Background source: Coast Guard)

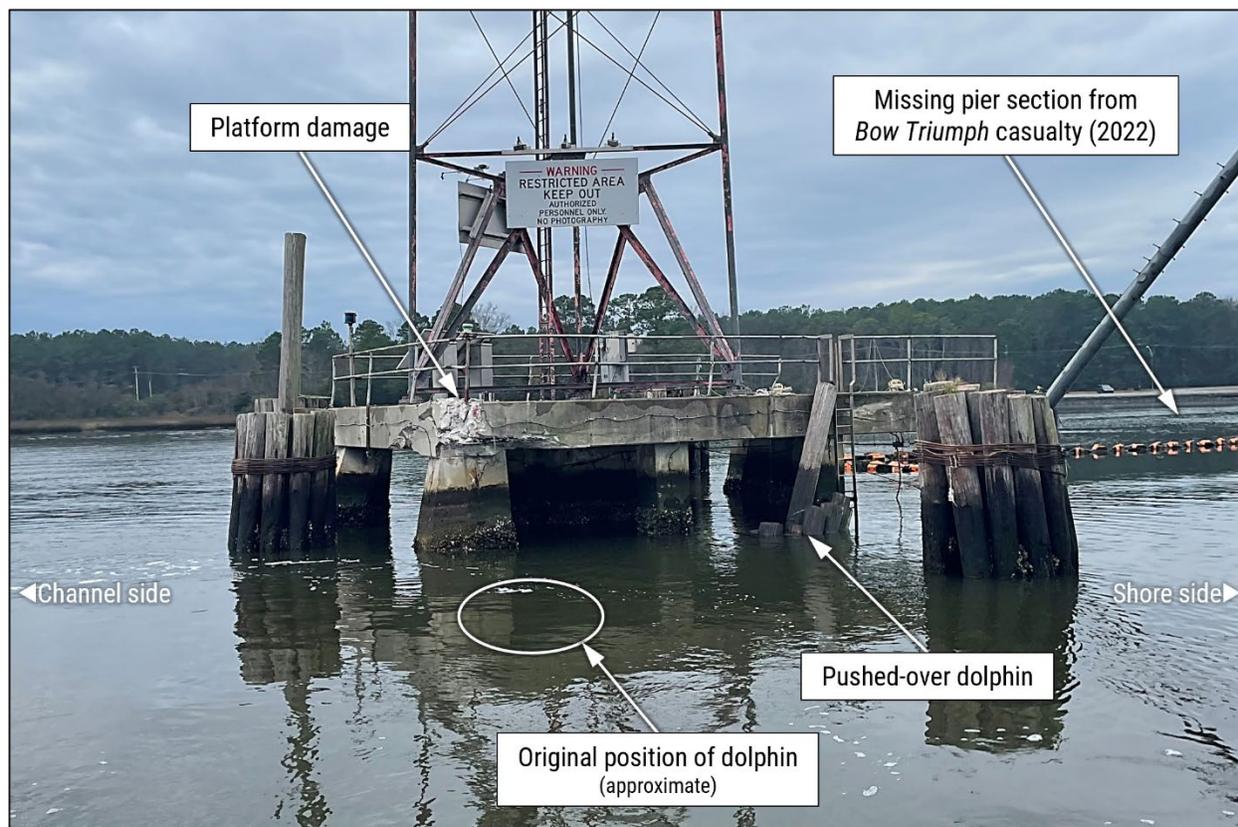
Cement on the northeast corner of the Pier B platform deck was cracked, with a small portion falling into the water. The protective dolphin, which was constructed of wood piles and positioned near the corner of the platform, was knocked over (see figure 6). The estimated cost to repair the damage to Pier B and the dolphin (not including previous damage from the *Bow Triumph* casualty) was \$8.1 million.

**Figure 6.** Naval Weapons Station Pier B, showing damage to the platform and protective dolphin.

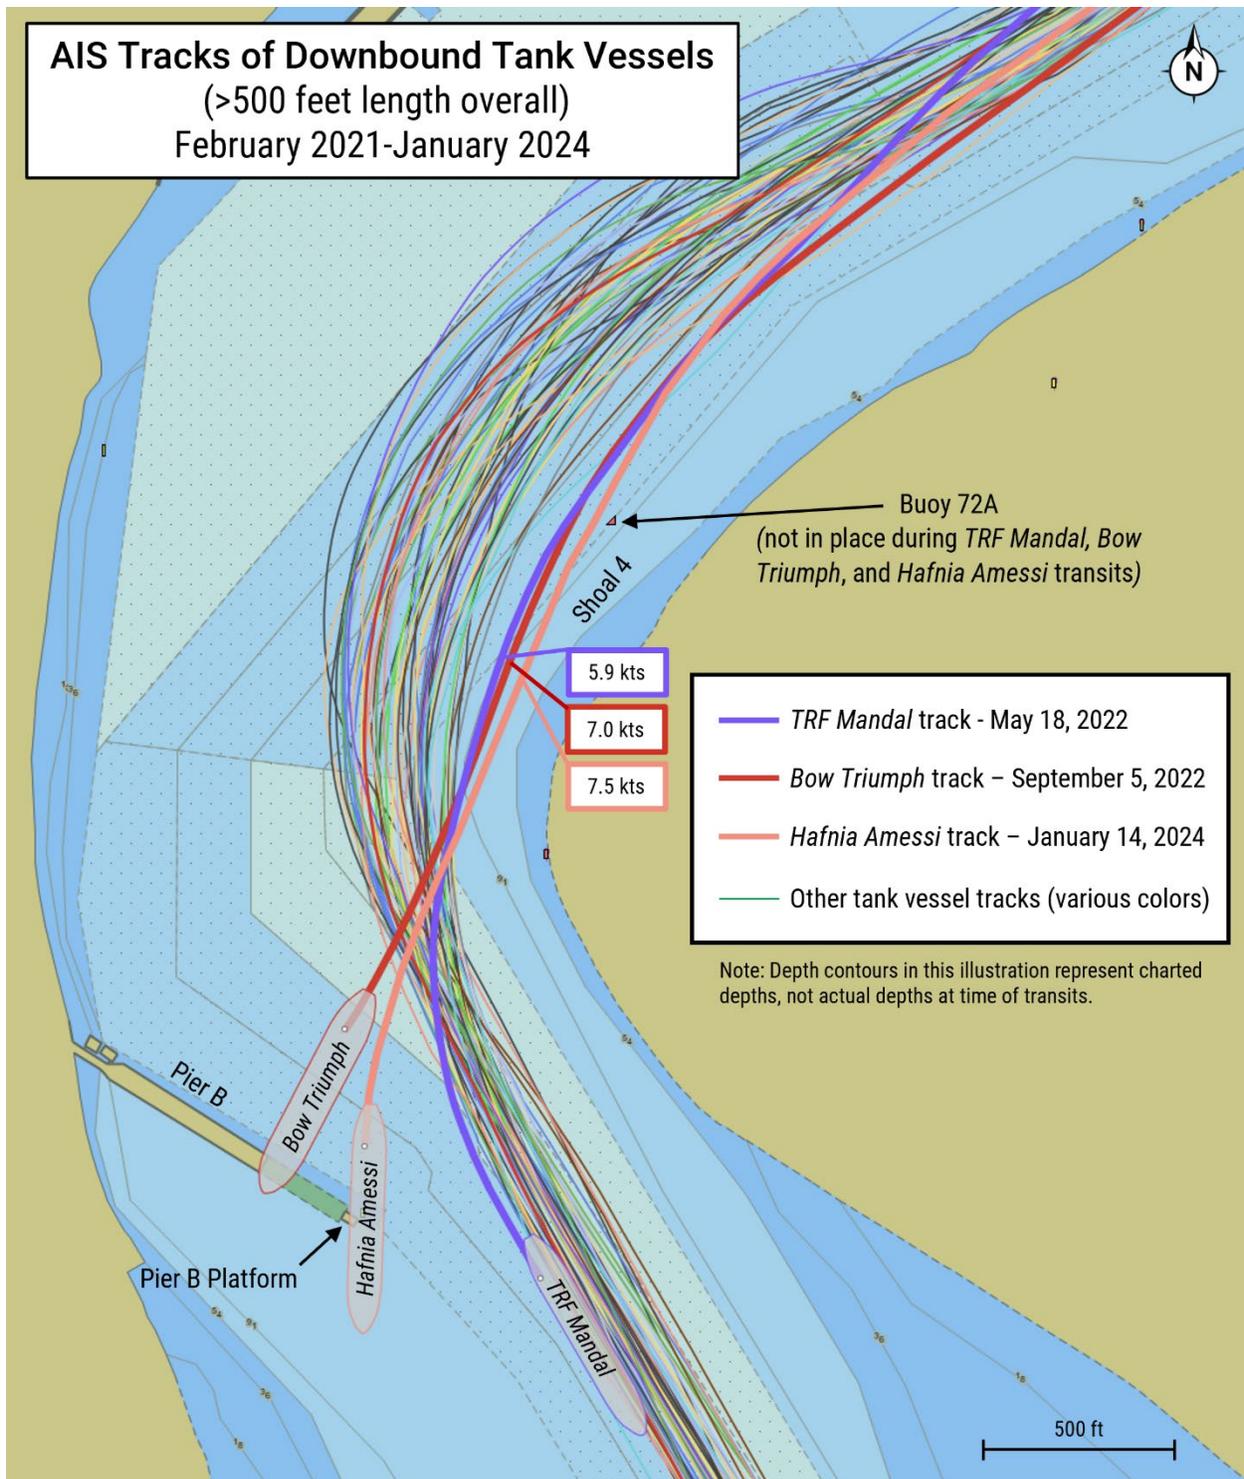
**Figure 7.** AIS tracks of tank vessels greater than 500 feet in length from February 2021 to January 2024. (Background source: NOAA ENC US5SC1LO as viewed on Made Smart)

Of the three vessels that transited on the eastern side of the channel, the *Hafnia Amessi*'s track came closest to the east bank of the river, based on AIS data (see figure 7).

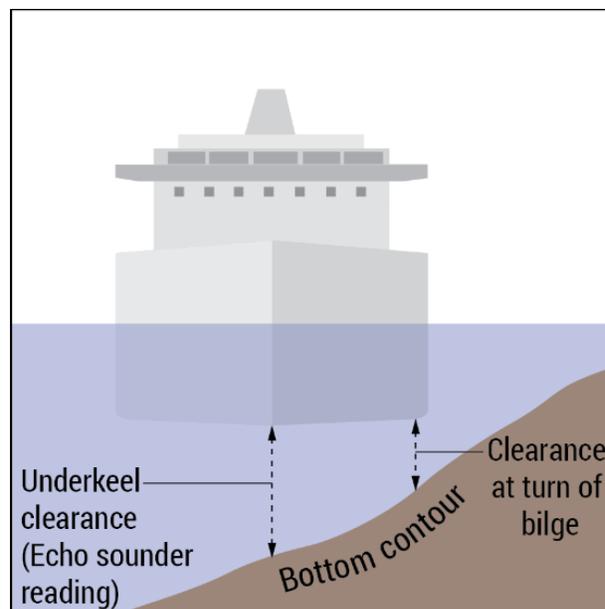
As the *Hafnia Amessi* transited along the east side of the channel, the vessel traversed a section where shoaling had reduced the depth significantly. Between 1015:24 and 1017:28, the tanker's recorded UKC reduced from 30 feet to 9.8 feet. Given the slope of the channel bank, the clearance under the hull at the turn of the bilge on the vessel's port side was likely shallower than the recorded UKC (see figure 10).<sup>13</sup> At the same time the pilot was attempting to turn the *Hafnia Amessi* to port, the bank effect forces worked against the turn by pushing the bow away from the bank (to starboard) and pulling the stern toward the bank (to port).

**Figure 10.** Exemplar of relative difference in hull clearances along a sloped bank/shoal. (Illustration does not reflect actual contour or vessel in this casualty.)
