MIR-25-13

Diesel Generator Engine Failure aboard Passenger Vessel *Ocean Navigator*

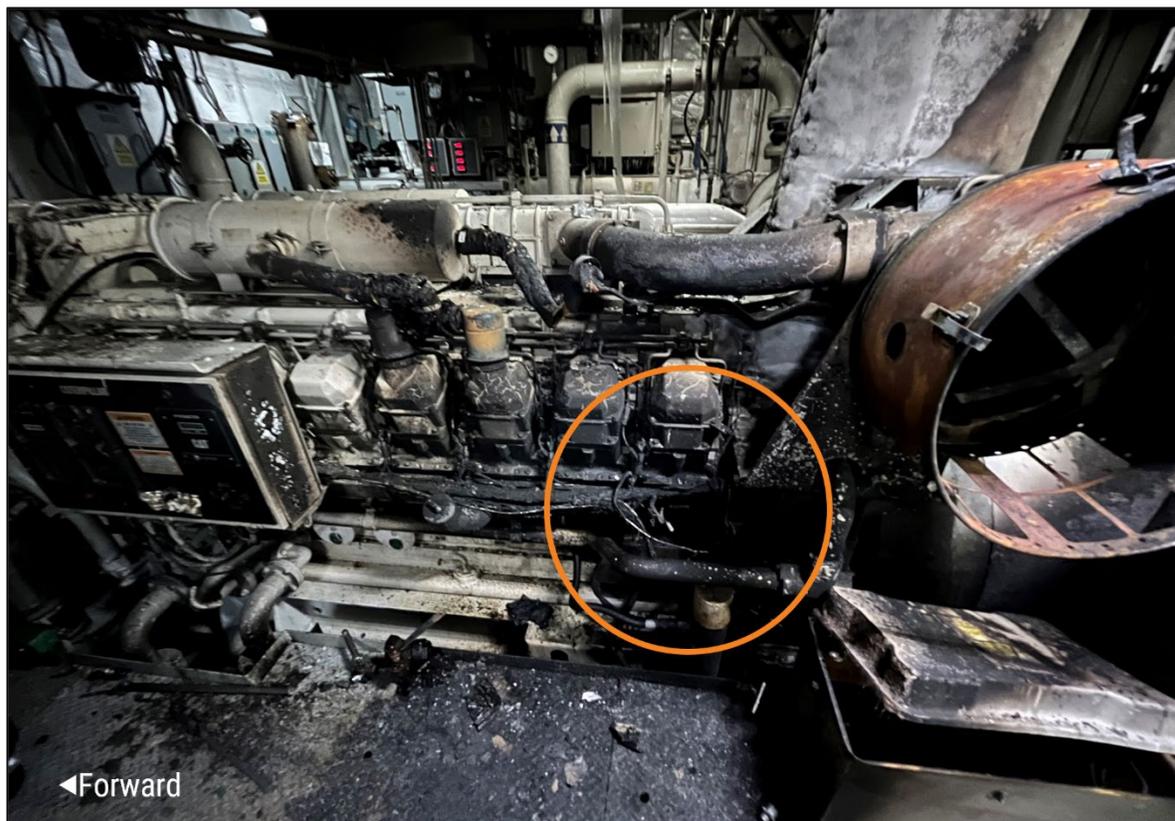
Coast Guard also requested assistance from a Bureau of Alcohol, Tobacco, Firearms and Explosives certified fire investigator, who participated in the examination of the damage. Investigators found that the no. 2 auxiliary engine was damaged beyond repair: the engine block, crankshaft, two connecting rods, counterweights, and other parts of the rotating assembly were damaged (see figure 5).

Figure 5. Damaged no. 2 auxiliary generator aboard *Ocean Navigator* after the engine failure. The circled area identifies the location of the engine block damage.

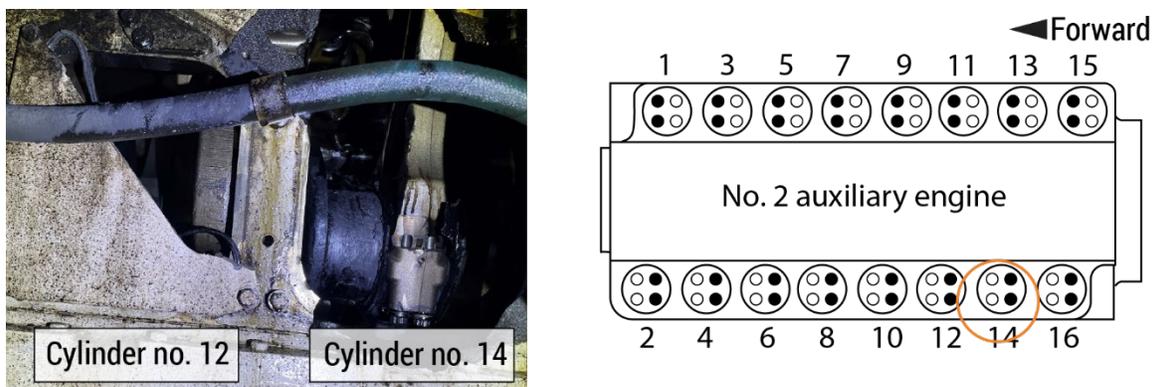
Investigators noted a hole about 10 inches high and 16 inches wide on the inboard side of the engine block in the area of the nos. 12 and 14 cylinders where the lower portion of the no. 13 connecting rod had been ejected (see figure 6). This area was located on the lower part of the engine near the deck plates between the two auxiliary engines.

Figure 6. Left to right: Damaged engine block on no. 2 auxiliary engine aboard *Ocean Navigator* after the engine failure. Graphic identifying area of engine failure on the no. 2 auxiliary engine.

The most significant smoke and heat damage was directly across the decking from the area of the no. 14 cylinder where the engine block was ruptured and extended upward toward the overhead and inboard toward the no. 1 auxiliary engine. The area in the engine room around and above the no. 2 auxiliary engine sustained smoke and heat damage. Soot was observed on all surfaces in the engine room and was heaviest on the components near the deck plates between the two auxiliary engines.

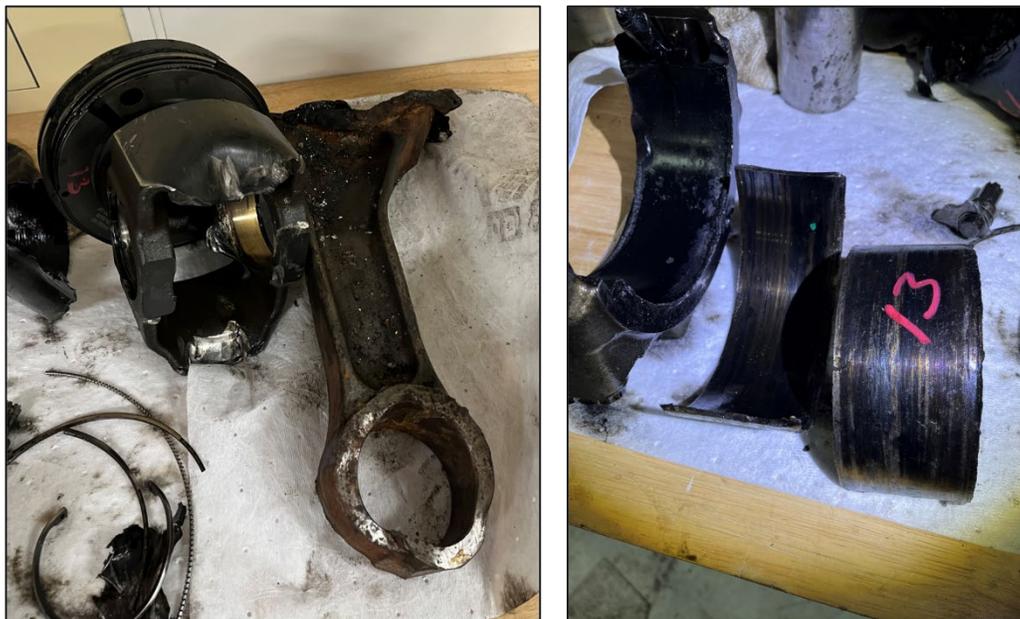
All connecting rods were removed, and big end bearings were inspected (see figure 7). According to the technicians, "it is common for high RPM engine to have cavitation marks on the bearings, but these were really bad conditions,

all of them.” Several of the rod bearings showed signs of cavitation erosion, a degradation of a bearing resulting from vapor-filled cavities in the lubricating oil that may include loss of material, surface deformation, or changes in properties.⁸

Figure 7. Left to right: No. 13 piston and connecting rod from the no. 2 auxiliary engine, and no. 13 connecting rod bearings from the no. 2 auxiliary engine.

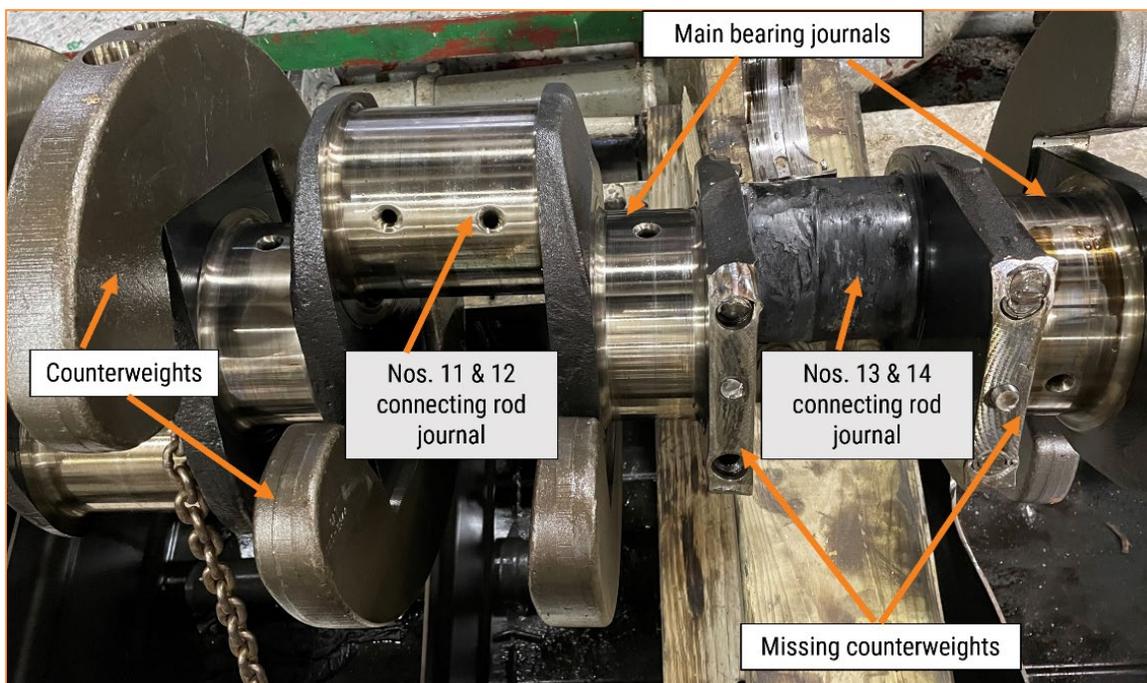
The technicians lifted the damaged engine block off its base to remove it from the vessel and access the crankshaft. The journal, which had the nos. 13 and 14 connecting rods attached to it, was severely damaged. Both counterweights had been forcibly disconnected from this section of the crankshaft (see figure 8).

Figure 8. Removed crankshaft from damaged no. 2 auxiliary generator on board *Ocean Navigator* after the engine failure.
