MIR-25-16

# Fire aboard Roll-on/Roll-off Container Vessel *Grande Costa D'Avorio*

Newark, New Jersey  
July 5, 2023

**Abstract:** This report discusses the July 5, 2023, fire aboard the 692-foot-long, Italian-flagged roll-on/roll-off container (Ro/Con) vessel *Grande Costa D'Avorio* while the vessel was docked at Port Newark, New Jersey. A pusher vehicle (a passenger vehicle, owned by the cargo loading company and retrofitted with a steel front bumper), operated by shoreside workers who were loading used vehicles onto the vessel's garage decks, caught fire in an interior garage deck. Vessel crewmembers attempted to put out the fire using portable fire extinguishers but were unsuccessful. The captain ordered the vessel's fixed gas (carbon dioxide [CO<sub>2</sub>]) fire extinguishing system to be activated. The crew attempted to seal the garage decks where the CO<sub>2</sub> had been released to allow the CO<sub>2</sub> to smother the fire, but they were unable to close a large rampway door that was controlled from a single panel inside the garage where the fire was located. Land-based firefighters arrived on scene. While attempting to put out the fire, two land-based firefighters

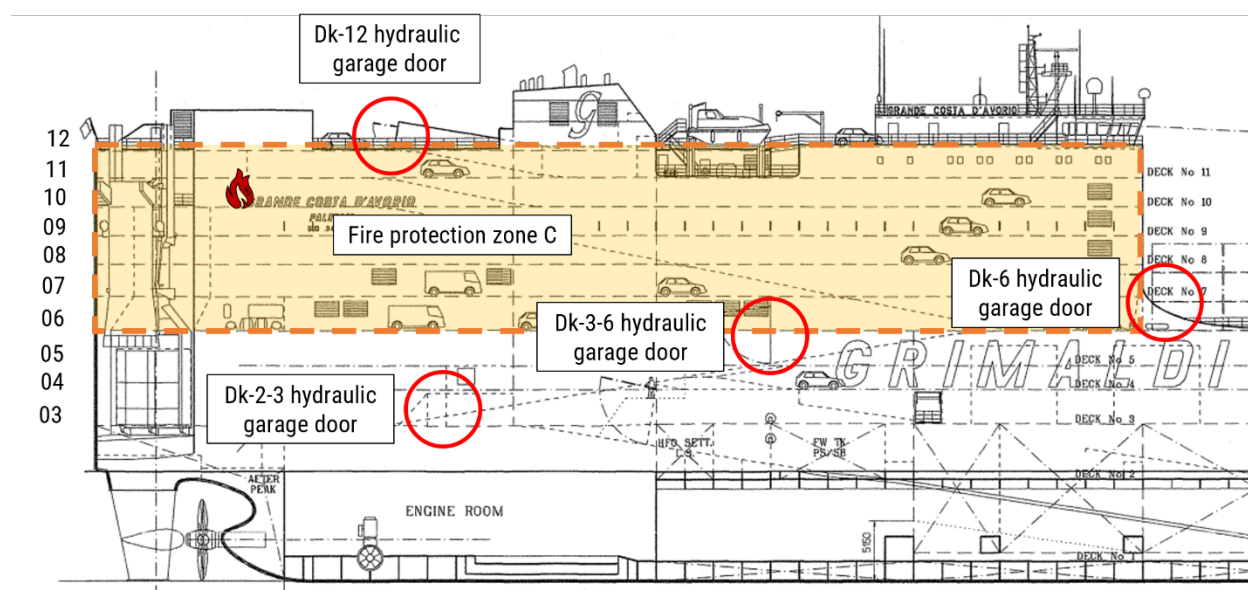
The *Grande Costa D'Avorio* had a fixed gas fire extinguishing system that, in the event of a fire, released CO<sub>2</sub> into one or more of the vessel's six fire protection zones.<sup>27</sup> (For more information on shipboard fire extinguishing systems, see Appendix D: Basics of Shipboard Firefighting.) The enclosed garage spaces of decks 6-11 were all part of the same fire protection zone (zone C) and were therefore designed to be able to be sealed off from the other decks and the outside with the aid of three hydraulically operated garage doors (see Figure 10). Although decks 7-11 were perforated with tie-down holes for securing cargo, deck 6 had deerings welded to the deck, but no holes, to maintain the fire boundary.

**Figure 10.** Partial profile of the *Grande Costa D'Avorio*. Fire zone C is indicated by the shaded region. The vessel's four hydraulic garage doors are circled. (The Dk-2-3 door was not part of the fire boundary for zone C.)

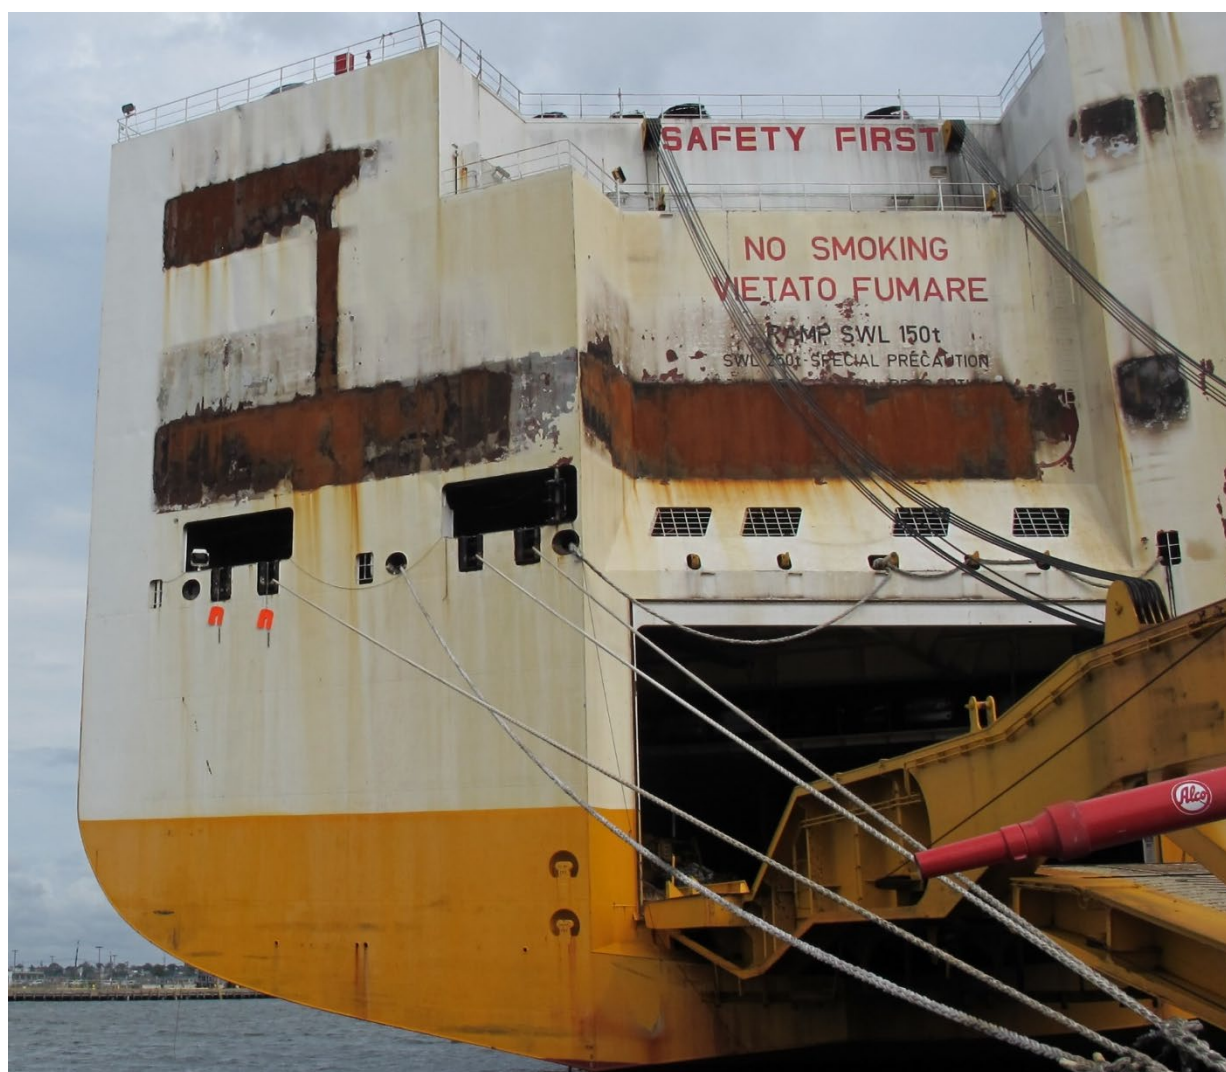
Although the exterior of the vessel was relatively intact after the fire, a large section on the port stern at deck 10 and the port aft corner at deck 11 exhibited significant thermal damage: all the paint was missing, and the bulkhead in those areas was heavily oxidized and warped (see Figure 12). The adjacent areas exhibited heavy sooting.

**Figure 12.** Damage to the vessel's stern.

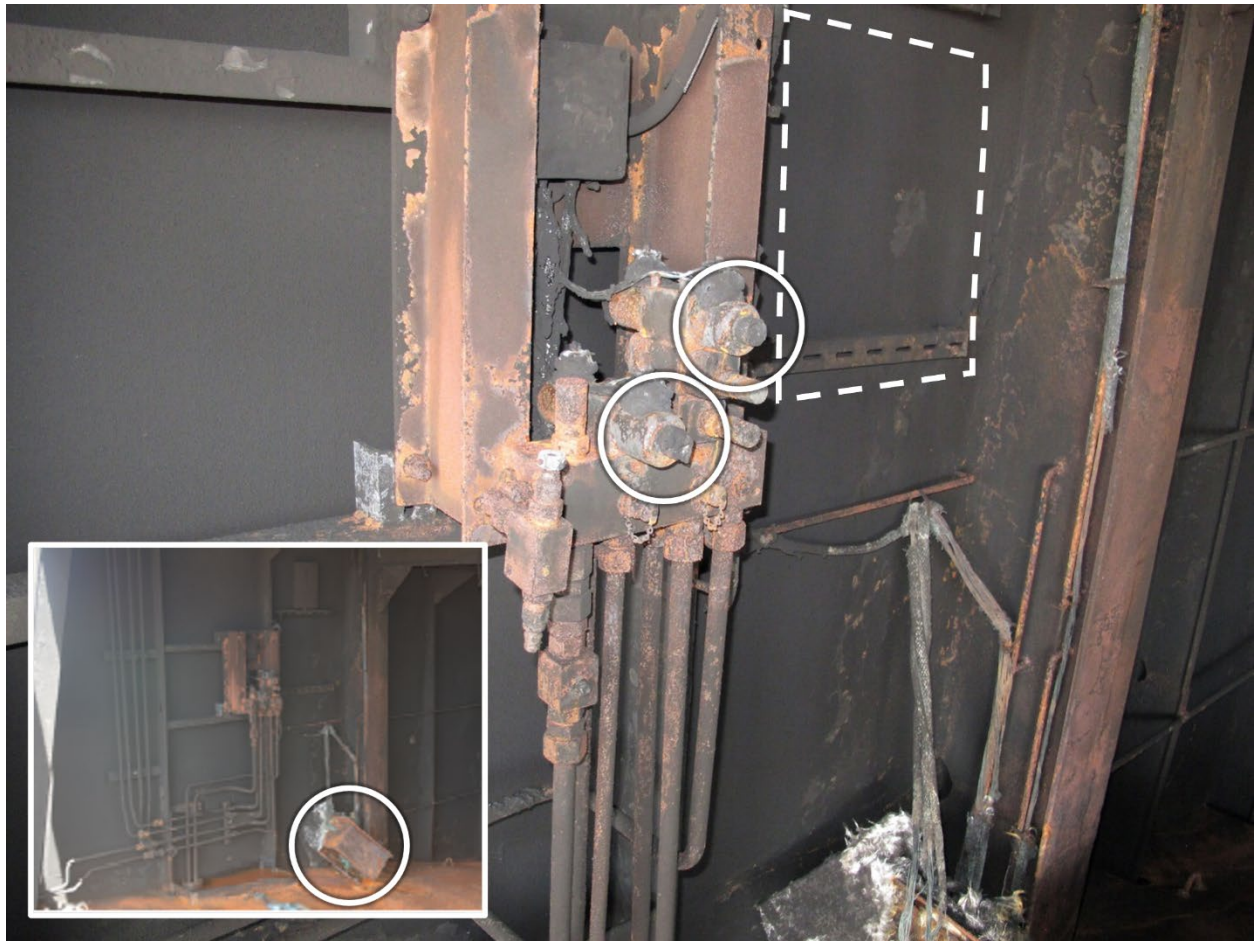
On both sides of the vessel, between deck 6 and deck 11, paint was missing in areas, and adjacent areas were discolored and blistered. Damage was also present on the forward starboard corner of deck 11. Similar thermal damage was found in the forward section of deck 11, next to the Dk-12 hydraulic garage door, which had remained open. The door control panel, located inside the vessel, was destroyed (see Figure 13).

**Figure 13.** The Dk-12 garage door hydraulic valve block after the fire, with manual operating control valves circled. The location of the door's control panel, which burned and fell off the bulkhead, is outlined in the dotted line. *Inset:* a wide view of the area, showing the control panel on the floor (circled). (Inset source: Bureau of Alcohol, Tobacco, Firearms and Explosives)

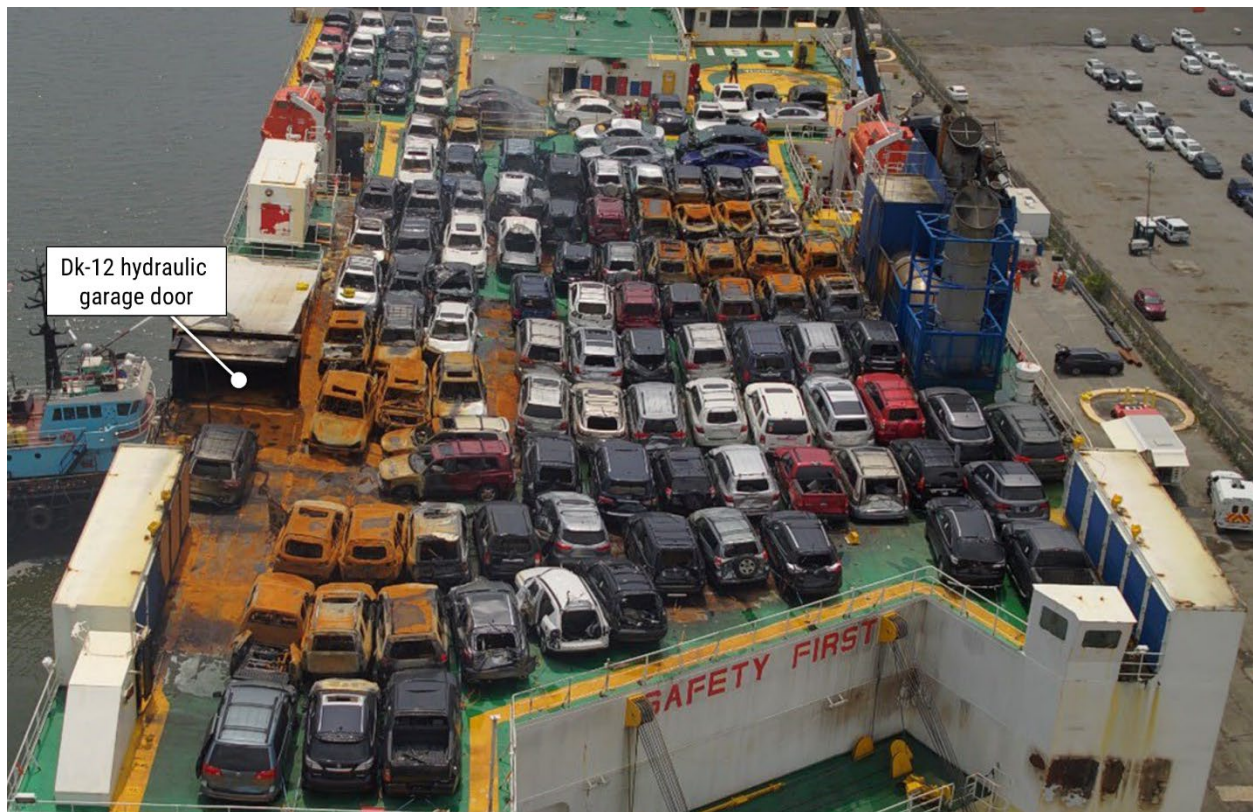
Additionally, the open portion of deck 12 exhibited significant warpage, and several groups of vehicles stowed on the deck were damaged or destroyed by fire (see Figure 14).

**Figure 14.** Overall damage to deck 12 (looking forward). (Background source: Bureau of Alcohol, Tobacco, Firearms and Explosives)

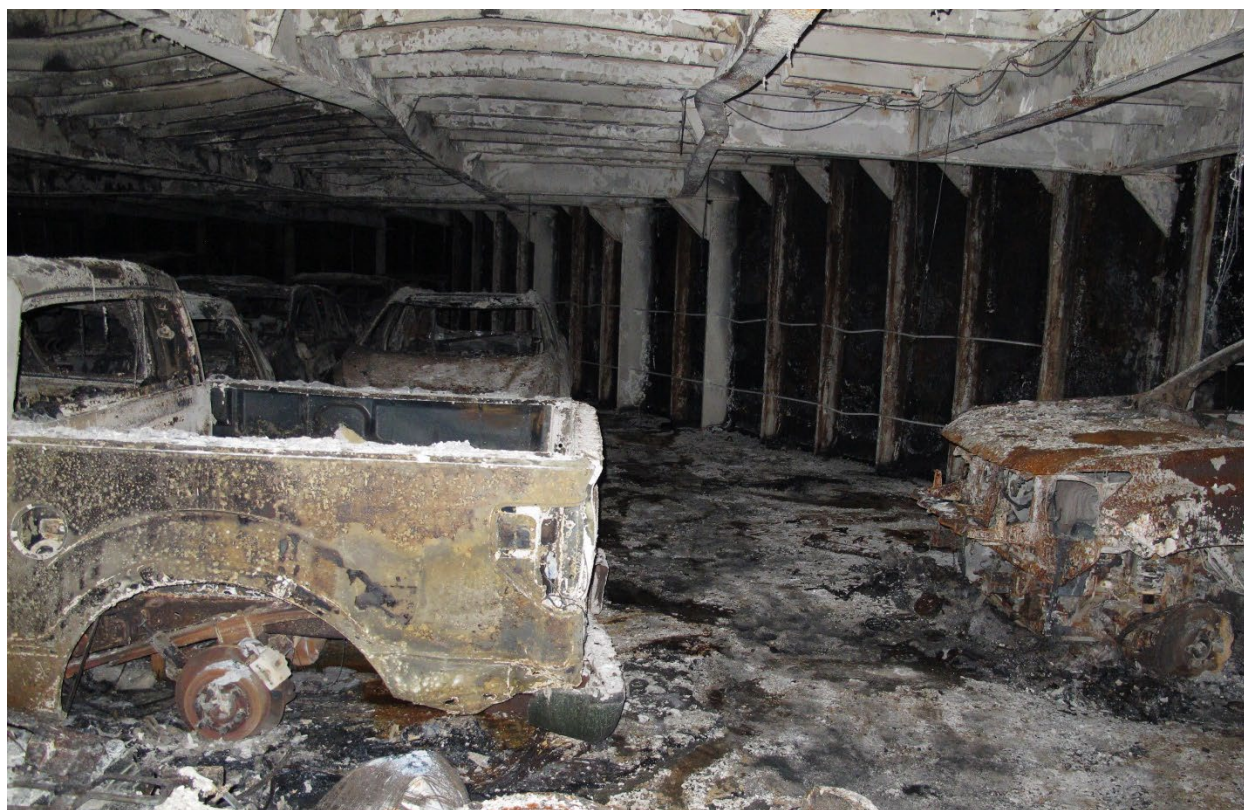
Decks 1 through 6 were undamaged. However, decks 7 through 9 exhibited varying degrees of fire damage to the ship's structure—including deck warpage, blistering paint, discoloration, and heavy sooting—and to loaded cargo. Figure 15 shows an example of the damage on deck 8.

**Figure 15.** Damage to deck 8 aft.

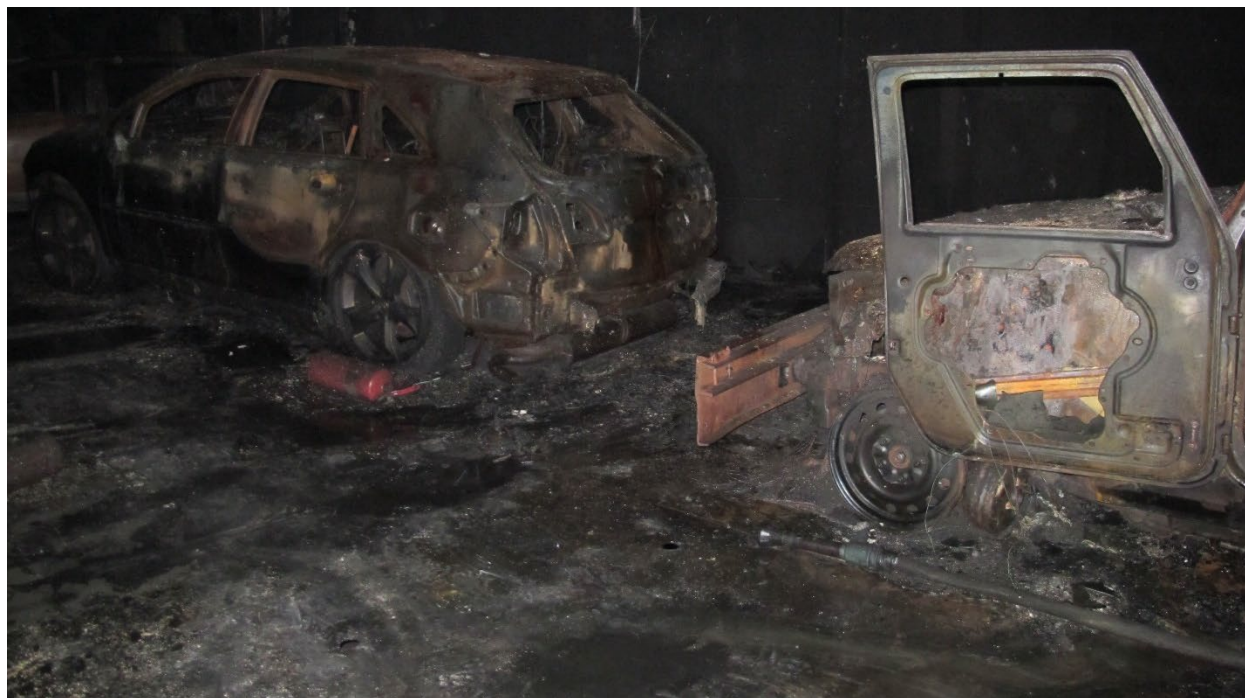
Two vehicles—a Jeep Wrangler and a Toyota Venza—were involved in the initiating events of the fire: The Jeep was being used to push the Venza to its stow position on deck 10 (see Figure 16). During this operation, a fire started on the Jeep and then spread to the Toyota.

**Figure 16.** The Toyota Venza (*left*) and Jeep Wrangler pusher (*right*) on deck 10.

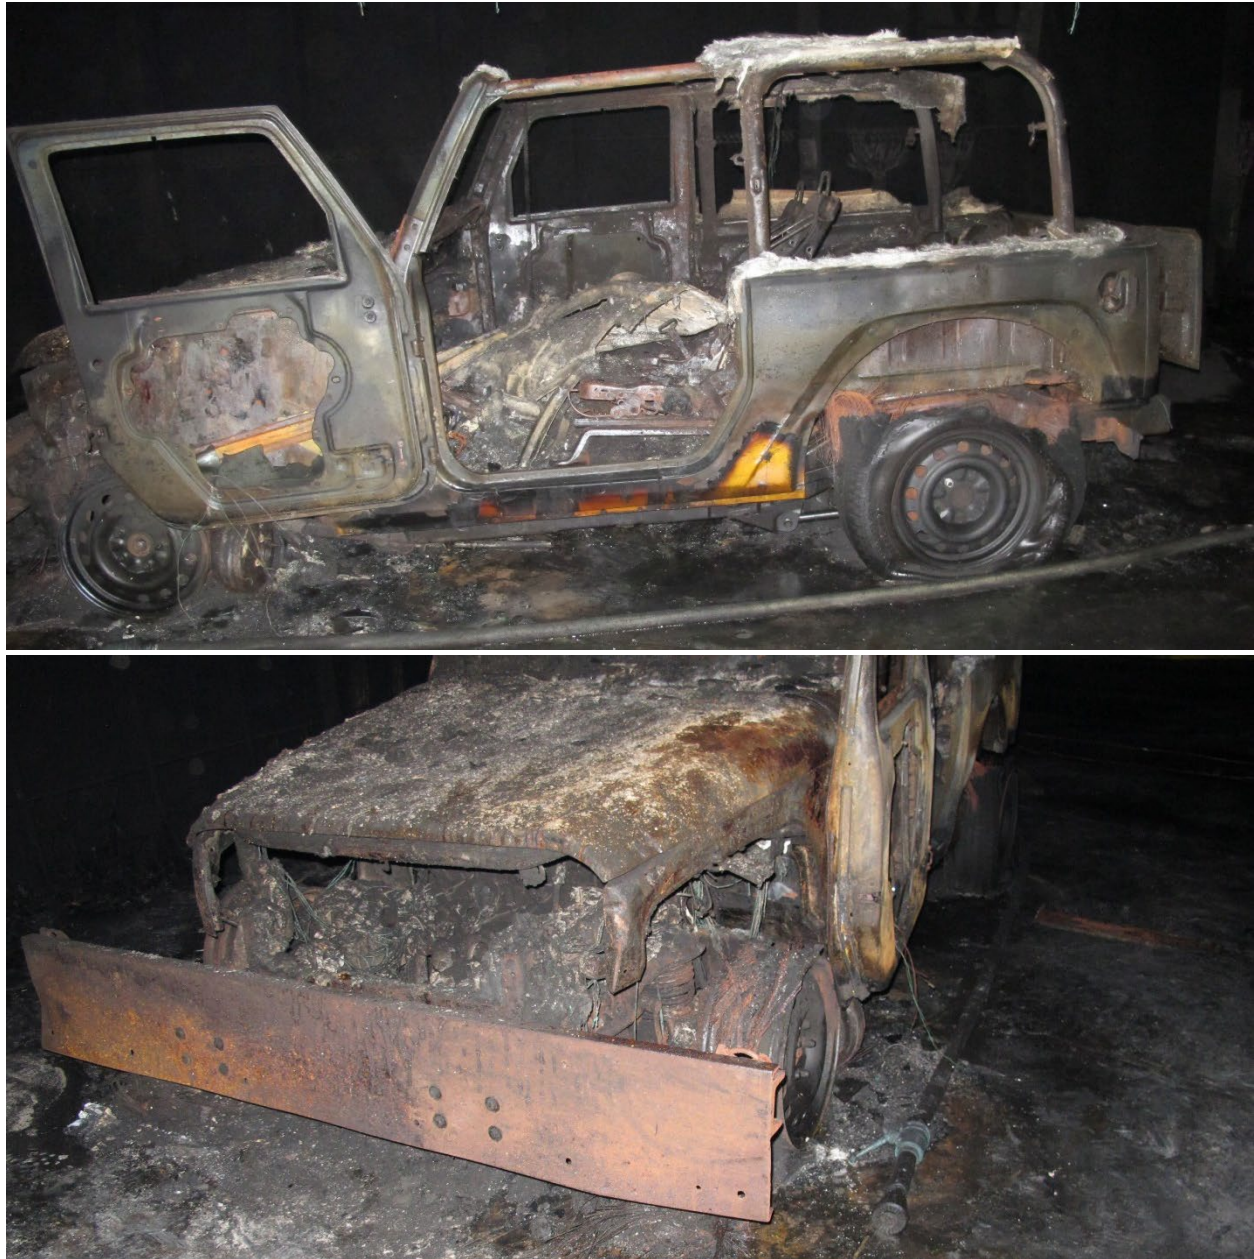
Investigators from multiple agencies and jurisdictions first examined the Jeep pusher vehicle on board the vessel in the location where the driver left it after he saw the fire (see Figure 17).<sup>32</sup> The Jeep sustained heavy fire damage. Almost all the vehicle's exterior paint was missing, and the remaining vehicle body was heavily oxidized and buckled in places. The oxidation pattern was heavier on the front of the vehicle (front, hood, and front quarter panel) and decreased in severity toward the rear of the vehicle. All nonmetallic components (light lens, fenders, door handles, grill, and weatherstripping) were missing and presumed destroyed by the fire. Both front tires and the passenger side back tire were completely consumed in the fire, and the driver side back tire was partially consumed. Most of the composite hard-top roof and all the windows were missing. The interior was destroyed, with only metallic components remaining. The push bar was still attached but also heavily oxidized.

**Figure 17.** (Top to bottom) Damage to Jeep (driver side), and front end with attached (retrofitted) steel front bumper/push bar.

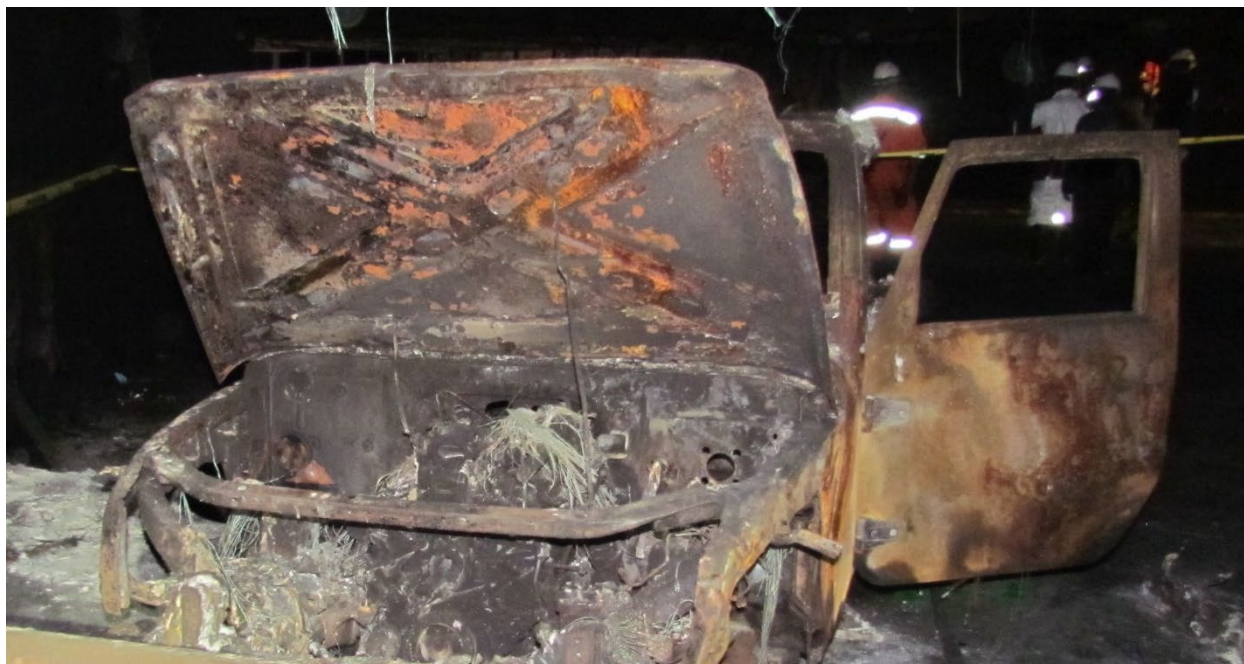
The engine compartment also sustained significant thermal damage: The underside of the hood was heavily oxidized, and all nonmetallic components in the engine compartment were missing and presumed consumed in the fire (see Figure 18).

**Figure 18.** Fire damage to the Jeep engine compartment.
