April 22, 2025

MIR-25-17

Contact of Towing Vessel *Cocodrie* with Valero St. Charles Refinery Walkway

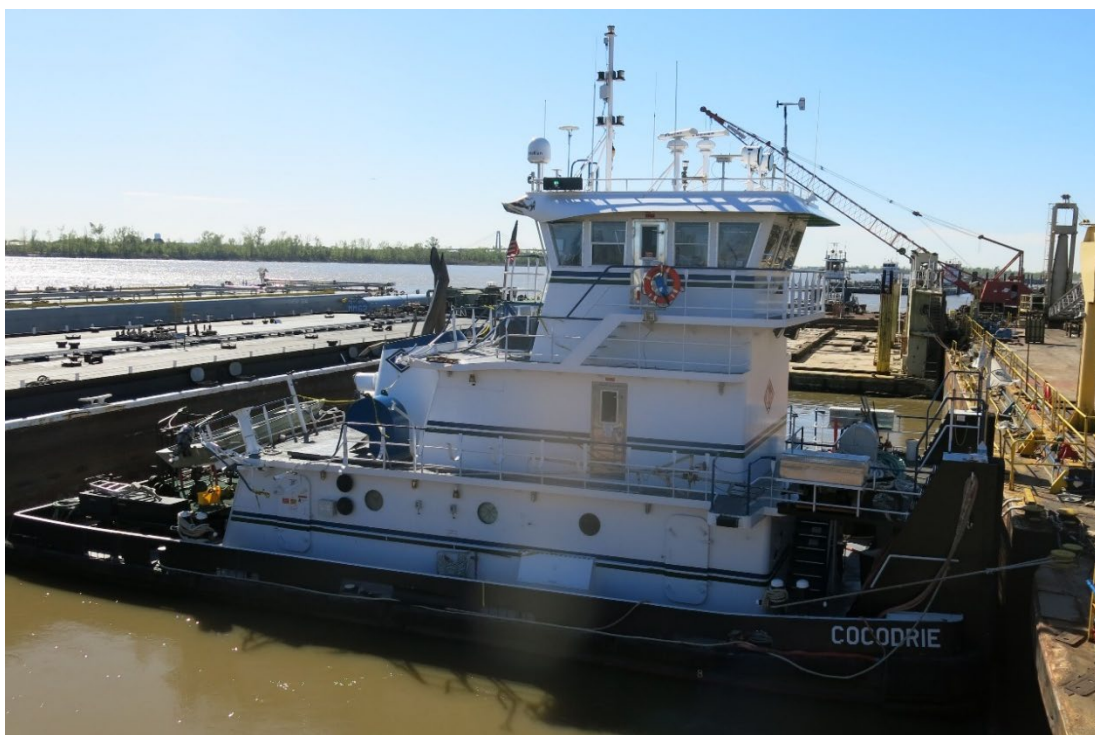
Figure 1. *Cocodrie* moored after the casualty on March 19, 2024.

Damage to the dock no. 6 walkway was estimated at \$429,000, not including loss of use. The dock was out of service for about 45 days. The walkway support piling was displaced and was no longer vertical. Support framing and cable tray supports at each side of the walkway were damaged as well. The *Cocodrie* sustained damage to its second deck—including multiple broken railings, buckled and fractured deck surface, and damage to the vessel's stacks—estimated at \$234,000. The total estimated damage to the dock and vessel was \$663,000.

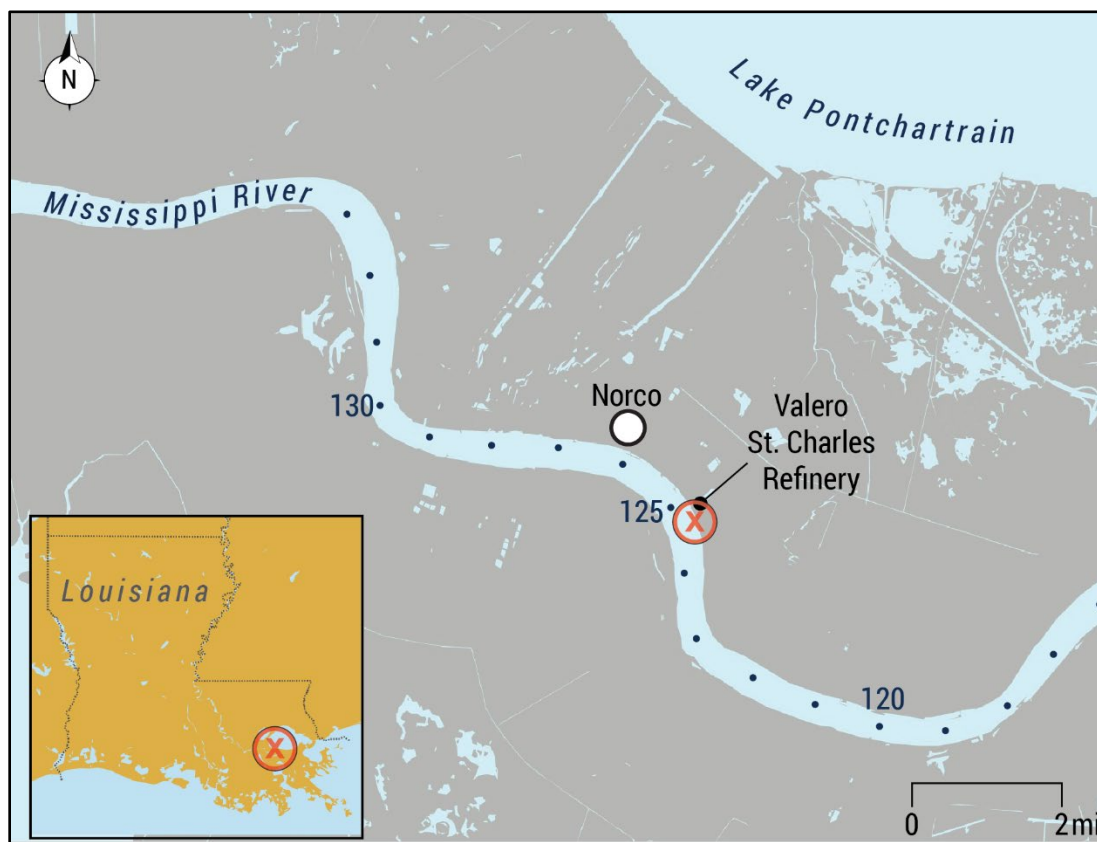
Figure 2. Area where the *Cocodrie* contacted the Valero St. Charles Refinery walkway and pilings, as indicated by a circled X. (Background source: Google Maps)

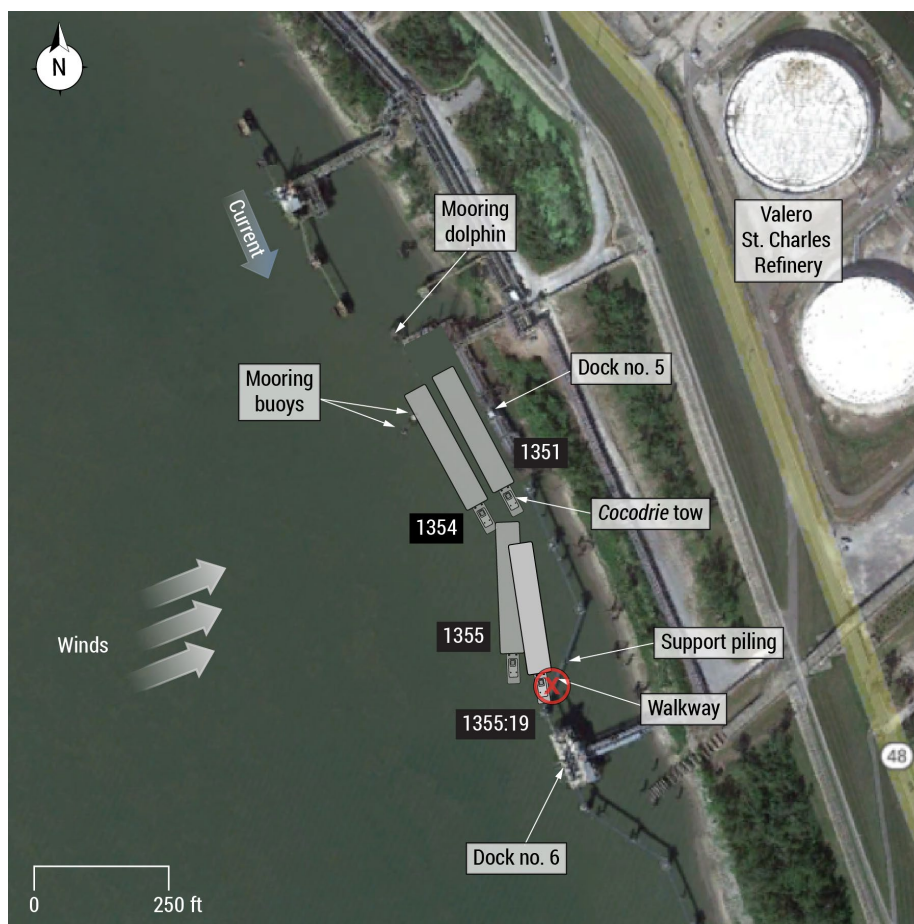
About 1354:30, the vessel was moving at a speed of 4.7 mph astern, and the tow was swinging at a rate of turn about 25° per minute to starboard. About 15 seconds later, when the vessel was about 110 feet from the dock no. 6 walkway piling, the astern speed was 5.3 mph. CCTV video from dock no. 6 captured propeller wash from the stern of the boat. The pilot said he came full ahead on the starboard engine, moved the flanking rudder to starboard, and moved the main rudders to port to try to avoid hitting the no. 6 dock's 100-foot-long walkway. At 1355:05, the stern of the *Cocodrie* began to swing to starboard and close on the dock no. 6 walkway, and, at 1355:19, the starboard-side aft corner of the wheelhouse of the *Cocodrie* struck the dock no. 6 walkway(see figure 4).

Figure 4. Path of *Cocodrie* tow up to and when the *Cocodrie* contacted the dock no. 6 walkway. (Background source: Google Earth; vessel data source: *Cocodrie* Rose Point)

In an attempt to “twist” the head of the tow to port (away from the dock and its walkway), the pilot came full ahead on the starboard engine, moved the flanking rudder to starboard, and moved the main rudders to port. However, given the *Cocodrie*'s proximity to the dock no. 6 walkway, the pilot's action was too late to arrest the vessel's astern momentum, and the aft corner of the *Cocodrie* wheelhouse struck the walkway, causing it to come away from its mountings and fall onto the *Cocodrie*.

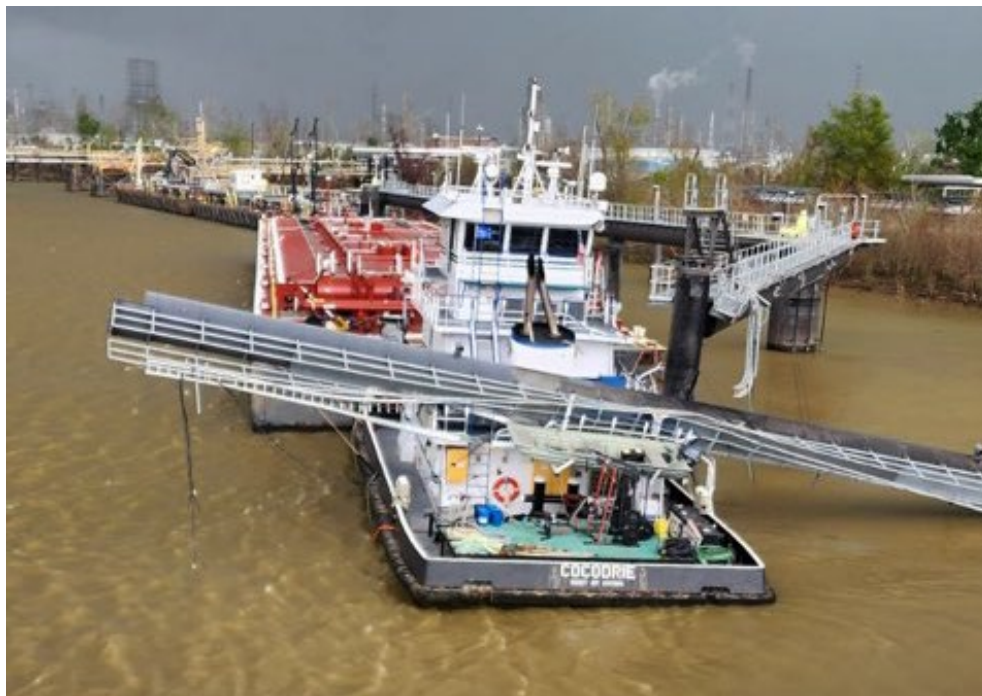
Designed to be removeable, the walkway came completely away from its mountings to a breasting dolphin and support piling and fell onto the open aft second deck of the *Cocodrie* (see figure 5). The *Cocodrie* made headway momentarily until the walkway got caught on the support piling to which it had been mounted, arresting the vessel's forward movement. No one was on the walkway at the time of the contact, and none of the *Cocodrie*'s crew were injured. After the contact, the relief captain, who was off watch and sleeping at the time, went to the wheelhouse, where he relieved the pilot at the helm.

Figure 5. *Cocodrie* with the walkway resting across the deck of the aft main deck structure. (Source: US Coast Guard).

The National Transportation Safety Board determines that the probable cause of the contact of the towing vessel *Cocodrie* with the Valero St. Charles Refinery dock no. 6 walkway was the sudden onset of strong beam winds, which increased the difficulty of the undocking maneuver with an empty barge.
