April 29, 2025

MIR-25-18

Contact of Bulk Carrier *American Mariner* with Munuscong Channel Junction Light

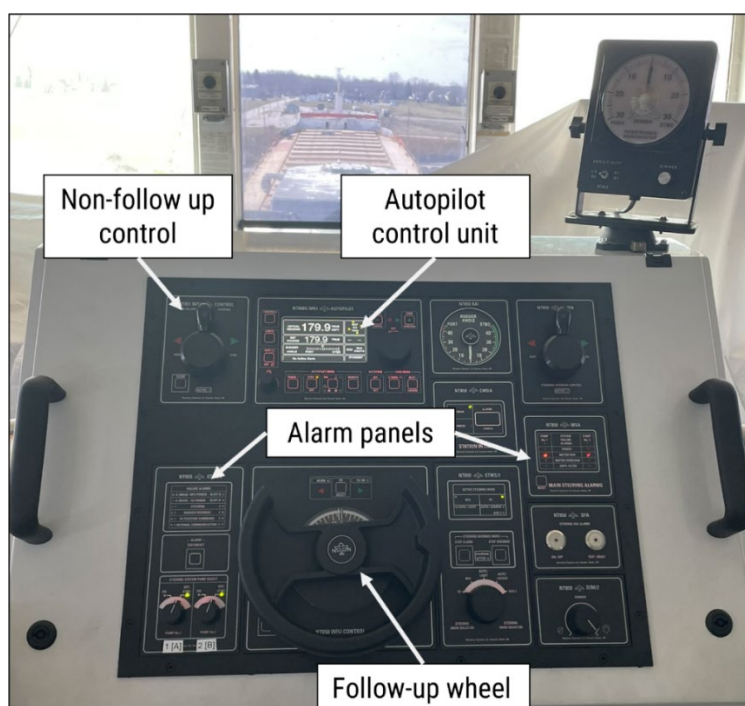
Figure 4. Steering control stand panel installed on the *American Mariner* during winter layup.

During the voyage leading up to the contact, alarms for the vessel's steering system sounded intermittently on the bridge while the crew was operating in hand steering and running both steering pumps. Crewmembers investigated the alarms but could not determine the cause, and the rudder appeared to properly respond to input commands. Additionally, the steering hydraulic system was found to be hunting between left and right positions while the two pumps were running. Once electronic technicians recalibrated the steering control system after the casualty, the steering alarms and hunting conditions no longer occurred—indicating likely issues with the newly installed control system's calibration of parameters.

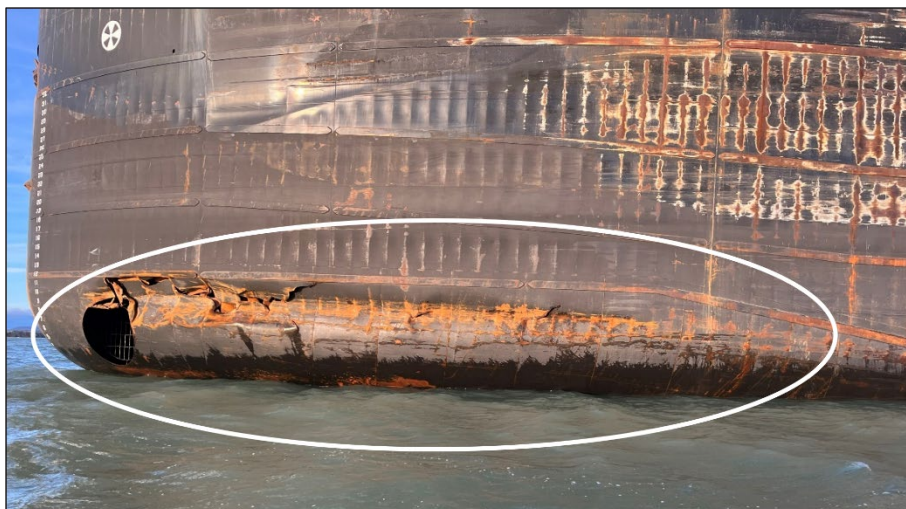
The vessel suffered damage to the hull plating and internal framing below the waterline to the forepeak tank and the no. 1 port ballast tank (see figure 6). Damages were estimated at \$800,750.

Figure 6. Damage to the port side of the *American Mariner* (circled) after striking the Munuscong Channel Junction Light. (Source: Coast Guard)

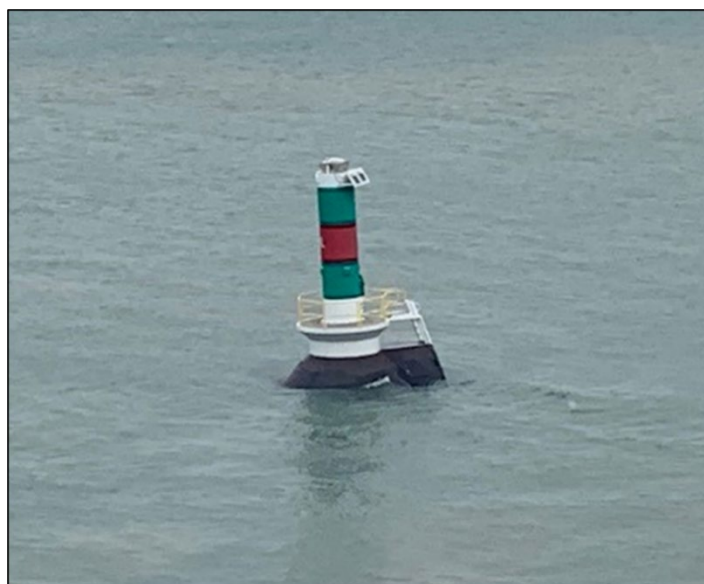
Initial underwater scans performed by the US Army Corps of Engineers indicated damage to the seabed foundation and underwater structure of the Munuscong Channel Junction Light, which caused the structure to lean from its originally constructed orientation (see figure 7). According to the Coast Guard Civil Engineering Unit, the estimated cost for repairs was \$1.25 million, and the cost for replacement was estimated at \$2.2 million due to the remote location of this ATON and mobilization costs for in-water work. As of the date of this report, repairs have not been made to the Munuscong Channel Junction Light.

Figure 7. Upper portion of the Munuscong Channel Junction Light after being struck by the *American Mariner*. (Source: Coast Guard)

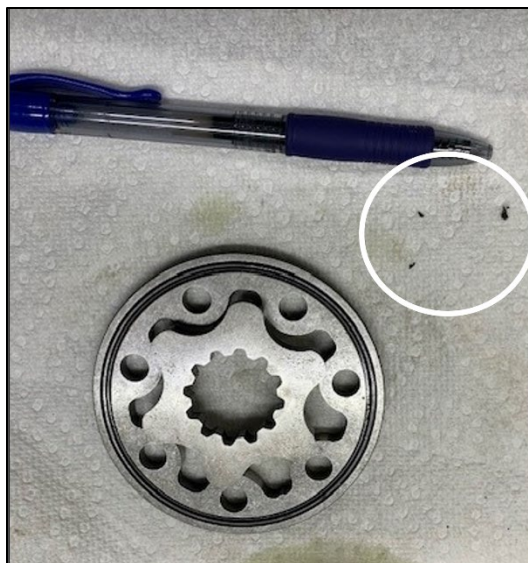
Later on the day of the casualty, third-party hydraulic technicians arrived aboard the anchored vessel and inspected the removed no. 1 control motor with ship's engineers. The third-party technicians reported that the motor would not rotate by hand and was "severely locked." One of the technicians used a hammer to separate the gear assembly, and a "non-metallic black piece of material" was found lodged between the inner and outer gear machining and gear housing. The chief engineer described the debris, saying it looked like "either gasket material or a sliver of an O-ring," and was about the size of a "quarter of a pencil eraser." The debris found inside the no. 1 control motor was retained for further testing (see figure 10). Section 1.3.4.2 provides more information about testing performed on the debris found in the no. 1 control motor.

Figure 10. Debris (circled) found in no. 1 steering gear control motor aboard the *American Mariner*. (Source: Coast Guard)

Immediately after the casualty, crewmembers inspected the steering system and determined that the no. 1 control motor (which controlled the stroke of the main hydraulic pump) within the vessel's steering system had failed. The motor was disassembled, and a piece of black, pliable debris was found to be lodged in between the rotating gears of the control motor, preventing it from rotating properly. Once seized, the control motor's corresponding linkages to the main steering pump remained stationary, preventing the main steering pump from changing output pressure and locking the rudder in its last ordered position at 20° left. Once a replacement control motor was installed, the steering system responded properly to steering commands from the bridge.

A FTIR analysis found that the two black pieces of debris from the steering system's no. 1 control motor and an exemplar O-ring (replaced on the directional valve during the winter layup period the month before the casualty) were PVDF; however, results from another type of analysis, EDS, differed. Additionally, the colors of the materials differed: the debris found in the no. 1 control motor was black and the exemplar O-ring was brown. Because the debris was not an exact match to the exemplar O-rings, it is possible that a similar type of PVDF O-ring used previously within the hydraulic system or a material from another component in the system downstream of the suction filters could have been dislodged during operation. Therefore, the origin of the debris found in the no. 1 control motor could not be positively identified, which indicates that the debris likely came from another hydraulic system component that was circulating through the unfiltered portion of the hydraulic control system.

The National Transportation Safety Board determines that the probable cause of the contact of the bulk carrier *American Mariner* with the Munuscong Channel Junction Light was O-ring-type material debris in the steering gear system's hydraulic oil becoming lodged within a control motor, which caused it to seize, resulting in the rudder locking at its last ordered position.

The service technician provided a plan to install a 10-micron filter (which has a finer mesh than the 125-micron filter) in the hydraulic control system to filter the

hydraulic oil being fed to the control motors. He stated that other Great Lakes vessels with similar steering systems have additional filters in the control circuit (the hydraulic piping that fed the control motors). The filter was intended to be located before the steering flow control valve for the hydraulic supply for both control motors and would include an electric pressure differential switch, which, if the filter became clogged, would send an alarm signal to the existing steering control panel. The hydraulic company also developed a plan (delivered in a service report) for disconnecting the steering control tie rod from the pump, which would allow for manual control of the pump direction in an emergency. As of the date of this report, these modifications had not yet been implemented aboard the *American Mariner*.

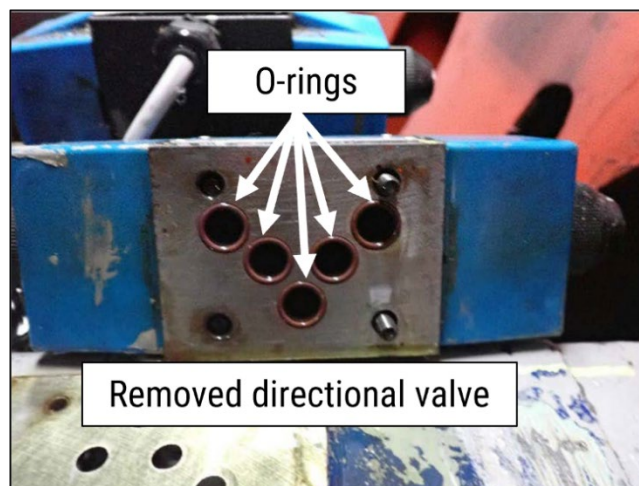
On September 23, 2024, the third-party laboratory released a summary of results for FTIR spectroscopy and EDS testing performed on one of the brown O-rings that had been installed during winter layup maintenance and two types of sealing materials (one green and one black) that had been previously removed from the *American Mariner* by technicians for comparative purposes (figure 11). The FTIR analysis determined that the exemplar O-ring material was PVDF, and the EDS analysis of the exemplar O-ring found the presence of carbon, oxygen, fluorine, calcium, and other trace elements, including barium and zinc. The FTIR analysis of the green sealing material found the material to be consistent with silicone-based thread sealant, and the EDS analysis confirmed the presence of silicon. The exemplar black sealing material was determined to be silicone rubber sealant with calcium carbonate filler. The EDS of the sealing material confirmed the presence of calcium.

Figure 11. Removed directional valve from *American Mariner* showing the replaced O-rings during winter layup. (Source: Grand River Navigation, Inc.)
