May 13, 2025

MIR-25-20

Fire aboard Fishing Vessel *Jordyn Rose*

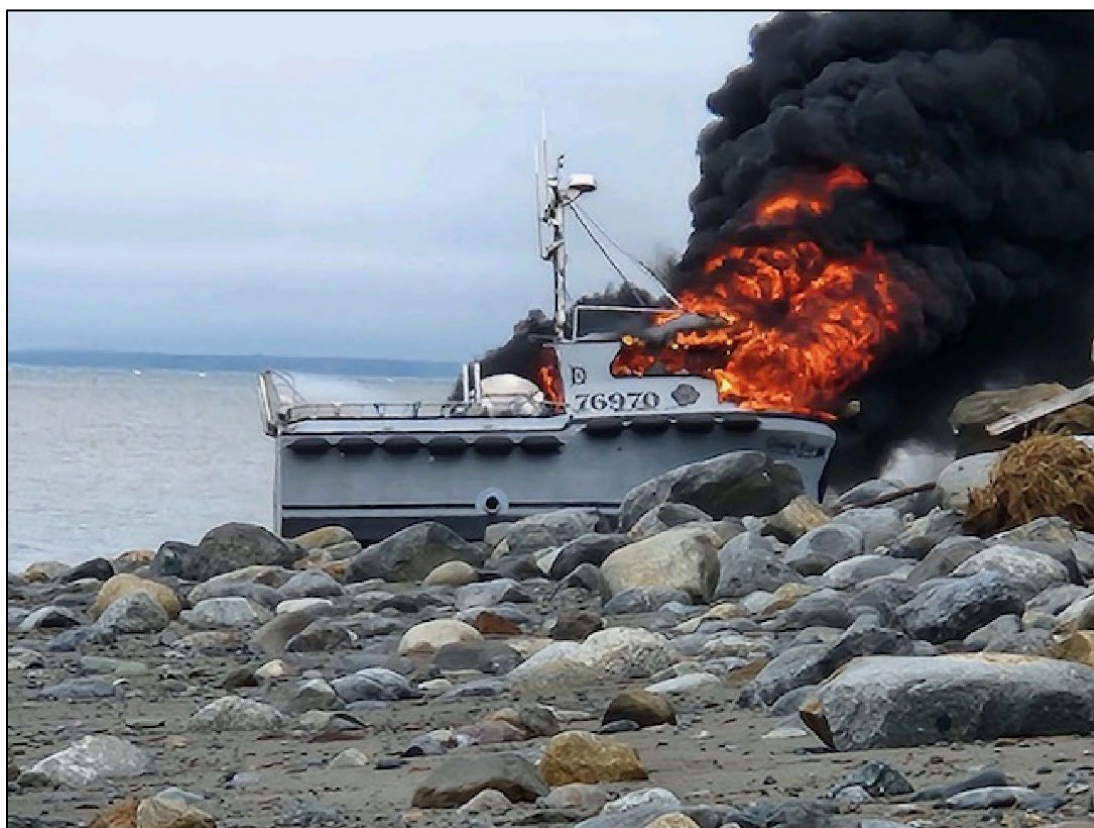
Figure 1. *Jordyn Rose* on fire on June 24, 2024. (Source: *Jordyn Rose* captain)

The captain was awoken from a nap by smoke and then saw smoke coming from the below-deck bunk area into the main cabin. After abandoning the vessel, he observed flames spreading into the main cabin from the bunk area. The captain's observations were consistent with the postfire survey report, which indicated that the greatest amount of fire damage, and likely area of origin, was near the port bow. Additionally, photos taken by the captain immediately after abandoning the vessel showed the fire near the port bow before it spread to the rest of the vessel (see figure 1).

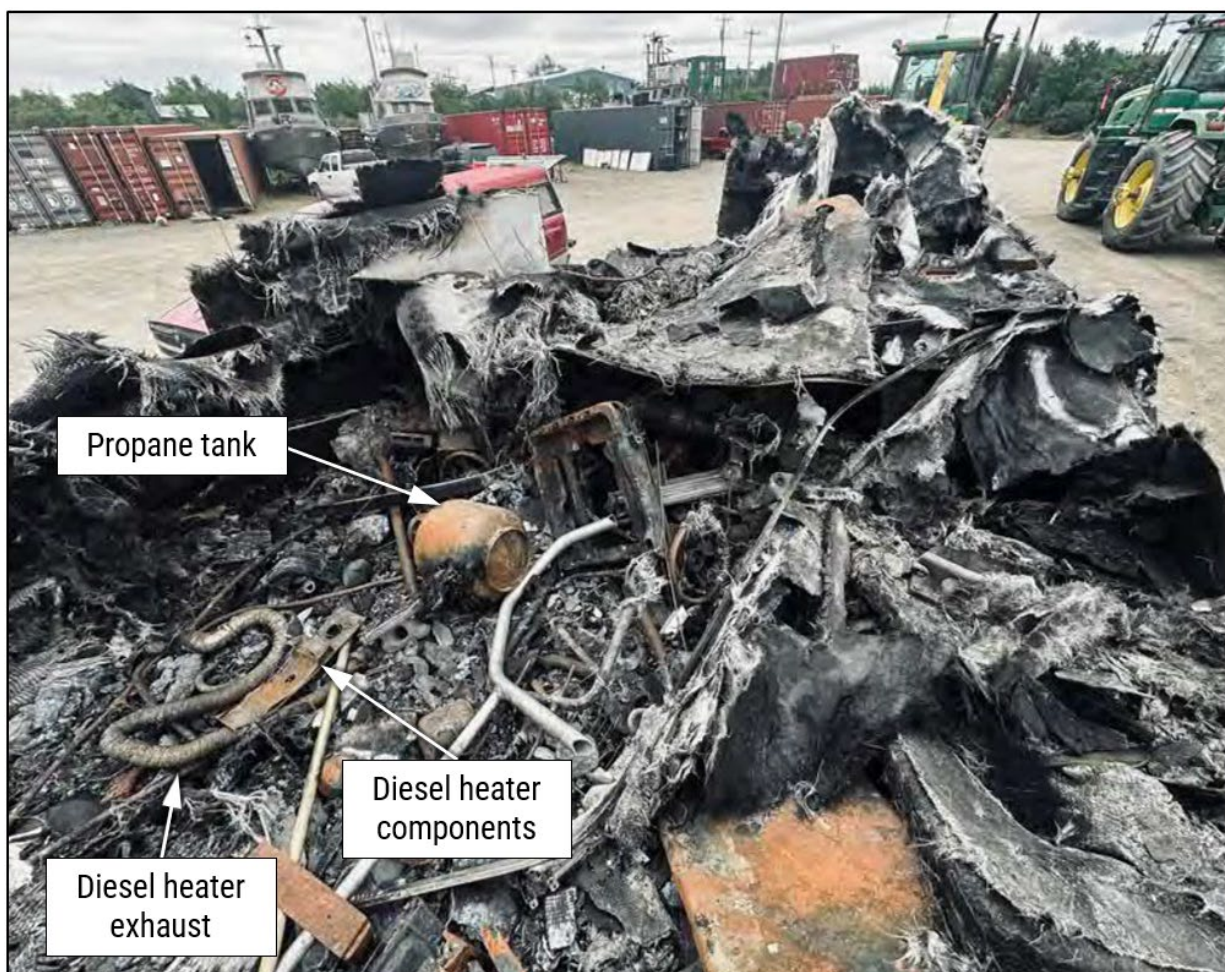
Two days after the fire, a survey was conducted on behalf of the vessel’s insurer. The surveyor found that the most severe fire damage was near the port bow, and that this was likely where the fire originated (see figure 3).

Figure 3. Fire damage to the *Jordyn Rose* bow (facing forward). (Background source: Alaska Survey Associates)

The National Transportation Safety Board determines that the probable cause of the fire aboard the fishing vessel *Jordyn Rose* was an undetermined interior source near the port bow of the vessel.
