May 29, 2025

MIR-25-22

Sinking of the Industrial Vessel *Cape Douglas*

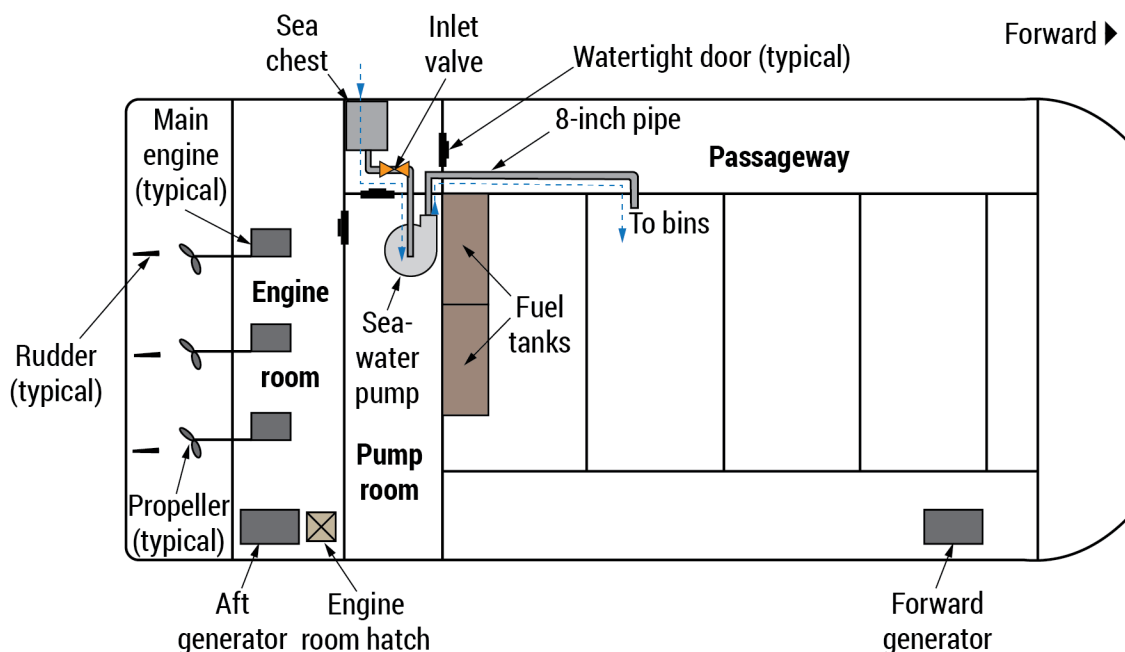
Figure 3. Simplified representation of the below-deck spaces of the *Cape Douglas* (not to scale) showing the inlet valve and seawater pump that supplied the 8-inch bin flooding line. Also shown are the vessel's portside watertight doors. (Background source: *Cape Douglas* captain)

The vessel's age (80 years old), visual signs of rust and deterioration, and documented hull wastage suggest a general degradation of the vessel and onboard systems, such as the deck washdown system. However, because the vessel was not salvaged, investigators could not determine the condition of the components of the deck washdown system, including the inlet valve between the sea chest and the seawater pump, the pump, or the associated piping. Based on the captain's statements, these components were over 25 years old and had not been used or tested for at least 2 years before the sinking. On the day of the sinking, the system was not tested before getting underway, so the captain would not have identified any issues with it. As the *Cape Douglas* neared the disposal site, the captain did not observe any flooding below deck while opening the inlet valve for the seawater pump and attempting to start the seawater pump. The flooding was only observed by the captain when he returned to the engine room about 15 minutes after opening the valve. Because the flooding occurred shortly after the valve was opened, the flooding was likely caused by a failure of the deck washdown system piping or the system's components downstream of the open valve.

While the *Cape Douglas* was equipped with watertight doors in the engine room and companionway spaces, these doors remained open during the transit. Maintaining watertight integrity of a vessel is a fundamental principle of safe operations on water. Within the hull, watertight bulkheads and watertight doors are designed to prevent progressive flooding by containing any incoming water to the compromised space. Had the watertight doors for the engine room, passageway, pump room, and sea chest room been secured, they may have contained the flooding.

The National Transportation Safety Board determines that the probable cause of the sinking of the industrial vessel *Cape Douglas* was flooding of a below-deck passageway or the pump room from an undetermined failure in the vessel's deck washdown system. Contributing to the sinking were open watertight doors, which allowed progressive flooding into the engine room and other below-deck spaces.

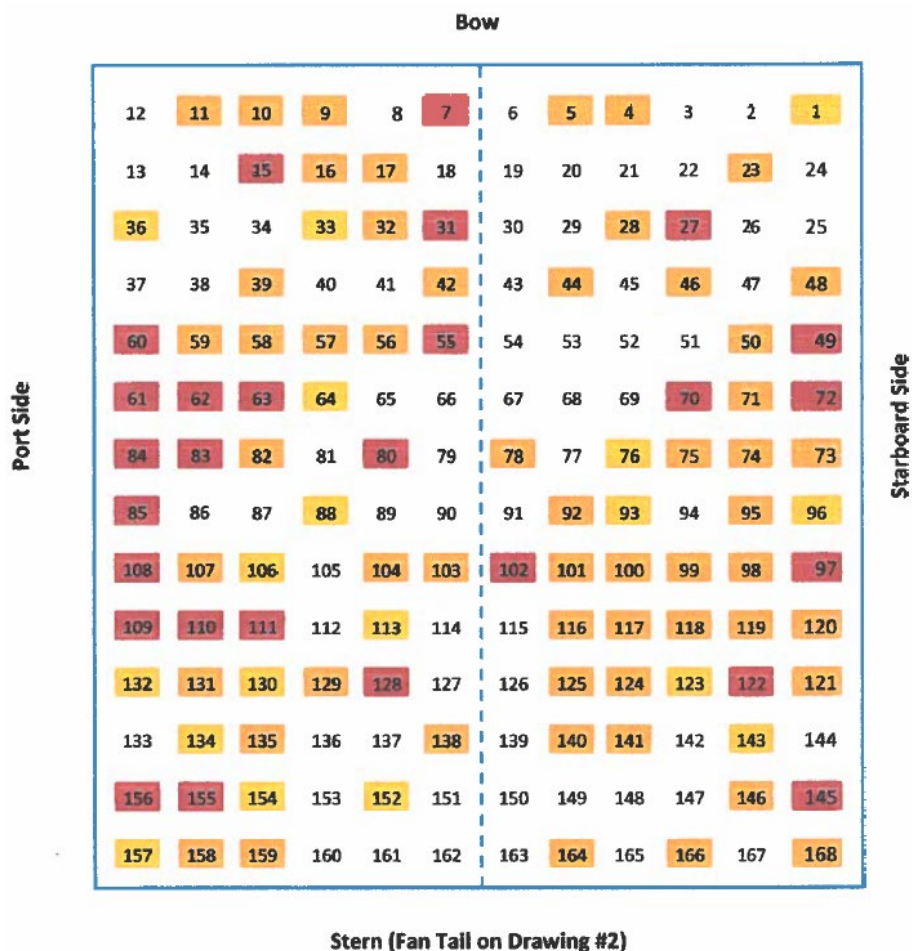
Over 2 years before the sinking, in August 2022, the *Cape Douglas* underwent a drydock survey and audio gauge hull testing. The survey concluded that the vessel was suitable for local, "limited fish waste product dumping" in Chiniak Bay, but "would require extensive refit for any heavy load/freight operations." Photos included in the survey report showed signs of rust and deterioration in below-deck areas, including the engine room and adjoining passageways. The audio gauge hull test showed that the majority of hull sections examined exhibited wastage greater than 15%, with many of these sections exceeding 25% wastage (see figure 4).⁴ The hull test report showed that the reference bottom plating thickness on the *Cape Douglas* was 0.312 inches.

Figure 4. Results of the 2022 audio gauge hull testing on the bottom plating of the *Cape Douglas* (numbers shown are survey audio gauge locations). Hull wastage between 15-18% is shown in yellow, 18-25% wastage is shown in orange, and wastage exceeding 25% is shown in red. (Source: Alaska Marine Surveyors, Inc.)
