June 11, 2025

MIR-25-23

Grounding of Towing Vessel *Tom Frazier*

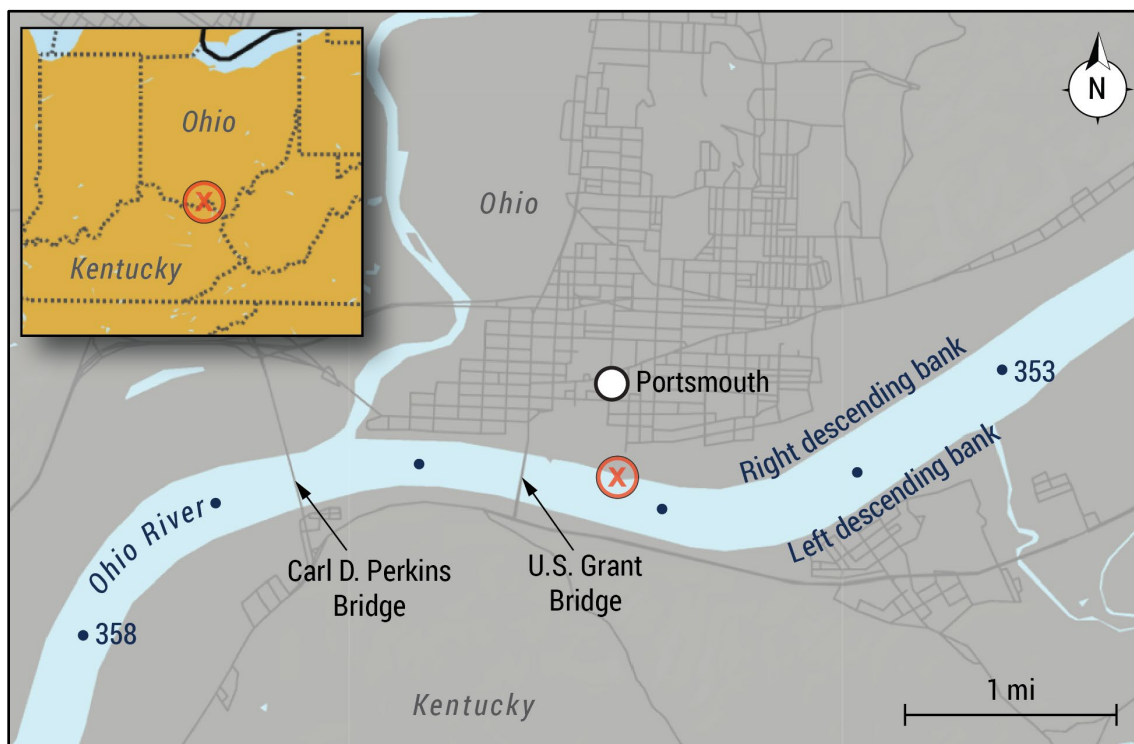
Figure 2. Area where the *Tom Frazier* grounded, as indicated by a circled X. (Background source: Google Maps)

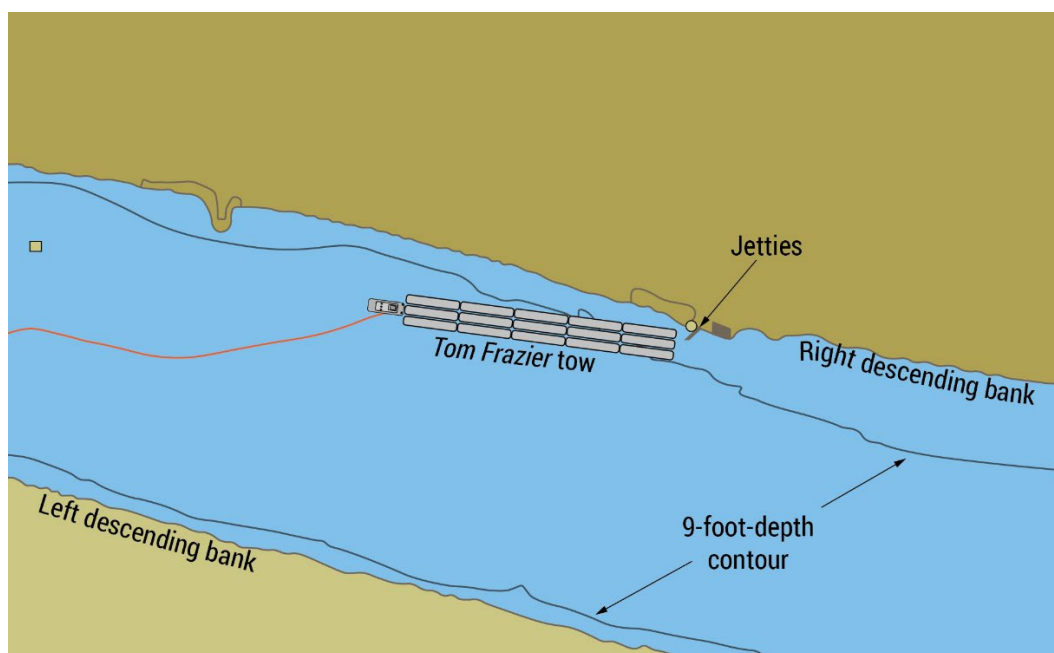
About 0.5 miles upriver from the U.S. Grant Bridge, jetties, made of stone, extended out about 55 feet (at datum) from the right descending bank of the river. The jetties, co-located with a boat ramp, protected marinas near the bridge from current and flotsam and were charted (see figure 4). When the *Tom Frazier* tow passed through the two bridges, the river level was 19.2 feet (at the Portsmouth gage), and the jetties were submerged (see section 1.3.2).

Figure 4. Re-creation of electronic navigation chart (ENC) showing stone jetties, with *Tom Frazier* tow arrangement and trackline overlaid. (Background source: ENC U370H332; trackline source: *Tom Frazier* automatic identification system)

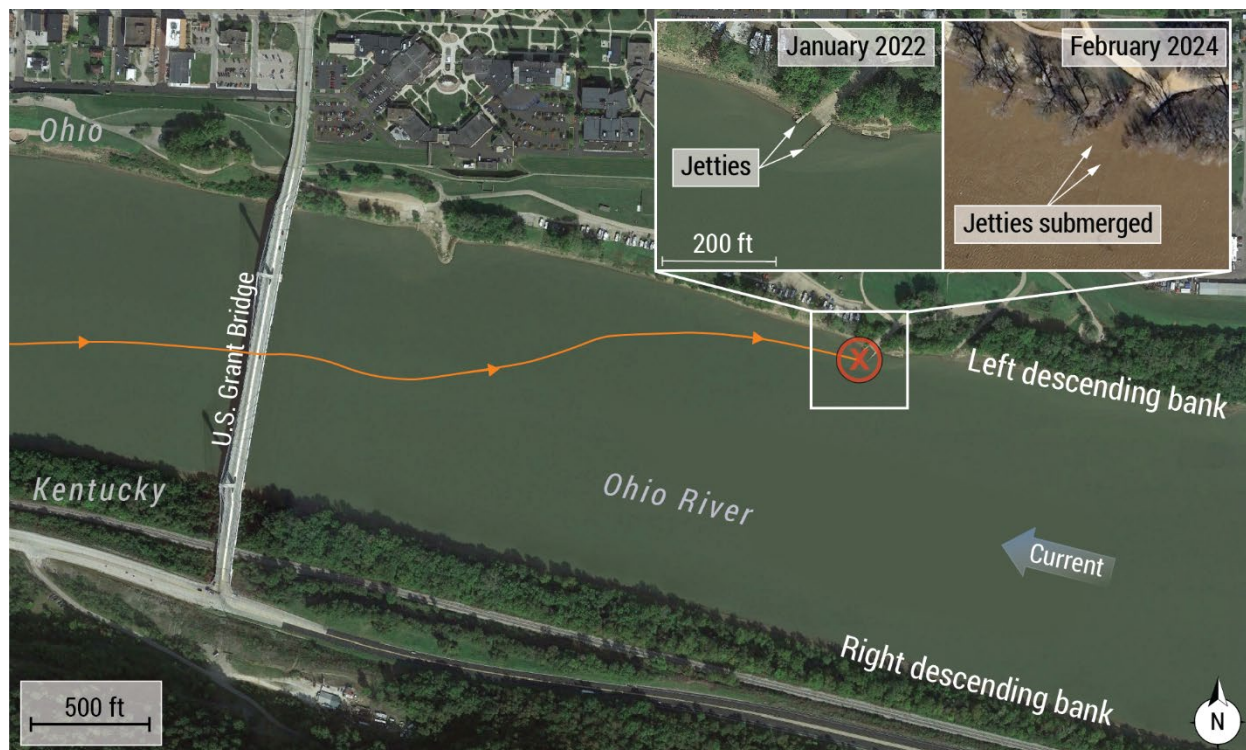
While the *Tom Frazier* tow was running close to and parallel with the right descending bank, outside the charted 9-foot-depth contour line, about mile 355, the empty barges passed over the jetties. At 1855, as the captain of the *Tom Frazier* attempted to maneuver the tow back into the channel while making a speed of about 4 mph, the *Tom Frazier* grounded on one of the jetties, puncturing the bottom plating and flooding a forward compartment (see figure 5).

Figure 5. Trackline of *Tom Frazier* tow as the vessel transited through the U.S. Grant Bridge and toward the right descending bank. Inset satellite photos show the jetties visible on January 26, 2022 (17.4 to 18.5 feet at the Portsmouth gage) and submerged on February 14, 2024 (28.7 to 31.6 feet at the Portsmouth gage). (Background source: Google Earth; trackline source: *Tom Frazier* automatic identification system; gage data: United States Geological Survey)

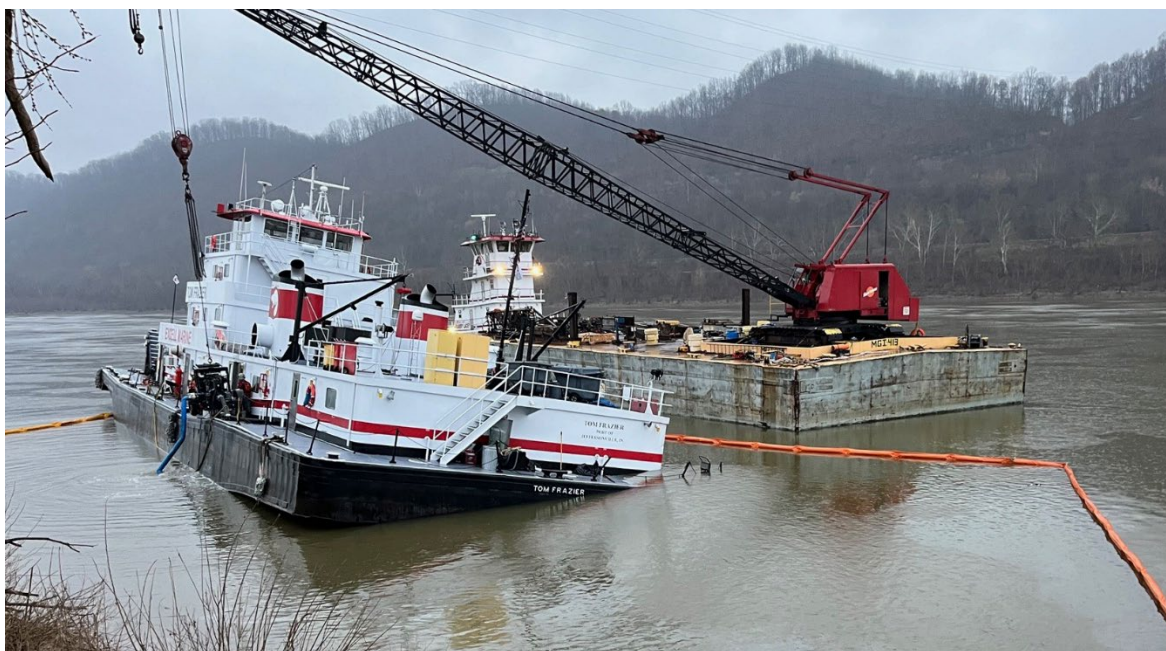
The *Tom Frazier* began listing to starboard, and the engine room flooded (see figure 6). The captain of the *Tom Frazier* notified US Coast Guard Sector Ohio Valley, via VHF radio, that they were taking on water and had nine people aboard. The Coast Guard notified Greenup County, Kentucky, officials, who launched the Southshore, Lloyd, and Portsmouth Fire Departments, among others, to the scene. Local first responders, individuals ashore, and crews from nearby vessels evacuated the crew to shore. The *Tom Frazier* tow was transferred to the towing vessel *Marty B*, which towed the empty barges to McGinnis' Debi Jo Dock (mile 334) in Greenup, Kentucky.

Figure 6. *Tom Frazier* aground and listing to starboard on February 11, 2024. (Source: Coast Guard)

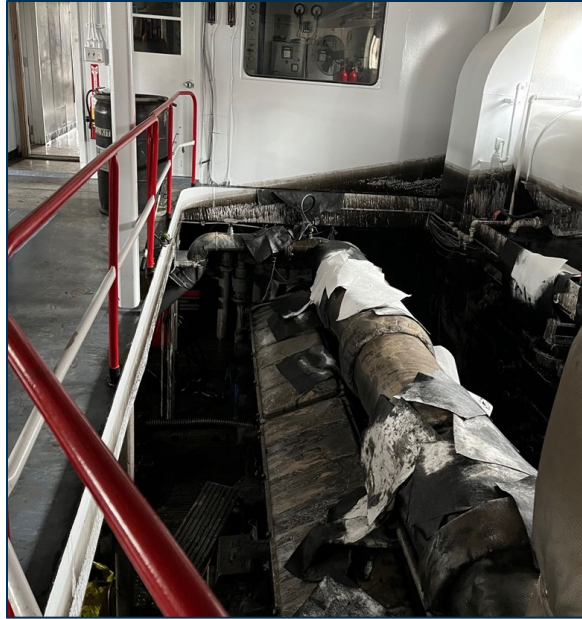
The *Tom Frazier* sustained damage to its bottom hull plating, deck plating, and headlog, as well as to transverse and longitudinal frames, inboard bulkheads, and a ballast tank (see figure 7). Damage was \$258,737.

Figure 7. *Tom Frazier's* engine room, looking forward. The oil-coated bulkheads show the height of water and angle of list before dewatering. (Source: Coast Guard)

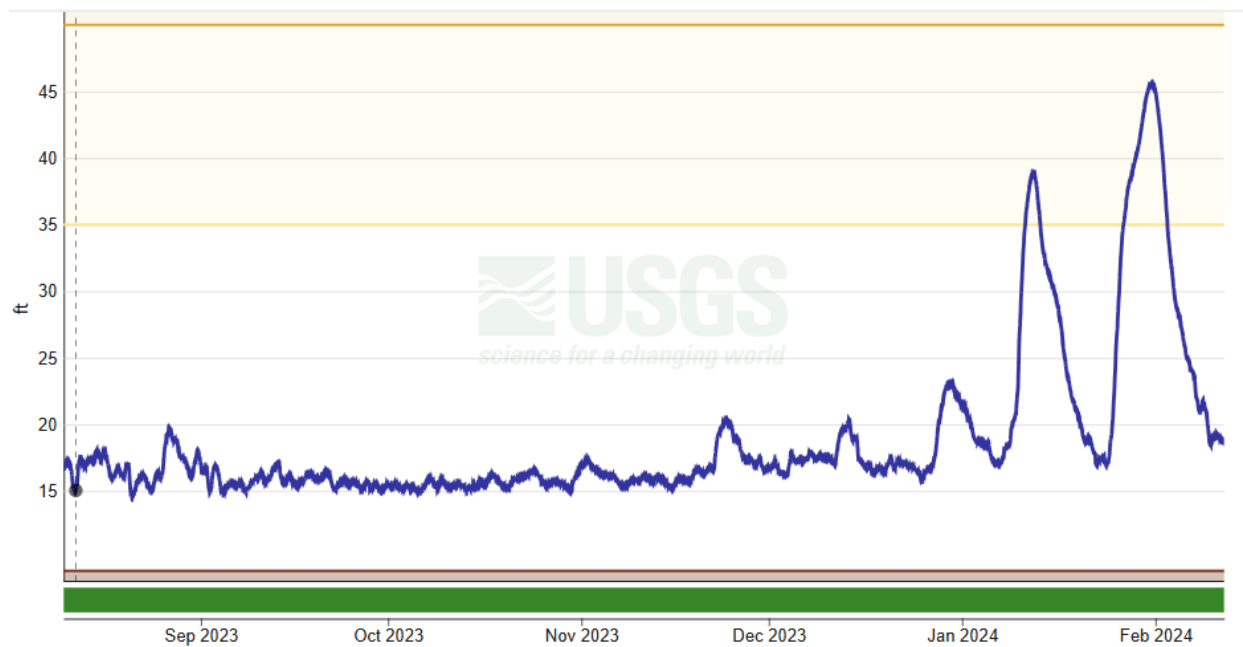
In January 2024, the Ohio River water level at Portsmouth, mile 355.5, rose from less than 20 feet, peaking at 45.6 feet on January 31 (see figure 8). The water level then receded, reaching 19.2 feet at the time of the grounding (February 10). On February 13 (the day the vessel was refloated), the water level rose from 18.5 feet to 28.7 feet. According to the United States Geological Survey, as of June 9, 2025, the Ohio River mean (average) water level at Portsmouth for the previous 14 years was 18.1 feet.

Figure 8. Ohio River water levels at Portsmouth between August 10, 2023, and February 11, 2024. (Source: US Geological Survey)
