Contact of *Duke* Tow with Power Transmission Poles and Pelican Island Bridge

On July 13, 2023, about 0130 local time, the towing vessel *Duke* departed the Texas International Terminal in Galveston, Texas, pushing two barges, when one of the barges in the tow contacted three power transmission poles near the Pelican Island Bridge, and the tug subsequently contacted the bridge (see figure 1 and figure 2).¹ There were no injuries, and no pollution was reported. Damage to the vessels, power poles, and bridge was estimated at over \$300,000.²

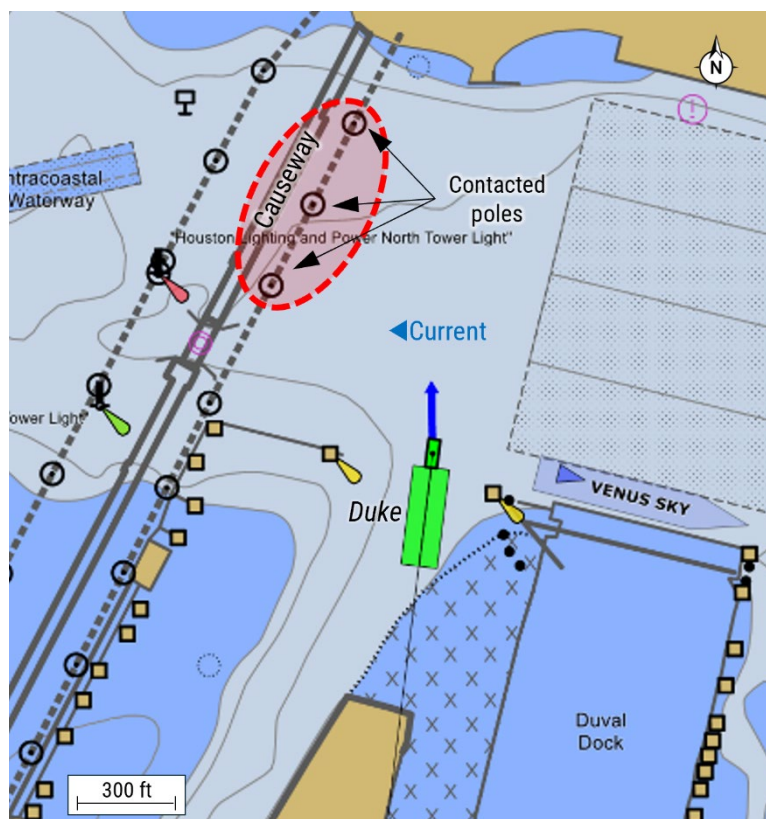
Figure 3. *Duke* tow departing the basin at 0120. The poles and section of the bridge contacted by the tow are circled. (Background source: Magnolia data as viewed on Rosepoint)

At 0123, the starboard-side barge (*MM-144*) in the *Duke*’s tow contacted the first of three Center Point Energy electrical poles adjacent (on the east side) to the Pelican Island Causeway Bridge. The barge drifted to starboard (west) into a second pole, then the bridge. As the captain moved the tow forward to extricate it from the poles, the barge made contact with a third pole. These contacts resulted in a power outage that extinguished the bridge streetlights.

At the time, the flood current, as noted by the captain, was about 0.8 knots, which would have pushed the tow toward the bridge as he backed into the channel. Given the captain's focus on the moored vessel to the east, he likely did not recognize that the current was pushing the tow faster than he anticipated and toward the power poles and bridge until the tow struck them.

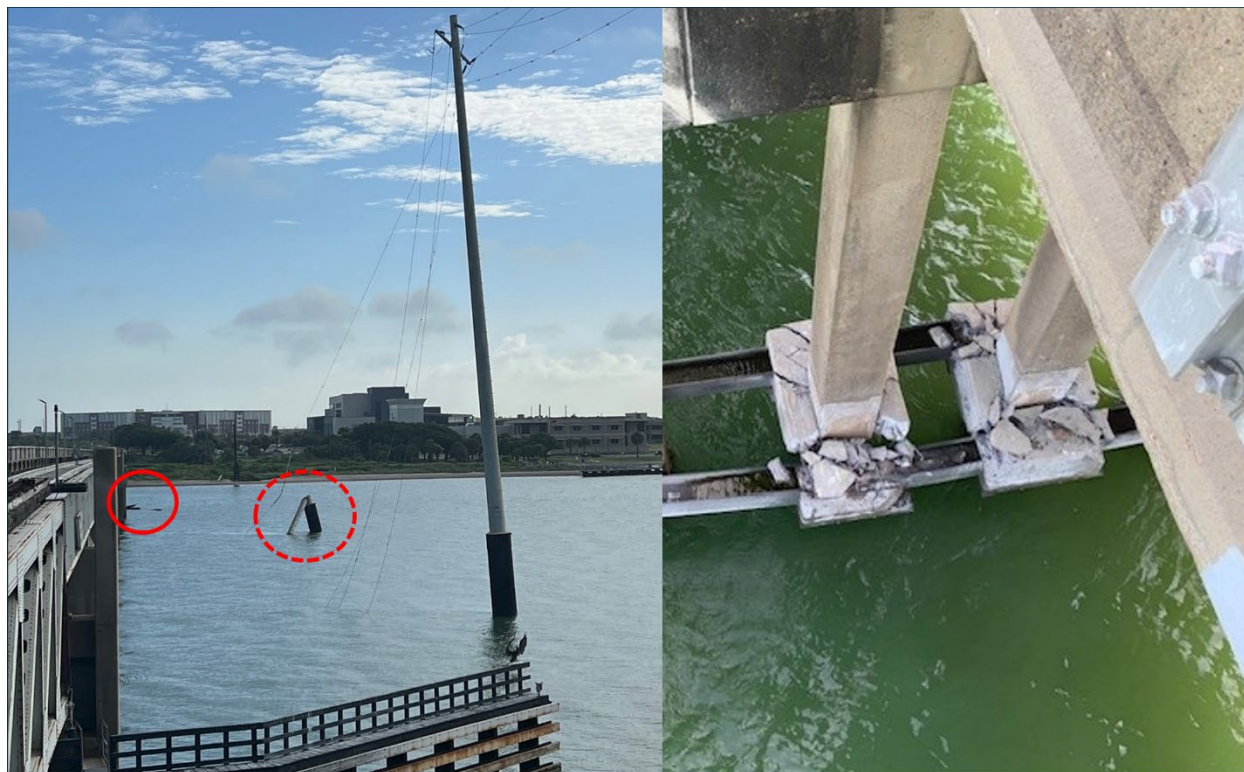
After striking the poles, the tow’s momentum carried the *Duke* into the bridge, where it contacted the bridge’s pilings (see figure 4). The captain told investigators that, at the time, he could not tell if he had hit the bridge pilings. He said he was watching for the bridge but didn’t see it in time to avoid it. After the contact, the *Duke* moored at Southwest Shipyard on Pelican Island, on the opposite side of Galveston Channel. Center Point Energy contacted the US Coast Guard to report the incident, and the Coast Guard closed the waterway (the causeway remained opened).

Figure 4. Left to right: The damaged power transmission poles, in the foreground and circled with a dotted line. The solid circle indicates the debris/damage to one of the bridge's piling clusters, seen right. (Source: Coast Guard)

Investigators later found cement debris consistent with missing portions of the bridge on *Duke's* aft deck. The towing vessel suffered two broken windows and a damaged rescue boat, davit, handrails, and rub rail, while the barge *MM-144* sustained a damaged ladder and wire conduit. Combined, the tug and barge damages amounted to about \$50,000. An electrical pole was knocked down and another left leaning. Two bridge piling clusters were destroyed, resulting in about \$250,000 of damage. The Texas International Terminal and other businesses and residents were without electricity for one day.
