June 24, 2025

MIR-25-26

Collision of *William B Klunk* Tow with Moored Barges

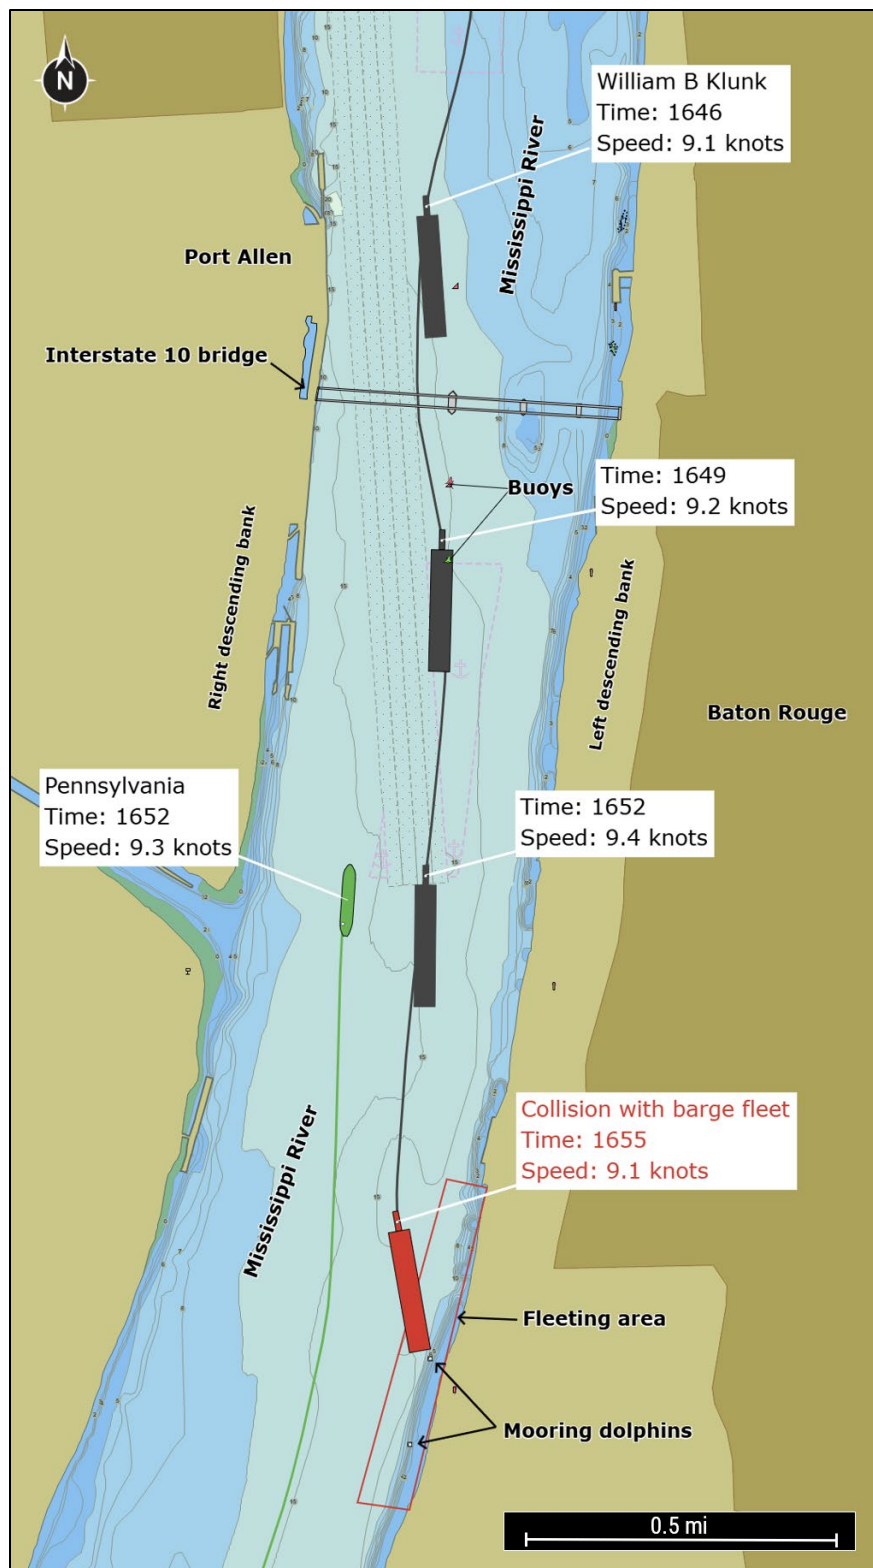
About 1647, the leadman was still in the wheelhouse as the *William B Klunk* transited under the Interstate 10 bridge (see figure 4). As the tow approached the bridge, the leadman told investigators, “The way he was set up, it didn’t look right to me,” and that, as the tow went under the bridge, it was pointed directly at two buoys on the downriver side of the bridge. When the leadman asked the pilot about the buoys, the pilot told the leadman that the tow would “slide” off them. Shortly after, both the leadman in the wheelhouse and the NOBRA pilot on board the *Pennsylvania*

Figure 4. Track of the *William B Klunk* before the collision. (Background Source: National Oceanic and Atmospheric Administration Electronic Navigation Chart US5BPGFB as viewed on Made Smart automatic identification system)

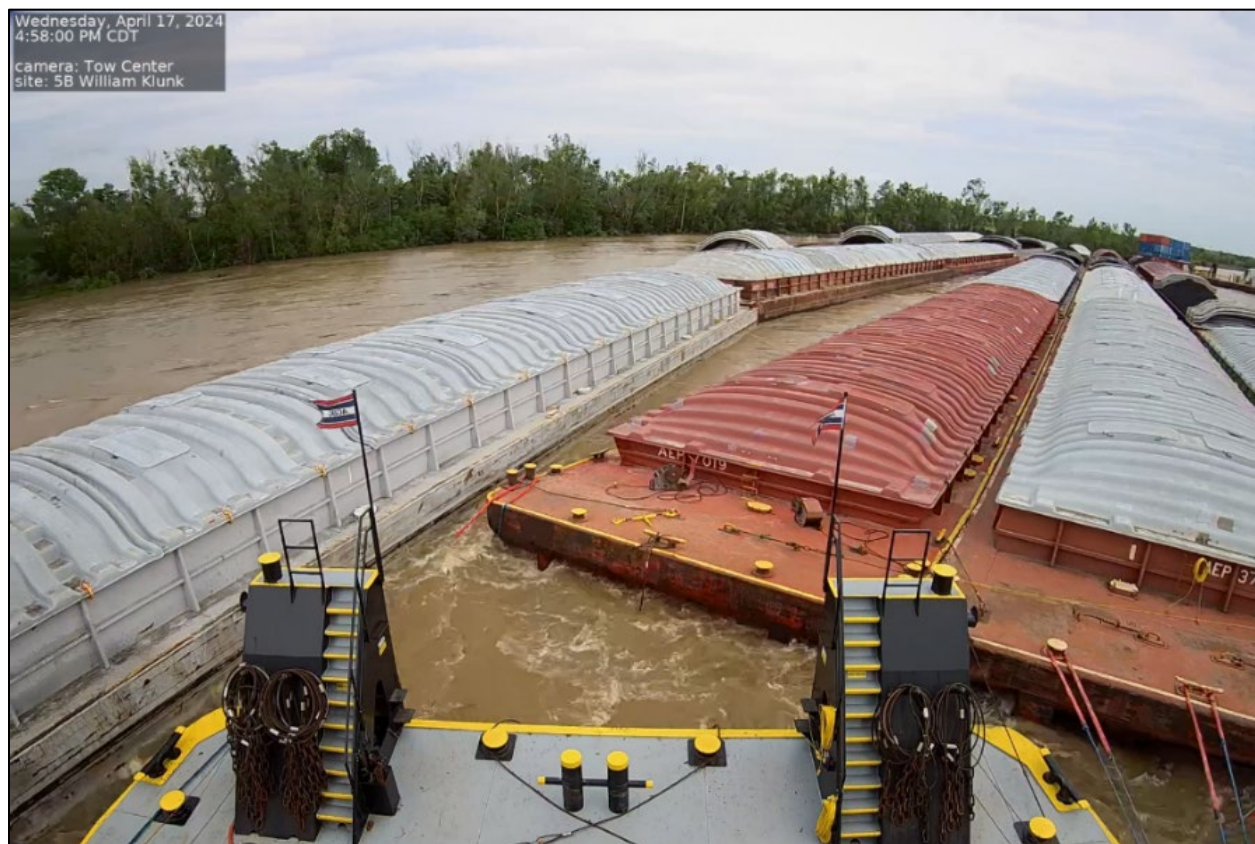
At 1657, the captain arrived at the operating console. About a minute later, the tow began to break apart (see figure 5). The captain took the helm from the pilot, and he noticed that the rudders were not responding to steering inputs. The captain radioed the chief engineer to notify him that the vessel had lost steering. The chief

Figure 5. Screenshot from the onboard image recorder system at 1658 showing the *William B Klunk* tow beginning to break apart after the initial collision. (Source: American Commercial Barge Line)

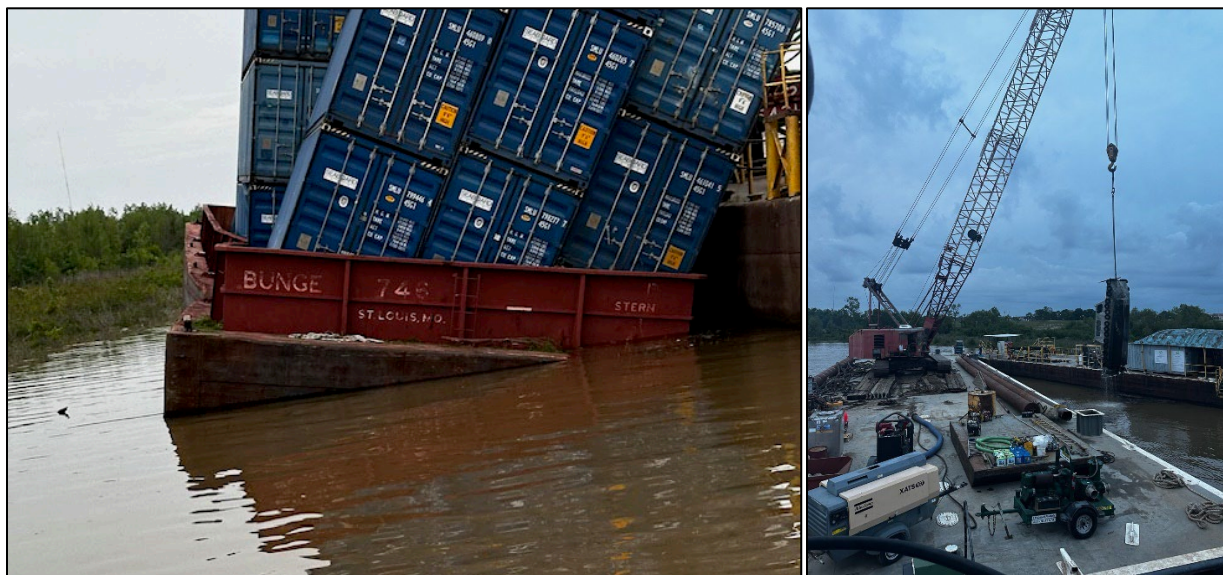
Three barges, a floating dock, a crew boat, and two mooring dolphins were damaged in the fleeing area. The container barge *BUNGE 746*, loaded with empty containers, was a total loss, and a fleeing area crew boat, *Mr. Bubba*, sank but was later recovered (see figure 6). Two mooring dolphins were destroyed. Total damages to the *William B Klunk* and tow, and the fleeing area (barges, floating dock, crew boat, and mooring dolphins) were estimated to be \$810,000.

Figure 6. Left to right: Container barge *BUNGE 746* listing after the collision, and the fleeing area crew boat *Mr. Bubba* being recovered after it sank. (Source: Coast Guard)
