MIR-25-27

Fire aboard Towing Vessel *Lucinda Smith*

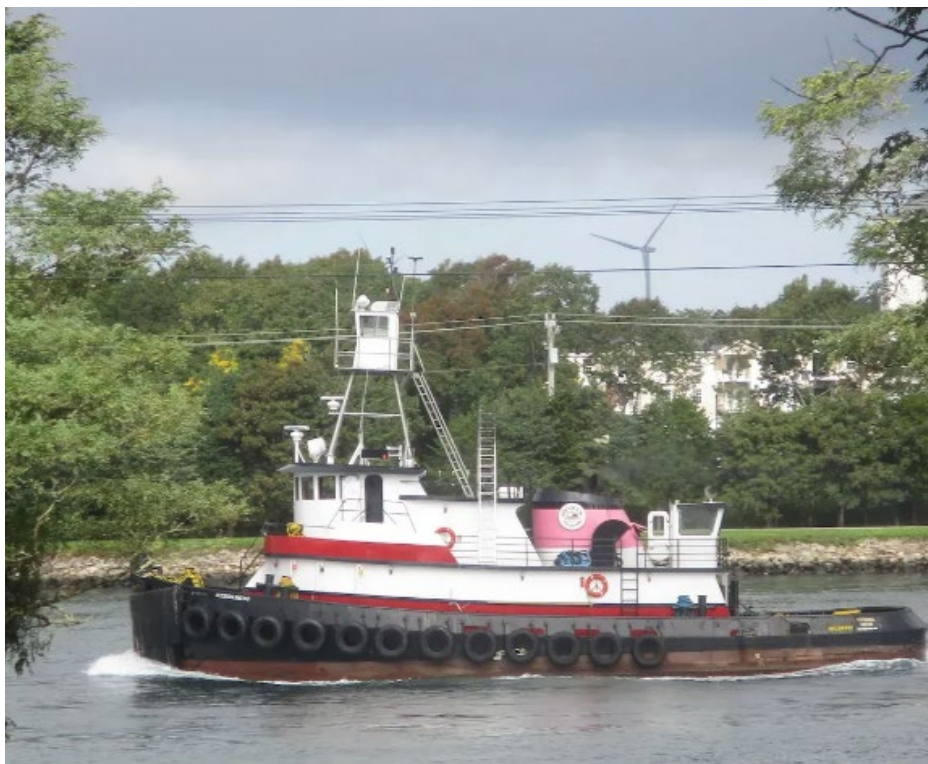
Figure 1. *Lucinda Smith* underway in 2022. (Source: Marinetraffic.com, Bill Black)

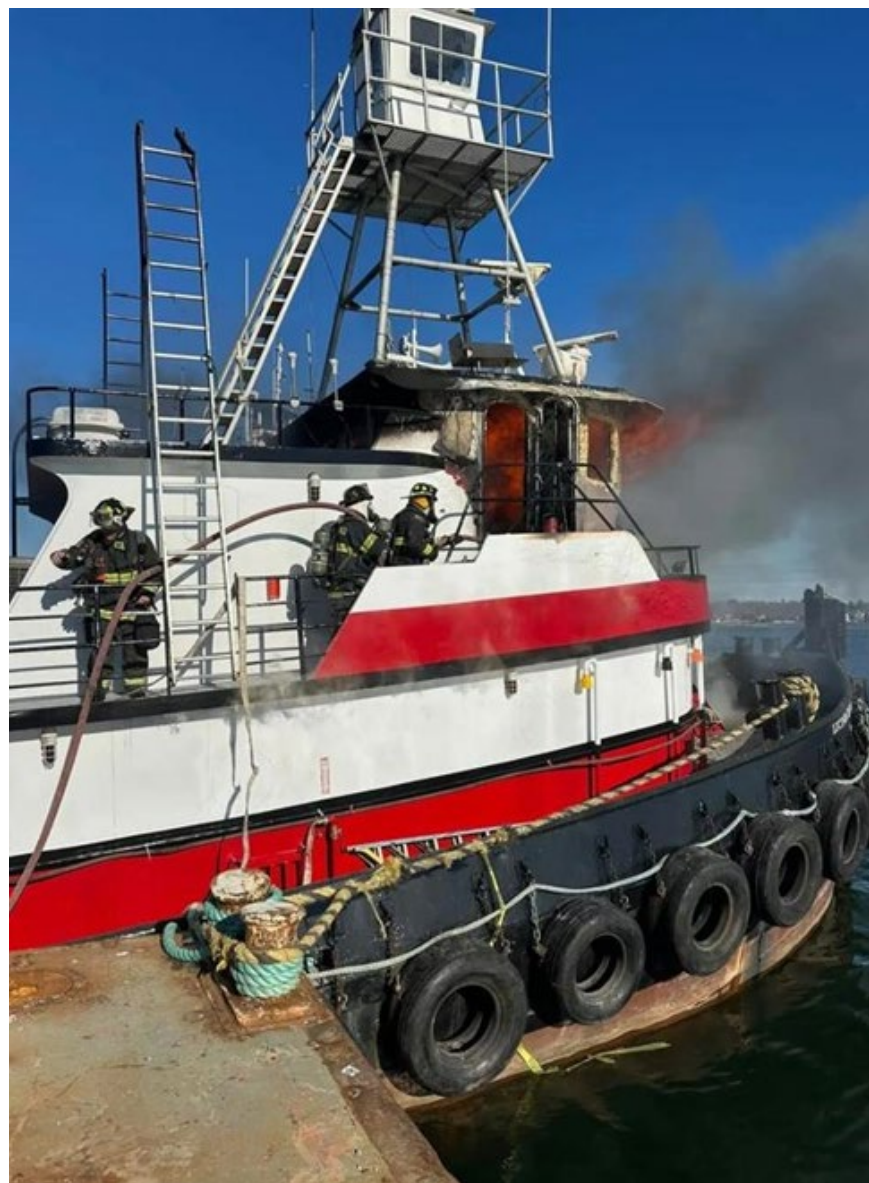
About 1130, the New Bedford Fire Department arrived on scene. Firefighters boarded the vessel with fire hoses and fought the fire, which had spread into other accommodation spaces and the wheelhouse (see figure 3). They declared the fire extinguished several hours later.

Figure 3. Land-based firefighters on *Lucinda Smith*. (Source: New Bedford Fire Department)

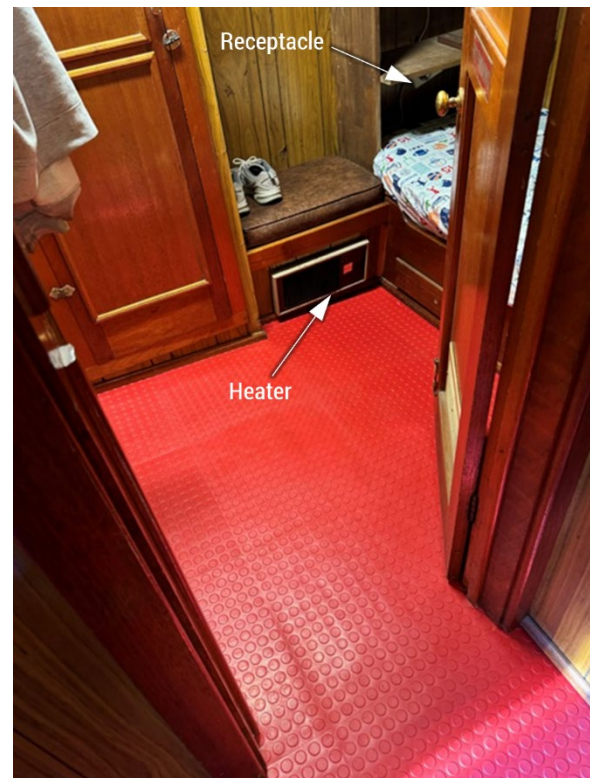
According to the first mate, the stateroom had an electrical wall receptacle on the bulkhead near one end of the bunk, and the only thing that was possibly plugged into it on the day of the fire was a cell phone charger (not attached to a cell phone), but he could not remember for sure (see figure 4). There was also a built-in heater and oscillating fan in the room, but the first mate told investigators they were not typically used. According to the operations manager of the vessel, all the wiring on board the vessel was original, and all the accommodation's interior framing, partitions, and paneling were wood.

Figure 4. First mate's stateroom, with partial view of the bunk, on unknown date before the fire. (Source: R B Our Equipment Leasing)

ATF investigators determined that the fire originated in the first mate's stateroom, aft of the wheelhouse, near the end of the bunk (by the electric heater). Electrical sources near the bunk included an electric heater, an oscillating fan, and an electrical wall receptacle. Crew interviews revealed that the heater and fan were not in use before the fire and thus likely were not an ignition source. The receptacle and associated vessel wiring were original to the vessel's construction and nearly 50 years old. If there was an electrical fault—such as a loose, broken, or frayed wire, or broken receptacle hardware—within the receptacle or nearby circuitry, it could have created excessive resistance heating. Resistive heating from electrical conductors within receptacles can produce sufficient heat to ignite nearby combustibles. However, due to the extent of the fire damage, the exact ignition source and cause of the fire could not be determined.

Once an ignition source was produced, combustible materials—wood paneling and framing, insulating material, clothing, and bed linen—near the fire's origin (end of the bunk) caught fire. After these combustible materials caught fire, they provided a path for the fire to expand into the overhead and eventually the entire stateroom, other accommodation areas, and the wheelhouse.
