MARINE TRANSPORTATION SAFETY INVESTIGATION REPORT M21A0041

CATASTROPHIC FAILURE OF MACHINERY, SUBSEQUENT FIRE, AND SINKING

Fishing vessel *Atlantic Destiny*

02 March 2021

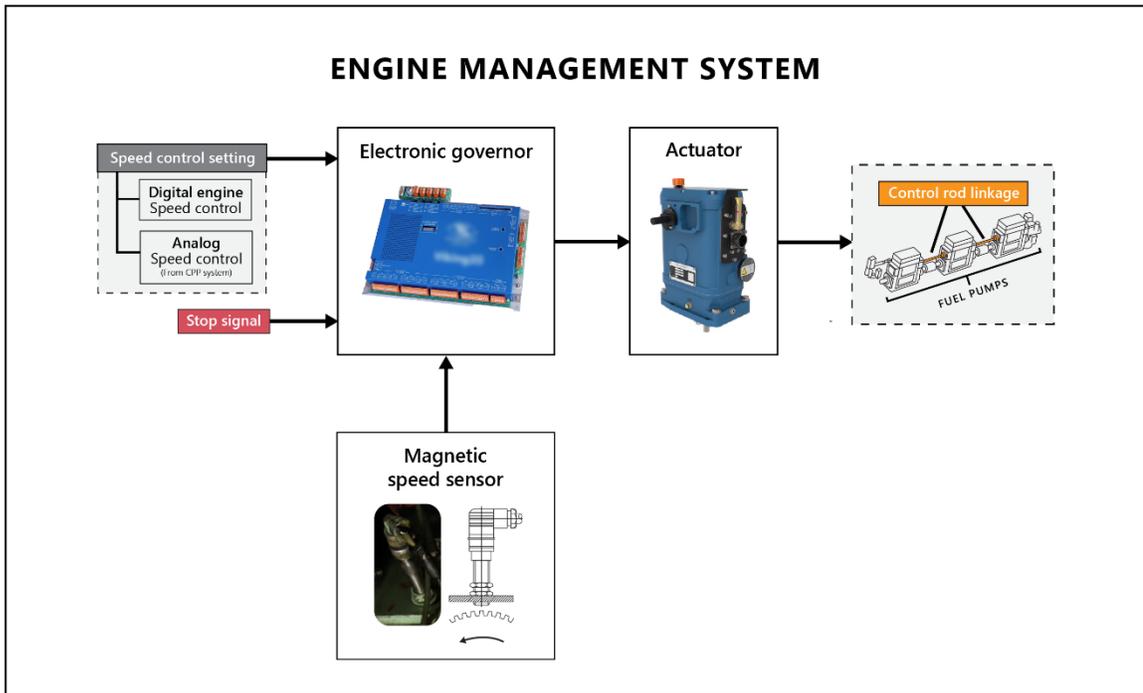
Figure 5. Diagram of the engine management system showing how the components are related (Source: TSB; photos of electronic governor and magnetic speed sensor from Deutz; photo of actuator from Europa)

The engine management system had 3 main components: the electronic governor, the magnetic speed sensor, and the actuator. The electronic governor used output from the magnetic speed sensor to provide a signal to the actuator, which governed the amount of fuel supplied to the engine and maintained a constant speed.

The sea conditions at the time of the occurrence were rough. Under such conditions, any deficiencies in the engine management system may be magnified due to varying loads on the propeller. In the period leading up to the occurrence, the electronic governor had been unreliable in maintaining a constant engine speed. In this occurrence, both shaft generators went offline unexpectedly and the engine reduced speed to 600 rpm. However, the engine began to increase speed almost immediately, likely as a result of the engine management system applying a signal to increase the fuel to the engine without feedback. The engine continued to overspeed until the shaft generators exceeded the design limit and exploded.

One or more components of the engine management system failed and caused it to continually increase the engine fuel supply, which caused the engine to overspeed.

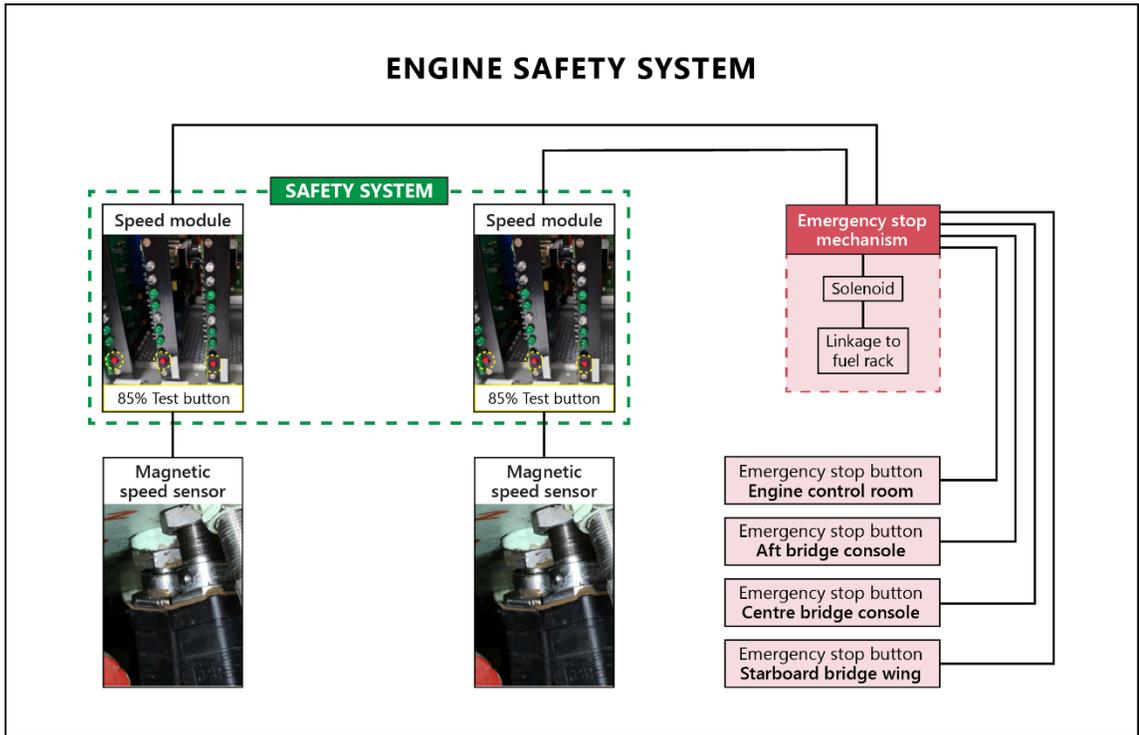
Figure 6. Diagram of the engine safety system showing the components of the overspeed protection system (Source: TSB)

The overspeed protection of the engine safety system on board the *Atlantic Destiny* consisted of 2 magnetic speed sensors fitted in the same location as the sensor for the engine management system, and 2 speed modules to send a signal to the emergency stop mechanism when an overspeed condition was detected. These sensors and modules were arranged in loops such that they acted independently of each other, providing redundancy, and shutting down the engine if only 1 loop signalled a speed in excess of the set parameter.

1035 rpm.¹⁵ The recorded value of the overspeed shutdown for the *Atlantic Destiny* engine was 1035 rpm or 115% of the engine speed for normal operating conditions. TC requires verification of safety monitoring devices¹⁶ but does not give specific numbers.

Both the automatic and manual activation of the engine safety system failed to prevent the engine speed from increasing beyond the design limits of the engine, causing a catastrophic failure and significant damage to the engine and the shaft generators.

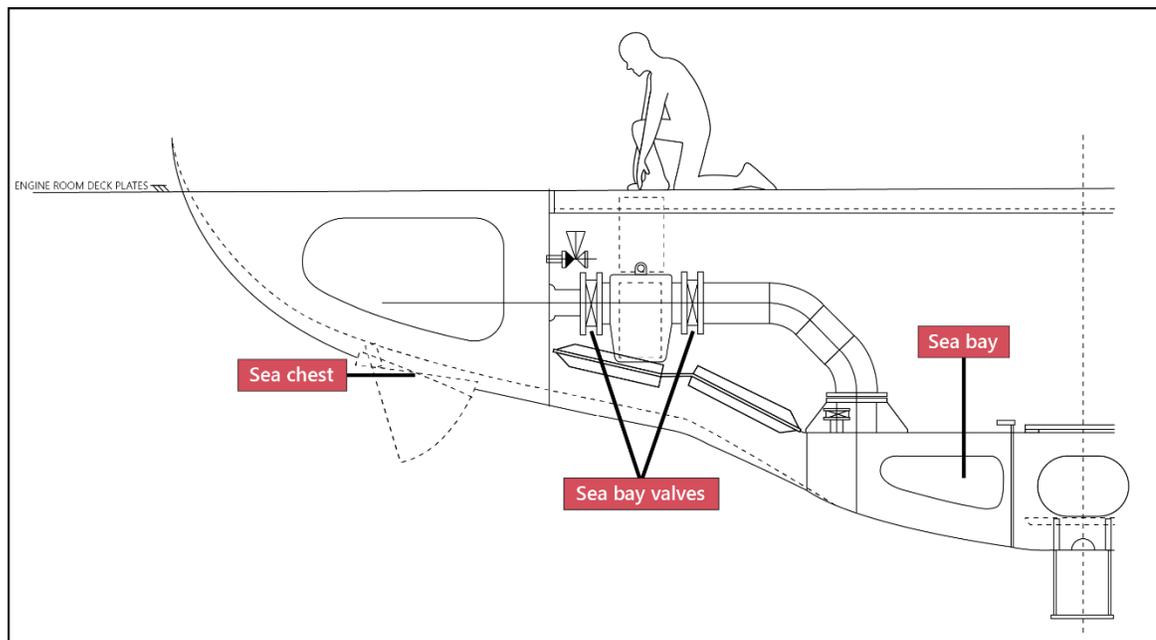
Figure 7. Diagram of sea bay valves in the engine room cross-section, showing the access point used in the occurrence. The TSB also added a human figure for scale. (Source: Ocean Choice International, Atlantic Destiny drawing No. 1-6577 Sea Chest and Inlet Grids, with TSB annotations)

The valves connecting the sea chests to the sea bay were replaced during the drydocking of the *Atlantic Destiny* in January 2019. The engineers reported that the sea bay valves were operated at the end of each trip when the strainers were alternated from port to starboard and cleaned.

The explosion of the shaft generators and associated machinery projected multiple hot metal fragments and hydraulic fluid throughout the engine room and started a fire. The metal fragments also damaged the seawater cooling system piping, resulting in an uncontrolled ingress of water.
