CROWN SEAWAYS

Marine accident report on occupational accident

19 NOVEMBER 2022

**MARINE ACCIDENT REPORT ON OCCUPATIONAL ACCIDENT
ON CROWN SEAWAYS ON 19 NOVEMBER 2022**

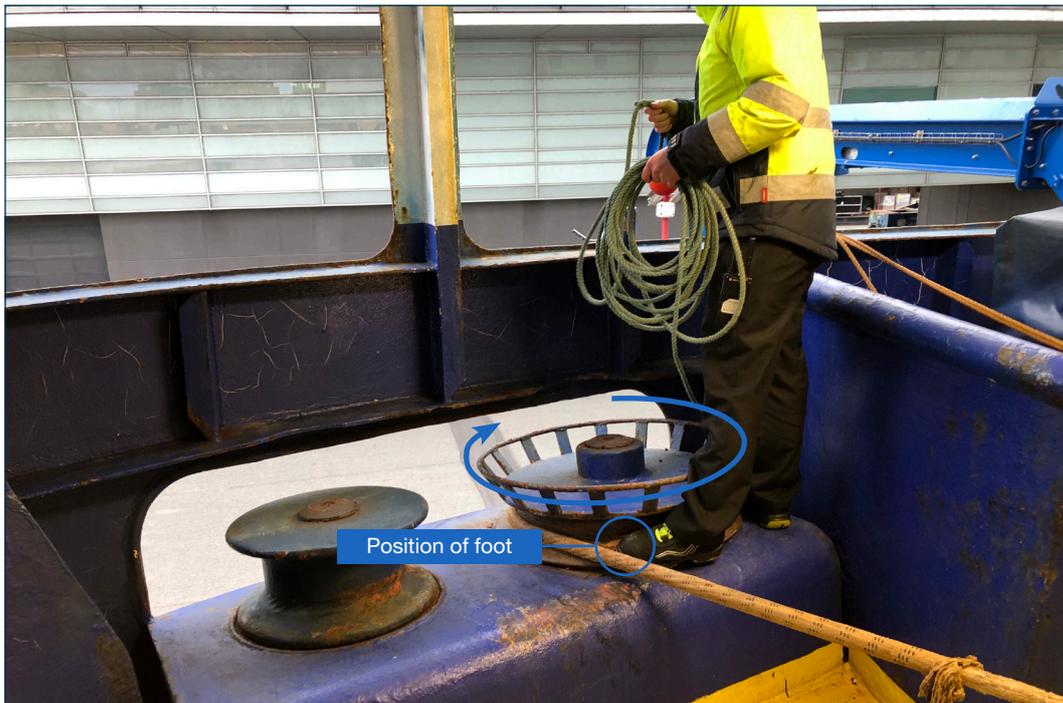
Figure 5: The OS's position during the accident
Source: DFDS, modified by DMAIB

At approximately 0955, the ship was a few metres from its final position. The AB controlling the winches by the gunwale was on standby to tighten the spring line, and the other AB was on standby to tighten the winch brake and to disengage the winch drum. At that moment, the OS stepped onto the warping roller fairlead and forcefully threw the fourth heaving line ashore. Because of the forward momentum of the ship, he lost his footing and took a step forward to regain his balance. He immediately noticed that his left foot was trapped between the roller and the spring line. As his foot was pulled into the roller, he let out a scream (Figure 5).

The two ABs immediately heard the OS's screaming, and the AB who stood next to the OS instinctively slackened the spring line, which caused the OS's foot to be pulled further into the roller. The AB called the bridge and told them to bring the ship forward to slacken the spring line, but he received no response. However, the ship was already moving forward, and as the AB slowly tightened the spring line, the foot was released, and the OS fell onto the deck. The cadet and the AB standing by the winch ran to the aid of the OS, who was visibly seriously injured on his lower left leg.

Unknown to the OS, the timing was wrong. He stepped onto the fairlead platform while the mooring was ongoing, the spring line had not been tightened and the winch brake had not been activated. In other words, the OS acted in accordance with the established practice, but at the wrong time. When the OS lost his footing, he accidentally stepped into the gap between the turning roller and the spring line and was trapped.

- *"Fleet wide knowledge sharing of the accident.*
- *Physical barrier installed to prevent stepping up on fairlead platform.*
- *Onboard mooring procedure changed. Heaving lines are now retrieved after engaging winch brakes.*
- *Accident has been shared in relevant external forums.*
- *Planned alternation of the warping roller fairlead to a roller fairlead design.*
- *Company instruction for onboard familiarisation is currently being reviewed.*
- *Enhanced focus on mooring operations at upcoming internal verifications."*

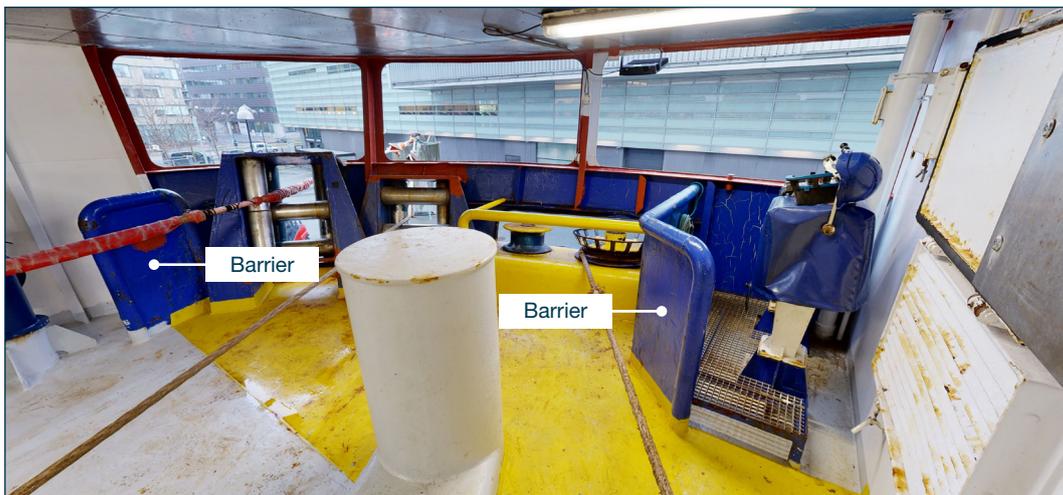
Figure 7: Barriers on port side (the yellow guard rail by the fairlead was installed after the accident)
Source: DMAIB

The four ventilation ducts for the car deck were located on each side of the forward part of the deck, with two in the centre of the deck. Also in the centre of the deck there was a closed stairwell and a storage room. On each side, barriers were fitted by the gunwale to protect the crew members from the mooring rope snapping back, which also governed how they positioned themselves during mooring (Figure 7).

- It was difficult for the crew members to keep the mooring winches in a clear line of sight when operating them.
- The safety barriers that protected the crew members from snapping mooring ropes governed where the crew members stood during mooring.
- When throwing the heaving lines ashore, the crew members had to be close to the gunwale and the fairleads to keep the line men ashore in a clear line of sight.

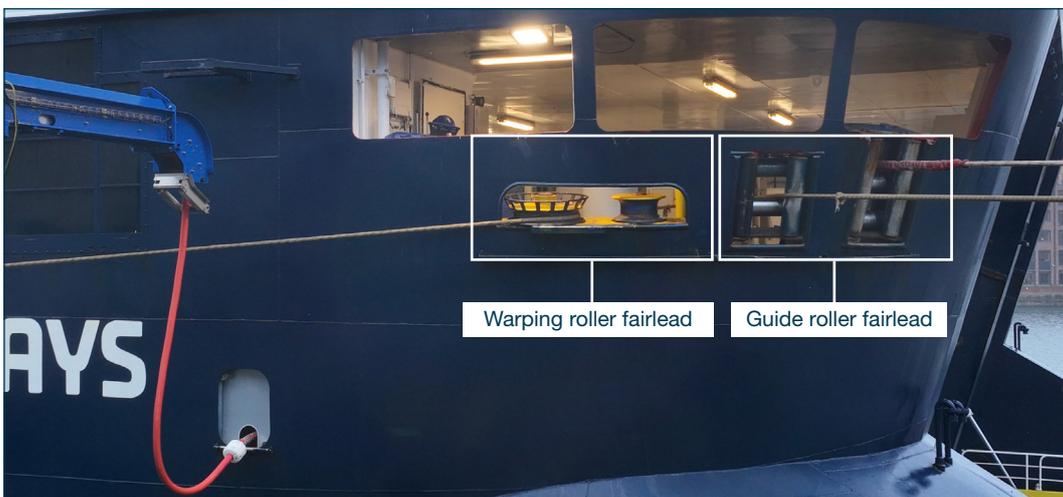
Figure 8: Fairleads on port side
Source: DMAIB

The aft mooring deck was enclosed, with openings in the centre and on each side of the ship. There were three fairlead openings on each side. Two were fitted with guide rollers and one was fitted with two warping fairlead rollers mounted on an elevated platform (Figure 8).

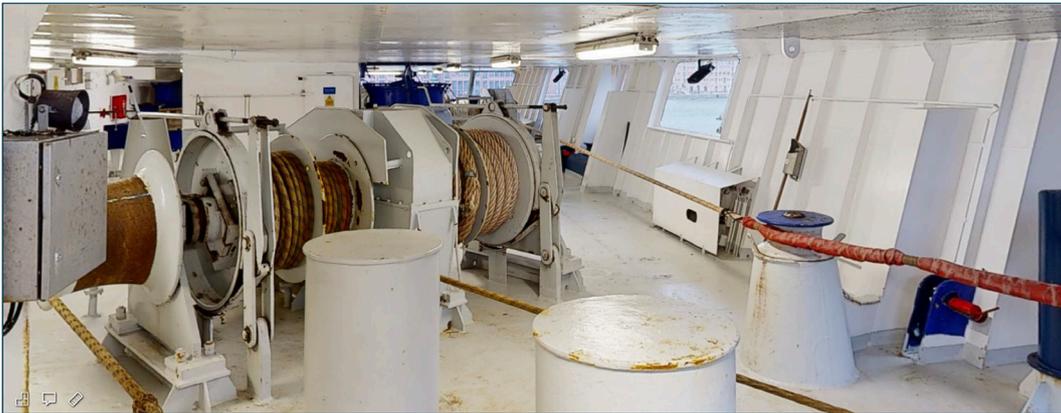
Figure 9: View of mooring deck from port side control station
Source: DMAIB

The view of the deck area was hampered by the storage room, the enclosed stairwell and the ventilation ducts (Figure 9). The height of the gunwale by the side opening was about one metre, with fairlead rollers in front of it. To get a view of the quay and the line men ashore, it was necessary for the crew members to climb the fairlead platform and/or the warping roller (Figures 10 and 11).

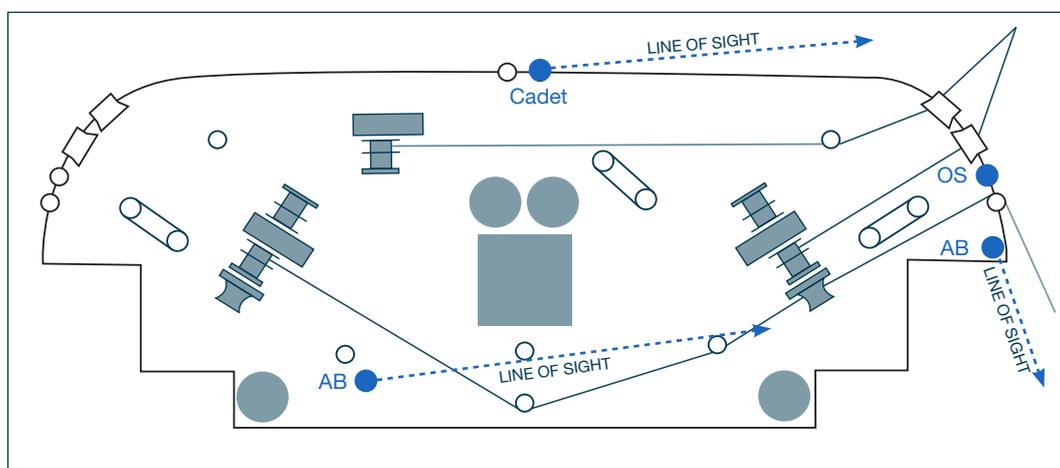
Figure 15: Line of sight of cadet and ABs
Source: DMAIB

During the different stages of the mooring, the crew had their attention directed towards their specific tasks, which could create blind spots where the crew members were not in line of sight of each other while working. Figure 15 shows the crew members' line of sight when the ship was about to come alongside on the day of the accident.

- Adhering to a specific sequence and timing of tasks during the mooring operation was pivotal in managing the hazards that the mooring operation entailed.
- During the mooring operation, the crew had their attention directed to specific places, which left other crew members in blind spots.
