# NORD MAGIC

Marine accident report on occupational accident

17 JUNE 2022

**MARINE ACCIDENT REPORT ON OCCUPATIONAL ACCIDENT  
ON NORD MAGIC ON 17 JUNE 2022**

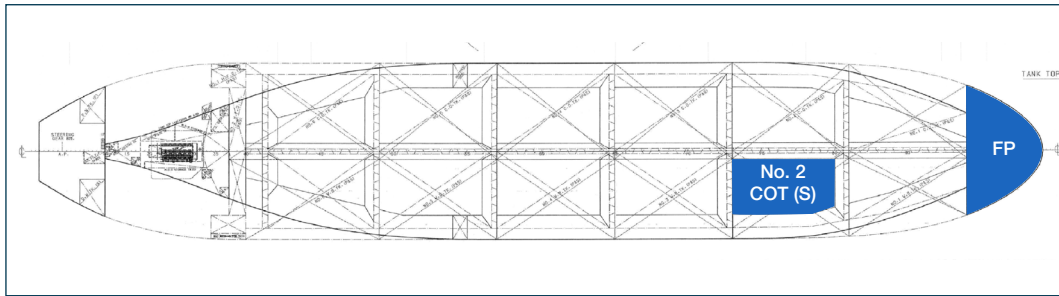
Figure 3: Overview of forepeak ballast tank and no. 2 COT (S)  
Source: Norden Synergy Ship Management A/S / modified by DMAIB

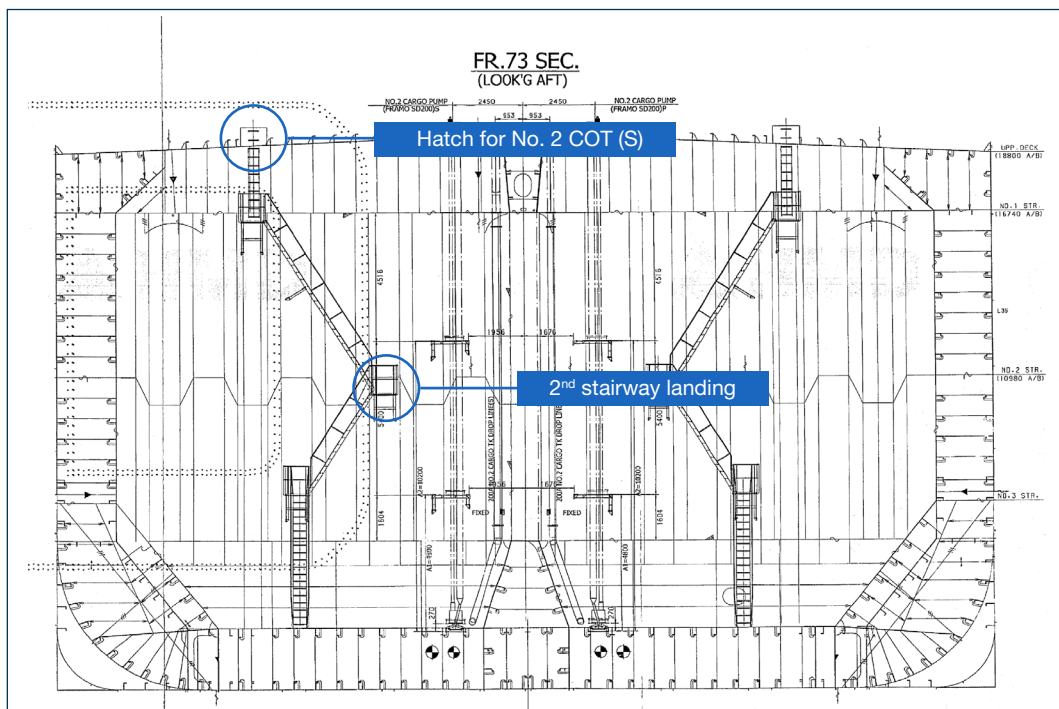
After lunch, the rain stopped, so the technicians went on deck to inspect the forepeak tank. The tank had been ventilated, and gas checks had been performed by the chief officer and deckhands earlier in the morning. At 1404, the able seaman (AB) called the bridge and notified the 2<sup>nd</sup> officer that the technicians were entering the forepeak tank and that they intended to enter no. 2 COT (S) afterwards. The officer made a note of the time. At 1453, the AB called the 2<sup>nd</sup> officer and notified him that the technicians were entering no. 2 COT (S), and the 2<sup>nd</sup> officer again recorded it. The hatch to no. 2 COT (S) was already partly open by about 10cm, and the AB opened it completely for the technicians to access the tank. He observed the technicians enter the tank and descend a vertical ladder to a platform and then down stairs onto a second stairway landing where they started to use their ultrasonic measurement tool (Figure 4).

Figure 4: Platform in no. 2 COT(S)  
Source: Norden Synergy Ship Management A/S / modified by DMAIB

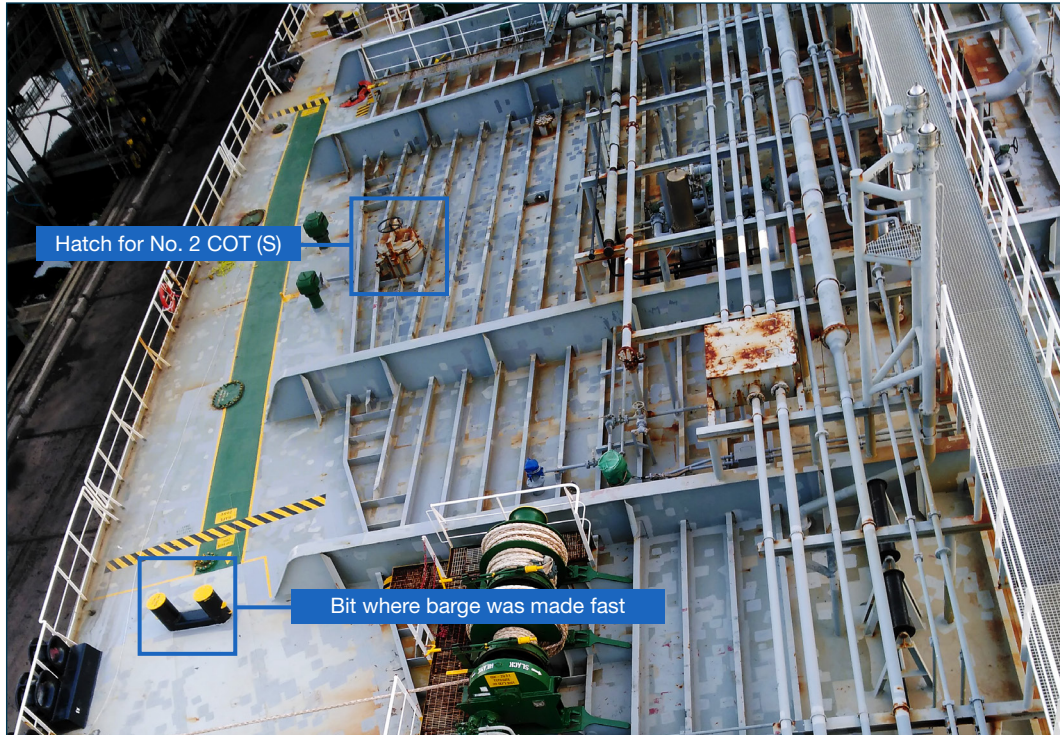
At 1512, as the AB kept watch at the tank hatch, he noticed that a second cargo barge was approaching the ship. He was contacted by the 2<sup>nd</sup> officer by radio who asked the AB to assist the ordinary seaman (OS) and the dayman to secure the cargo barge on the starboard side. It would not take him farther than 10 meters from the tank's hatch, so he considered it unproblematic (Figure 5).

Figure 5: NORD MAGIC  
Source: DMAIB

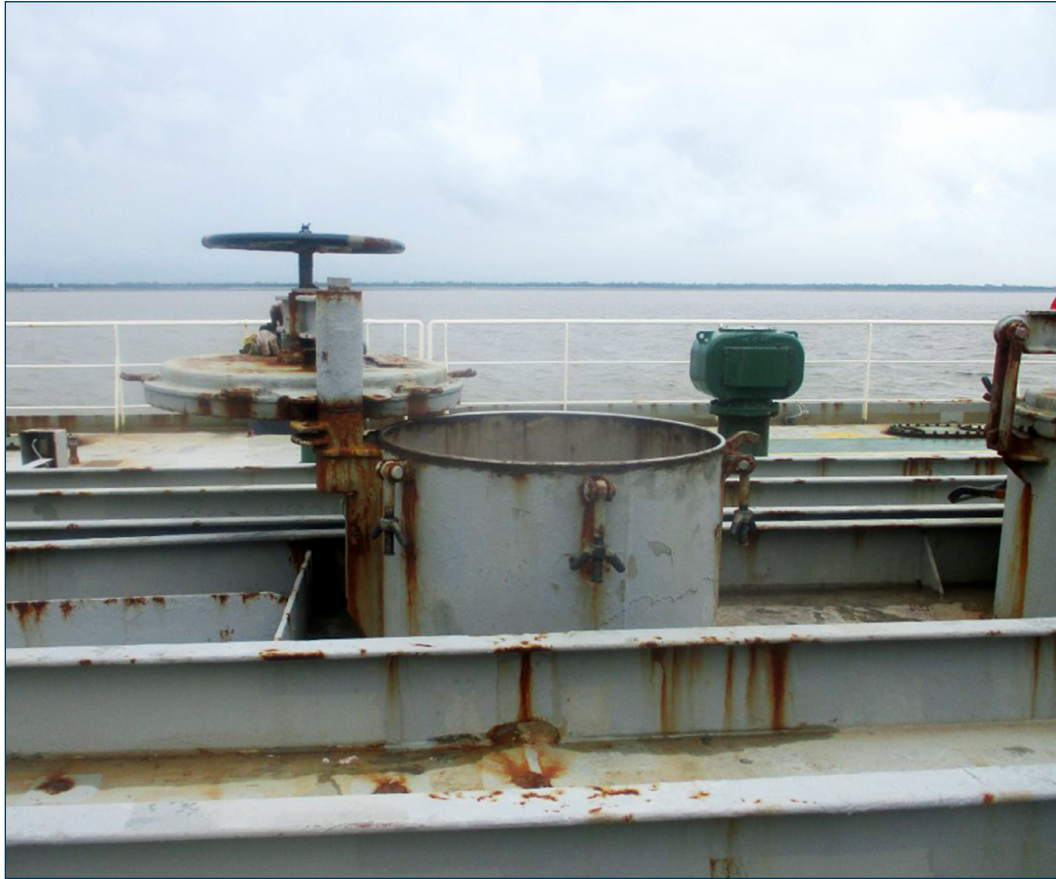
No. 2 COT (S) was accessed through a hatch on the aft part of the tank. The hatch was secured with dog clips and a handwheel mechanism. When the dog clips were released and the handwheel loosened, the hatch could be slid open (Figure 6).

Figure 6: Hatch no. 2 COT (S)  
Source: Norden Synergy Ship Management A/S

The access hatch to no. 2 COT (S) was either not fully closed on completion of the pre-wash or was cracked open by about 10 cm at some point later in preparation for the future cleaning and inspection of the tank. By 17 June 2022, the mixture of soybean oil residue and seawater had been in the tank for about 19 days.

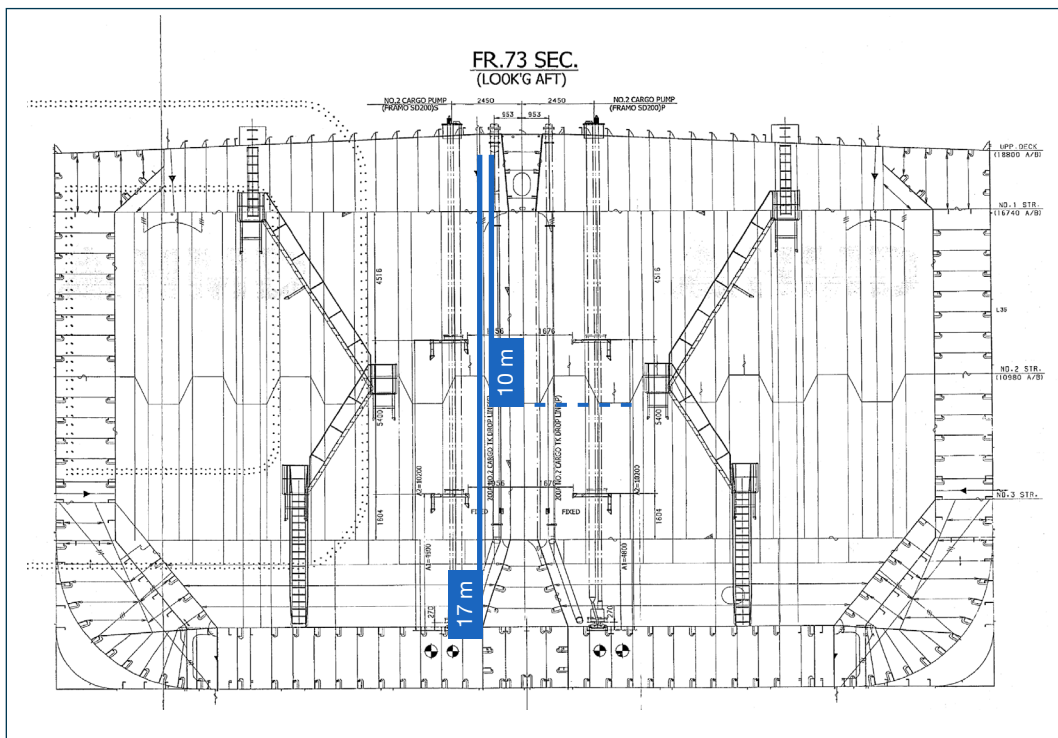
Inside the tank, a vertical ladder led to a platform from which a sloped stainless steel ladder reached the bottom of the tank via two platforms. The vertical distance from the hatch to the bottom of the tank was 17 meters, and the distance from the hatch to the second (and middle) platform, where the technicians were found, was about 10 meters (Figure 7).

Figure 7: No. 2 COT (S) looking aft  
Source: Norden Synergy Ship Management A/S / modified by DMAIB

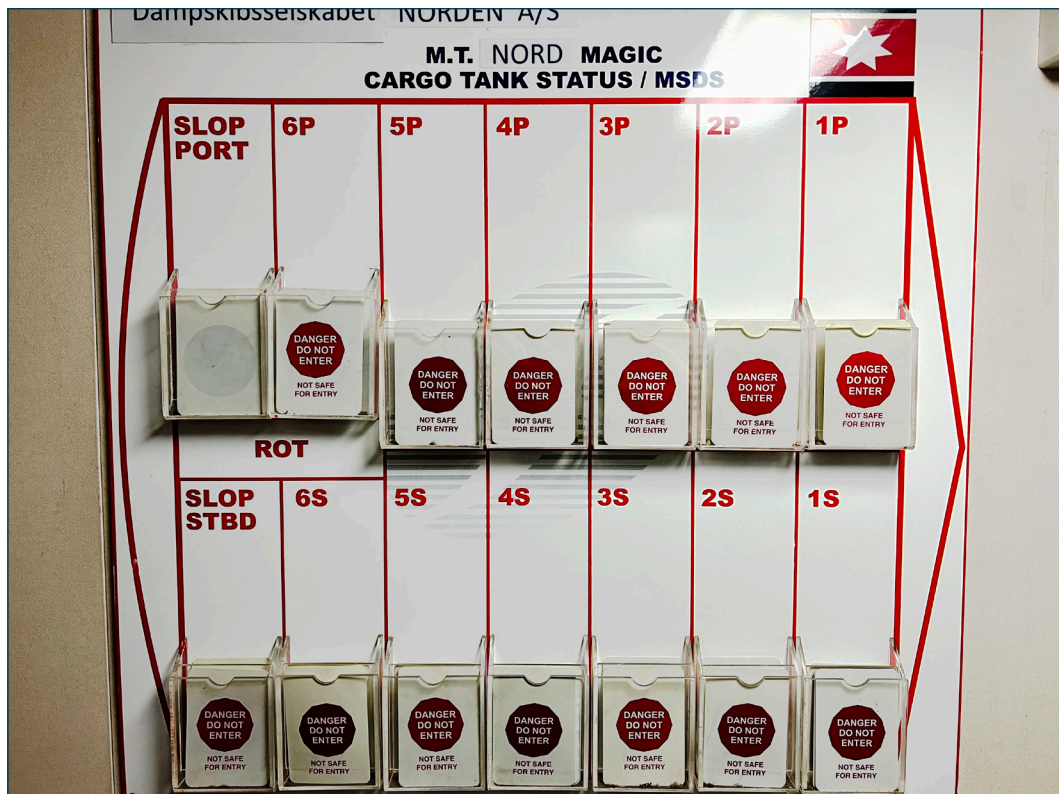
After the transition of management there was a continuous update in close association with the standards of Synergy Marine Group's database of procedures and review processes. Thereby it was ensured that the documents in the safety management system were standardised and compliant with industry standards and international regulation and guidance. Traces of this change could be observed on NORD MAGIC in the presence of the obsolete safety management system concerning enclosed space entry, e.g. message boards used in the previous safety management system (Figure 8).

Figure 8: Obsolete message board on NORD MAGIC  
Source: NORD MAGIC

- The procedure did not make reference to dedicated training or offer advice related to using the work permit.
- Remains of an obsolete safety management system were found on the bulkhead outside the cargo control room.
