Report on the investigation of the collision  
between the general cargo vessel  
***Scot Carrier***  
and the split hopper barge  
***Karin Høj***  
resulting in the capsize of the barge with two fatalities  
in the Bornholmsgat traffic separation scheme, Sweden  
on 13 December 2021

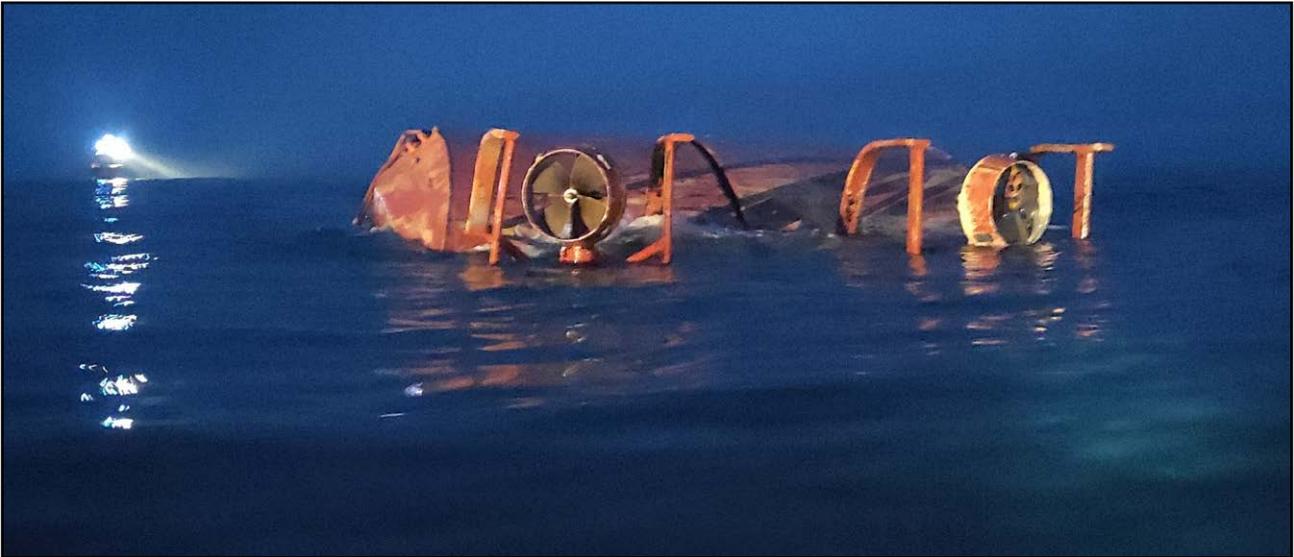
Figure 13: Karin Høj's upturned hull, showing azimuth drive units at the stern

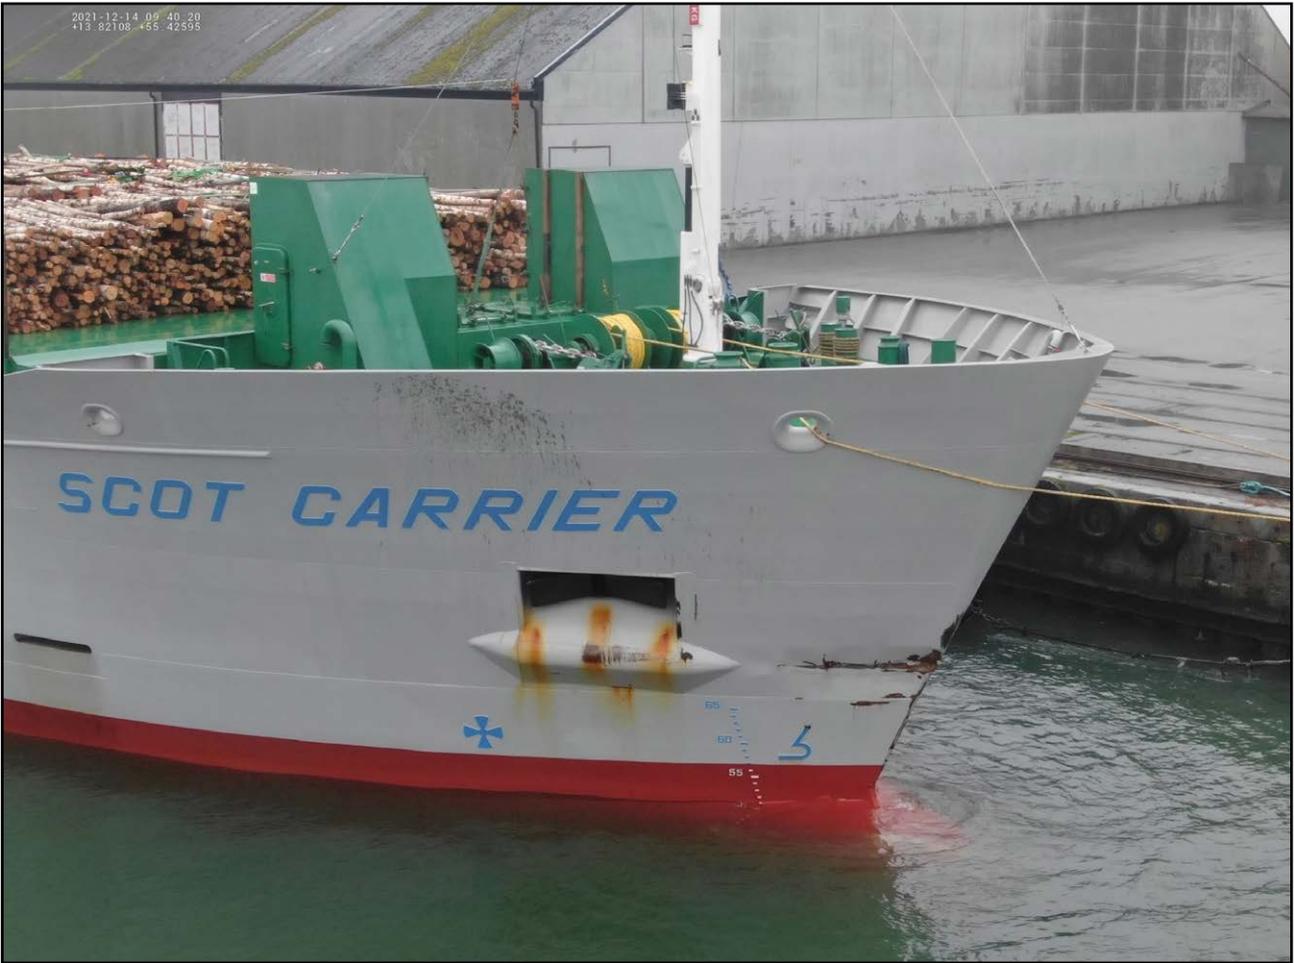
At 1400, Sweden Rescue directed *Scot Carrier* to proceed to the nearby port of Ystad, Sweden. Coastguard officers boarded and inspected the vessel on its arrival. Inspectors from both the MAIB and Danish Marine Accident Investigation Board (DMAIB) attended *Scot Carrier* later the same day, carrying out an immediate inspection of the ship’s hull and taking photographs of the damage to its bow (**Figure 15**). The inspectors noted silt stains above the ship’s name on the starboard side and new damage to the paintwork on its port side (**Figure 16**).

**Figure 15:** Damage to *Scot Carrier's* bow, showing collision damage on stem and hull, and silt staining above the ship's name

On 14 December, a Lloyd's Register surveyor attended *Scot Carrier* to assess the damage to the ship's bow (**Figures 15, 16 and 18**) and noted:

The surveyor issued *Scot Carrier* with a condition of class<sup>10</sup> that required repairs to be completed within 2 months.

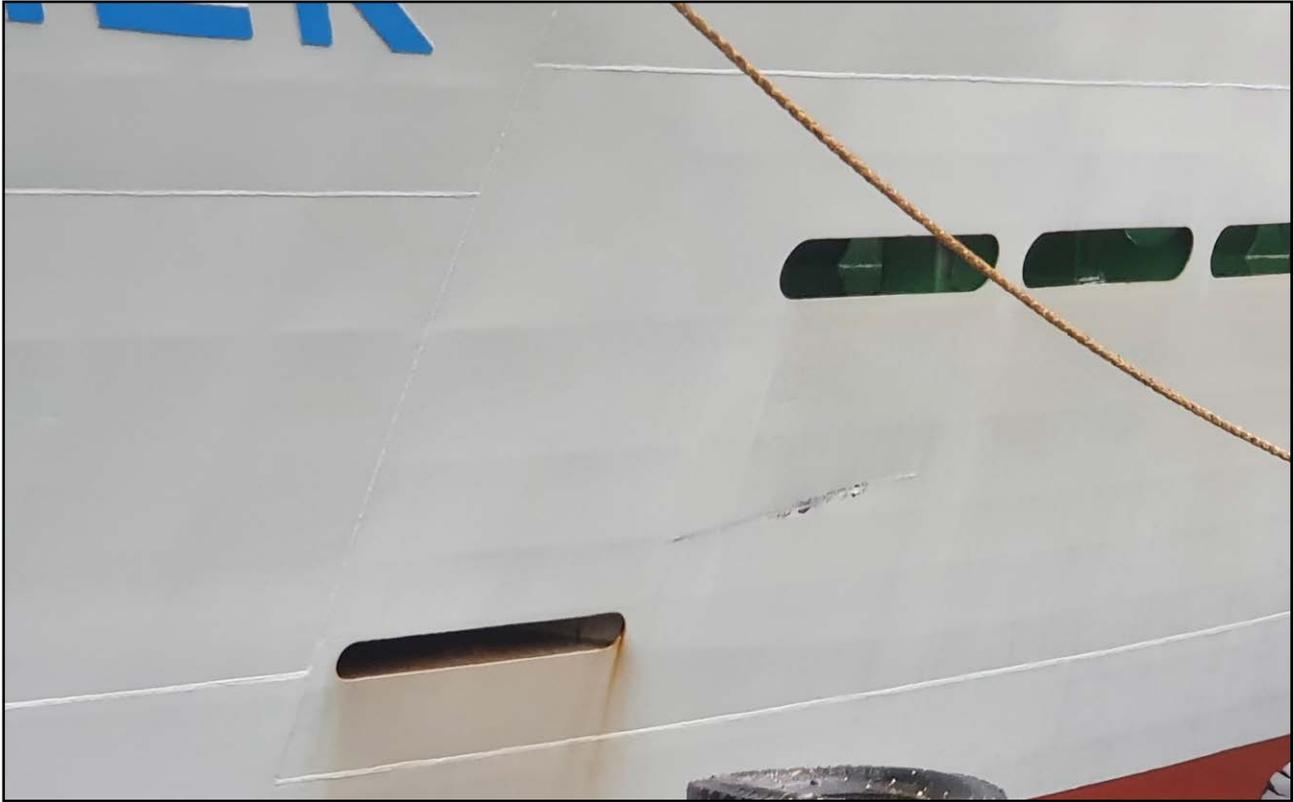
**Figure 16:** Damage to *Scot Carrier's* paintwork on the ship's port side

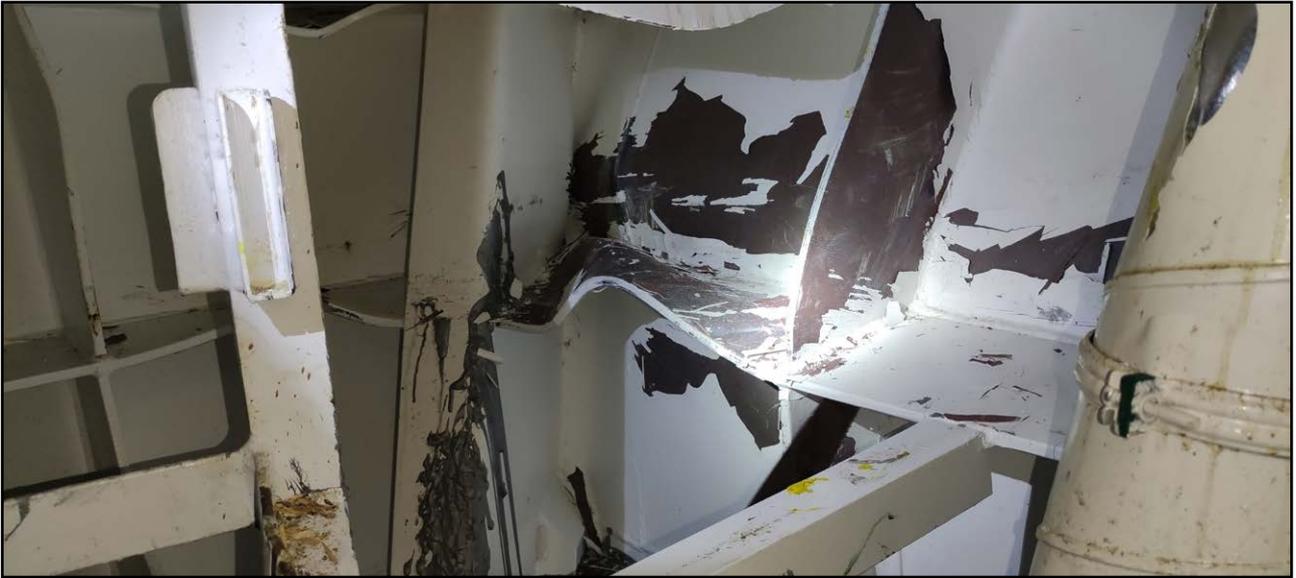
**Figure 18:** Damage to *Scot Carrier*'s internal bow structure

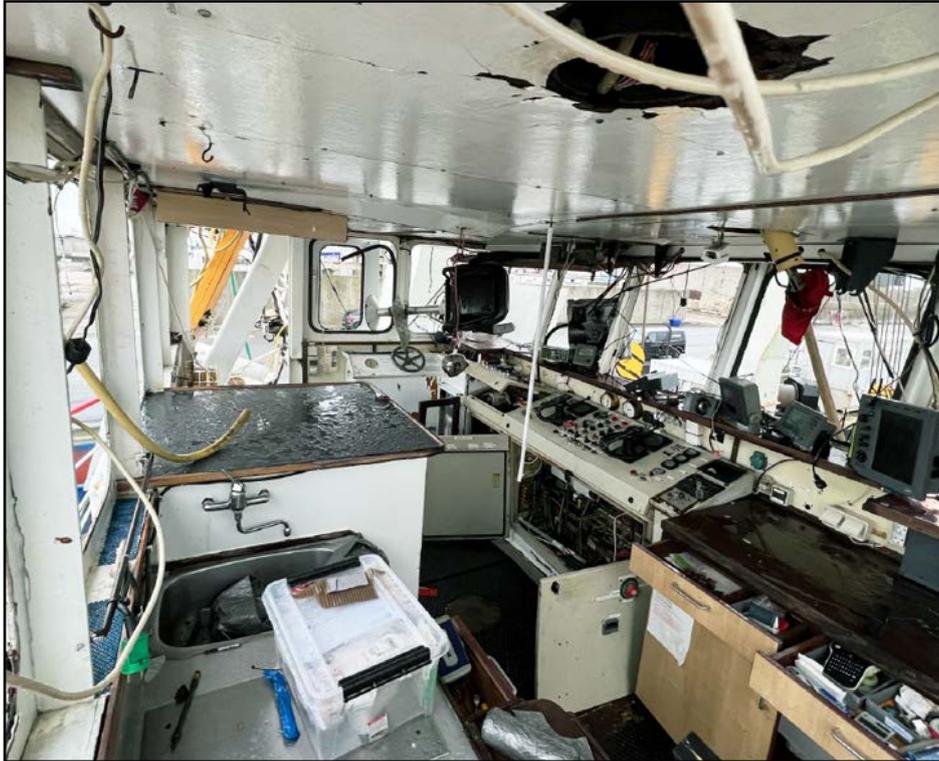
*Karin Høj's* bridge had sustained extensive damage while the vessel was being towed while inverted and later grounded. All of the window panes were missing and the helm chair and navigational equipment had been torn from their mountings (**Figure 24**). Paper objects such as charts and logbooks were lost. No data was recoverable from the electronic navigation systems.

**Figure 24:** Karin Høj's bridge, post-salvage

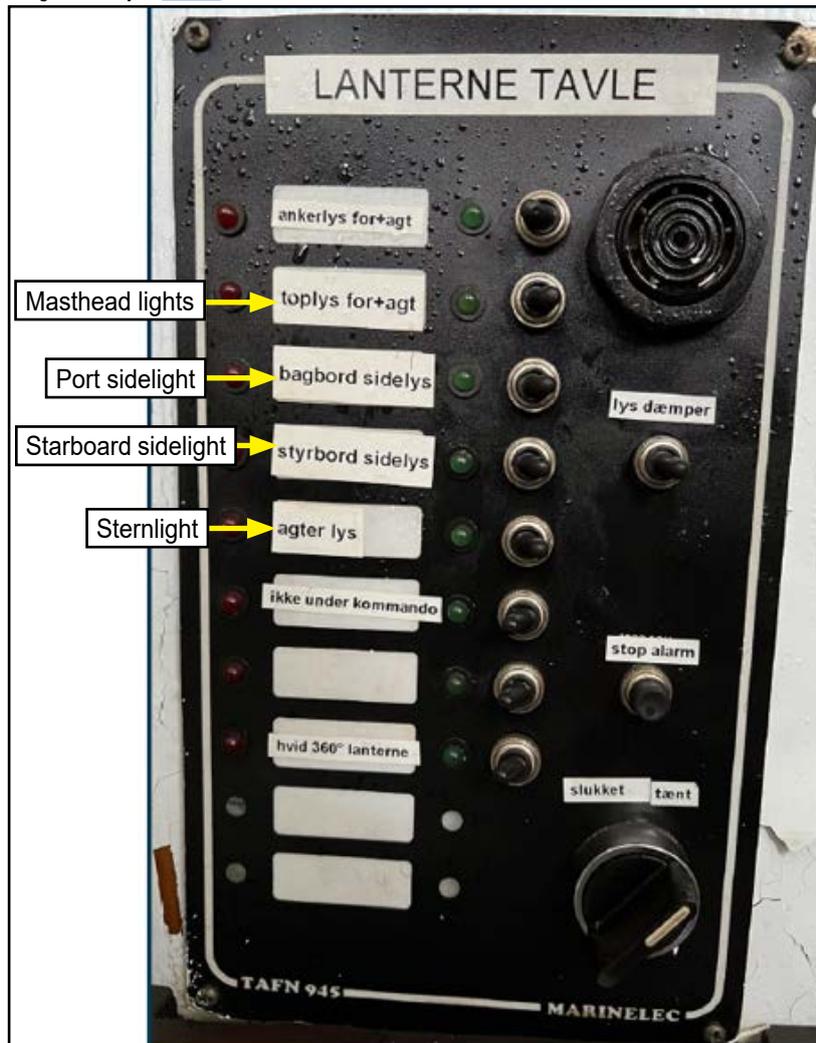
The switches to the masthead lights, port and starboard sidelights and stern light were in the *on* position (**Figure 25**). The key in the BNWAS control panel was in the *on* position (**Figure 26**). It was not possible to determine the BNWAS alarm interval setting selected.

**Figure 25:** Karin Høj's control panel for navigation lights

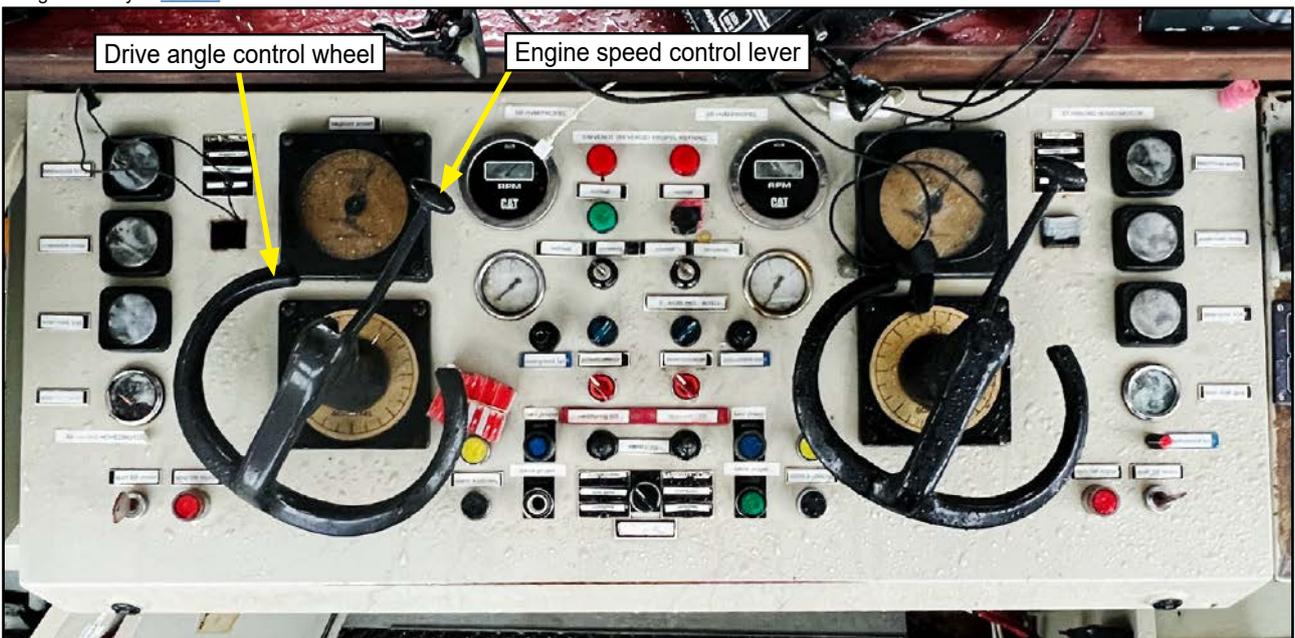
Both bridge azimuth drive angle control wheels were positioned at 30° thrust to port with the speed control lever at full ahead (**Figure 27**). The controls were easily turned, and their position as well as the position of the azimuth drive units might have changed during the salvage operation.

Figure 27: Karin Høj's azimuth drive controllers

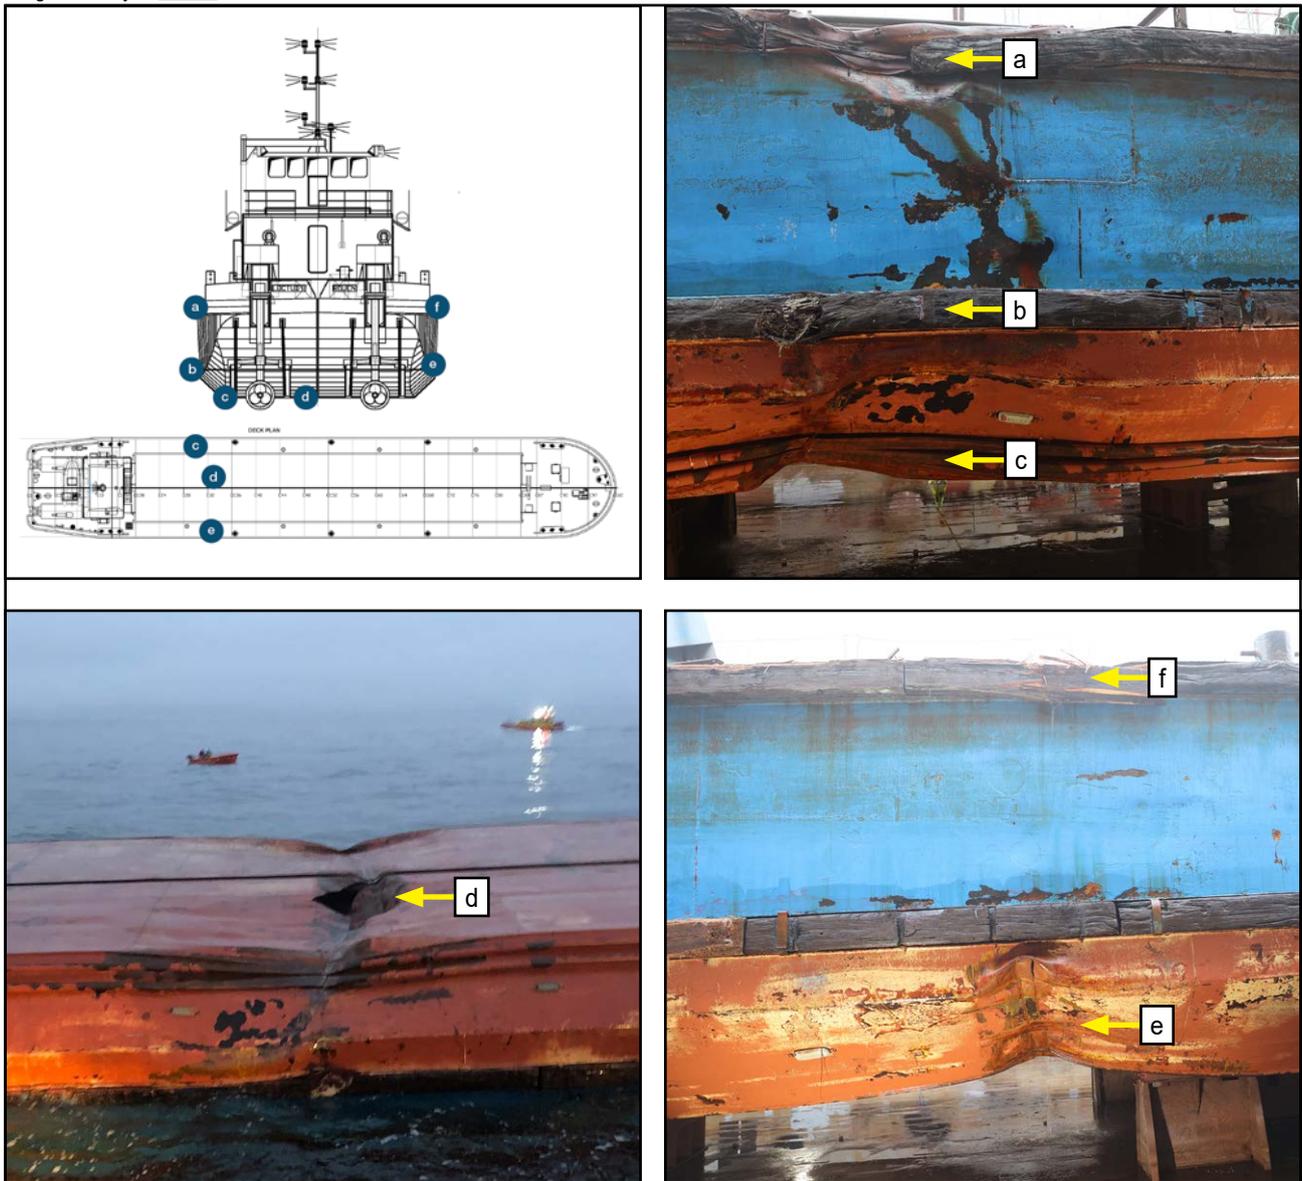
*Karin Høj's* hull had sustained severe damage forward of the accommodation, between frames 28 and 34 (**Figure 28**), including:

- a) indentation in the side plating at the gunwale and a crushed upper fender;
- b) large indentation in the upper part of the bilge plating;
- c) indentation on the lower part of the bilge plating;
- d) penetration of the hull plating on the port side of the keel;
- e) indentation in the bilge plating; and
- f) a crushed fender.

**Figure 28:** *Karin Høj's* hull damage

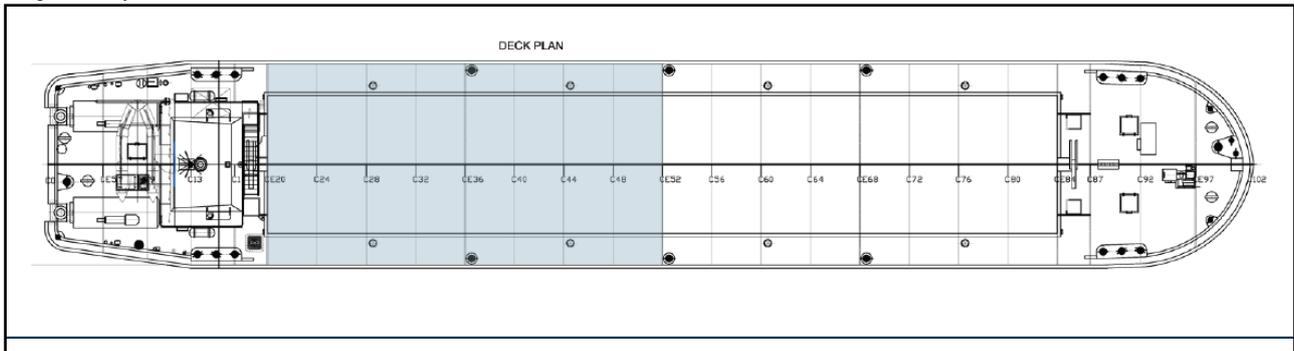
DMAIB reconstructed the loading condition using the barge's estimated draught and stability booklet. It was calculated that *Karin Høj*'s intact stability fulfilled the criteria set by the International Maritime Organization (IMO) in its adoption of the International Code on Intact Stability, 2008<sup>16</sup>. The vessel's damage stability was calculated in line with the accident condition and showed that the breached hull integrity at frame 33 to 34 allowed water ingress into the void spaces between frames 20 and 52 (**Figure 29**).

**Figure 29:** *Karin Høj*'s void spaces in area of frames 20 to 52

For both scenarios, the damage stability was calculated in line with the ship being in an upright position. The results of both scenarios showed that filling the void spaces near the hull breach would not have influenced the vessel's stability sufficiently enough to cause it to capsize.

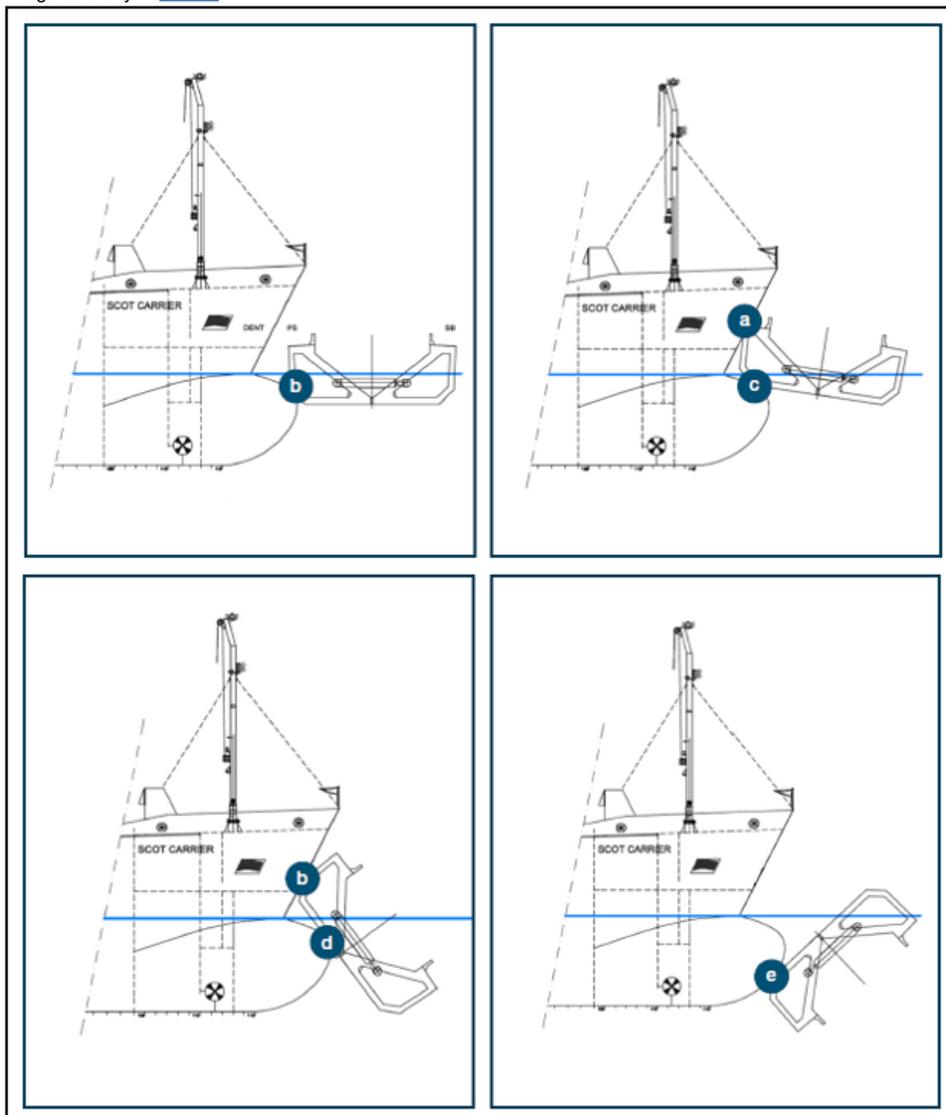
**Figure 33:** Likely dynamics of collision and *Karin Høj*'s capsizing, showing damage points
