VIBIMA & LOUIS

Marine accident report on collision

28 FEBRUARY 2023

The report is issued on 24 April 2024.

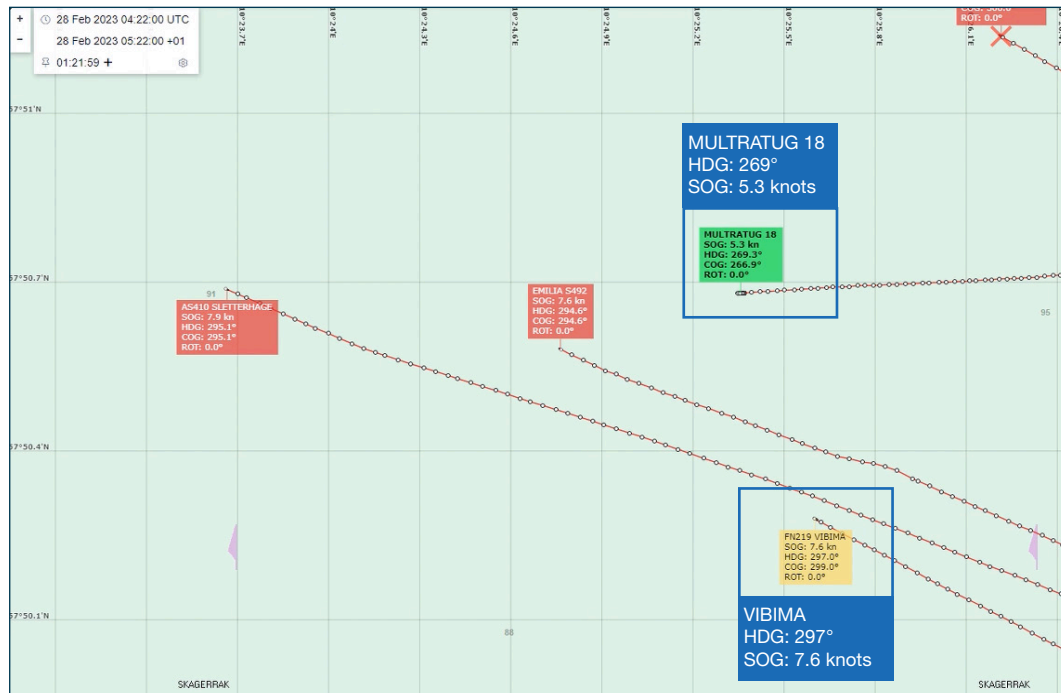
Figure 6: 0522 - VIBIMA and MULTRATUG on steady courses.
Source: Plotter MadeSmart, modified by DMAIB

At 0522, MULTRATUG 18 was heading 269° and VIBIMA was heading 297°. Both ships had kept steady courses for more than an hour (Figure 6). Approximately one minute later, at a distance of 0.3 nautical miles, the deckhand on VIBIMA was alerted by the AIS of the risk of collision with MULTRATUG 18 and turned the ship to starboard to heading 345° (Figure 7).

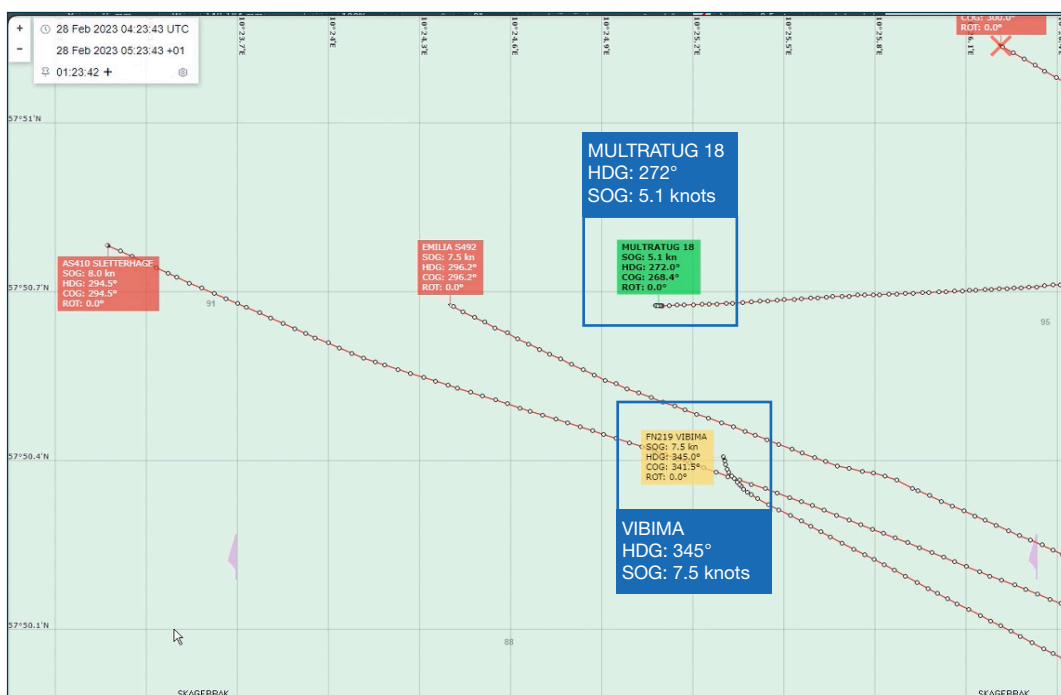
Figure 7: 0523 - VIBIMA turning to starboard.
Source: Plotter MadeSmart, modified by DMAIB

MULTRATUG 18's chief officer saw VIBIMA's course alteration visually, by radar and by AIS, and he assessed that the fishing vessel was passing clear of the tug and the barge.

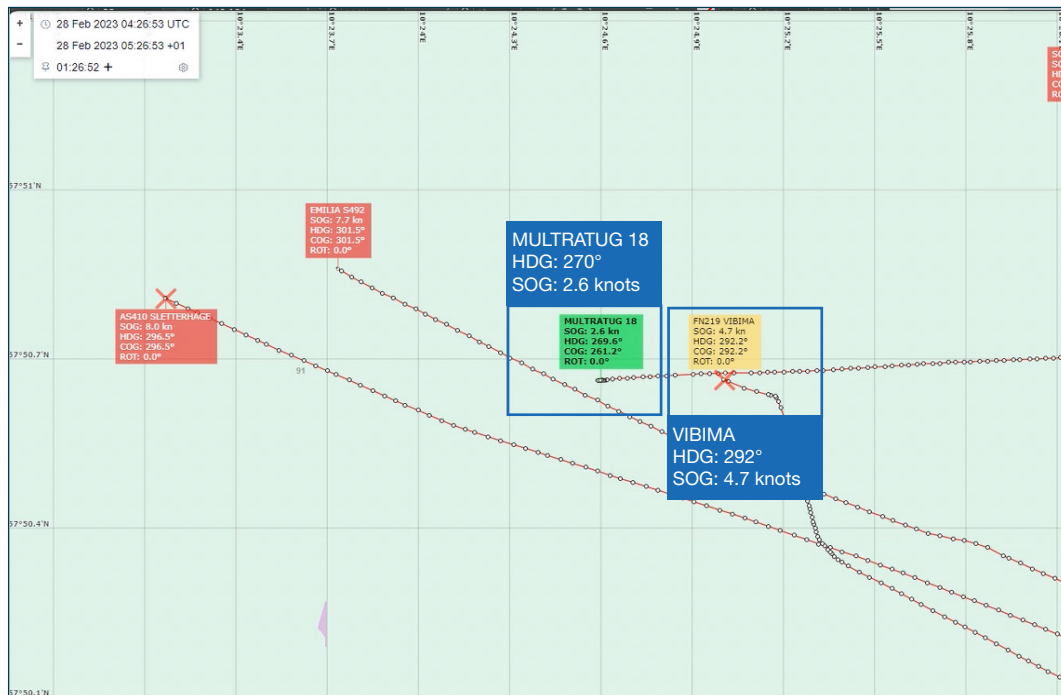
Figure 8: Collision
Source: Plotter MadeSmart, modified by DMAIB

The collision with LOUIS occurred about three minutes later, at 05.26, as the deckhand monitored MULTRATUG 18 on the fishing vessel's port bow (Figure 8).

At the time of the impact, VIBIMA was heading of 292° at 4.7 knots and MULTRATUG 18 was heading 270° at 2.6 knots. Although this indicates that the angle of impact was approximately 22°, this does not take account of effect of yawing on LOUIS, the extent of which is unknown. The speed of impact was approximately 2.1 knots.

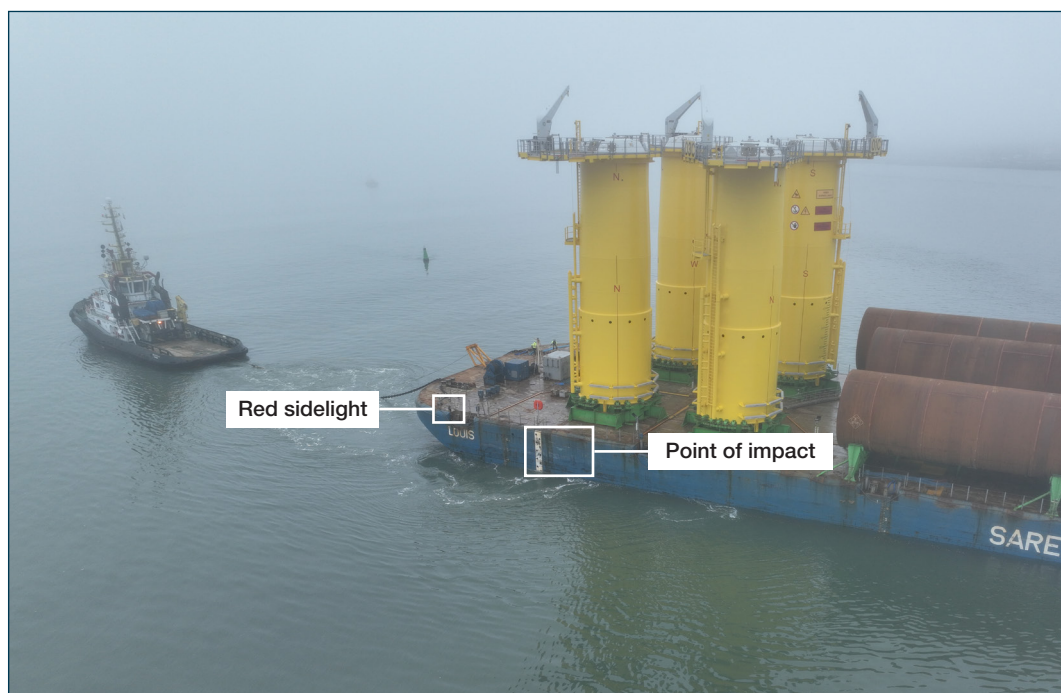
Figure 9: Location of impact on port side of LOUIS' bow.
Source: DMAIB

During DMAIB's examination of the damage on LOUIS the following day, it was determined that the impact of the collision was on the port side bow, just aft of the red side-light (Figure 9 and 10).

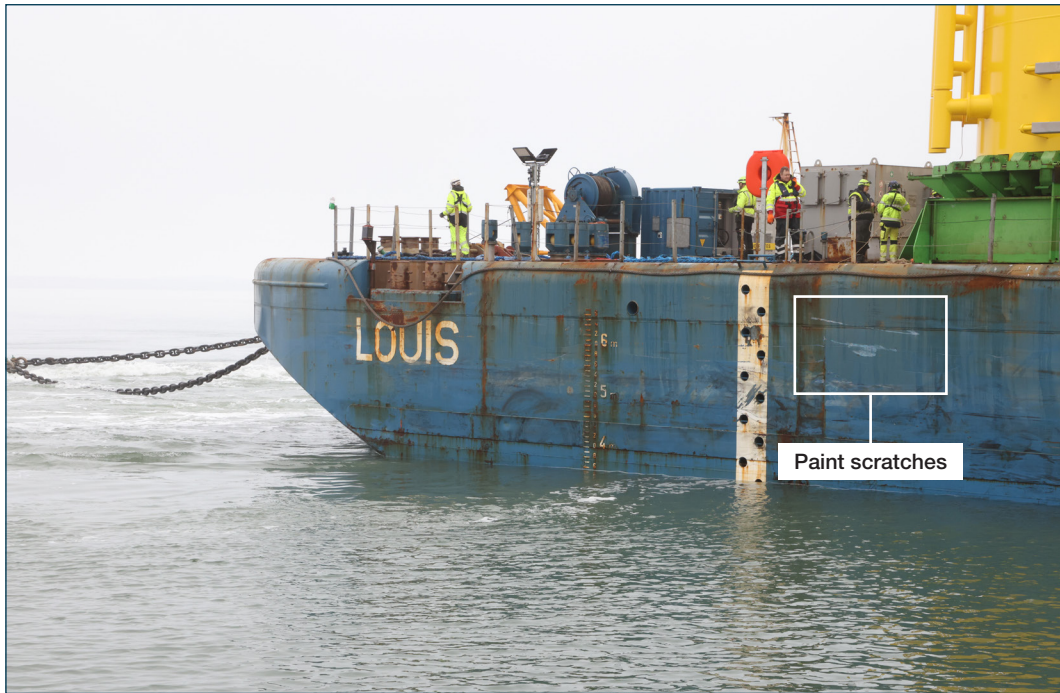
Figure 10: Damage on port side of LOUIS.
Source: DMAIB

A number of paint scratches were found with no visible indentations, which suggests that the impact happened at an angle that made VIBIMA slide forward alongside the hull of LOUIS. Additionally, paint scratches were found by the bow (Figure 11).

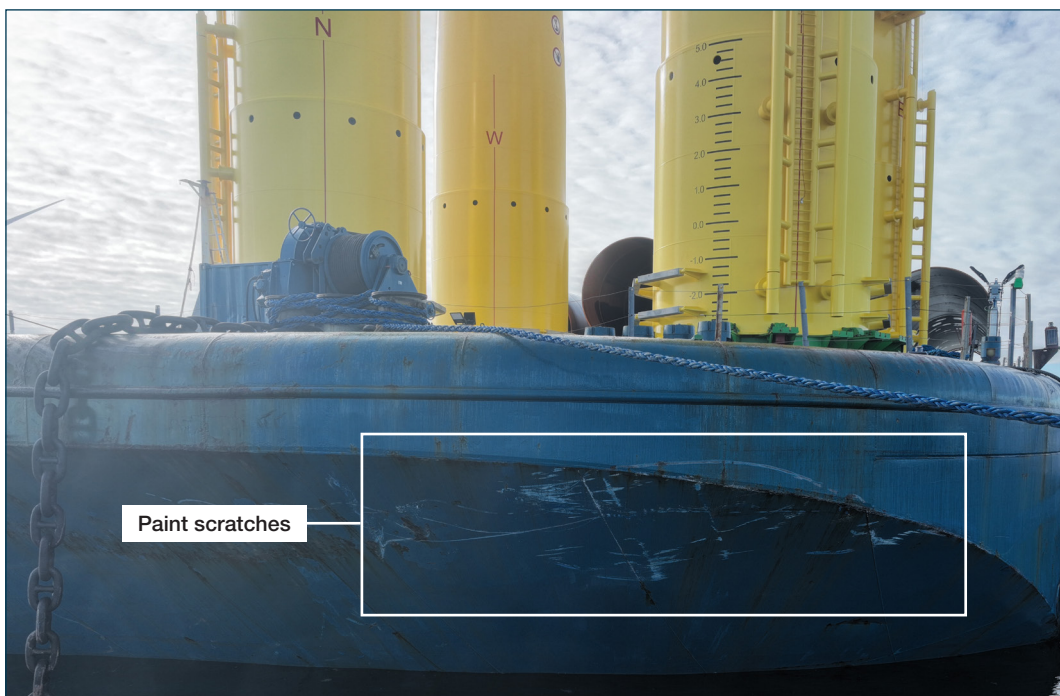
Figure 11: Damage on LOUIS' bow.
Source: DMAIB

This damage coincides with the testimonies of the crew on MULTRATUG 18, which described how VIBIMA overtook LOUIS after the impact and was partly forced under the bow. A photo taken by a crew member on MULTRATUG 18 seconds after the impact showed VIBIMA on a parallel course with MULTRATUG 18 (Figure 12).

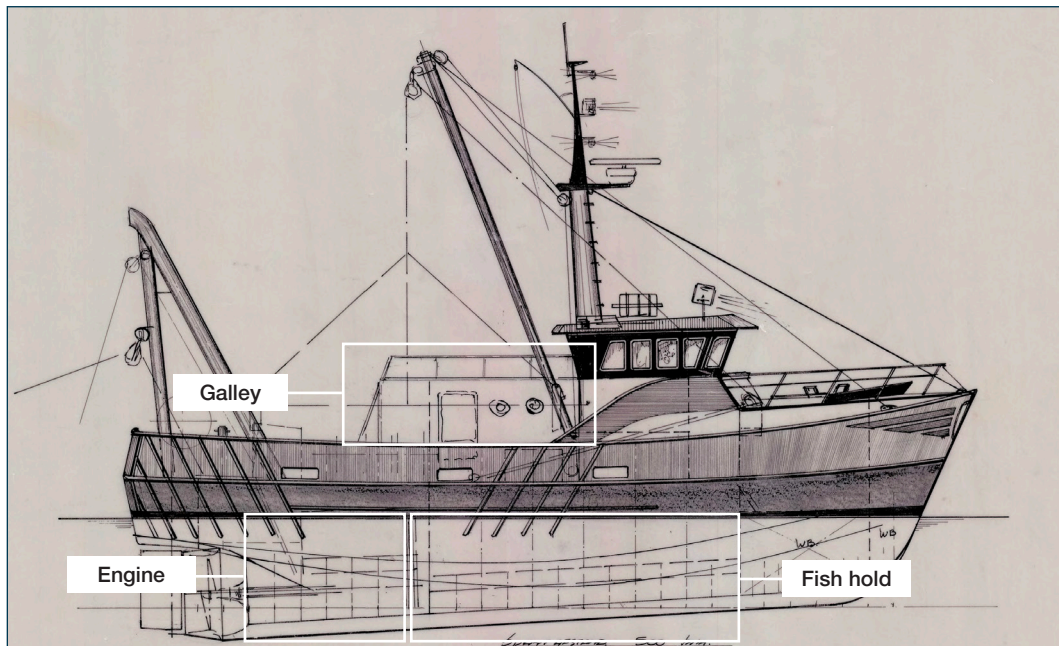
Figure13: VIBIMA's general arrangement.
Source: Scheepsbouwkundig Bureau, modified by DMAIB

There was no updated general arrangement of the ship available, and VIBIMA had undergone several changes since the ship was built in 1978. However, an archival drawing of the ship from when it was built in 1978 was found. When comparing testimonies from the crew and to the drawing, it was determined that the changes were mainly related to the fishing equipment and not the hull and main compartments.

Testimonies from the crew members on VIBIMA indicated that, after the impact with LOUIS' bow, VIBIMA's stern was quickly submerged and water gushed into the galley. The stern was submerged before the master escaped from the cabin to the wheelhouse. This indicates that the engine compartment, and possibly the fish hold, were immediately flooded, causing the ship to lose buoyancy.

The residual buoyancy in the forward part of the ship indicates that the compartments in the forward part of the hull were not damaged during the impact.

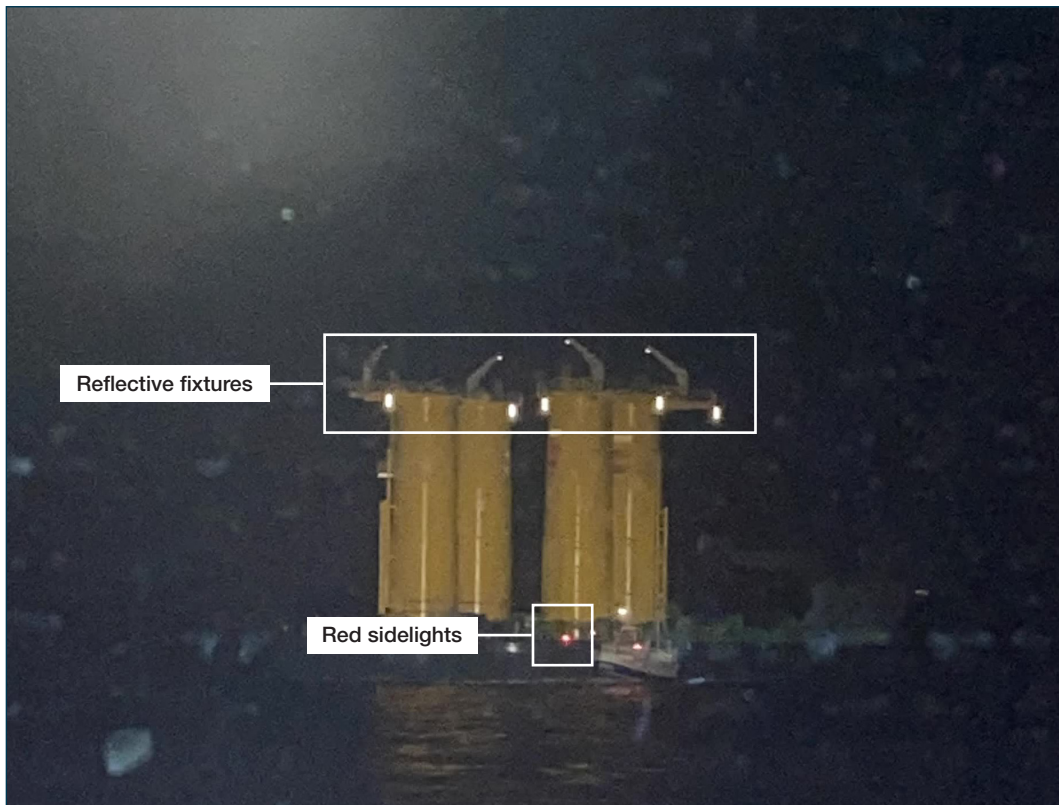
Figure 15: Lights and reflective fixtures on LOUIS.
Source: Private photo.

LOUIS was equipped with side lights and a stern light. Reflective fixtures were mounted on top of the windmill structures. On Figure 15 the port side light and the fixtures can be seen in good working order.

The searchlight on MULTRATUG 18 that illuminated LOUIS, as seen on Figure 15, was reportedly turned on prior to the collision to make the barge more visible. However, it is uncertain if the searchlight was pointed directly towards LOUIS' hull and the wind turbine structures immediately prior to the collision. Shortly before the collision, one of the fishing vessels that passed ahead of MULTRATUG 18 reported that they did not see the barge visually. Therefore, it is possible that the searchlight was not pointed at LOUIS during some periods due to the barge yawing.
