Summary report on occupational accident

2 NOVEMBER 2021

SUMMARY REPORT ON OCCUPATIONAL ACCIDENT ON BB ON 2 NOVEMBER 2021

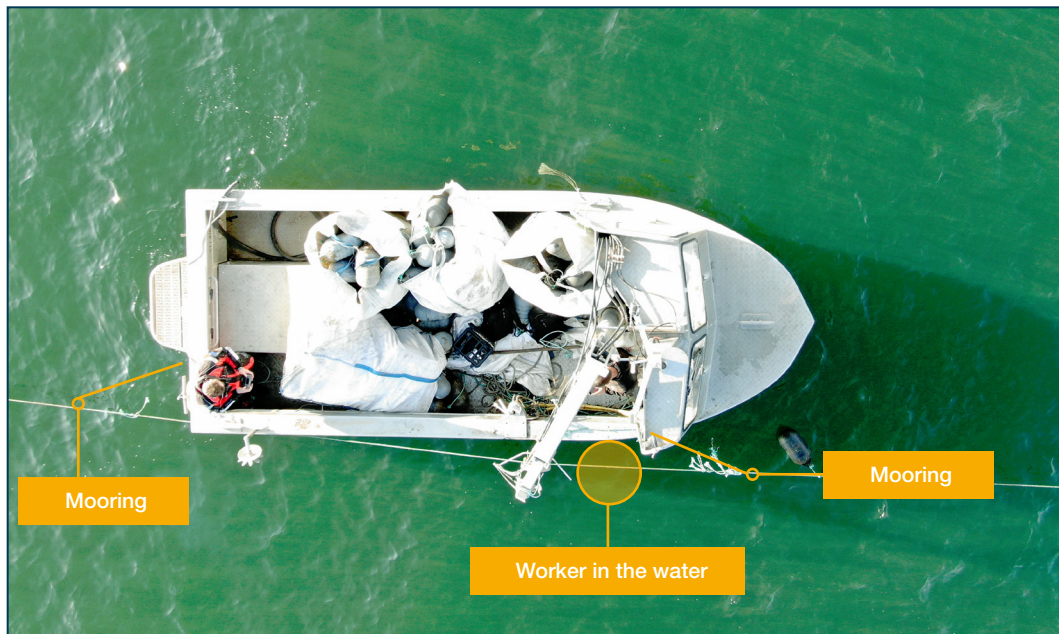
Figure 3: Work boat alongside mussel farm longline

DMAIB examined the work boat while it was alongside in the harbour and brought the work boat to the mussel farm where the accident happened. On site the scene of the accident was reconstructed based on the owner witness statements (figure 3).

The reconstruction of the accident site showed that the crane was not in use, and the longline was secured. The longline had thus not been under tension and suddenly released. This indicates that the worker was in the process of shortening the longline when he fell overboard.

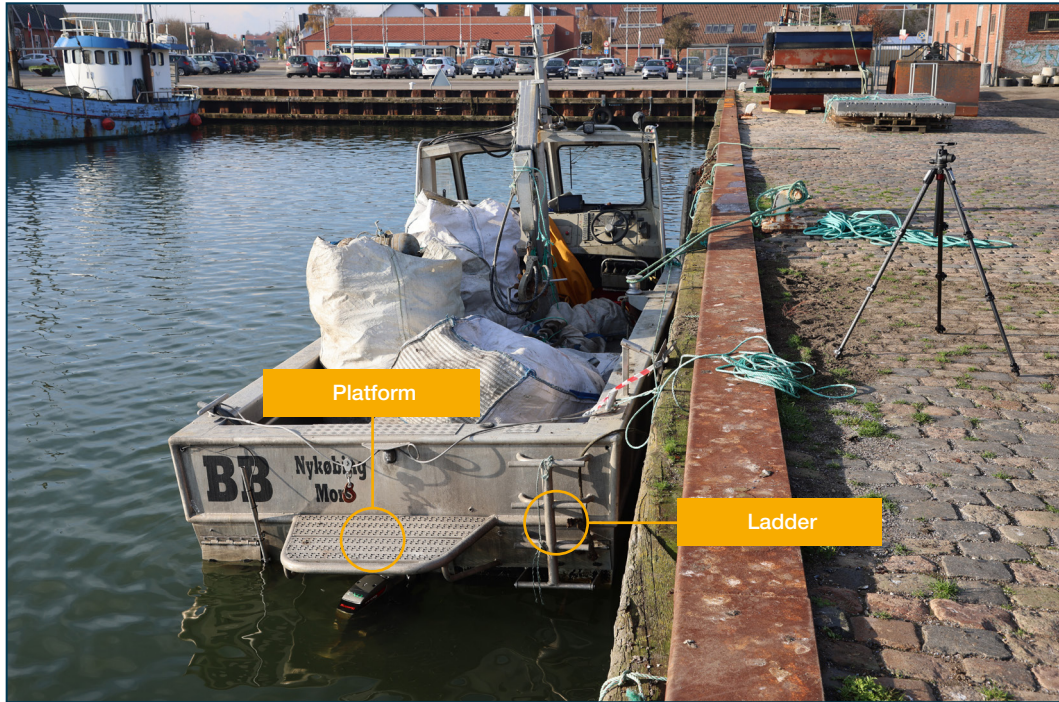
Figure 4: The work boat's ladder and platform
Source: DMAIB

A ladder and a platform were mounted on the boat's stern which was to be used for climbing out of the water, if a crewmember fell overboard (figure 4).

The ladder was fitted in an upward position and could be released by a person in the water pulling a string. Once pulled down, part of the ladder was submerged, making it easier to climb onto the platform. When the boat was found, the ladder had not been released.

Once in the water the worker struggled with taking off some of his clothing, but he did not manage to swim to the ladder. It is a common assumption that falling overboard in water temperatures of about 10°C is not life-threatening and that a person can always survive for hours in that temperature range. However, as for instance stated in IMO's Guide for cold water survival, there are serious threats to a person immersed in cold water (which is defined as 15°C and below), apart from the major threats of drowning, hypothermia and collapse. The initial responses to immersion in cold water may include inability to hold one's breath, an involuntary gasp followed by uncontrollable breathing, which can lead to inhalation of water, and increased stress on the heart. This phase typically lasts for about 3 minutes, and the cooling of the muscles and nerves immediately starts to reduce the person's ability to perform physical tasks such as swimming and manual dexterity in general. In such conditions it would be difficult for the worker to reach the ladder and climb onto the boat. After having been submerged in the water for a prolonged period, he likely lost consciousness and drowned.

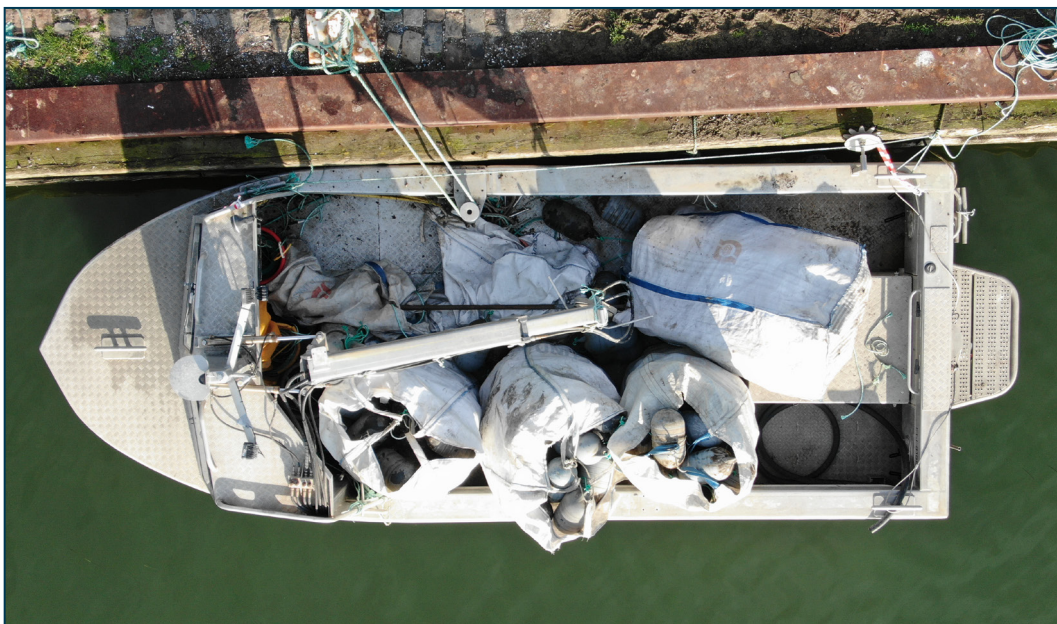
Figure 5: The work boat's deck
Source: DMAIB

On the boat's deck four full bags and two empty bags with buoys were found occupying most of the deck area (figure 5). According to the owner's statement nothing unusual was observed on the boat when he arrived and saw the worker in the water, i.e. there were no lines or buoys unusually positioned, and the crane was in its usual place.

To assess the risks of falling overboard, the investigator measured the height of the boat's gunwale. On the aft part of the deck the gunwale measured 82 cm and forward by the conning station it measured 77 cm.

There were, however, conditions on the boat in combination with work practices which could enhance the risk of falling overboard. The work practices necessitated that the worker leaned outboards to work on lines and buoys, and the gunwale had a height to make that work practice possible. Unexpected events such as sudden movements of the boat or stumbling on equipment on deck could make the worker lose balance and tumble overboard.

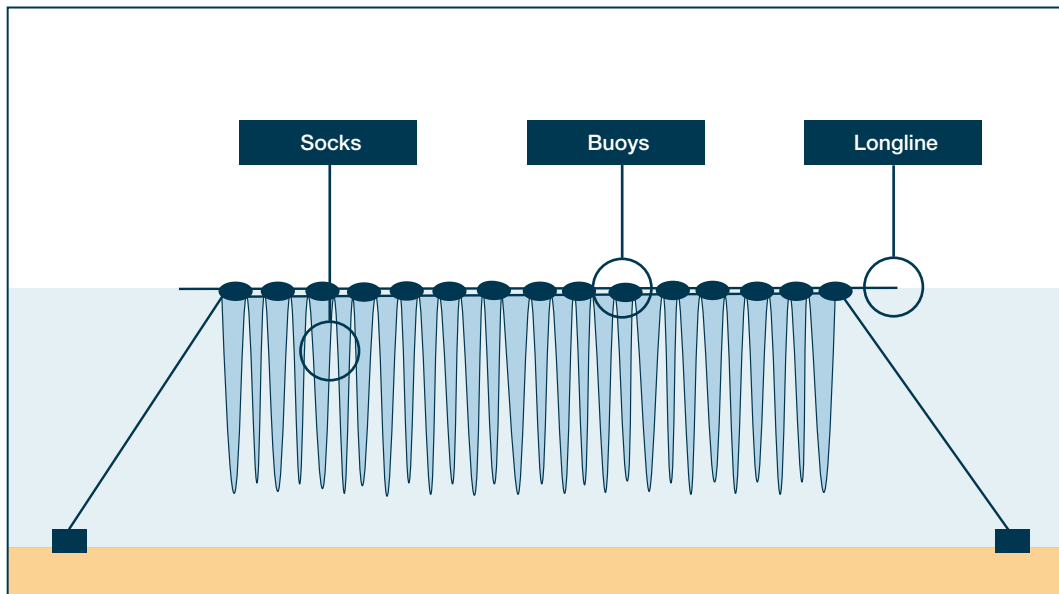
Figure 6: Surface longline
Source: DMAIB

The deceased worker had been with the company for several years and was thus familiar with the boat, the equipment and the work practices. On the day of the accident, he was to connect buoys on the longline where the socks with mussels were to be attached later in the season (figure 6).

The two empty bags found on the deck indicated that the worker had completed fitting 1/3 of the buoys. On the day of the accident the work entailed fastening the boat to the longline (see figure 2), shortening the longline by lifting it out of the sea using the crane and cutting off a section. The longline tended to become stretched and thus longer after having been in the sea for a prolonged period. Once the longline had been shortened, the buoys were attached.
