BEAUMAIKEN

Marine accident report on grounding

**MARINE ACCIDENT REPORT ON BEAUMAIDEN'S
GROUNDING ON 18 OCTOBER 2021**

The report is issued on 12 January 2022.

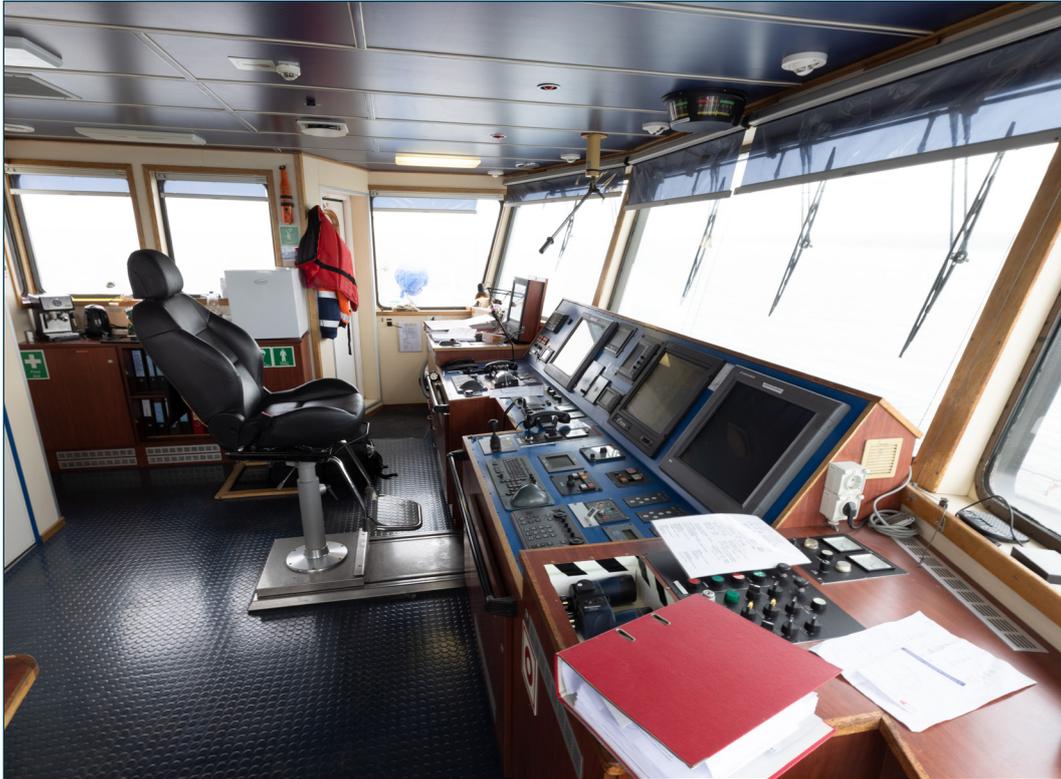
The ship proceeded in Kadetrenden on course 062°, and the next course change was to be made near Bornholm 4-5 hours later. There was little traffic, and the weather was good. During the watch the master sat in the navigational chair and made several phone calls to friends while he listened to music (figure 3).

Figure 3: Conning station on BEAUMAIDEN.
Source: DMAIB

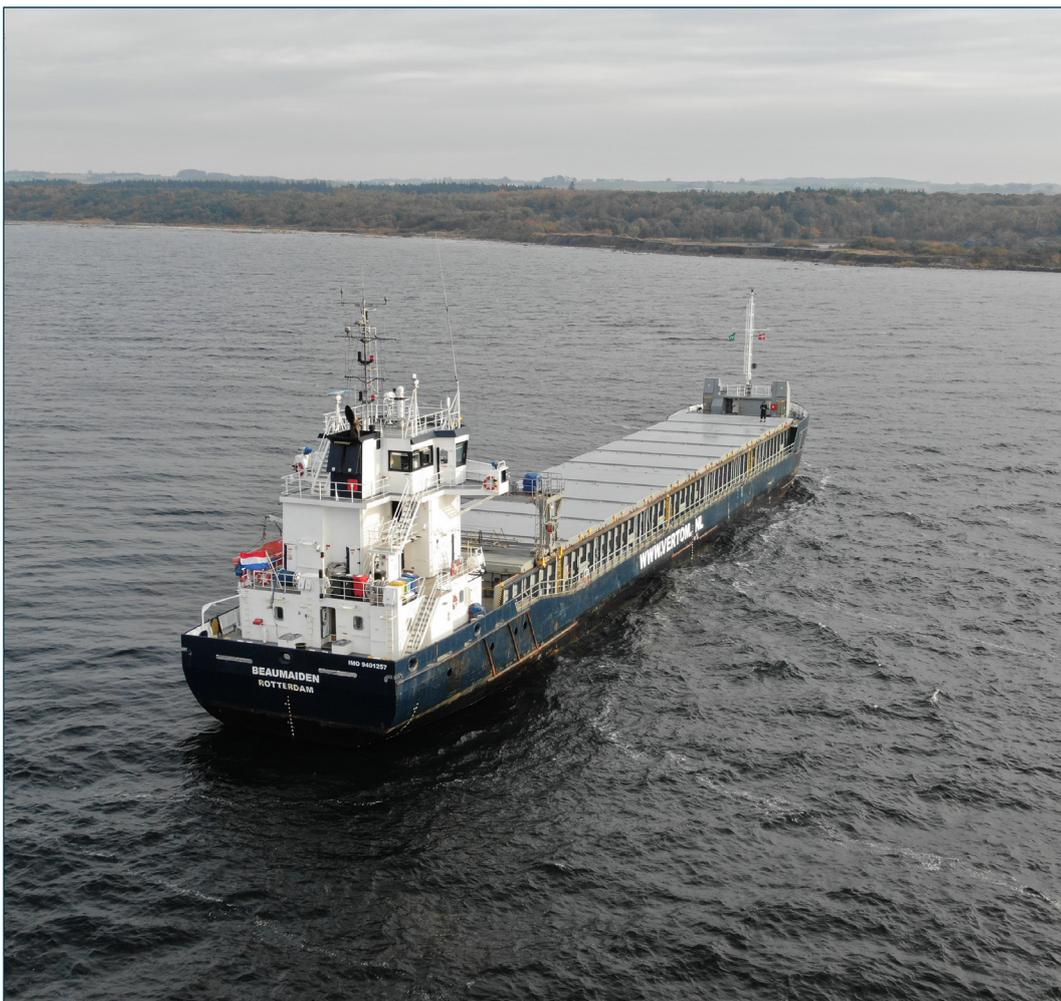
On the bridge the master and the chief officer had a conversation about what had happened. They tried to make a manoeuvre astern while the chief engineer monitored the main engine system in the engine room. But the ship did not move, and the chief engineer stopped the main engine. The time was 0346, approximately half an hour after the grounding (figure 4).

Figure 4: BEAUMAIDEN grounded
Source: DMAIB

The following days the company arranged for the ship's hull to be inspected by divers and contracted a tug to bring BEAUMAIDEN afloat. It was determined that the ship had run aground on sand/sand stone, and thus the hull did not show any sign of significant damage, only some minor cracks in some welding seams and indentations to the hull.

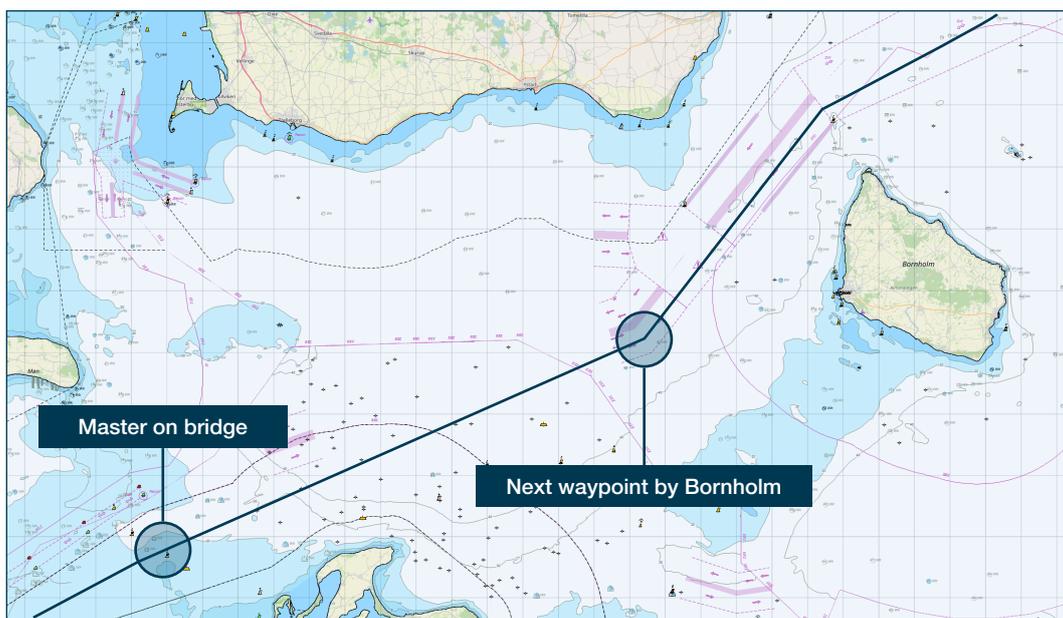
The master of BEAUMAIDEN went to the bridge and relieved the chief officer just before 2000. A few minutes later, the ship reached a waypoint, but it only required a minor course change from 062° to 066°. The distance to the next waypoint at the southern part of TSS Bornholm's Gat was 51 nautical miles. At a speed of approximately 10 knots, the next turn would be about five hours after the change of watch, i.e. according to the route plan the master did not have to make any course changes on his watch (figure 5).

Figure 5: BEAUMAIDEN planned route.

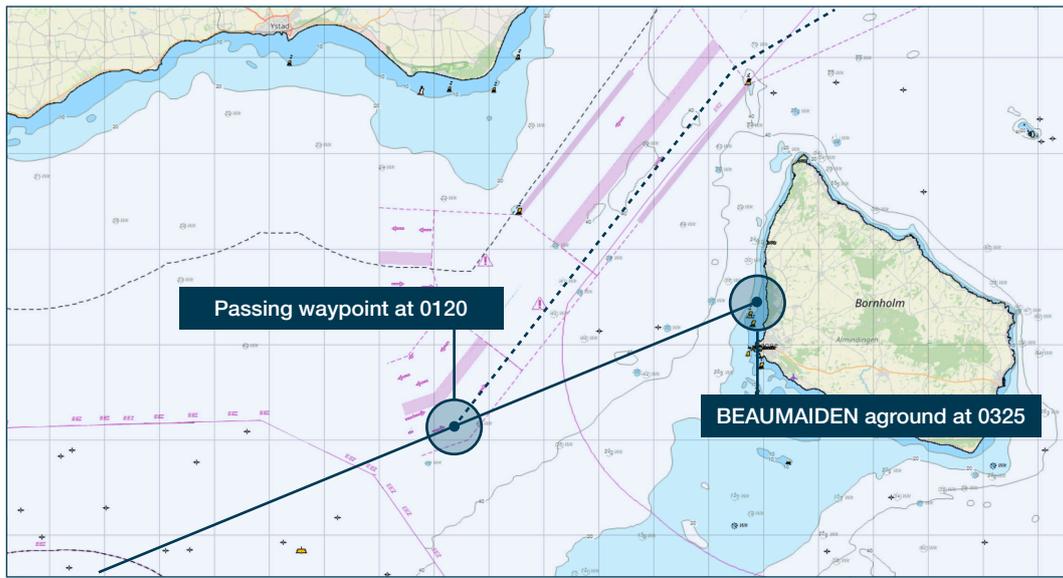
An examination of the master's phone records showed that the last call was made at 2322 after which he went to his cabin at approximately 2330. At 0120, BEAUMAIDEN passed the waypoint in the southern part of TSS Bornholm's Gat where the ship's course should have been changed to 038°, but the ship continued on course 066°, heading directly towards Bornholm, where it went aground at 0325 (figure 6).

Figure 6: BEAUMAIDEN passing the waypoint
Source: © Made Smart Group BV 2021 © i4 Insight / DMAIB

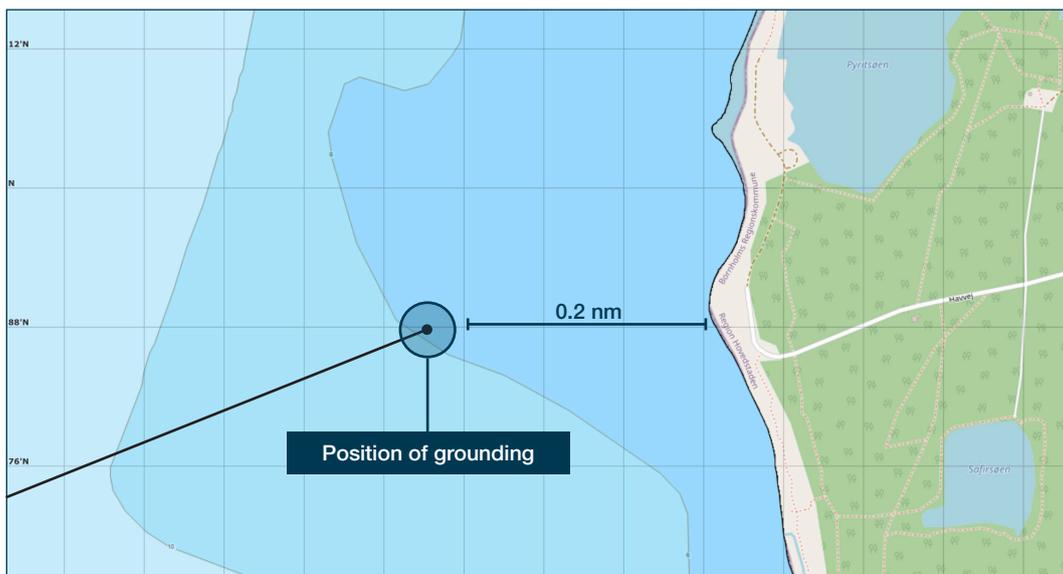
The ship went aground approximately 0.2 nautical miles from shore within the 6 m depth contour in an area where the seabed consisted mainly of sand and sand stone (figure 7).

Figure 7: Location of grounding by Sorthat Odde
Source: © Made Smart Group BV 2021 © i4 Insight / DMAIB

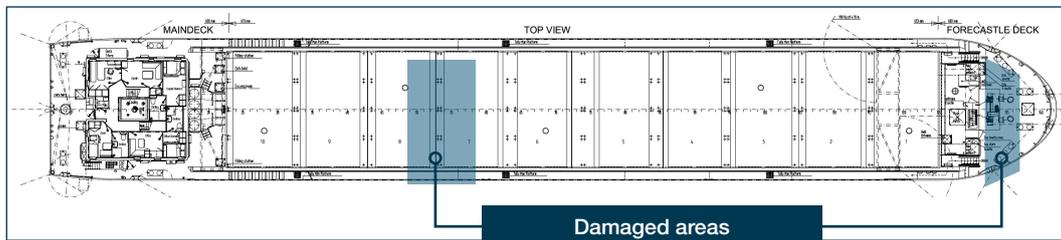
The examination of the ship's hull performed by divers established that the ship stood on a shallow area abaft midship by frames 41-45 and was lifted about one metre, decreasing the draught from 5.40 to 4.40 metres (figure 8). Damages to the hull in the forepeak and minor indentations in the hull were observed.

Figure 8: Location of grounding

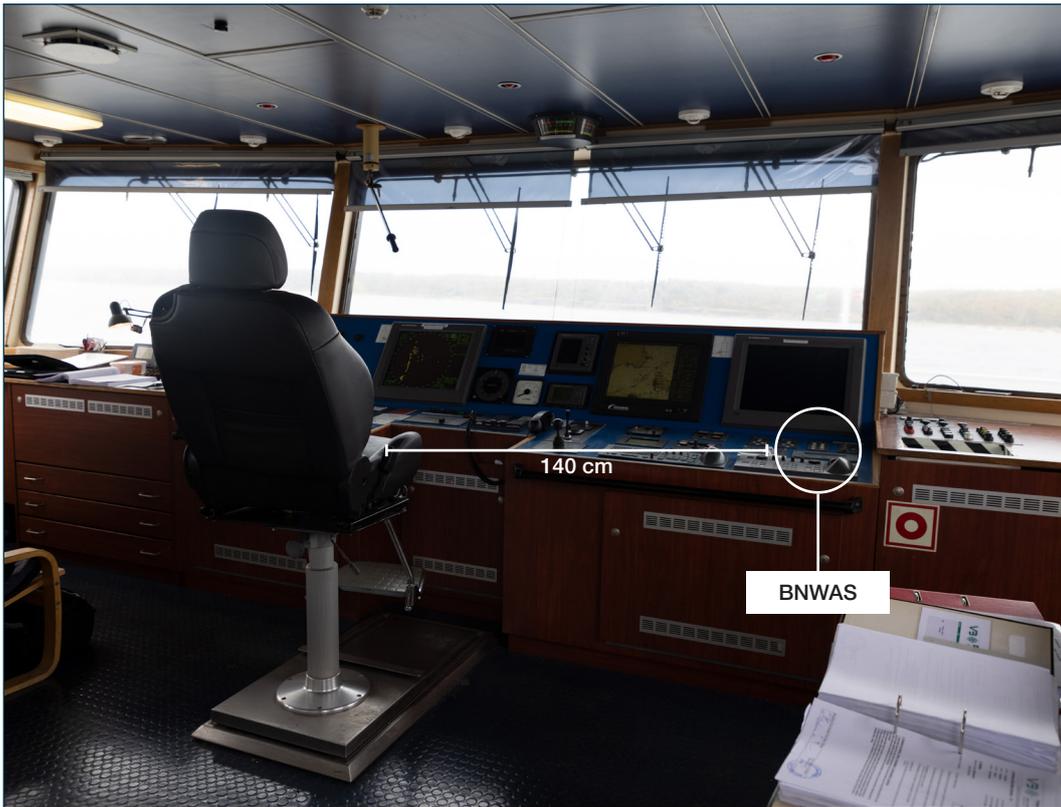
On BEAUMAIDEN the BNWAS was mounted on the main console by the conning station approximately 140 cm from the navigational chair (figure 9). During the visit on board, DMAIB performed a function test of the system, and it was found to be in working order (figure 10).

Figure 9: BNWAS by the conning station.
Source: DMAIB

During normal operation the system was reset by the OOW pressing the reset button on the BNWAS panel. Alternative reset arrangements can be incorporated to initiate the reset function from other equipment on the bridge capable of registering operator actions, e.g. radar and ECDIS controls. However, on BEAUMAIDEN there was no such integration with other equipment, and the OOW therefore had to stand up from the navigational chair every 3-12 minutes to reach the reset button.

The BNWAS was activated by using a key which was in the master's possession, but at the time of the grounding the system was not activated, and the key was not available on the bridge. DMAIB's inquiries into bridge watch practises on BEAUMAIDEN indicated that the BNWAS was normally not used by the onboard crew, because it was found to be troublesome to constantly reset the system, when the reset button could not be reached from the navigational chair. Thus, on the day of the grounding the BNWAS could not alert the other crewmembers about the bridge being unmanned.

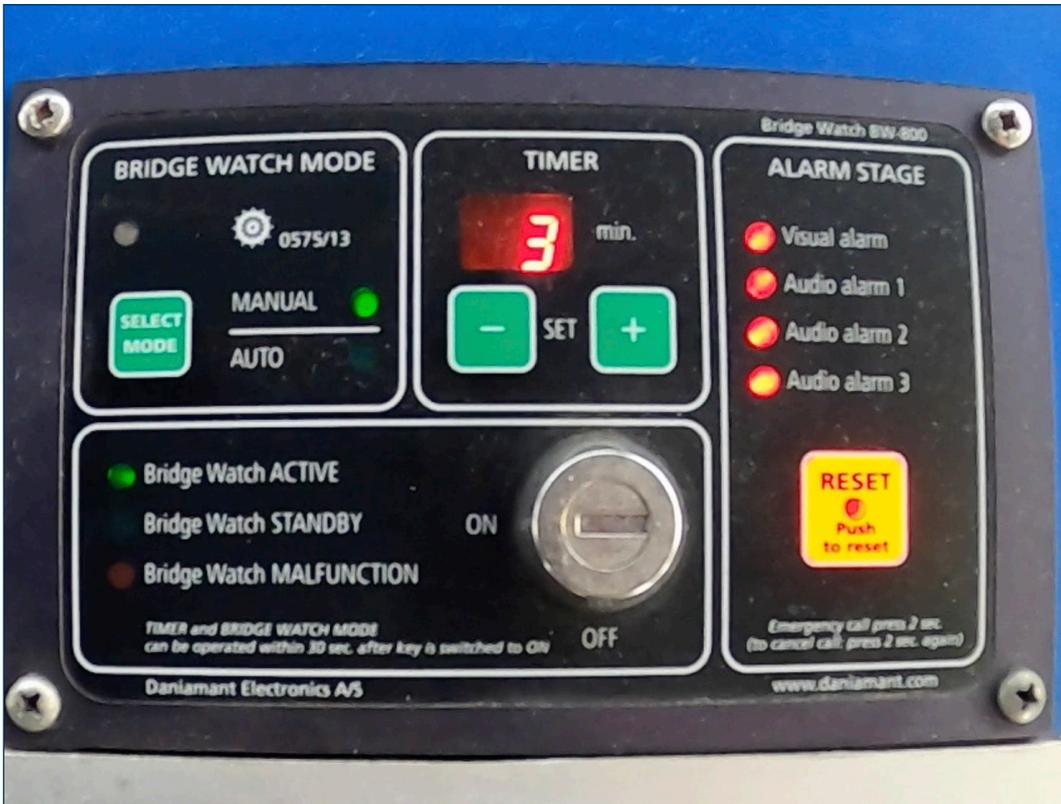
Figure 10: BNWAS during DMAIB test procedure.
Source: DMAIB
