Marine accident report on occupational accident

16 FEBRUARY 2022

**MARINE ACCIDENT REPORT ON OCCUPATIONAL
ACCIDENT ON DANMARK ON FEBRUARY 2022**

DMAIB
Danish Maritime Accident Investigation Board
Batterivej 9
DK-4220 Korsoer
Denmark

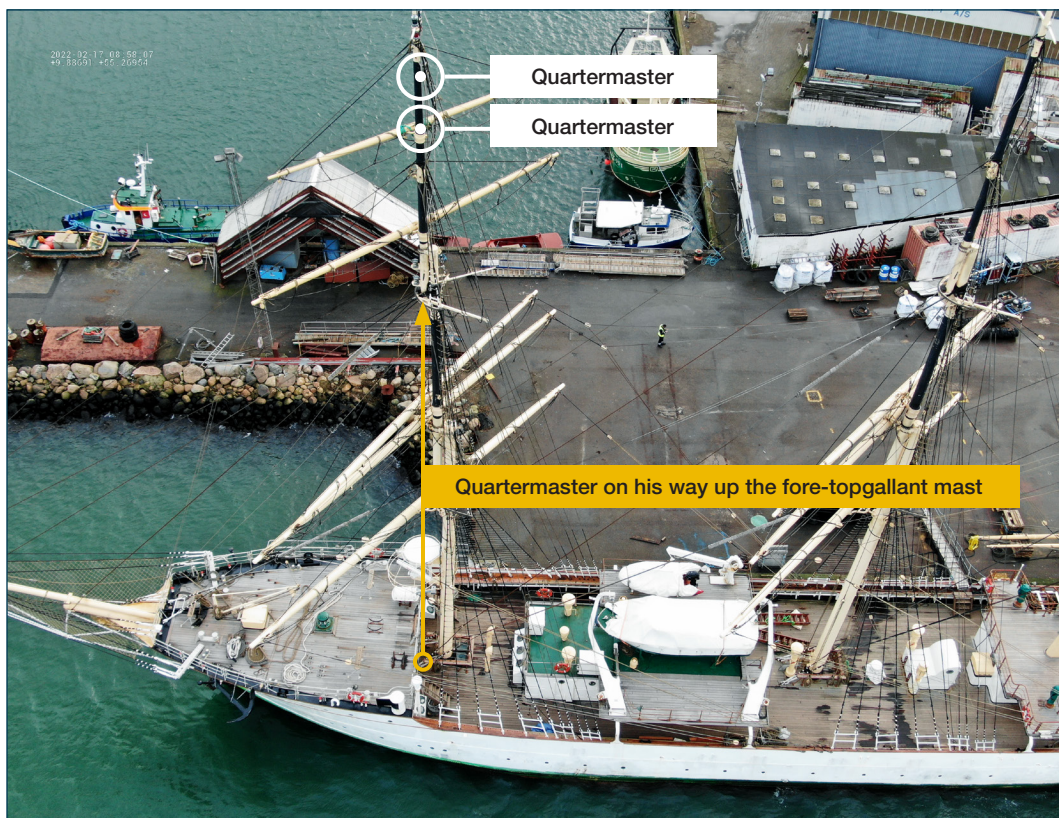
The two quartermasters on the foremast had prepared the royal yard but they did not have a radio to communicate with the mate, or strops to attach to the topgallant yard. As a result, a quartermaster who had just climbed down from the main topgallant mast, climbed the port side of the foremast carrying strops and a rigging bag containing a UHF radio. As he climbed, the two quartermasters that were already aloft on the foremast waited, one in the Jacob's ladder over the royal yard, and the other at the royal yard (figure 3).

Figure 3: Overview of fore-topgallant mast.
Source: DMAIB

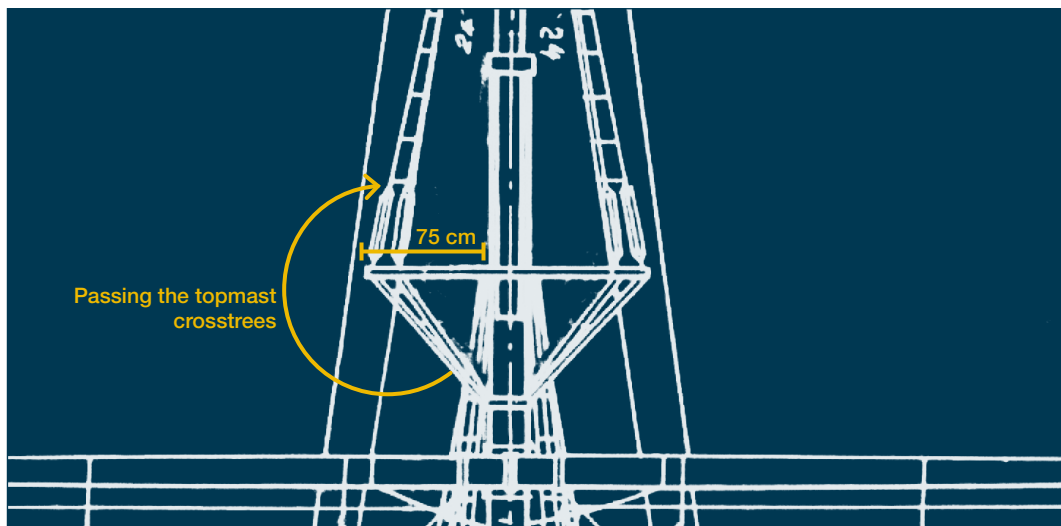
The topmast crosstrees had an overhang of about 75 cm from the topmast at its widest point, which made it necessary for the quartermaster to climb by way of the topmast futtockshroud to get up and out over the topmast crosstrees (figure 7). Figure 8 shows a picture taken from the spot on the pin rack where the quartermaster fell from the topmast crosstrees. The distance between the topmast crosstrees and the deck was about 25 metres. The quartermaster fell directly onto the pin rack as there was no rigging in that area to break the fall.

Figure 7: Topmast crosstrees on the fore-topgallant mast
 Source: Nakskov Shipyard/DANMARK, modified by DMAIB

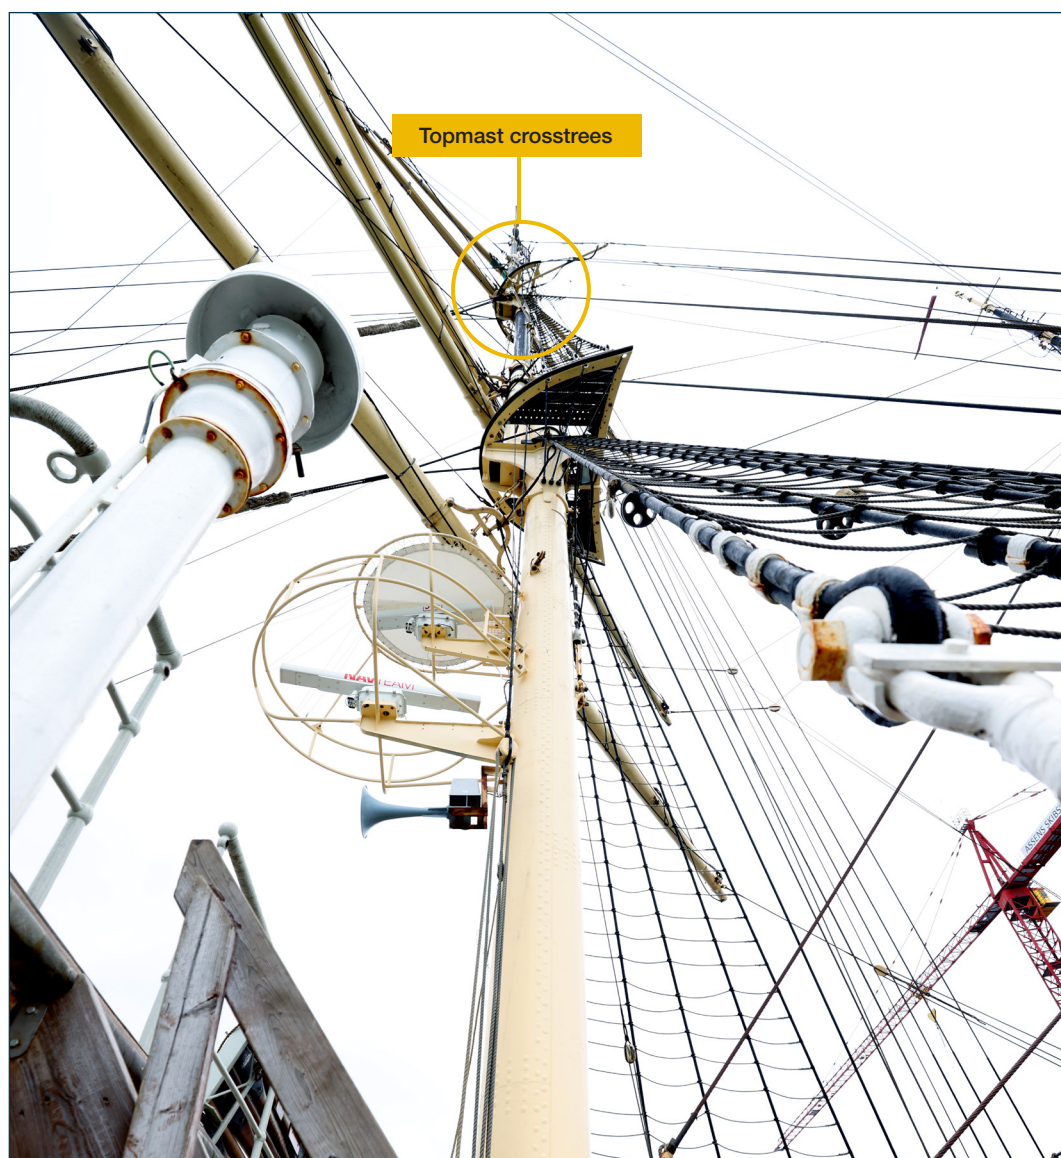
Figure 8: Topmast crosstrees on the fore-topgallant mast seen from the pin rack
 Source: DMAIB

- *The deceased fell from an estimated height of 20 metres when he had to pass the topmast crosstrees.*
- *The deceased presumably lost his grip on the shroud when he had to climb the topmast crosstrees by swinging one of his legs up onto the topmast crosstrees.*

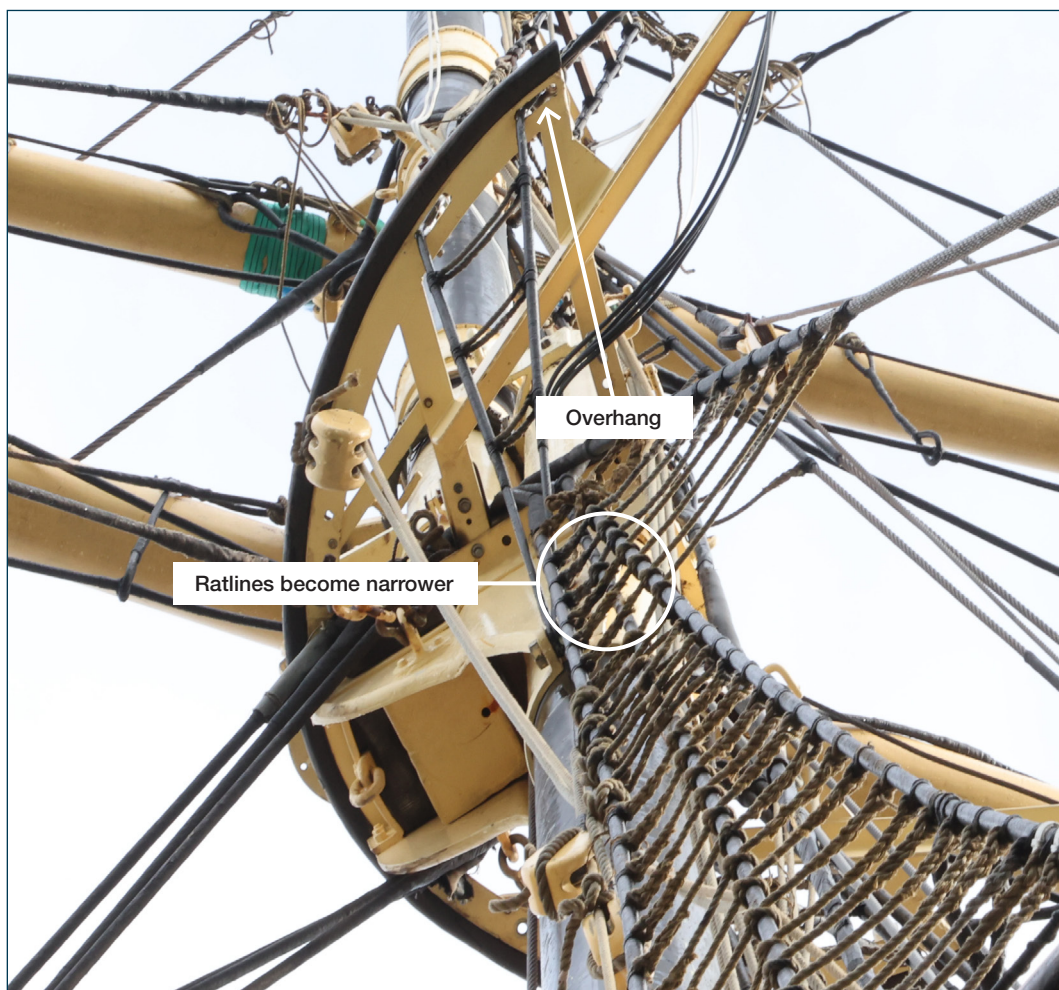
Traversing the top and topmast crosstrees had to be carried out with caution. When ascending, a person had to lean backwards to negotiate the overhangs. In addition, the ratlines under the crosstrees were very narrow and required the feet to be angled a particular way to enable a person to push/lift themselves onto the crosstrees (figures 9 and 10).

Figure 9: Shroud under topmast crosstrees on the fore-topgallant mast.
Source: DMAIB

Since the above conditions could not explain why the quartermaster lost his grip, the fall of the quartermaster most likely had to be due to conditions related to the way the climb was carried out. The investigation showed that the usual three-point safety stance when climbing the rigging did not provide the quartermaster the same safety at all positions in the rigging. Climbing in the shroud up to the top and topmast crosstrees was characterised by the fact that he was to some extent supported by the shroud, because it was at an angle from the railing towards the ship's deck. But immediately under the top and the topmast crosstrees, the shroud slanted in the opposite direction, which would have required the quartermaster to support his own weight. In these locations, his climbing technique and physical ability became crucial, because he was unable to stop and rest at these points. The quartermaster fell while in the topmast futtockshroud, where the ratlines narrowed markedly and a specific positioning of the feet was required when passing the topmast crosstrees. If problems arose at this point, it was necessary to change the foot position, which may have compromised the quartermaster's three-point safety stance and challenged his physical endurance. However, the investigation has not been able to unequivocally identify the exact problems the quartermaster experienced when passing the topmast crosstrees, that caused him to lose his footing and grip on the shroud.
