HENDRIKA JACOBA

Marine accident report on fall between quay and ship

29 MAY 2022

**MARINE ACCIDENT REPORT ON FALL BETWEEN QUAY
AND SHIP ON HENDRIKA JACOBA ON 29 MAY 2022**

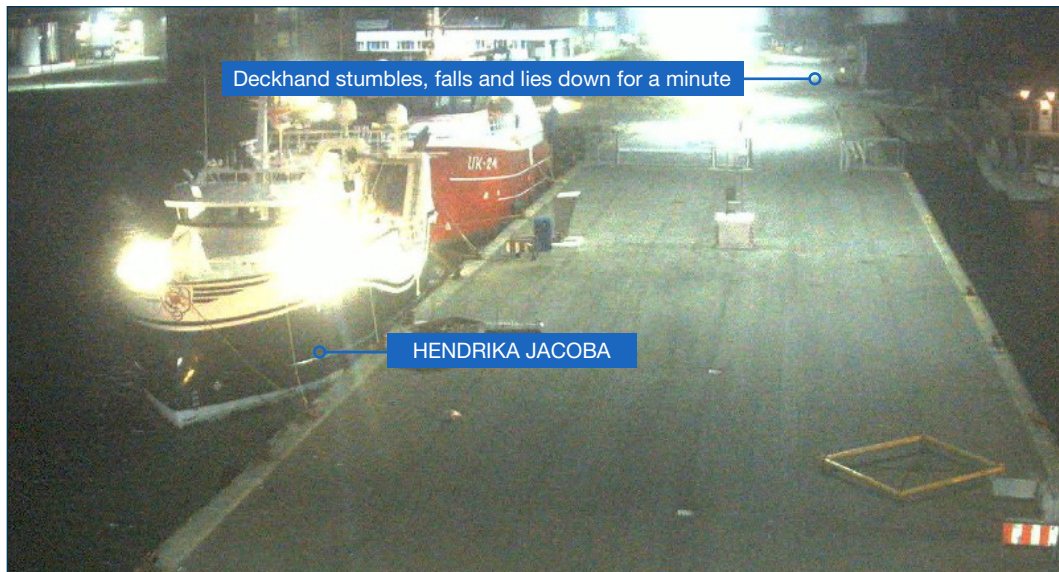
The deckhand comes around the corner to the street leading to the quay where HENDRIKA JACOBA is berthed. No other persons can be seen on the quay. As the deckhand passes a workshop on the corner of the street, he stumbles and falls to the ground. One minute later, he gets up and continues to move unsteadily in the direction of HENDRIKA JACOBA (Figure 2).

Figure 2: Deckhand falls outside workshop on his way to HENDRIKA JACOBA.
Source: Thyboron Port / DMAIB

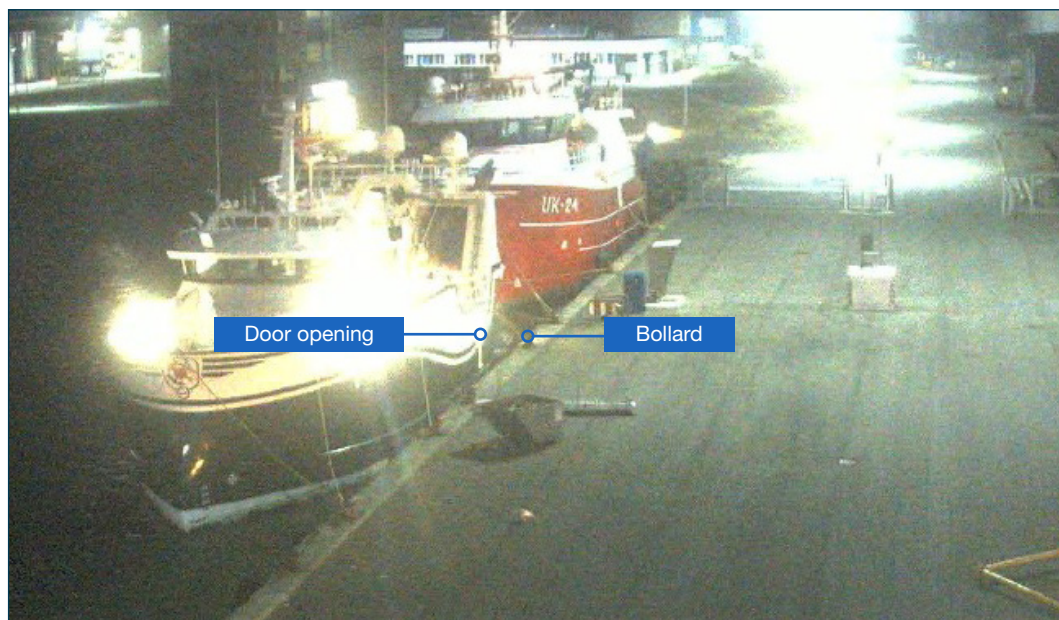
The deckhand arrives at HENDRIKA JACOBA and pauses for a moment. He then walks to a bollard located near a door opening in HENDRIKA JACOBA's port side and stands on the right side of the bollard. He then seems to change his mind and goes left of the bollard (Figure 3).

Figure 3: Deckhand pauses at the bollard on the quay at the opening to HENDRIKA JACOBA.
Source: Thyboron Port / DMAIB

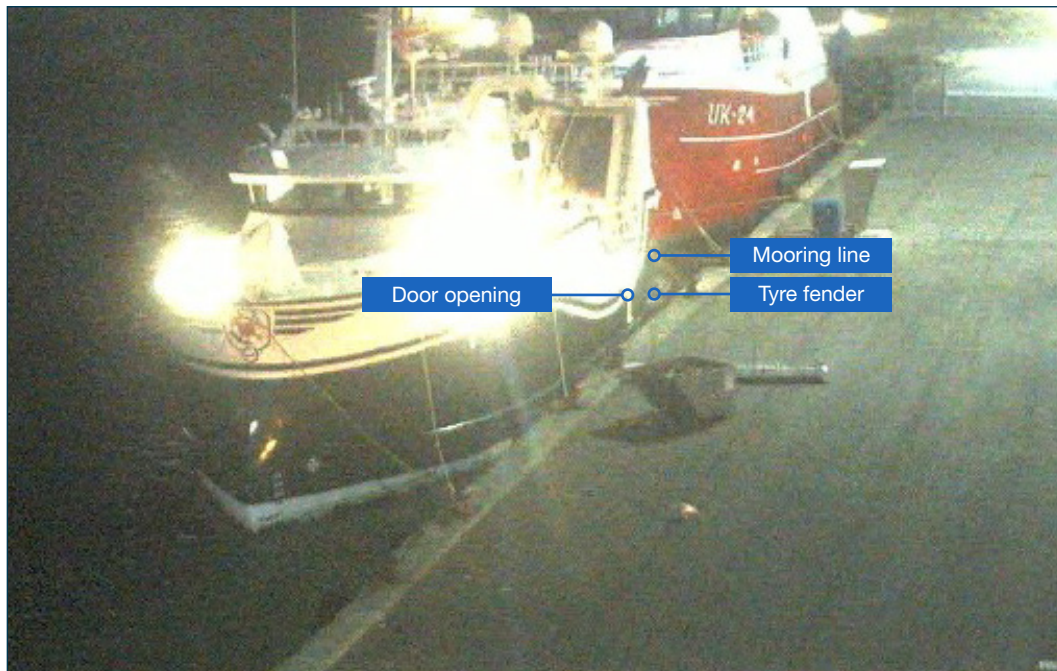
The deckhand steps on a tyre fender fastened to the bollard and grabs onto a mooring line going from the bollard to the weather deck on HENDRIKA JACOBA (Figure 4).

Figure 4: Deckhand grabs on to mooring line, step on the tyre fender and leans upper-body into door opening.
Source: DMAIB

The deckhand leans the upper part of his body forward into the door opening with his head first. He then starts to take a step, extending one foot towards the door opening. While taking a step onto the ship, the deckhand loses his balance, falls between the tyre fender and the ship and disappears.

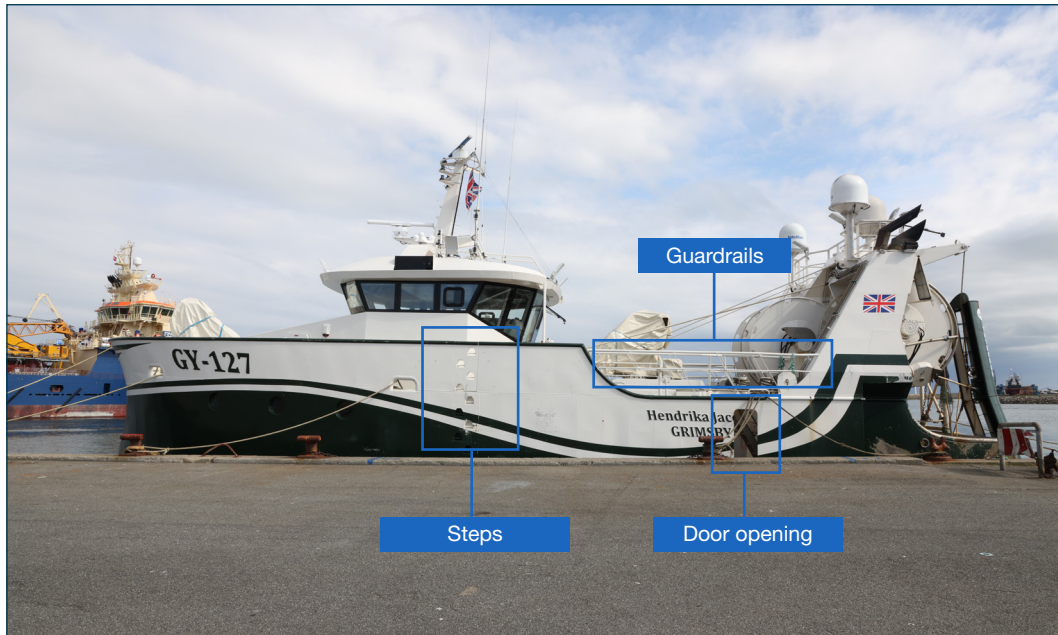
- A door opening in the ship side accessing the main deck.
- Steps built into the ship side with a door to the weather deck.
- Guard rails at the weather deck.

The access ways were used depending on the level of the quay in relation to the ship. If the quay was high compared to the ship, the crew preferred to climb and step over the guardrails. If the quay was low, the door in the ship side was normally used. The steps integrated in the ship side were used in both situations. The choice of access way also depended on the distance between the quay and ship, which was determined by the fenders' size and location in relation to the ship.

Figure 5: Access ways on HENDRIKA JACOBA's port side.
Source: DMAIB

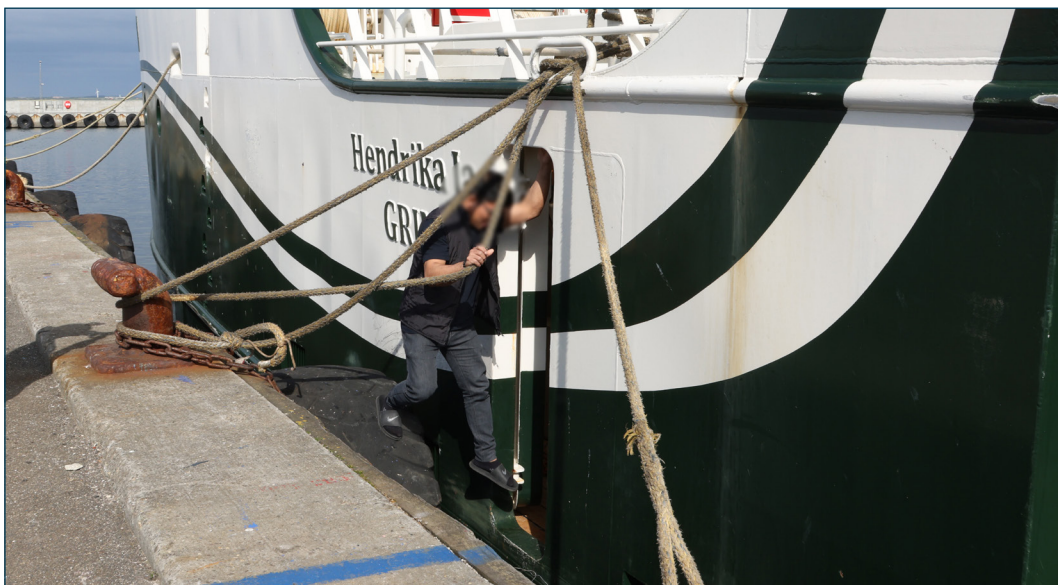
During the investigation on the ship, crewmembers demonstrated how to access the ship by the door opening to the main deck, which was located beneath quay level. The crew stepped on a tyre fender located close by the door opening and held on to a mooring rope fastened on the weather deck while stepping down onto the ship. During DMAIB's examination on the ship, the tyre fender was located slightly fore of the door opening. This made it necessary for the crewmembers to stand on a sloping part of the fender, when stepping down on the ship (Figure 6).

Figure 6: Crew member demonstrates how to access HENDRIKA JACOBA via door opening.
Source: DMAIB

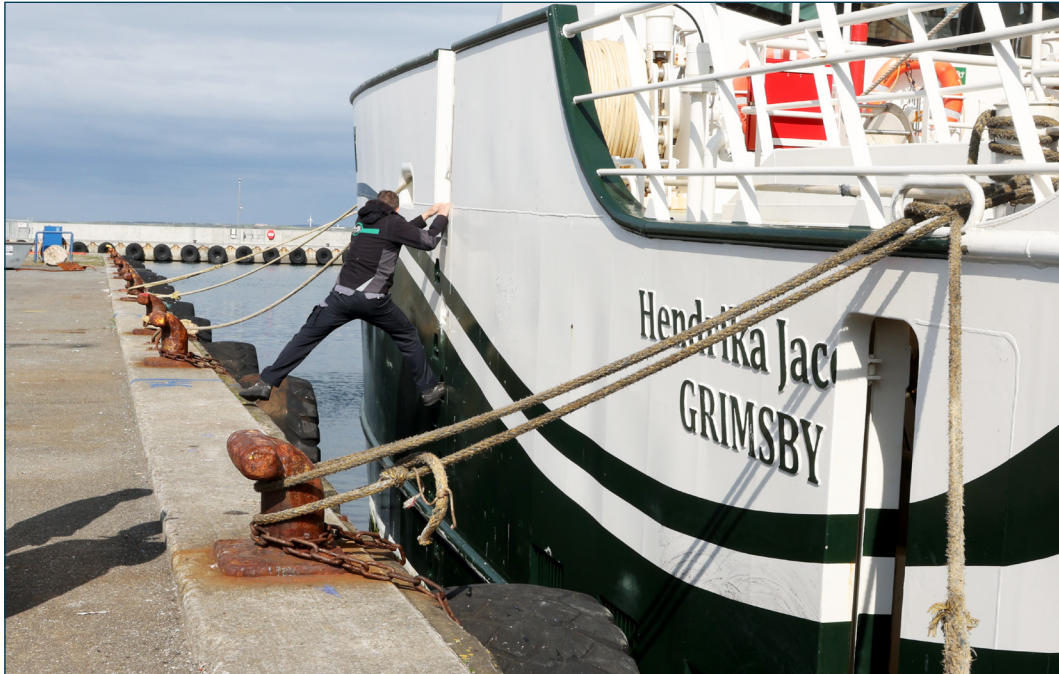
The crew also demonstrated how to pass from ship to quay via the steps integrated in the ship's side. The steps were not aligned with a tyre fender, and it was necessary to straddle the gap between the ship and the quay. Due to the crewmembers' difference in height, this was not a feasible accessway for all crewmembers (Figure 7).

Figure 7: Crew member demonstrates how to leave HENDRIKA JACOBA via the steps.
Source: DMAIB

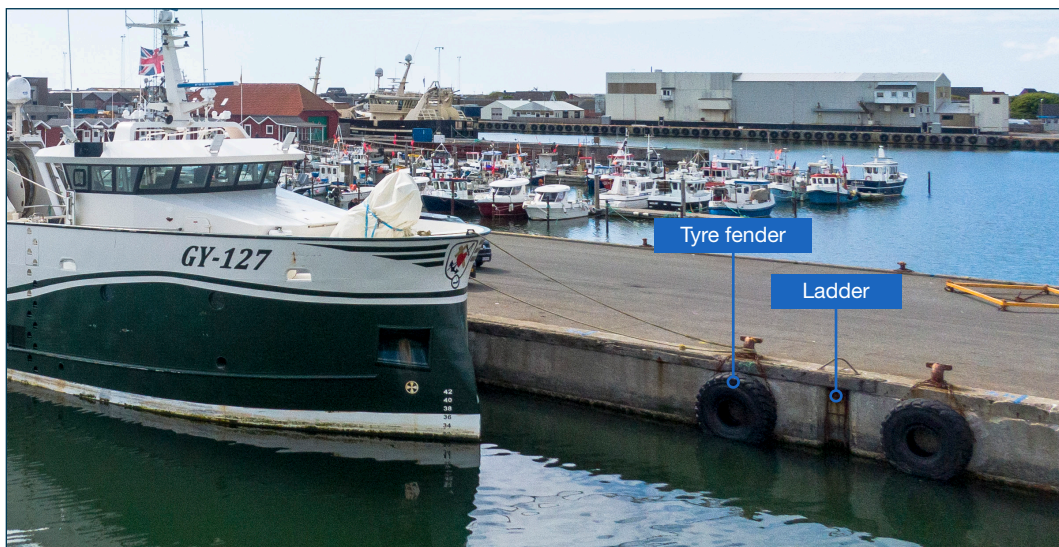
The bollards on the quay were fitted with tyre fenders of varying sizes fitted on the quay wall (Figure 8). The crew perceived the quay to be suitable, due to the number and width of fenders hanging on the quay wall. The fenders protecting HENDRIKA JACOBA from the quay wall had a width of 70 cm. Also, a fender could be used to close the gap between the door opening in the port ship side and the quay.

The quay wall had integrated ladders (Figure 8). At HENDRIKA JACOBA's berth, two ladders were fitted: one by the aft and one forward. Tyre fenders blocked the view and access from where the deckhand fell in the water to the integrated ladders (Figure 9).

Figure 8: Tyre fenders and integrated ladders on Tanker Quay.
Source: DMAIB

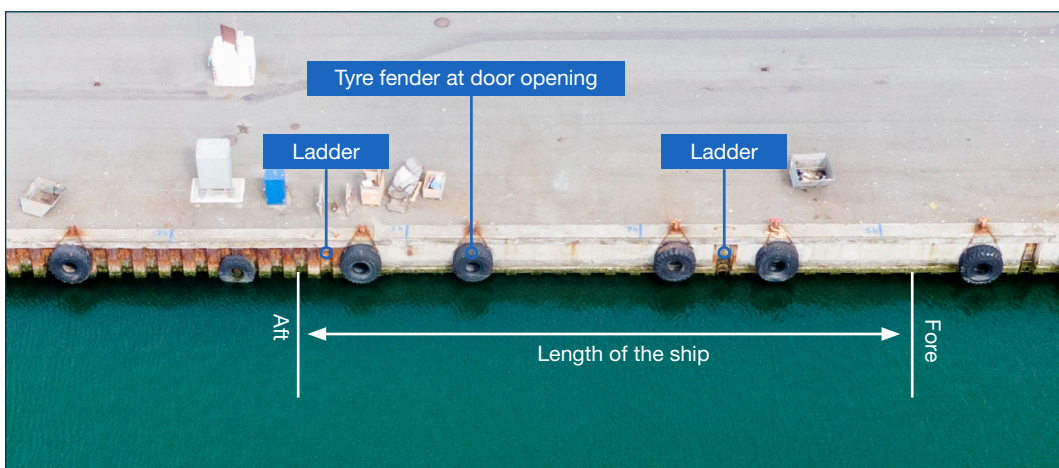
Figure 9: Location of ladders in relation to tyre fender by the door opening on HENDRIKA JACOBA.
Source: DMAIB

When falling into the water, the deckhand had little or no possibility of saving himself. During the fall, he hit his head hard against the deck at the door opening, which likely caused confusion or unconsciousness. Depending on the alcohol level in his blood at the time of the accident, he would be more susceptible to cold chock and hypothermia. If he were able to overcome this, the combination of the quay layout and the ship's position rendered him no possibility of coming out of the water. The door opening in the ship side and the quay side were too high up, and the ladders in the quay wall were out of sight and reach.

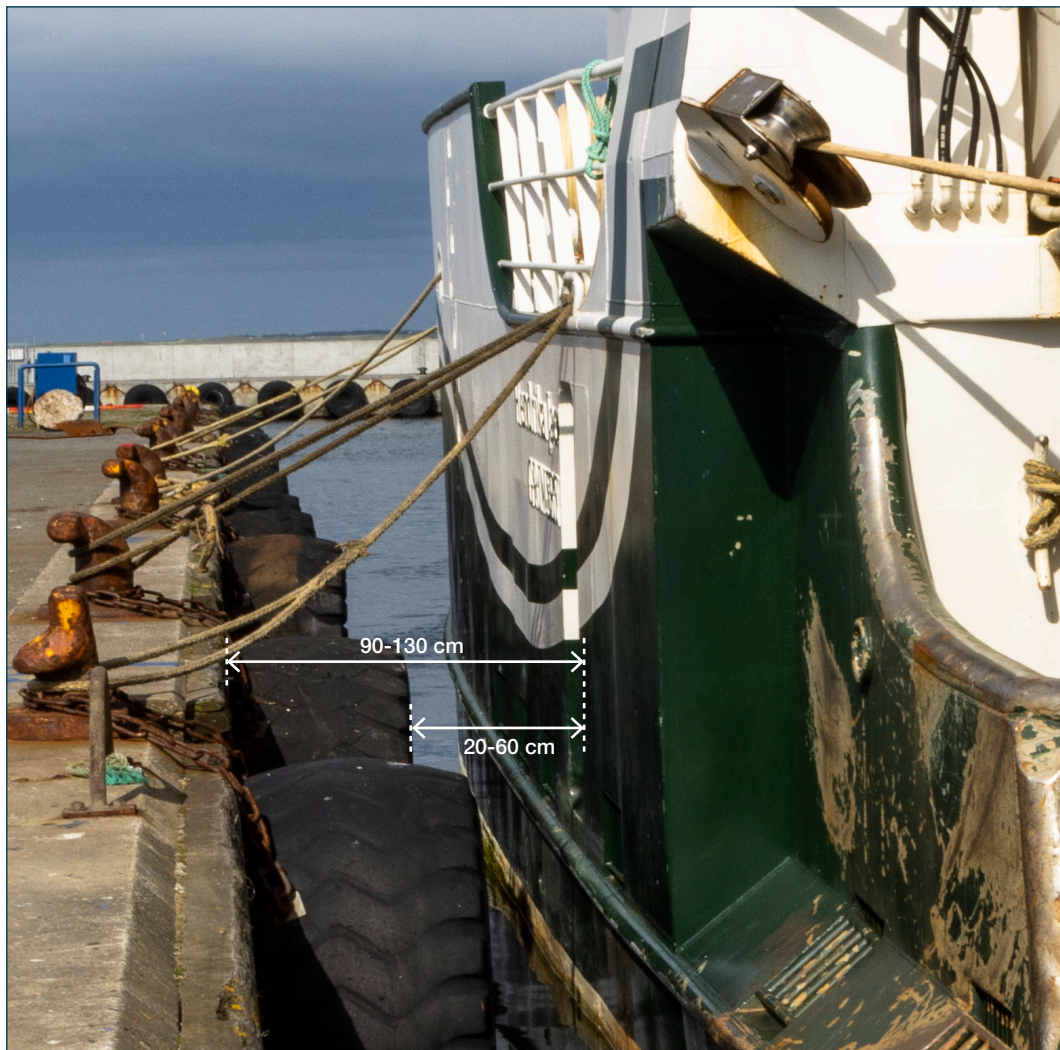
When the sea level decreased during the weekend, the mooring lines slackened, allowing the ship to shift in off-quay, fore and aft direction. On CCTV recordings it can be observed that the ship was moved by waves and swell, especially with the aft-part moving off-quay resulting in a gap between quay and ship. DMAIB measured the horizontal distance between the quay wall and the door opening in HENDRIKA JACOBA's ship side to vary between 90-130 cm (Figure 11).

Figure 11: Distance between quay and ship.
Source: DMAIB

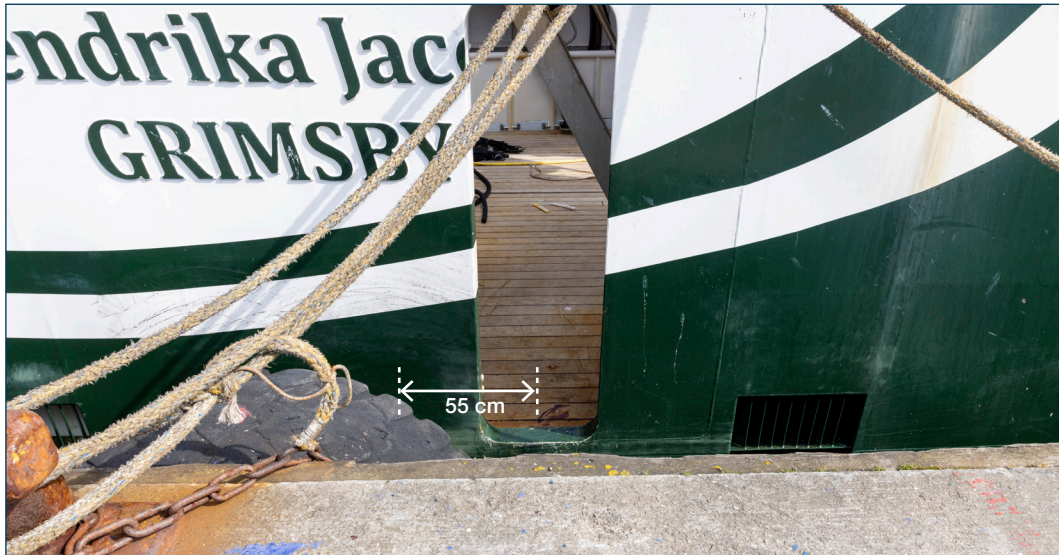
From the stepping point on the tyre fender to the middle of the door opening the distance was 55 cm (Figure 12), and the stepping point was 82 cm higher than the door opening (Figure 13). The distance from the sloping part of the tyre, where the crewmembers set off when stepping from fender to ship, varied between 100-115 cm on the day of investigation (Figure 14).

Figure 12: Horizontal offset between stepping point on tyre fender and door opening. 30 May 2022 at 1730.
Source: DMAIB

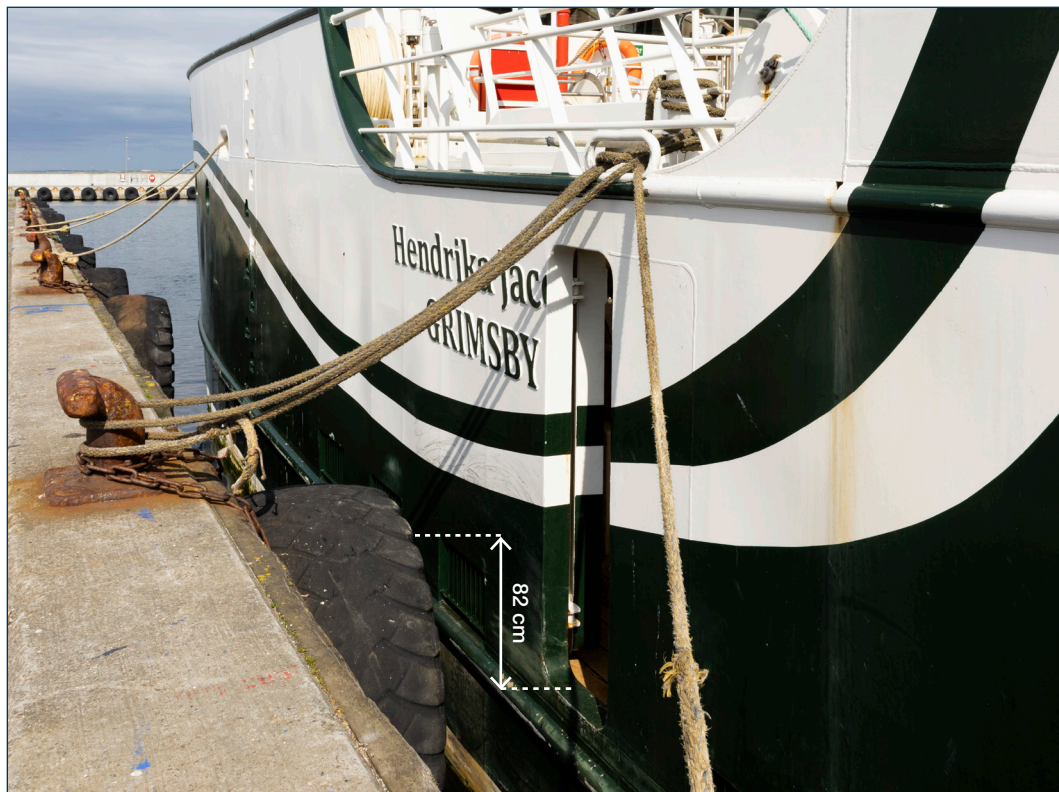
Figure 13: Difference in height between stepping point on tyre fender and door opening. 30 May 2022 at 1730.
Source: DMAIB

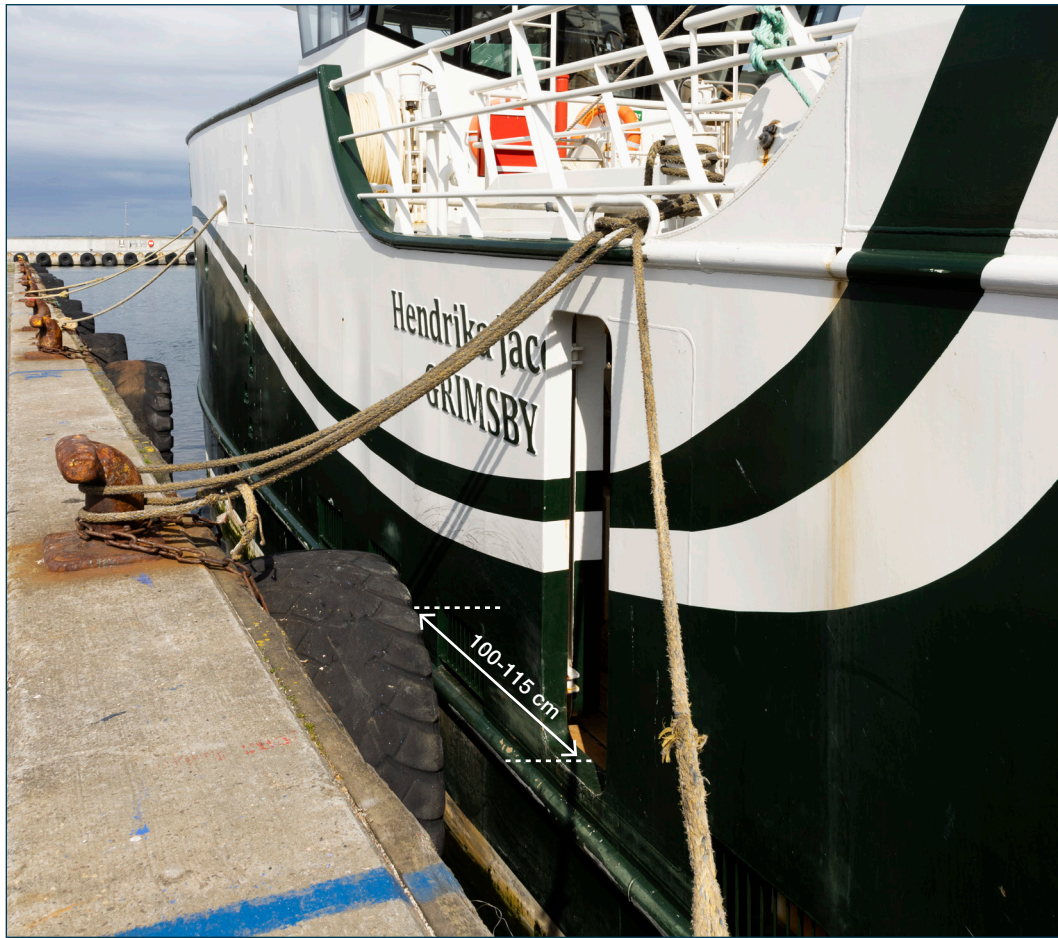
At the time of the accident, the sea level was 8 cm higher than at the time the measurements were made. This meant that the gap was a few centimetres shorter at the time of the accident.

Figure 14: Actual distance to straddle when stepping from tyre fender to door opening. 30 May 2022 at 1730.
Source: DMAIB.

During the investigation, the off-quay distance varied between 20-60 cm, but due to the offset and the height difference between fender and doorstep, the distance from the stepping point on the tyre fender to the door opening varied between 100-115 cm. At the time of the accident, the sea level was 8 cm higher than during the investigation, and swell could be observed on the CCTV. The distance to overcome during the time of accident was thus a few centimetres less than 100-115 cm, but the ship was lying more unsteadily along the quay.
