May 15, 2025

# Capsizing and Sinking of Towing Vessel

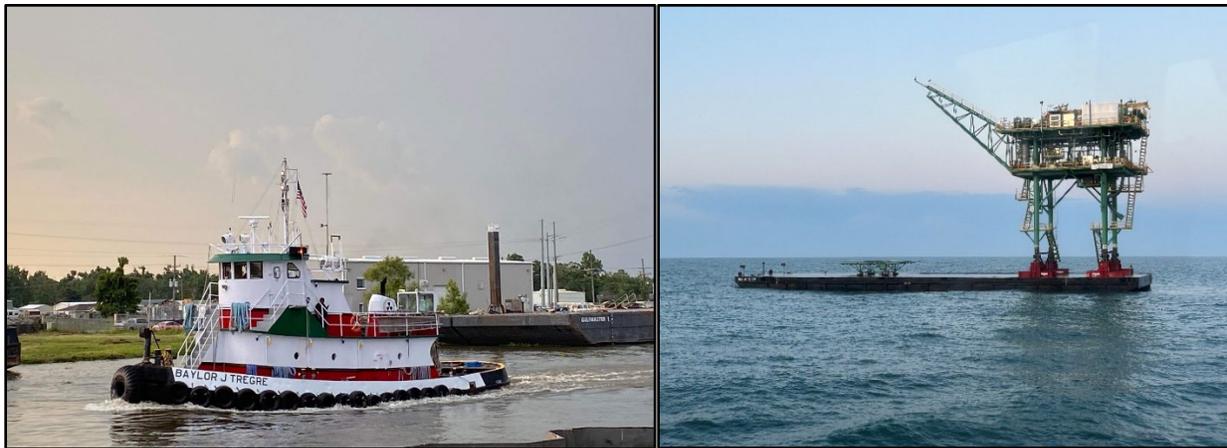
**Figure 1.** Left to right: Towing vessel *Baylor J. Tregre* at unknown date, and ocean barge *MARMAC 27* after the casualty. (Source: Trinity Towing LLC)

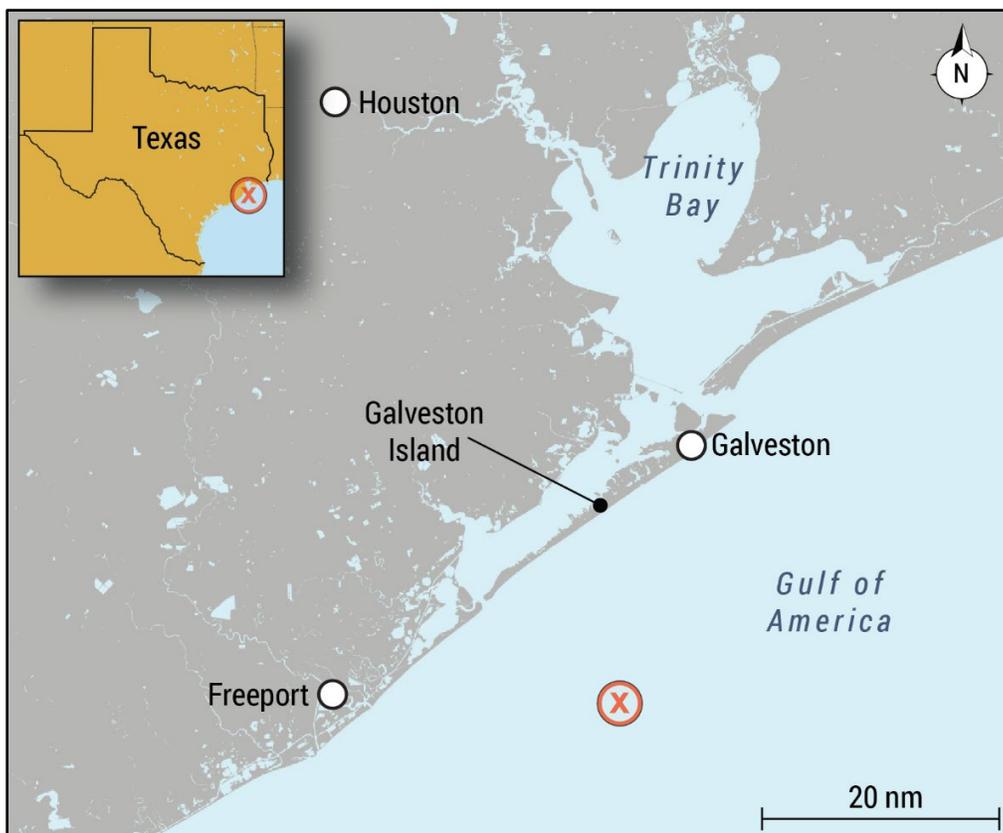
**Figure 2.** Area where the *Baylor J. Tregre* capsized and sank, as indicated by a circled X. (Background source: Google Maps)

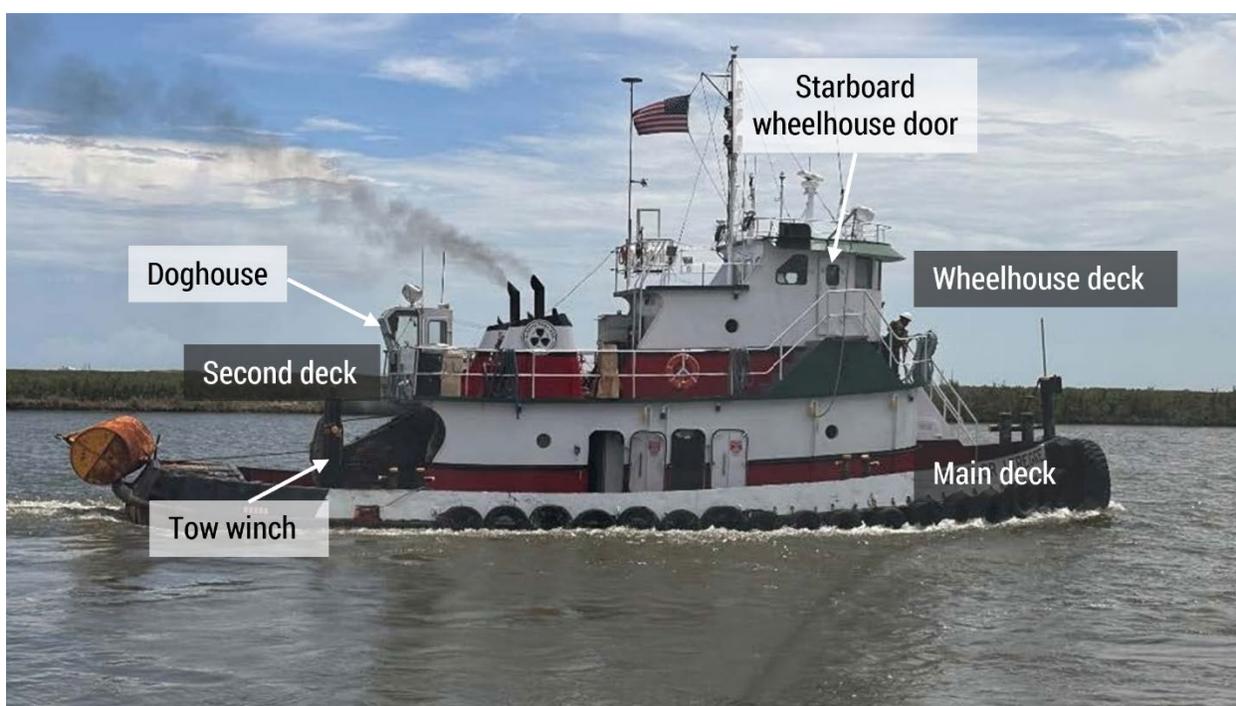
**Figure 4.** *Baylor J. Tregre* underway at unknown date before the casualty, with doghouse, tow winch, and starboard wheelhouse door labeled. (Source: Trinity Tugs LLC)

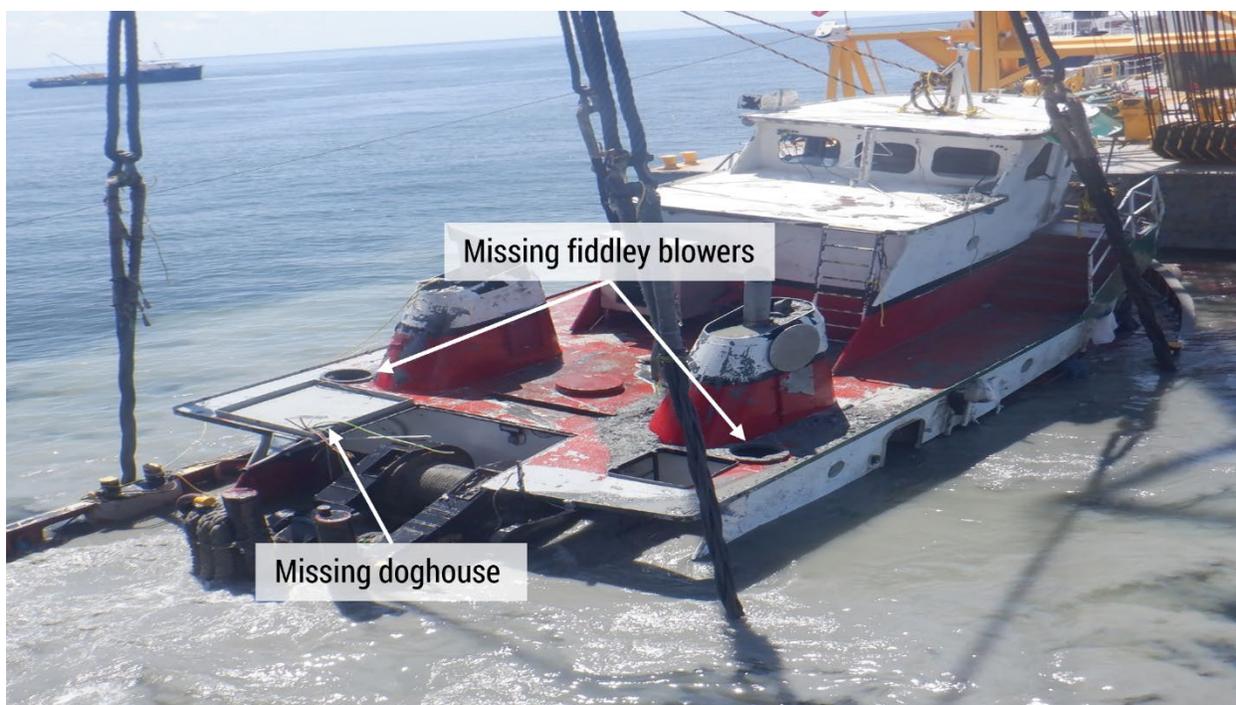
**Figure 6.** *Baylor J Tregre* after salvage, showing the doghouse and fiddley blowers missing. (Background source: Coast Guard)

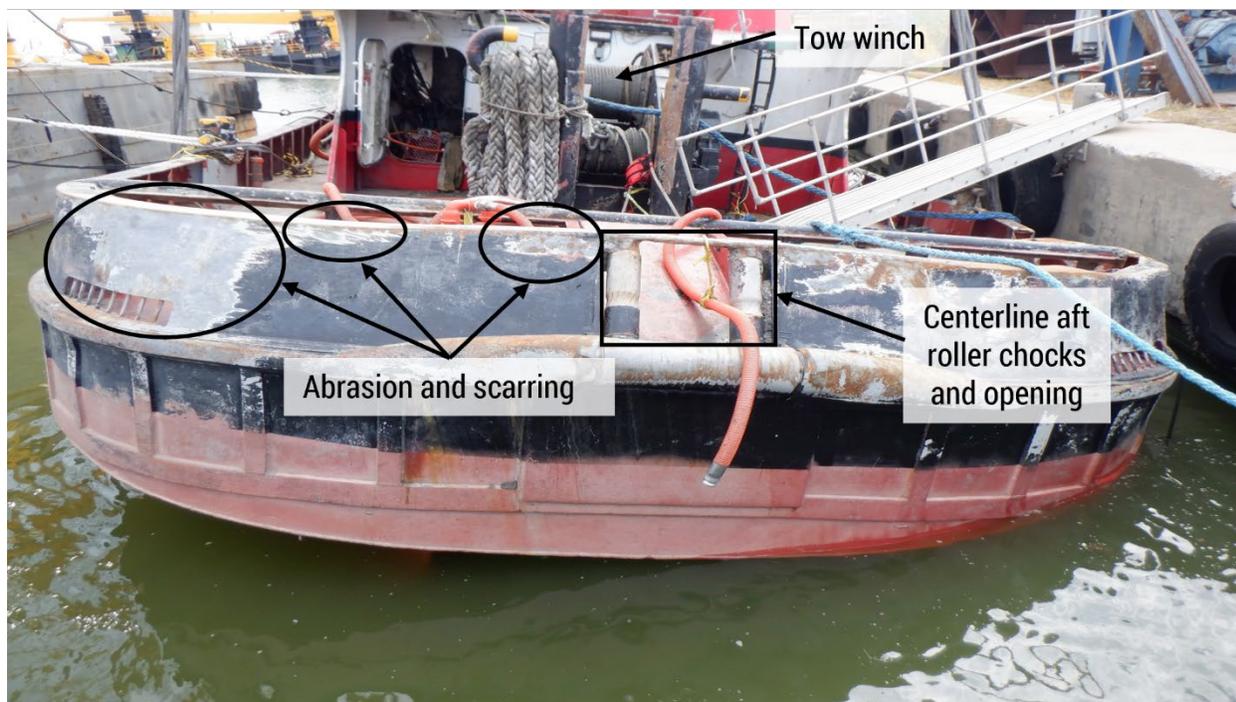
**Figure 7.** Abrasion markings and scarring (circled) on the vessel's port quarter bulwarks. (Background source: Coast Guard)
