Report on the investigation of the  
person overboard from the keelboat

***Limbtless***

resulting in one fatality

off Cowes, Isle of Wight, England

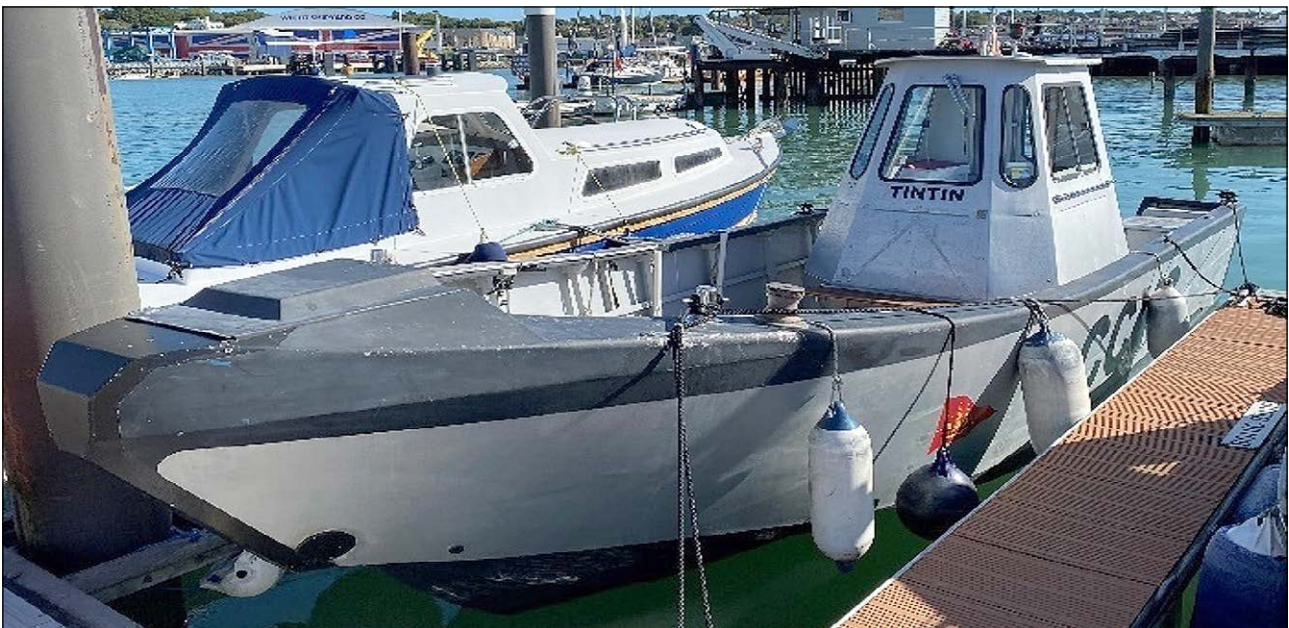
**Figure 6:** Cowes Corinthian Yacht Club committee boat

The Cowes Corinthian Yacht Club's aluminium committee boat (**Figure 6**) was used as a marker at one end of the start line. The race officer and three other people were on board. There was no means of recovering people from the water other than the derigged, stowed boarding ladder. The freeboard was 0.9m at the lowest point near the wheelhouse.
