April 4, 2025

MIR-25-14

## Contact of *Amber Brittany* Tow with Vane Dike

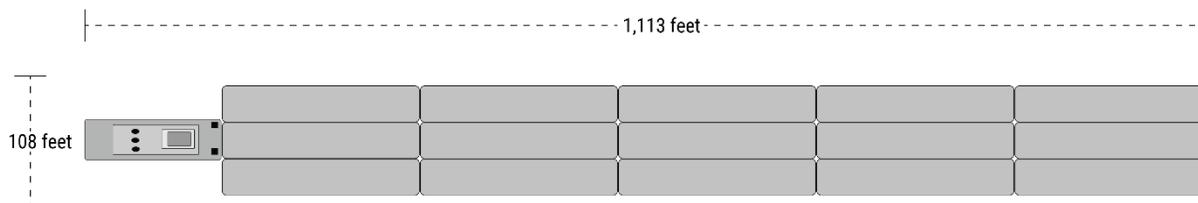
On March 5, 2024, at 1544, the *Amber Brittany* departed from the Sitran Coal Terminal at mile 818 on the Ohio River. The towing vessel was pushing 15 loaded coal barges and was transiting upbound for the Kentucky Utilities Ghent Generating Station near mile 535. Each barge measured 195 feet long by 36 feet wide, and the tow was arranged into three strings of five barges (see figure 3). The 4,600-hp tow had an overall length of 1,113 feet and an overall width of 108 feet.

**Figure 3.** *Amber Brittany* tow arrangement.

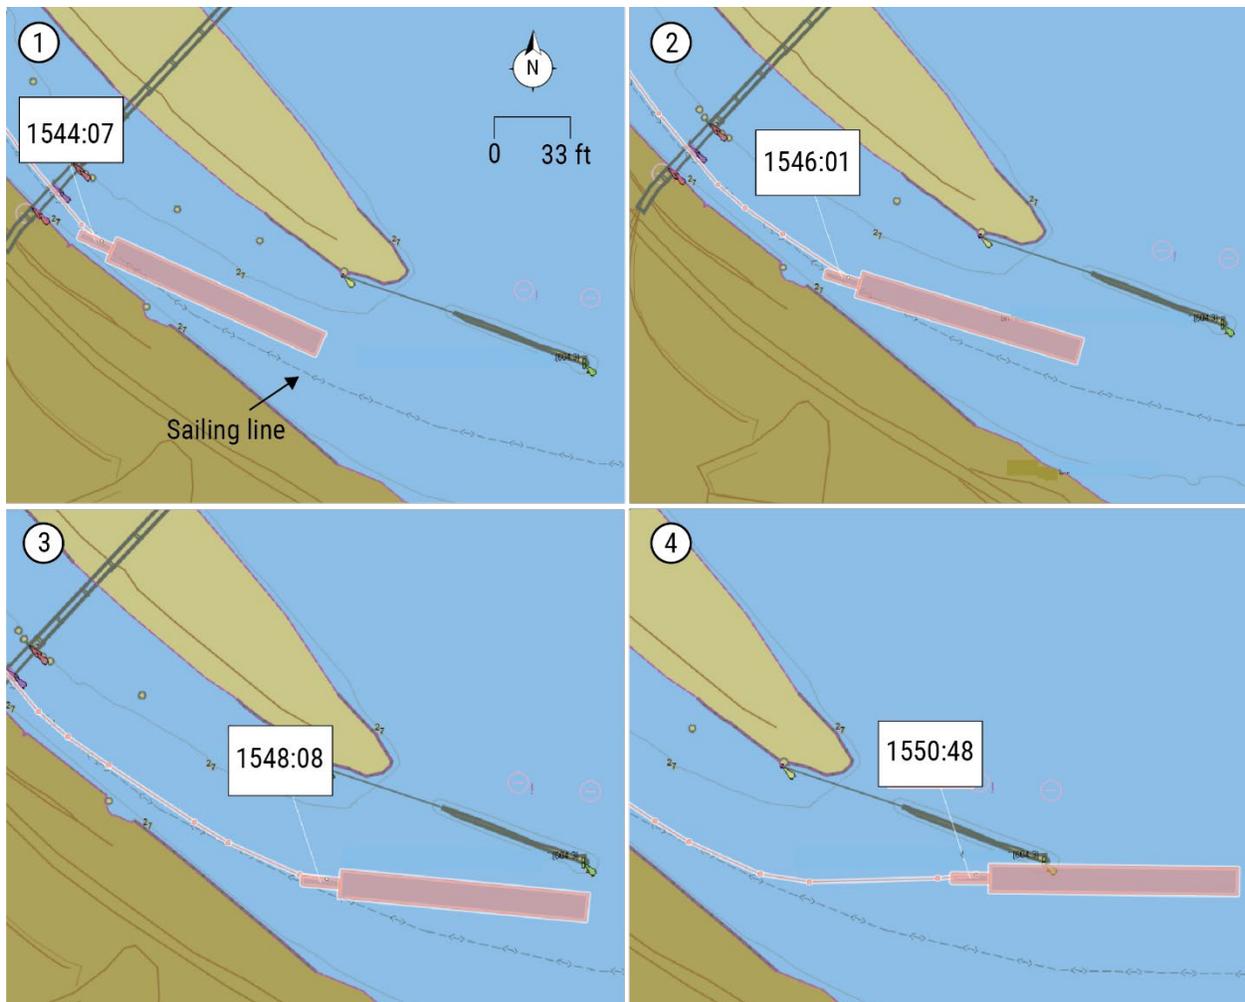
At 1550, the second barge in the port string of the *Amber Brittany* tow contacted the vane dike mooring cell (see figure 4). The tow broke apart immediately after contacting the mooring cell. The pilot sounded the general alarm, and the captain came to the wheelhouse shortly after the contact and assisted the pilot with communications, such as reporting the incident and coordinating with assist vessels.

**Figure 4.** The *Amber Brittany* tow as it came through the Louisville and Indiana Railroad Bridge, its heading altered to port, it was set off the sailing line, and it contacted the vane dike mooring cell.

As the *Amber Brittany* made its port turn while passing under the L&I Railroad Bridge, the head of the tow entered the area of the canal where the effect of an outdraft current, if present, would be expected. The dam gates were almost fully open, and river levels were rising, resulting in a strong outdraft, which pulled the head of the tow to port. The head of the tow continued to be drawn to port as the tow proceeded upriver. The pilot's attempt to counteract the force of the outdraft was ineffective, and the tow was set upon the vane dike mooring cell. In addition to the outdraft, there could have been a water surge in the Portland Channel—resulting from a lock filling that took place 8 minutes before the contact—that also impacted the *Amber Brittany* tow.

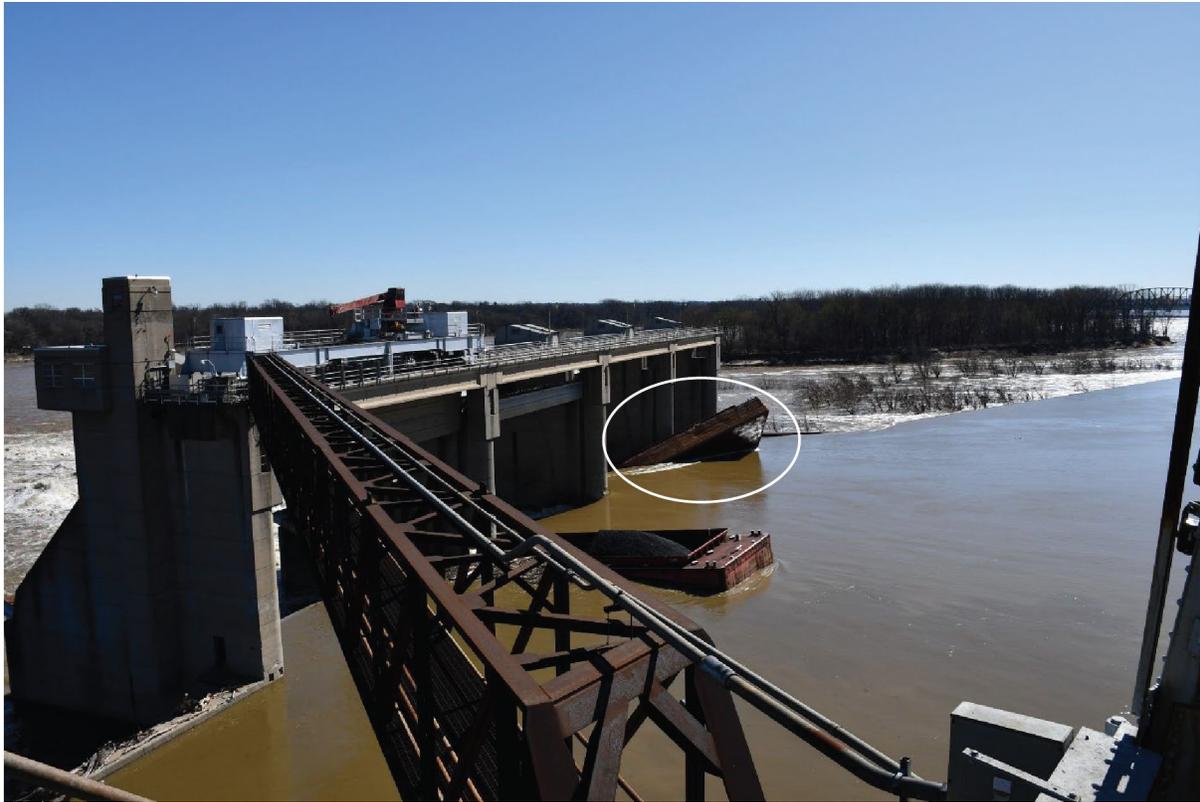
Ten of the 15 barges broke free from the tow and floated downstream on the north side of the vane dike. Eight of the barges that broke free struck and lodged alongside L&I Railroad Bridge pilings. The remaining two barges drifted downriver, eventually lodging in the McAlpine Lower Dam gates 2 and 3 (see figure 5).

**Figure 5.** Barges from the *Amber Brittany* tow lodged in the Lower McAlpine Dam Gate after the tow broke apart.

The *Amber Brittany* was not damaged from the contact. Five of the fifteen barges in the tow sustained damage. The two barges that became temporarily lodged in the lower dam gates were eventually forced through due to rising river conditions March 22 and April 4, respectively. One barge sank beneath the lower dam gates, and the other was recovered and pushed ashore. One barge was damaged but was repaired and placed back into service on March 12. Another barge partially sank along the bank near Shippingport Island but was repaired and refloated on March 14. One barge sank near an L&I Railroad Bridge pile but was repaired and refloated on March 22. Total damages to the barges, cargo, and dam gates were estimated at \$1.3 million.

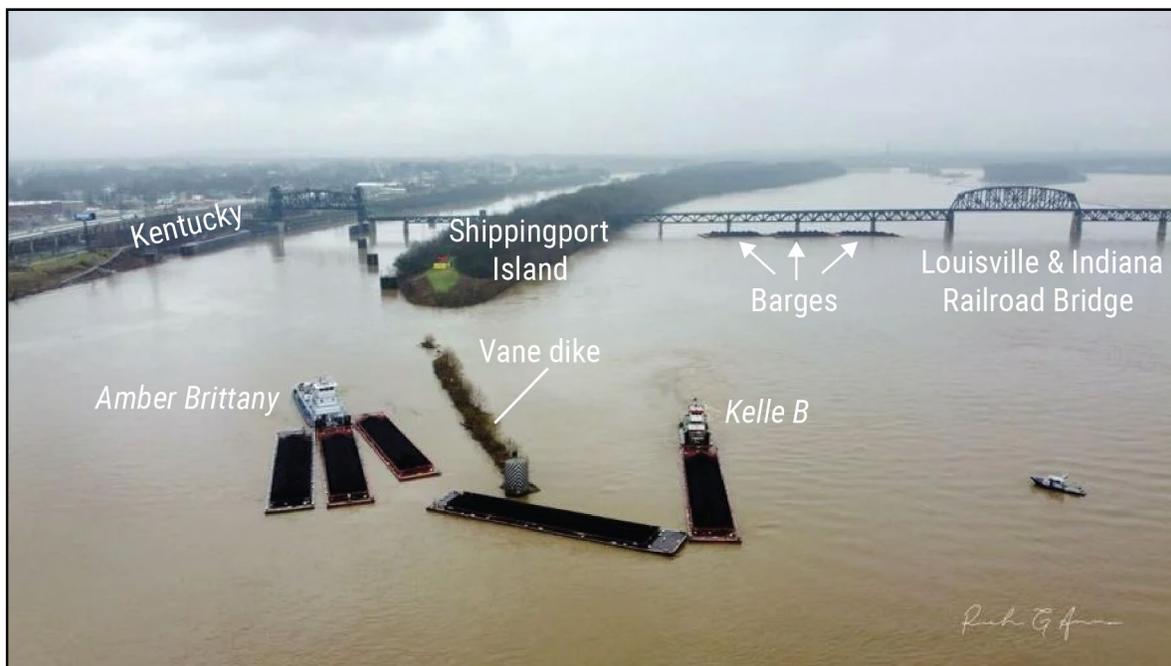
In the hours following the contact, vessels in the area attempted to recover the barges (see figure 6). During the recovery efforts, one barge sank near the bridge. Another barge began to take on water and was pushed to the bank of Shippingport Island.

**Figure 6.** The *Amber Brittany* with three barges, and tug *Kelle B* assisting, after the tow broke apart. Eight barges that broke free from the tow are lodged alongside the L&I Railroad Bridge pilings. (Background source: Rich Ammon)

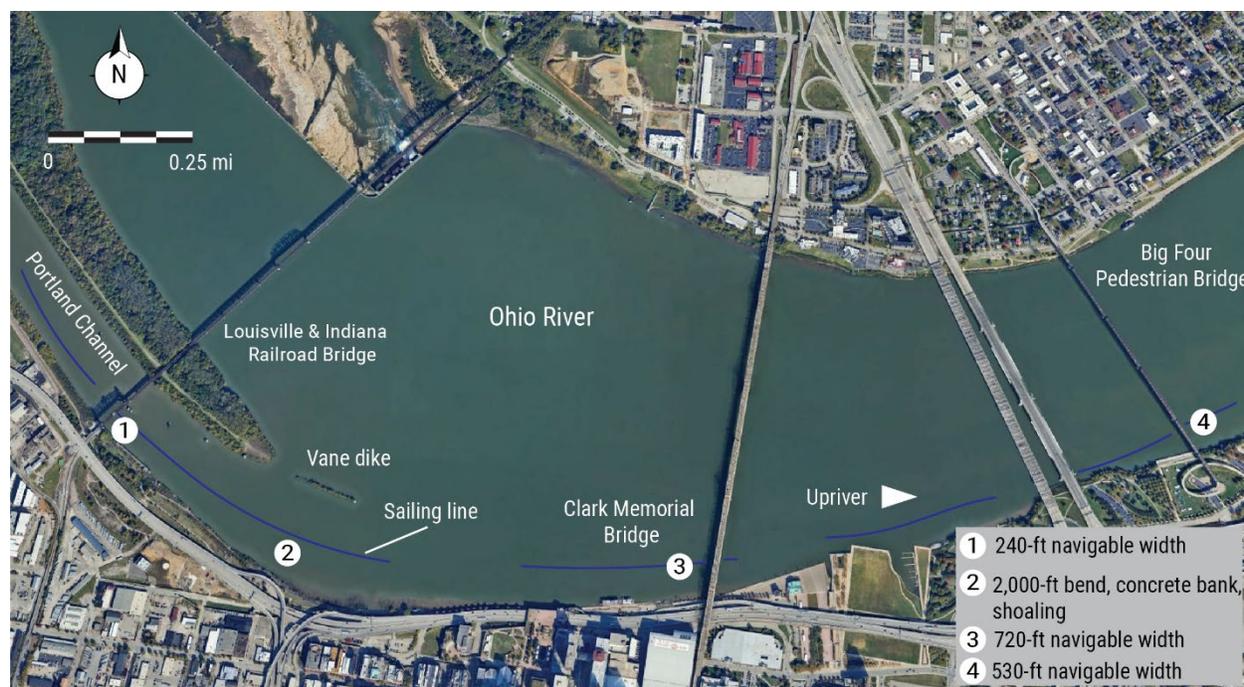
At the L&I Railroad Bridge near the upstream end of Shippingport Island, the navigable width of the Portland Channel reduces from about 555 feet to 240 feet beneath the bridge span. Transiting upriver, a bend in the river occurs just after the bridge and continues for about 2,000 feet. For the length of the bend, a concrete riverbank and naturally occurring shoaling extend along the Kentucky (left descending) bank. The vane dike is on the opposite side of the channel at the same location along the sailing line.

Upstream of the vane dike mooring cell, 0.6 miles along the sailing line, is another bridge, the George Rogers Clark Memorial Bridge, with a navigable span of 720 feet located along the Kentucky bank. This bridge is the first of four bridges within 0.7 miles along the sailing line. The most upstream of these bridges, the Big Four Pedestrian Bridge, has a navigable span of 530 feet (see figure 7).

**Figure 7.** Navigational considerations for a vessel transiting upriver on the portion of the Ohio River between the Louisville and Indiana Railroad Bridge and the Big Four Pedestrian Bridge. (Background source: Google Earth)

The upstream section of the McAlpine Locks and Dam is uniquely difficult to navigate, even under ideal circumstances. The geography of this stretch of the river (multiple bridges, bend in river, concrete riverbank, shoaling), combined with changing water currents near fixed hazards to navigation, creates an environment that is challenging. Prevalent outdraft currents near the vane dike and the location of the narrow span of the L&I Railroad Bridge are particular concerns when transiting the McAlpine Locks. There have been nine reported incidents in this area involving towing vessels since January 2020, totaling over \$2.7 million in property damage. Of note, the NTSB investigated the contact of the *Queen City* tow with the vane dike in March 2023 and determined that the probable cause was the pilot not effectively compensating for the strong outdraft while navigating toward the lock channel entrance during a period of high-flow conditions.<sup>9</sup>

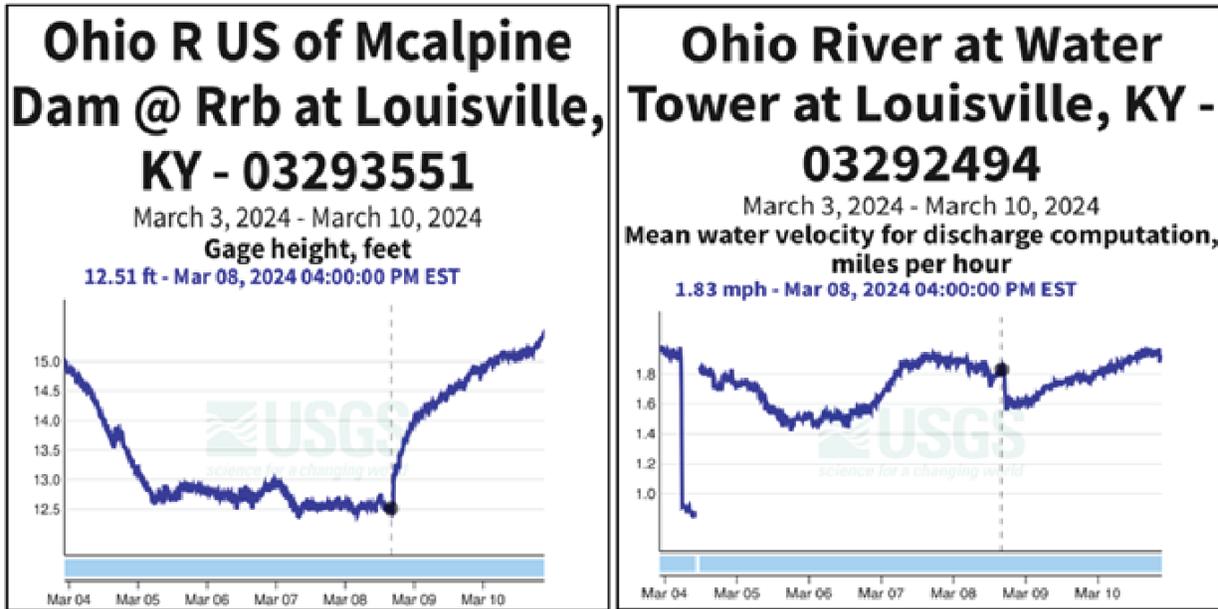
The United States Geological Survey publishes real time river data available to mariners, including river gage, precipitation, and mean water velocity (see figure 8). Mariners use this information to plan for water conditions while transiting the Ohio River. A river gage sensor was located near the L&I Railroad Bridge on the northeast side of Shippingport Island. There was no water velocity sensor in the immediate vicinity of the vane dike or Portland Channel entrance. There was a sensor beneath the locks and dam that measured water discharge in cubic feet per second. The Coast Guard is currently reviewing a May 2022 proposal to install a high-frequency radar system near the approach to the McAlpine Locks and Dam to monitor water-surface velocities in real time.

**Figure 8.** *Left to right:* Gage height measured near Shippingport Island and water velocity at the Water Tower station, 3.6 miles upstream from the vane dike. (Source: United States Geological Survey)

Changing river levels, sediment deposits, lock fillings, and dam gate openings all influence the hydrodynamic forces in the area of the Portland Channel. The speed, direction, and force of the water currents at the channel entrance are difficult to anticipate. The nearest water velocity meter is located more than 3 miles upriver from the McAlpine Locks and Dam and does not provide detailed information that would
