# THE ATLANTIC EMPRESS SINKING—A LARGE SPILL WITHOUT ENVIRONMENTAL DISASTER

Stuart A. Horn and Captain Phillip Neal  
Mobil Oil Corporation  
150 East 42nd Street  
New York, N.Y. 10017

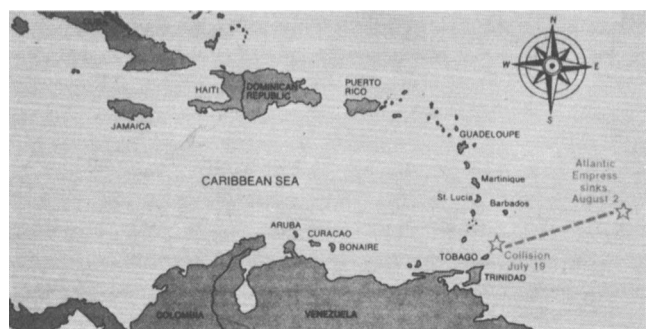
the Caribbean Sea in a position roughly 20 miles (mi) northeast of the island of Tobago (Figure 1). First reports indicated that the *Atlantic Empress*, 288,000 dwt, was carrying 276,000 tons of light crude oil bound for Mobil's Beaumont refinery, had 26 seamen missing and presumed dead, and was drifting, on fire, and surrounded by a large slick. The *Aegean Captain*, 207,000 dwt, was also reportedly seriously damaged, on fire, and had at least one casualty. The total capacity of both ships, 3.5 million bbl of crude oil, could possibly be lost in the immediate future. No additional reconnaissance was possible during the nighttime hours.

Figure 1. Collision site and surrounding areas.

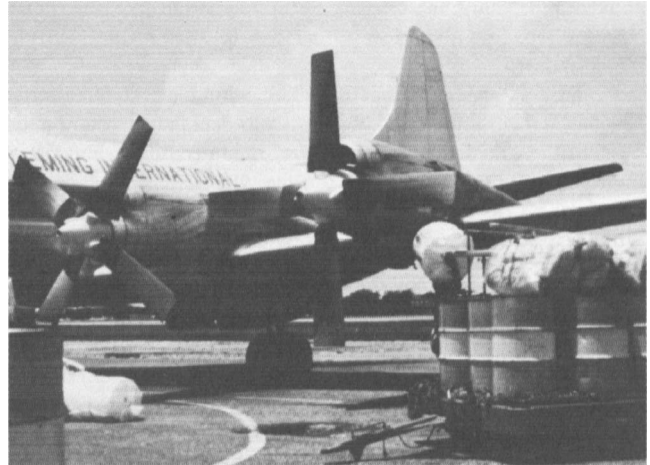
Four flights of equipment, including dispersants, spraying equipment, communications packages, sorbents, and firefighting equipment had arrived at Port of Spain (Figure 6) and were being delivered to sites where they might be required. The Mobil tankers *Tasso* and *Vigilant* had been dispatched to stand by for lightering purposes (Figure 7). Media interest continued high this day.

Figure 6. Cargo plane being offloaded.

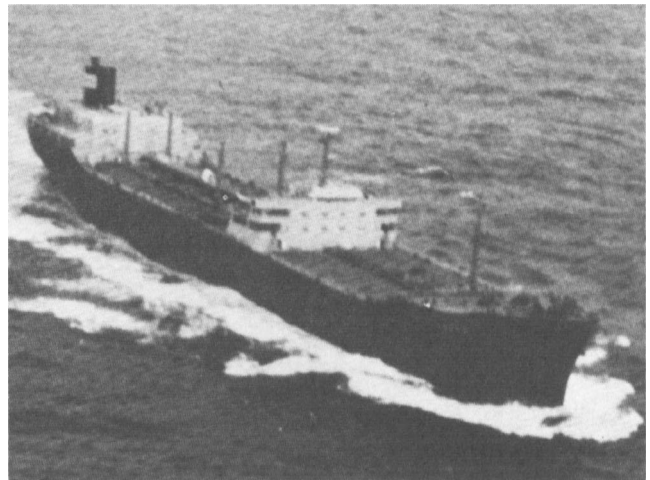
Figure 7. Mobil tanker *Tasso*.

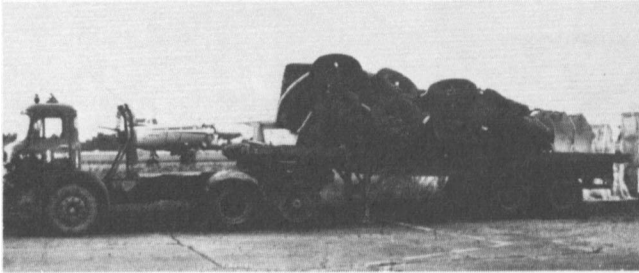
Figure 8. Lightering equipment.

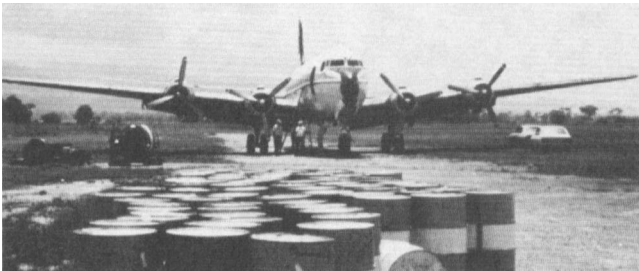
Figure 9. DC-4 spray aircraft.

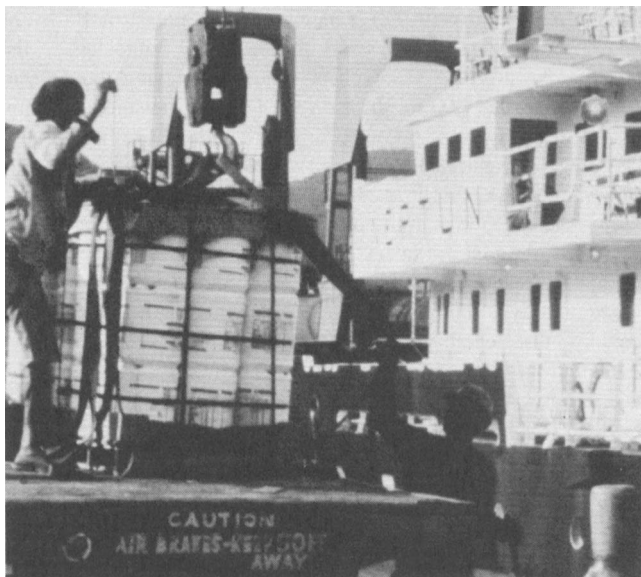
**Friday, July 27, and Saturday, July 28.** In anticipation of a major firefighting effort on July 29, activities centered upon the arrival of additional chemicals and equipment, moving these cargoes to the docks and loading them on tugs (Figure 10). One

Figure 10. Firefighting chemicals being loaded on tug.
