Report on the investigation of
the capsize and foundering of the fishing vessel

***Njord* (SH 90)**

resulting in one fatality

on 6 March 2022

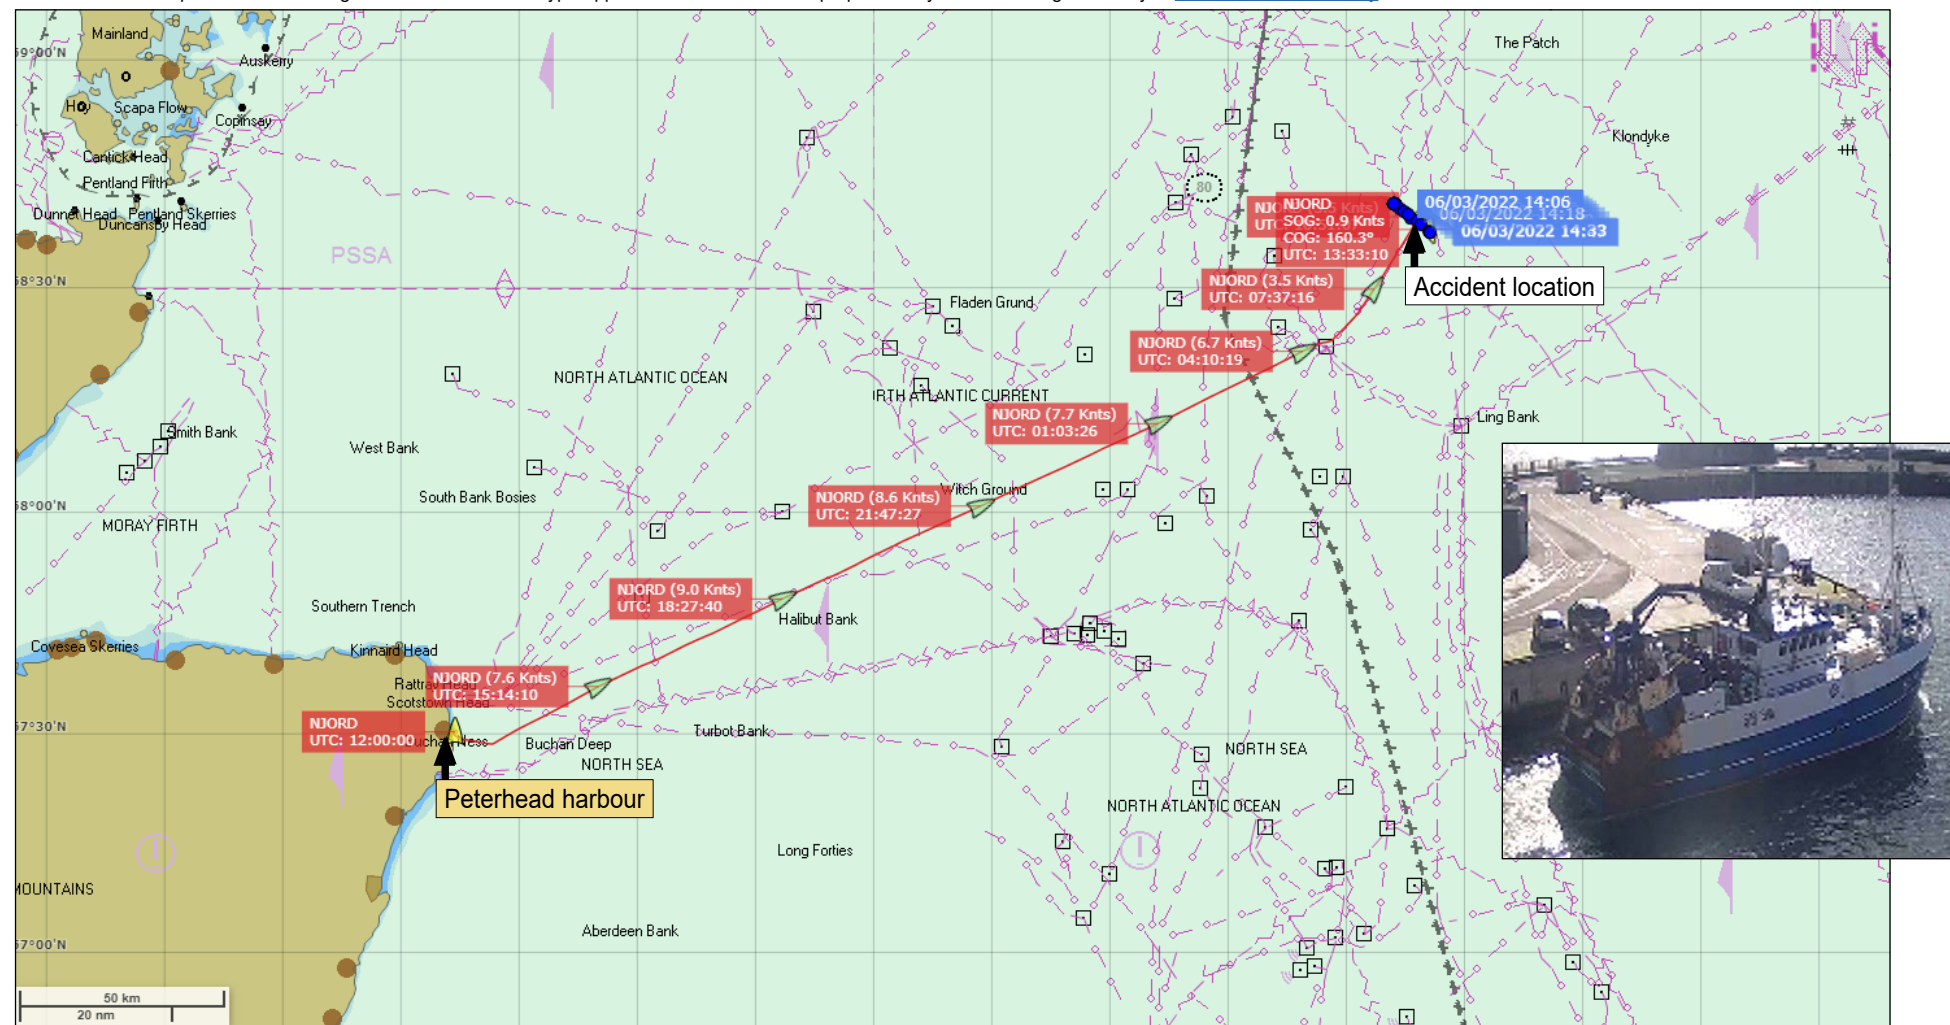
Figure 1: Track of *Njord* and (inset) CCTV still, showing the vessel leaving port at 1222 on 5 March 2022

At 1222 on 5 March 2022, the 26.56m stern trawler *Njord* departed Peterhead harbour, Scotland to head for fishing grounds in the Norway sector of the North Sea (**Figure 1**). On board were the skipper/owner (skipper), a relief skipper and six deckhands.

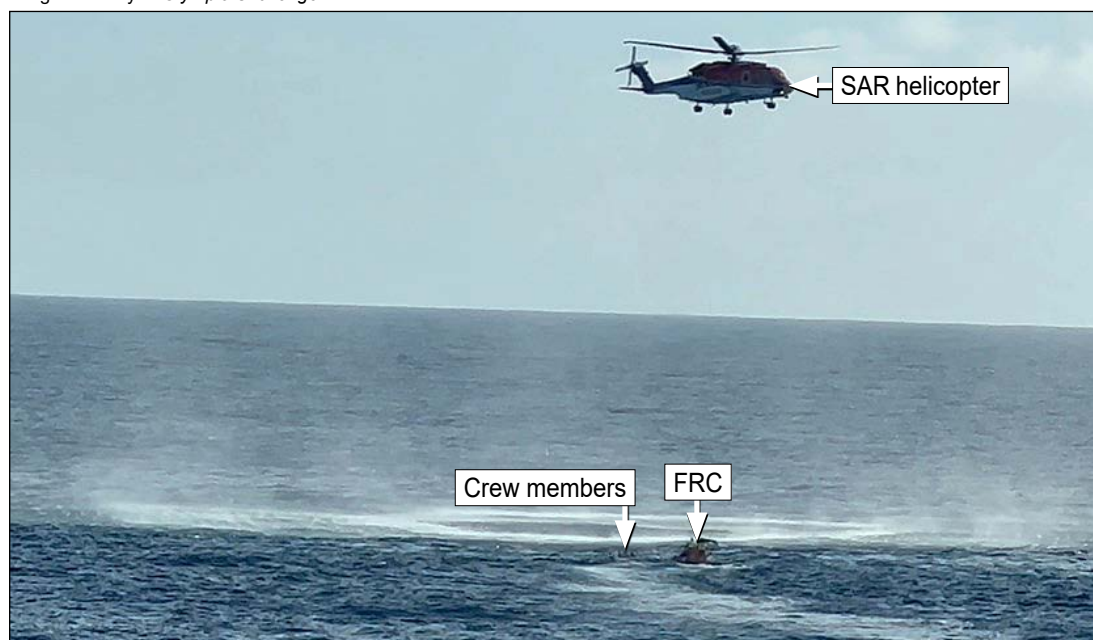
Figure 5: SAR helicopter and *Olympic Challenger* FRC at the scene

The SAR helicopter contacted *Olympic Challenger* and requested that its FRC rescue the remaining five crew members from the water. By 1441, the FRC had recovered the remaining five crew members and was heading back to *Olympic Challenger*. The SAR helicopter remained at the scene until all five crew members were safely on board the FRC (**Figure 5**) and then departed.

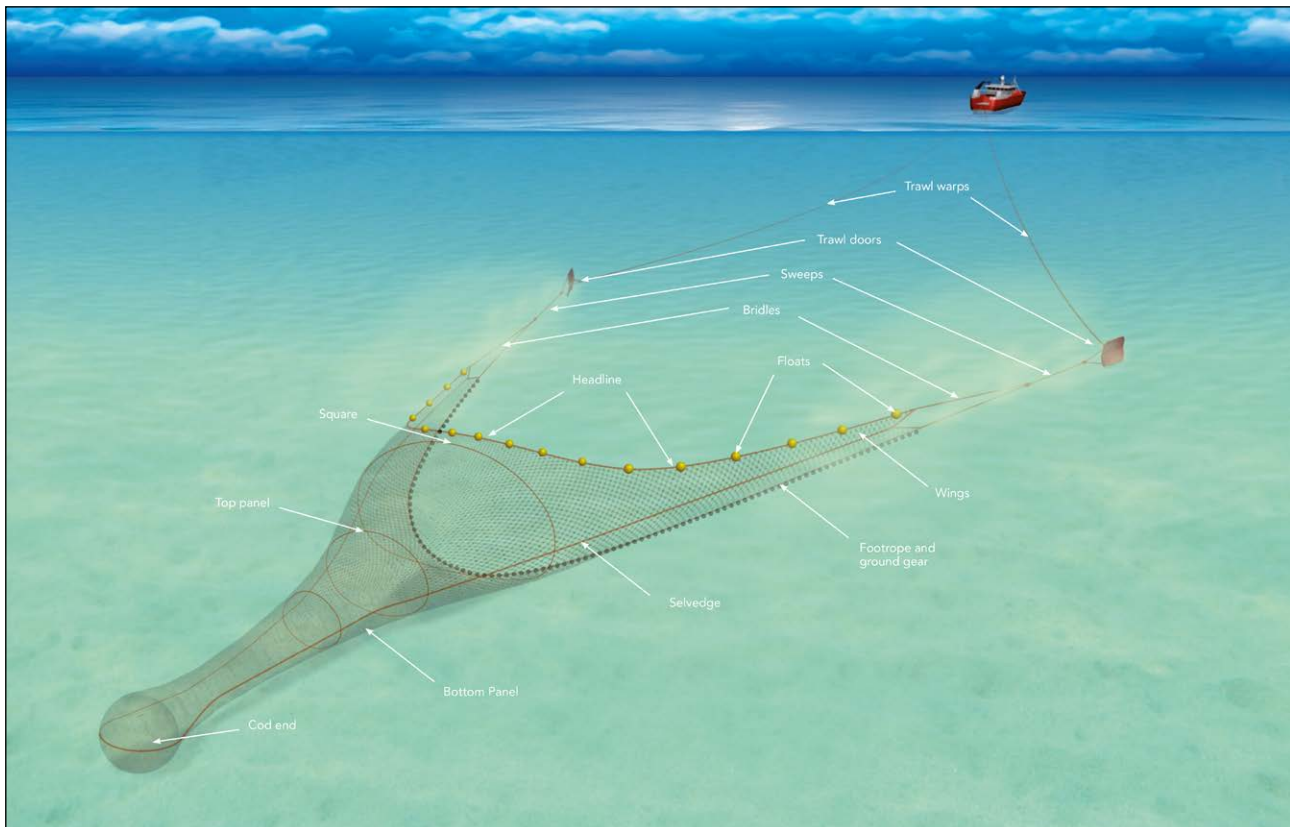
Figure 7: Single net trawl method

Njord was designed as a stern trawler to fish on the seabed using a single net shot from the stern. Trawl doors were used to keep the mouth of the net open (**Figure 7**). On 9 June 2021, shortly after purchasing *Njord*, the skipper made several modifications to the vessel.

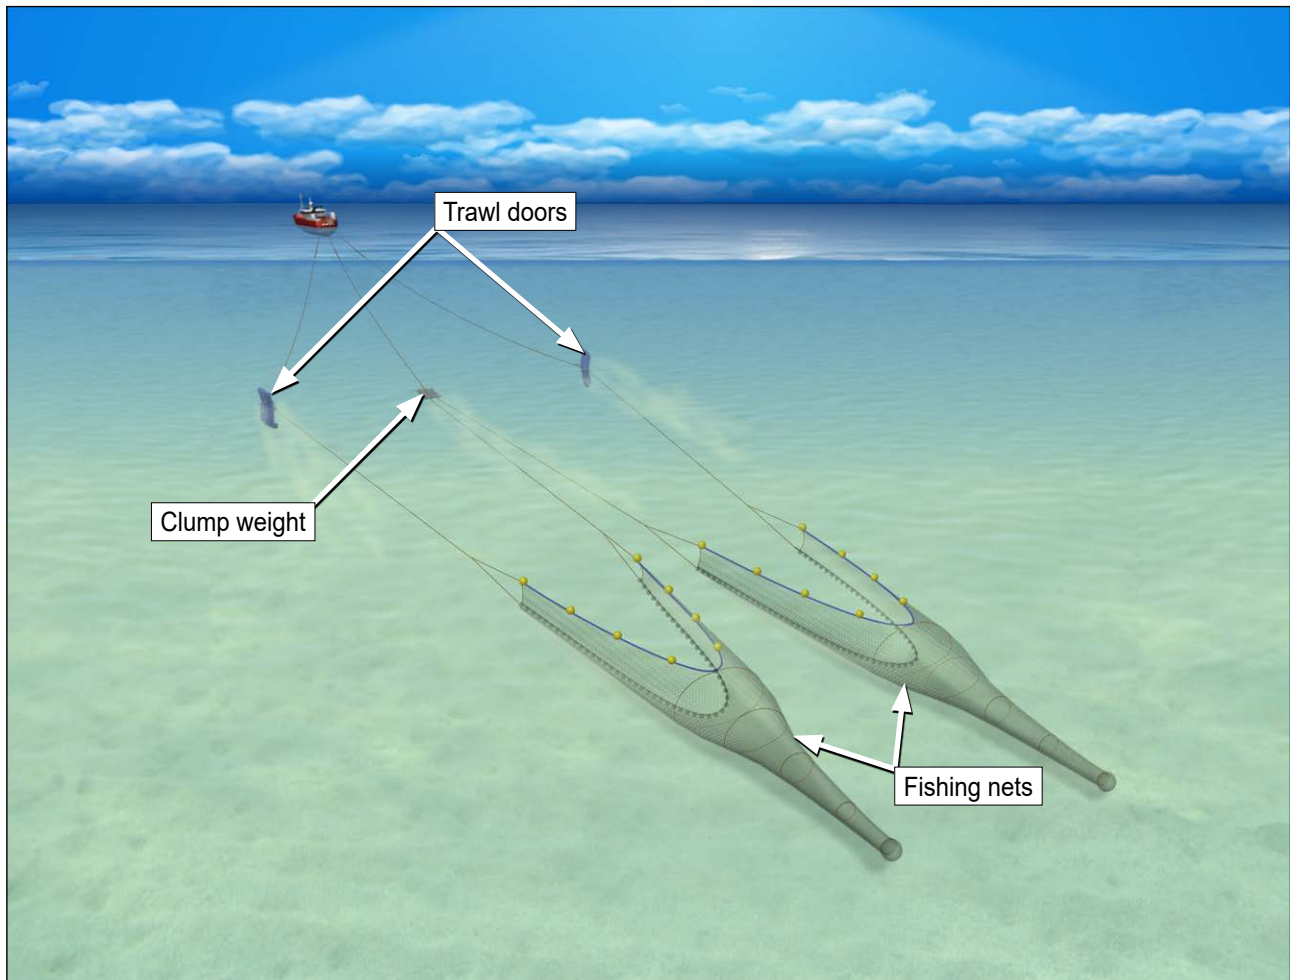
Figure 9: Twin net trawl method

The reason for these modifications was to enable *Njord* to fish for prawns using twin nets (**Figure 9**), which were towed across the seabed with a clump weight rigged between them to keep the nets in contact with the seabed.
