Failure of chain link investigation on board *Cornishman* report no. 2021-5360

FAILURE OF CHAIN LINK ONBOARD CORNISHMAN

Failure investigation

Report No.: 2021-5360, Rev. 0

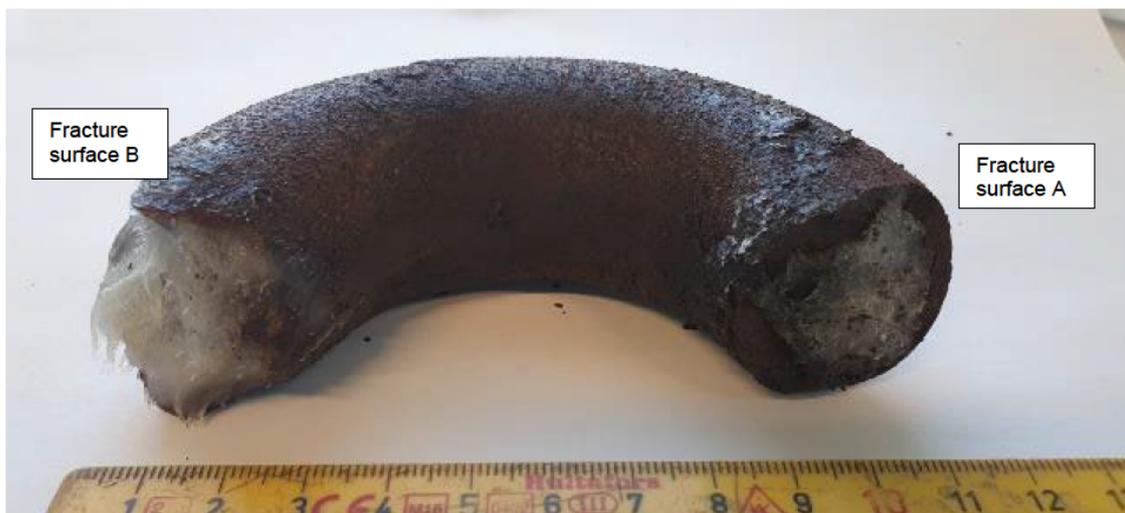
Figure 4-4 Sample BJC/4, part of fractured link, portside chain. The letters A and B is used further for identification of the two fracture surfaces.

Part BJC/4	Part of fractured link, portside chain	6	See Paragraph 5.1 for visual examination
Part BJC/5	Part of portside chain, towards trawl	7	<ul style="list-style-type: none"> - No crack-like indications from visual inspection - Uneven surface in connection to the weld - Wear mark in both ends of the link. Against link 8, there are wear marks towards both shoulders. - See Figure 4-27

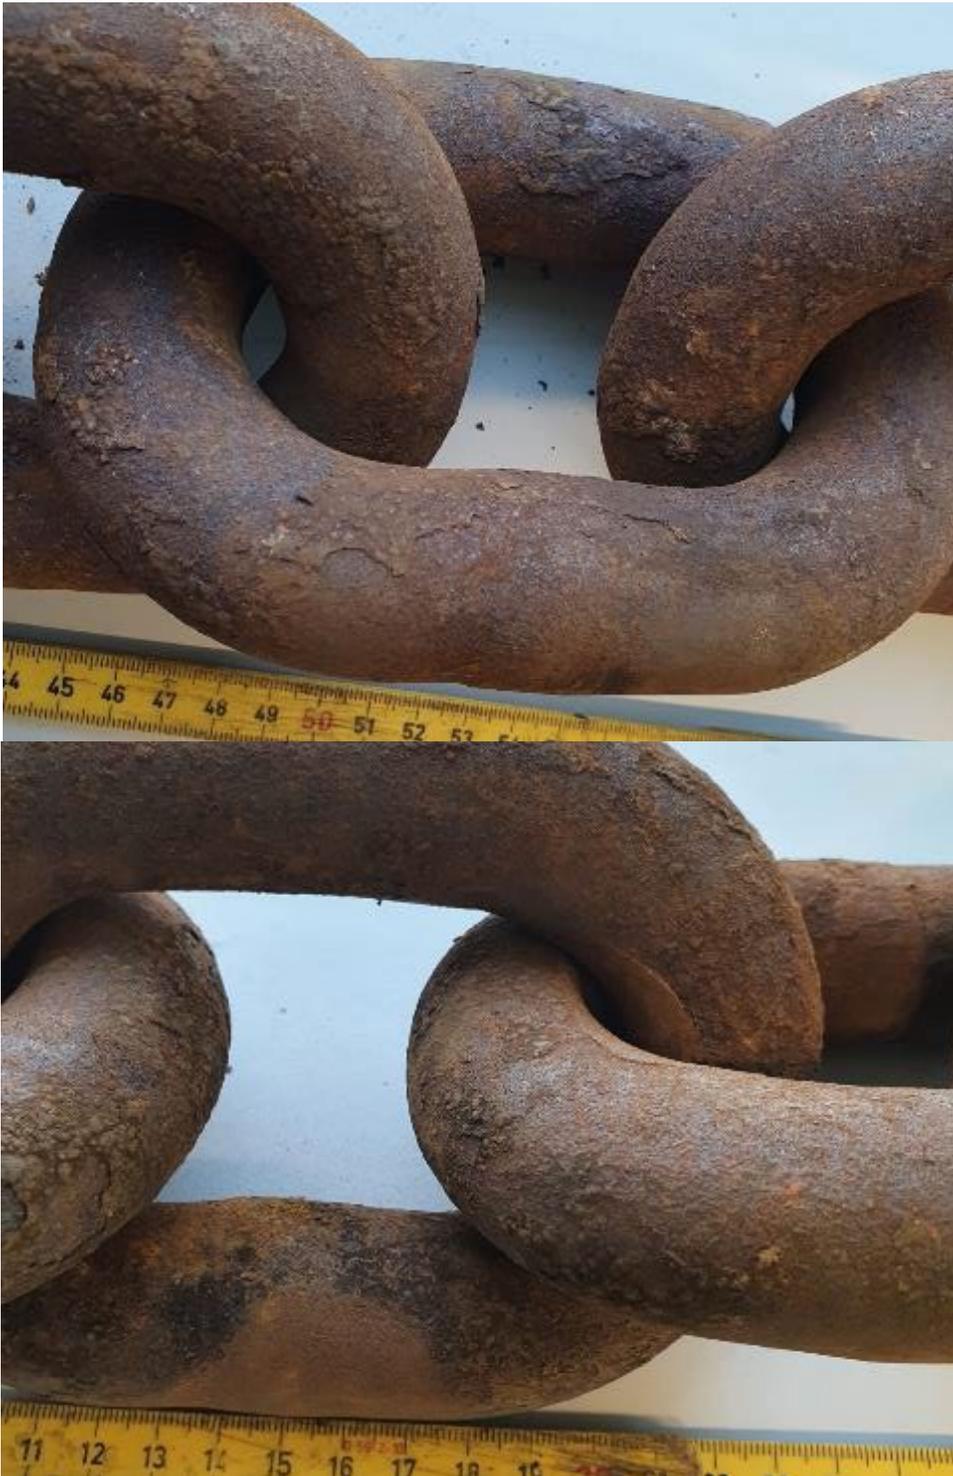
Typical appearance of chain surfaces prior to any cleaning is shown in Figure 4-8. Only a limited visual examination was performed prior to cleaning, as the large amount of corrosion products on the link surfaces was considered to obscure most relevant observations.

Figure 4-8 Typical appearance of chain surface prior to cleaning. Upper: BJC/3; Lower: BJC/5.

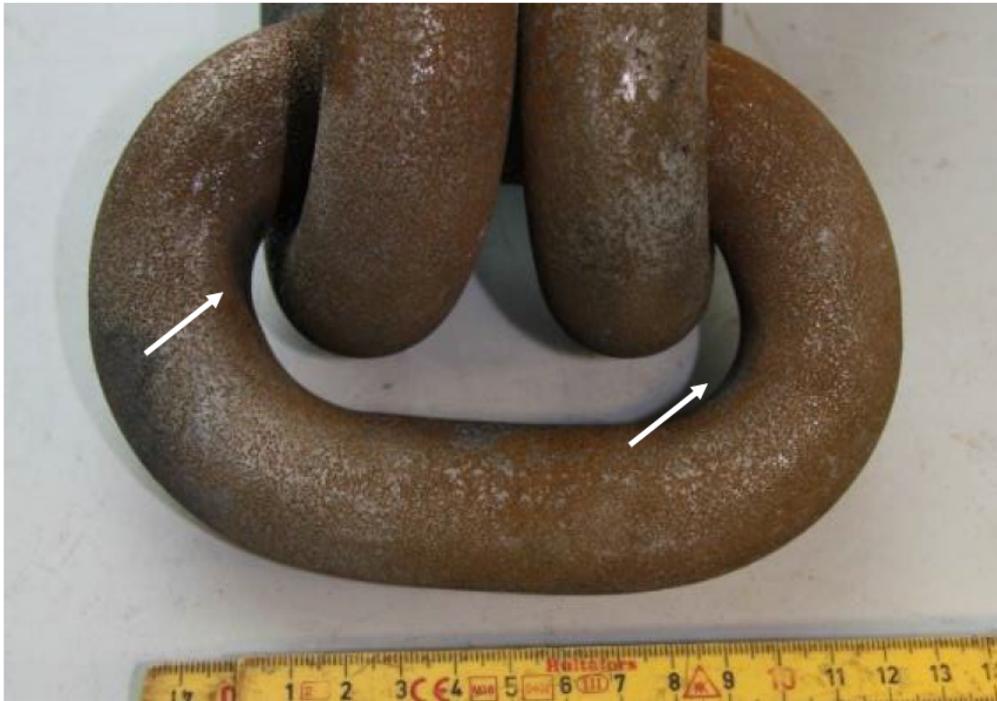
Part ID	Description	Link no.	Observations
Part BJC/1	Part of portside chain, connected to steel wire rope	1	<ul style="list-style-type: none"> - Crack-like indications in both ends of the link - The larger crack extends approximately 180° around the chain link circumference. - Uneven surface in connection to the weld - No significant wear/deformation marks - See Figure 4-11
		2	<ul style="list-style-type: none"> - No crack-like indications from visual inspection - Uneven surface in connection to the weld - No significant wear/deformation marks. - See Figure 4-12
		3	<ul style="list-style-type: none"> - No crack-like indications from visual inspection - Uneven surface in connection to the weld - No significant wear/deformation marks. - See Figure 4-13
		4	<ul style="list-style-type: none"> - No crack-like indications from visual inspection - Uneven surface in connection to the weld - Some increased interlink wear towards link 5 is seen - See Figure 4-14

Figure 4-14 BJC/1 – Link 4 after cleaning. No crack-like indications. Some interlink wear seen, indicated by arrows.

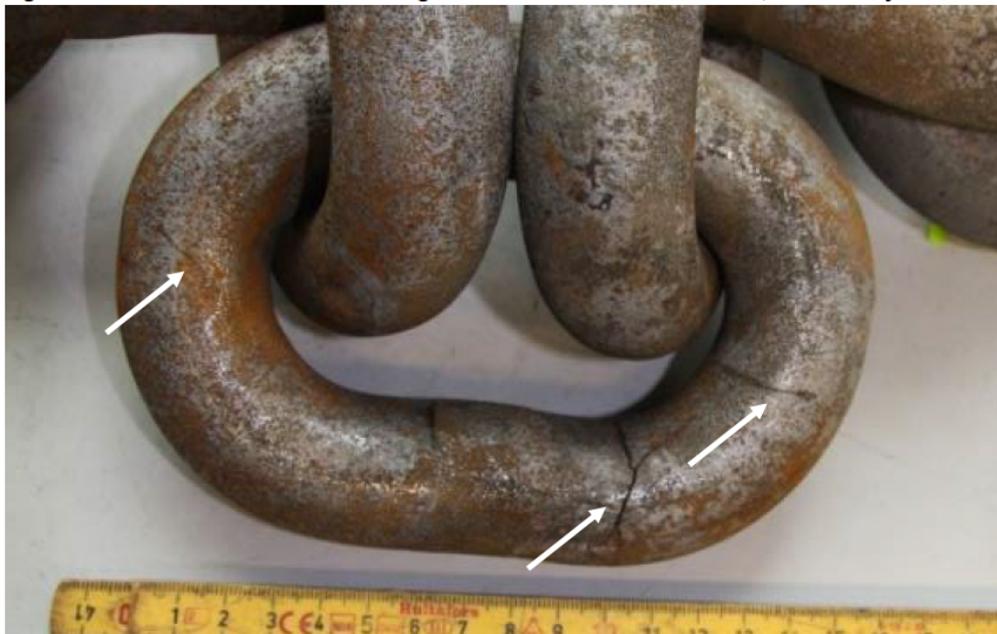
3	<ul style="list-style-type: none"> - Crack-like indications in both ends of the link. - The larger crack extends approximately 270° around the chain link circumference. - Uneven surface in connection to the weld - No significant wear/deformation marks. - See Figure 4-19
		4	<ul style="list-style-type: none"> - Crack-like indications in both ends of the link, also one crack close to the weld. - The larger crack extends approximately 360° around the chain link circumference. - Uneven surface in connection to the weld - No significant wear/deformation marks. - See Figure 4-20
		5	<ul style="list-style-type: none"> - Crack-like indication towards link 4 - The larger crack extends approximately 180° around the chain link circumference. - Uneven surface in connection to the weld - No significant wear/deformation marks. - See Figure 4-21
		6	<ul style="list-style-type: none"> - No crack-like indications from visual inspection - Uneven surface in connection to the weld - No significant wear/deformation marks, however an asymmetric geometry is seen. - See Figure 4-22

Figure 4-20 BJC/3 – Link 4 after cleaning. Crack-like indications are seen in both ends, as well as close to the weld, as indicated by arrows.

Test id.:	Obtained breaking load	Location of fracture
Part BJC/3, starboard used chain (including several links with crack-like indications)	223 kN	Three fractures of link 4
Part BJC/2, unused reference link	994 kN	Crown of middle link
Requirements according to relevant standards		
NS-EN ISO 818-2 /1/	1290 kN	-
ASTM A391 /2/	1288 kN	-
Certificate		
Result	1480 kN	-
Requirement	1290 kN	-

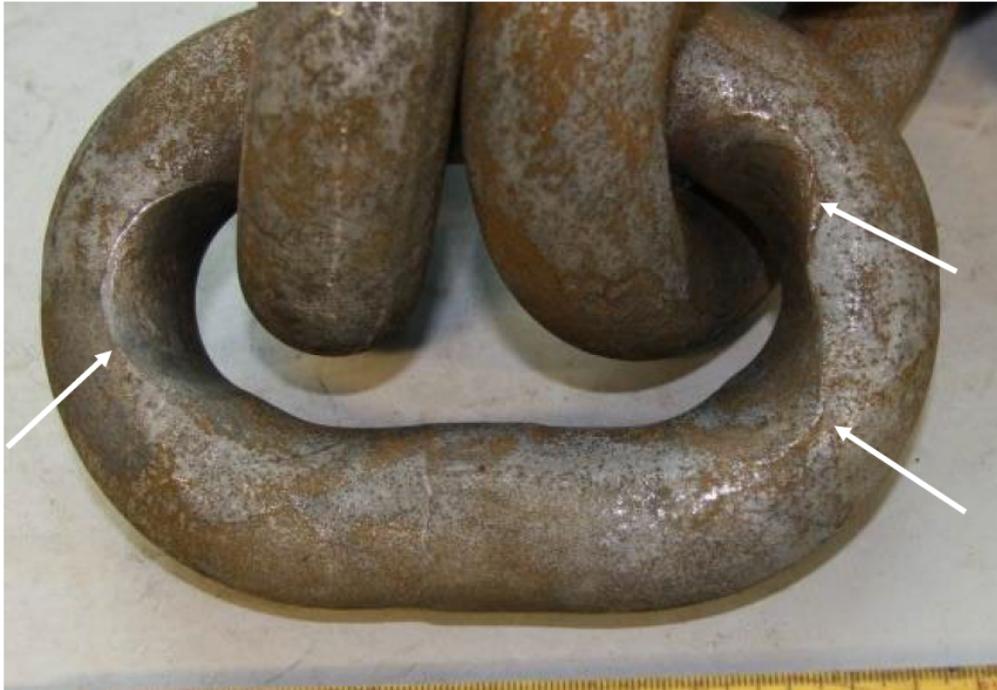
Figure 4-25 BJC/3 – Link 9 after cleaning. No crack-like indications, however significant wear/deformation of the interlink areas.

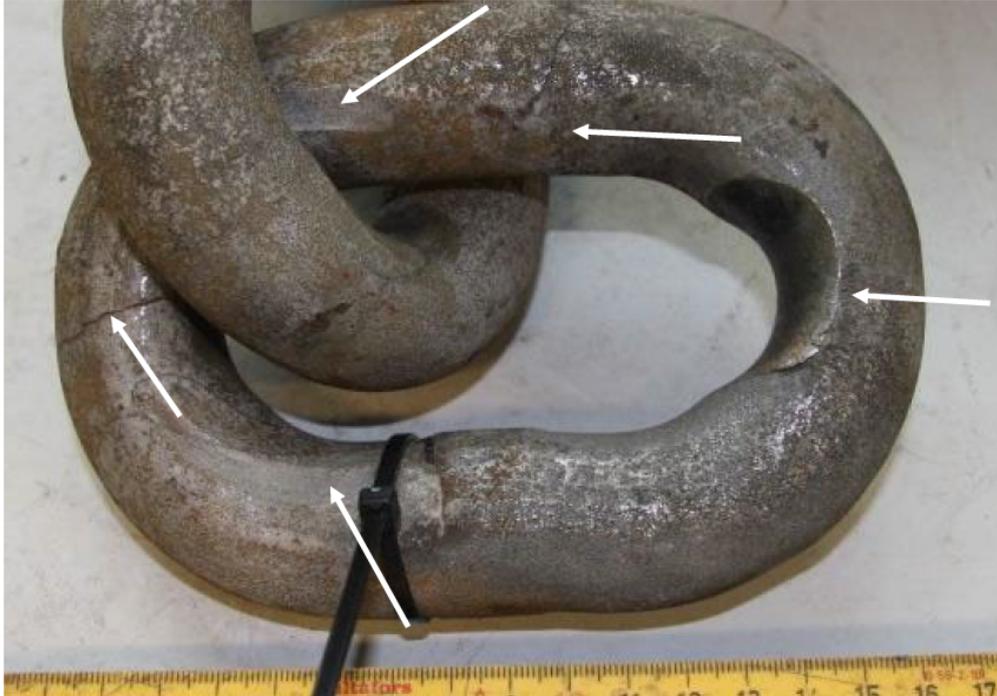
7	<ul style="list-style-type: none"> - No crack-like indications from visual inspection - Uneven surface in connection to the weld - Wear marks towards link 8, mainly on one side, towards both shoulders - See Figure 4-23
		8	<ul style="list-style-type: none"> - No crack-like indications from visual inspection - Uneven surface in connection to the weld - Wear marks towards both sides, towards both shoulders - See Figure 4-24
		9	<ul style="list-style-type: none"> - No crack-like indications from visual inspection - Uneven surface in connection to the weld - Significant wear marks towards both ends. Towards link 8, marks towards both shoulders, towards link 10, one main mark - See Figure 4-25
		10	<ul style="list-style-type: none"> - Visual crack-like indications in one end of the link and on one leg - Uneven surface in connection to the weld - Significant wear mark in one end of the link - Wear marks on side/shoulders - See Figure 4-26

Figure 4-26 BJC/3 – Link 10 after cleaning. Crack-like indications are seen in one end of the link and on the leg of the link, significant interlink wear/deformation, in the other end, and wear marks on the side of the link, close to the crack. All are indicated by arrows.

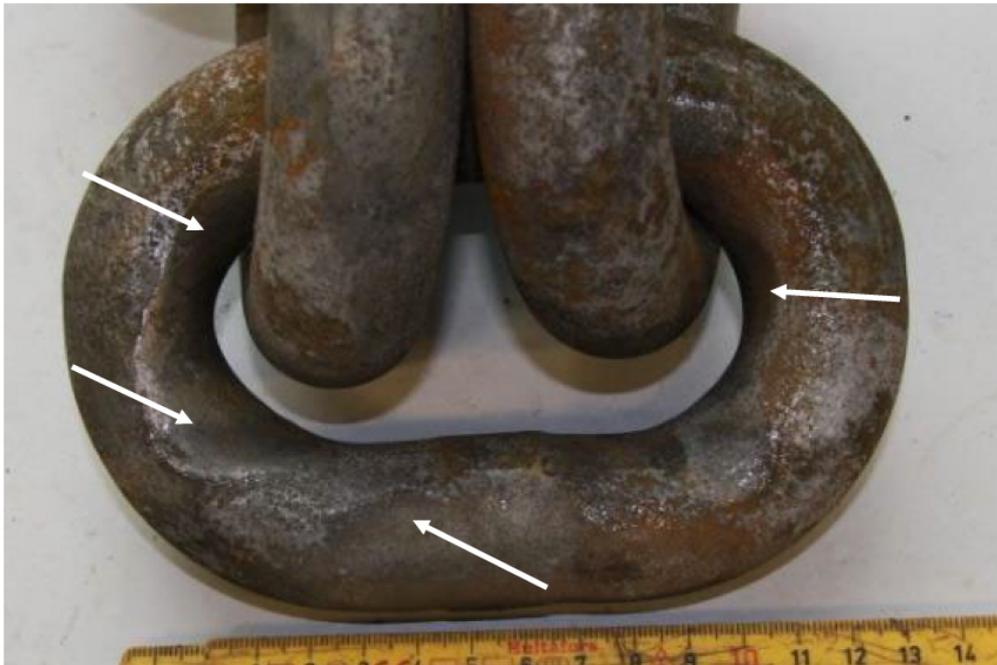
Part ID	Description	Link no.	Observations
		8	No crack-like indications from visual inspection Uneven surface in connection to the weld Significant wear mark in both ends of the link. Against link 9, there are wear marks towards both shoulders. See Figure 4-28
		9	No crack-like indications from visual inspection Uneven surface in connection to the weld Significant wear mark in both ends of the link. Against link 8, there are wear marks towards both shoulders. See Figure 4-29
		10	No crack-like indications from visual inspection Uneven surface in connection to the weld Significant and asymmetric wear mark in both end of the link Wear marks on side/shoulders See Figure 4-30

Figure 4-28 BJC/5 – Link 8 after cleaning. Significant interlink wear/deformation, indicated by arrows. No crack-like indications.

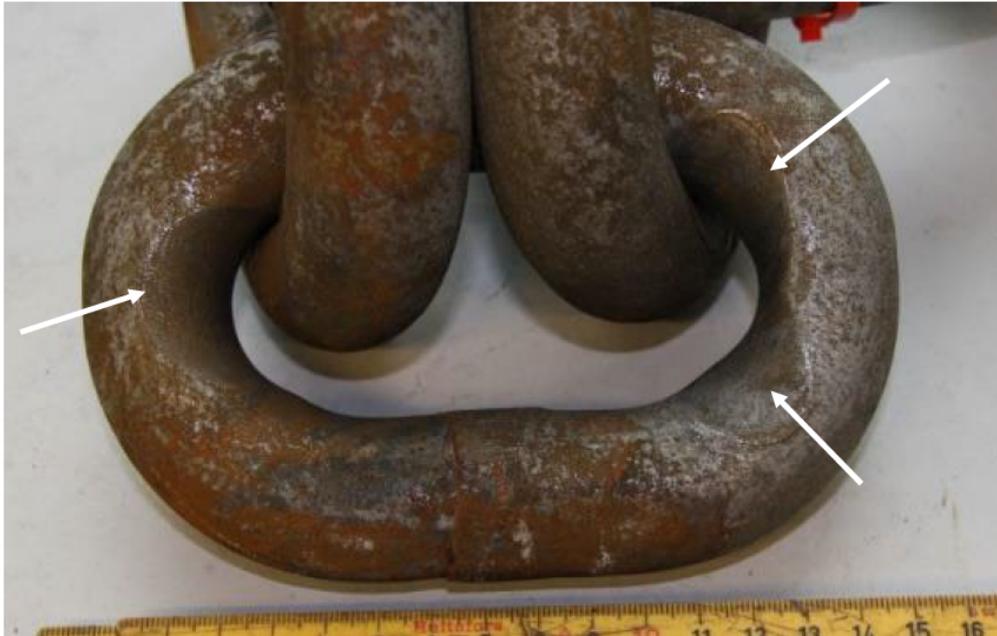
Figure 4-29 BJC/5 – Link 9 after cleaning. Significant interlink wear/deformation, indicated by arrows. No crack-like indications.

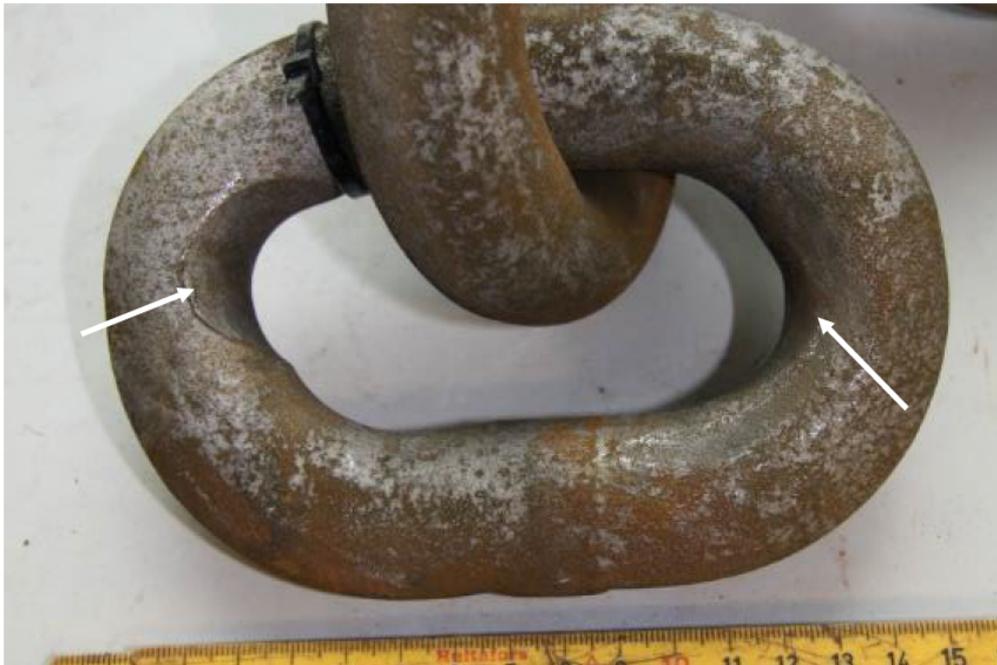
Figure 4-30 BJC/5 – Link 10 after cleaning. Significant asymmetric wear/deformation marks in the interlink areas, indicated by arrows. No crack-like indications.

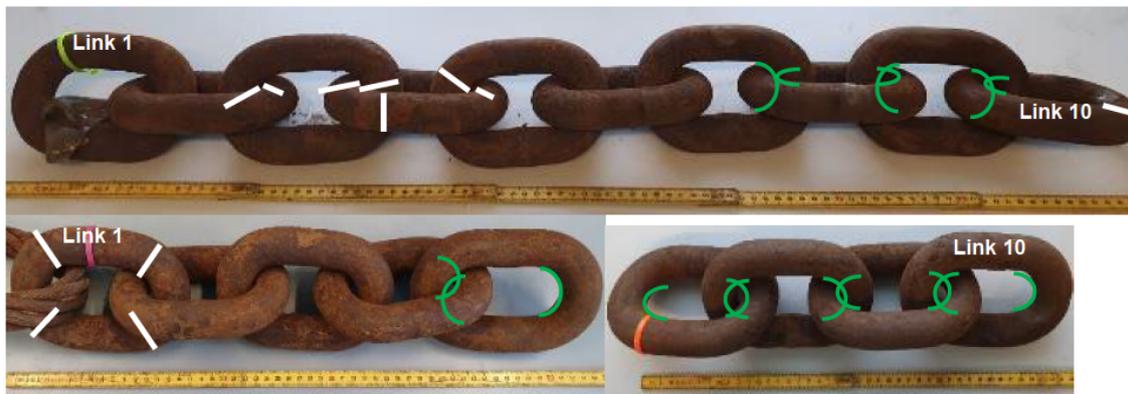
together with the known positions, and is shown in Figure 4-31. Included in Figure 4-31 are also the most significant wear and cracks found by visual examination. A comparison of wear pattern of the corresponding links from portside and starboard chain is shown in Figure 4-32.

Based on the comparison, the fractured link is number six, counted from the steel wire rope. According to the images shown in Figure 4-9 this link is positioned at the derrick head, where the chain gets in contact with the pin, and towards the steel wire rope side.

Figure 4-31 Comparison of position of chain segments between the portside and the starboard chain. The white lines indicate observed crack-like indications, while the green markings show wear.

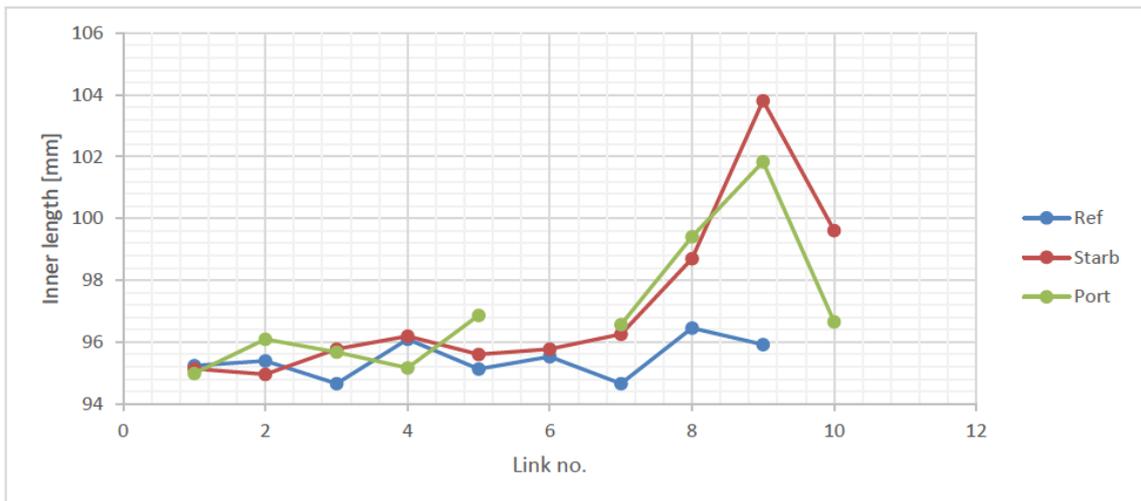
- The inside length of the different links shows increased lengths towards the trawl side of the chain (higher link number), as shown in Figure 4-33. This is mainly caused by wear/deformation in the interlink area, as no increase in outer chain length is seen. The similar trend seen for both chains, indicate that the assumed orientation of the parts is correct.

Figure 4-33 Measured inner length plotted versus link number.

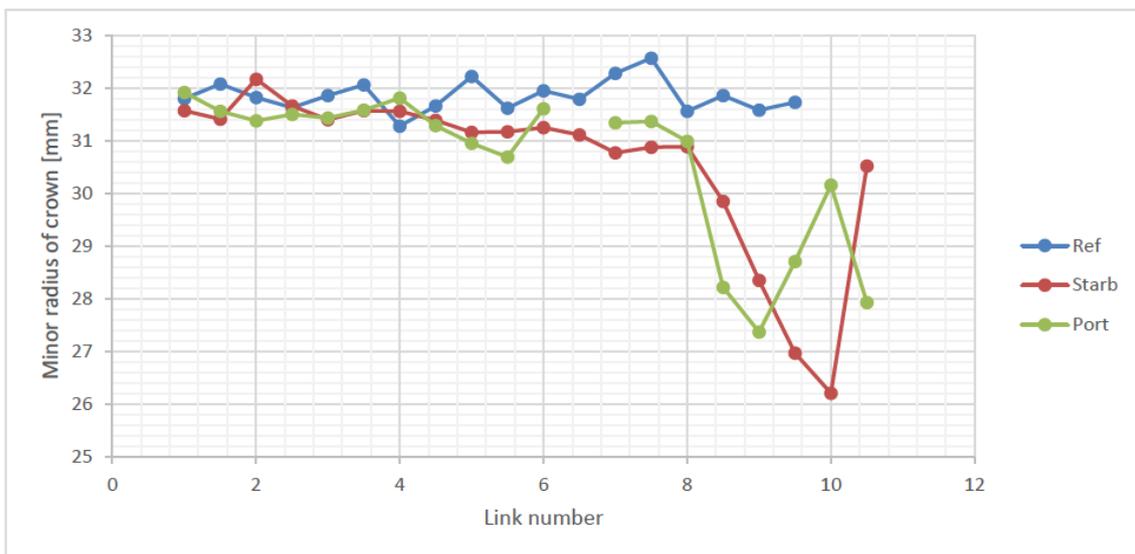
- The minor crown diameter (the one along the length direction of the chain, i.e., the one decreased by interlink wear), is plotted versus link number in Figure 4-34. For both portside and starboard chain, there is a significant decrease due to wear/deformation in the links closer to the trawl (i.e., higher link numbers). This corresponds to the increasing measured inner length as the decrease in wear gives lower inner length. The cause of more wear is most likely more movement of chain links relative to each other in this area.

- Based on the plots, there is not expected significant interlink wear/deformation on the fractured chain link.

Figure 4-34 Minor diameter of crown plotted versus link number.

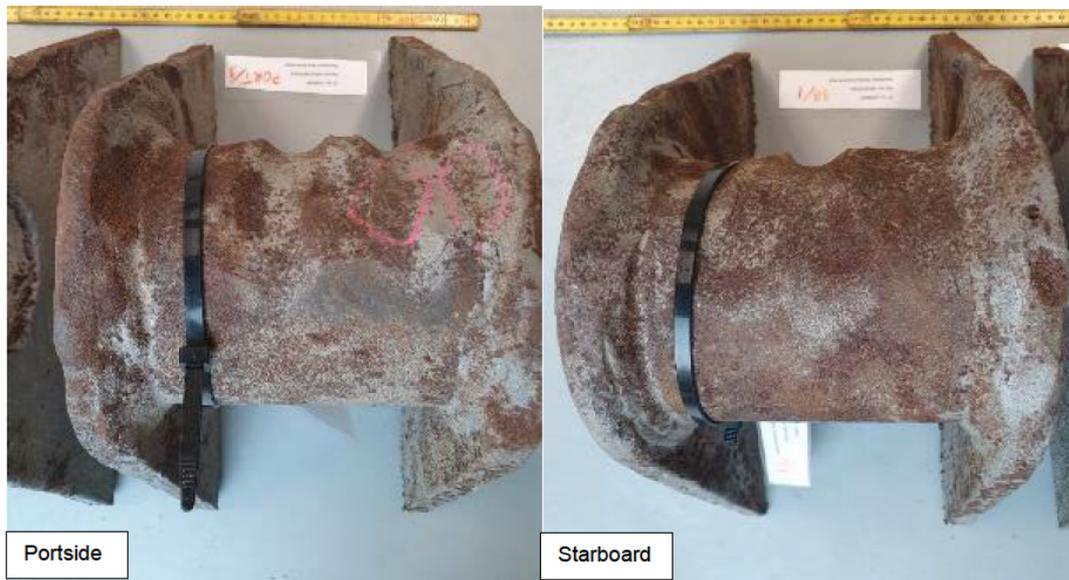
The derrick heads were sandblasted before the NDT, to remove paint and corrosion products, and most of the visual examination was performed after sandblasting. Significant wear is seen on both derrick heads, as shown in Figure 4-35. Close-up images of the wear/deformation on the pin and on the cheek plates are shown in Figure 4-36 and Figure 4-37. For both derrick heads, the wear/deformation is found on one side of the pin, i.e., upwards where the chain has been hanging over the pin. As shown in Figure 4-38, the geometry of the wear marks corresponds to the link geometry. The pink markings on several of the images shows the position of indications from MPI. These are believed to be folding of the material as the chain moves over the derrick head, i.e., related to the deformation of the surface material, and not cracks. See Paragraph 4.6 for MPI results.

Figure 4-35 Overview images of the two derrick heads.

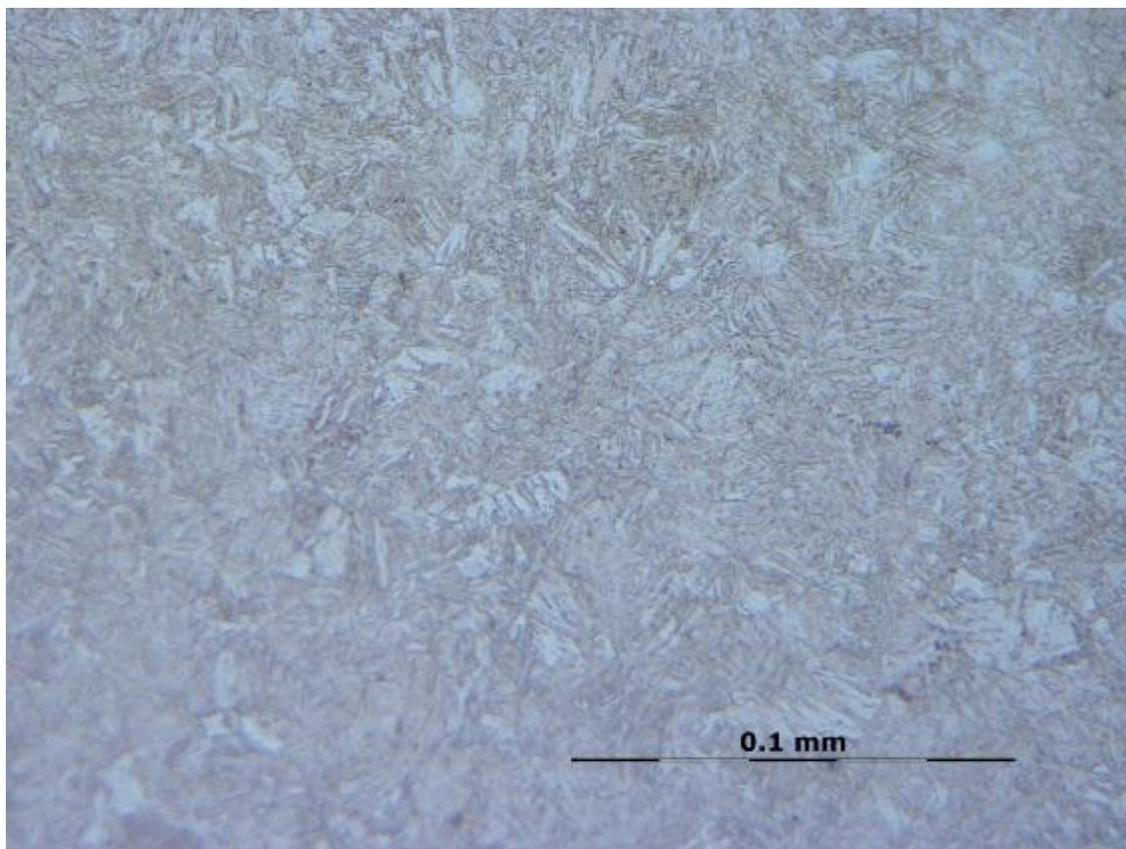
Figure 4-39 Typical example of quenched and tempered microstructure of chain material, fractured link: Quenched and tempered microstructure ca 10 mm from outer surface.

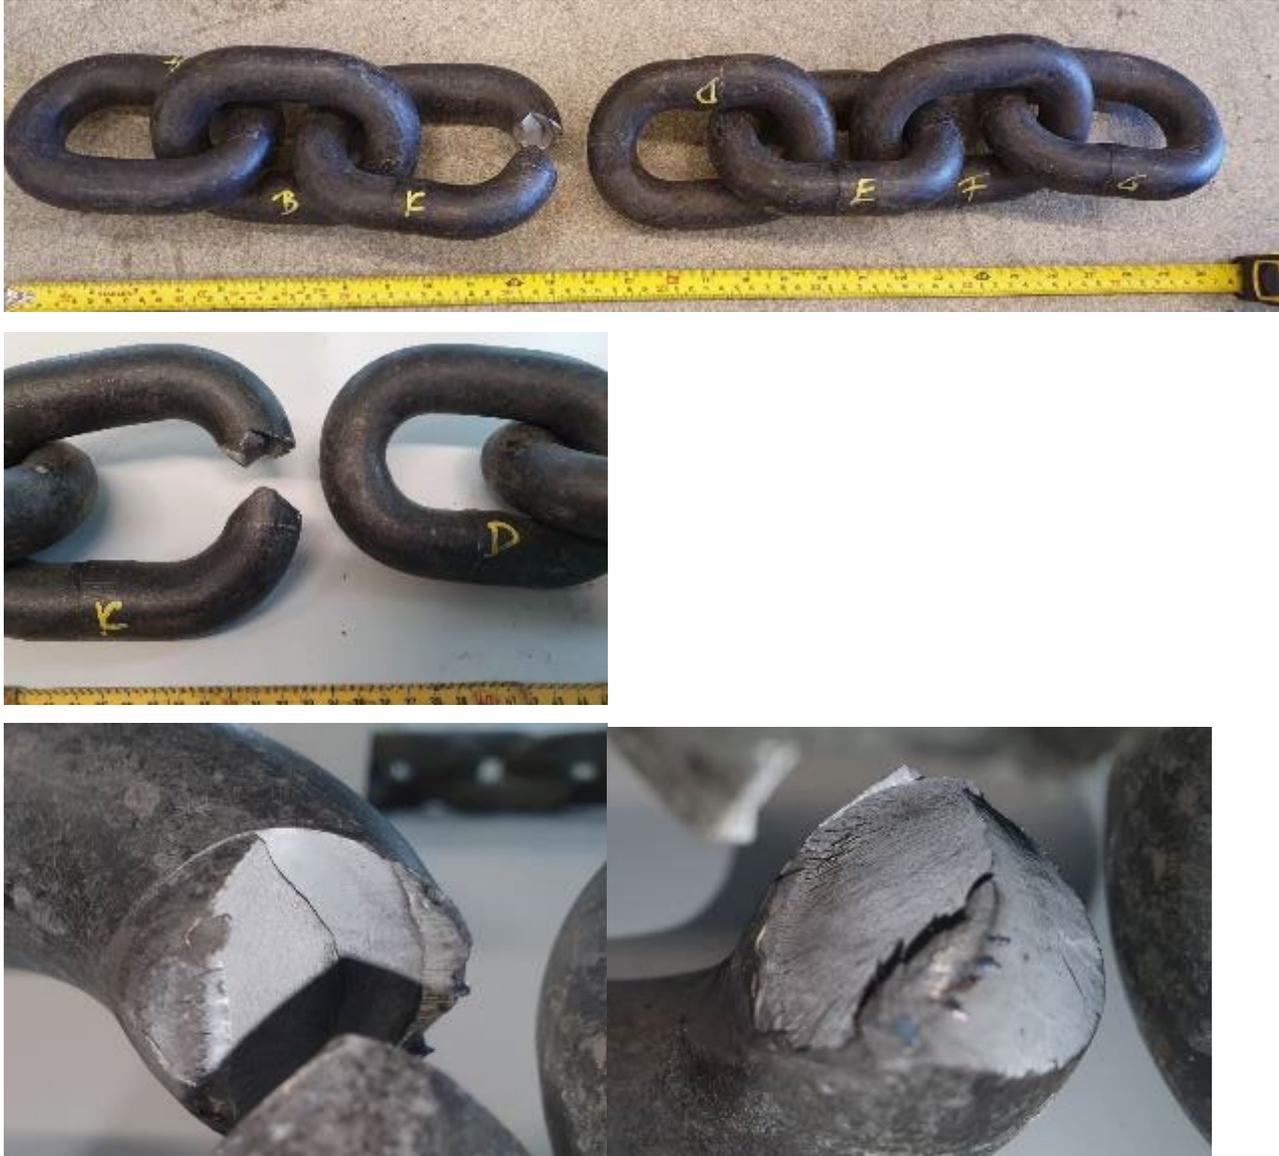
The fracture has initiated from the inside of the crown of one of the mid chain links, and has a typical appearance for an overload fracture. No indication of pre-existing crack (i.e. areas of corrosion on the fracture surface) is seen.

Figure 4-47 Break load testing of unused reference sample. The upper image shows the whole length after break load testing, the lower images show the fractured link. The letters on the chain links are for internal use only.

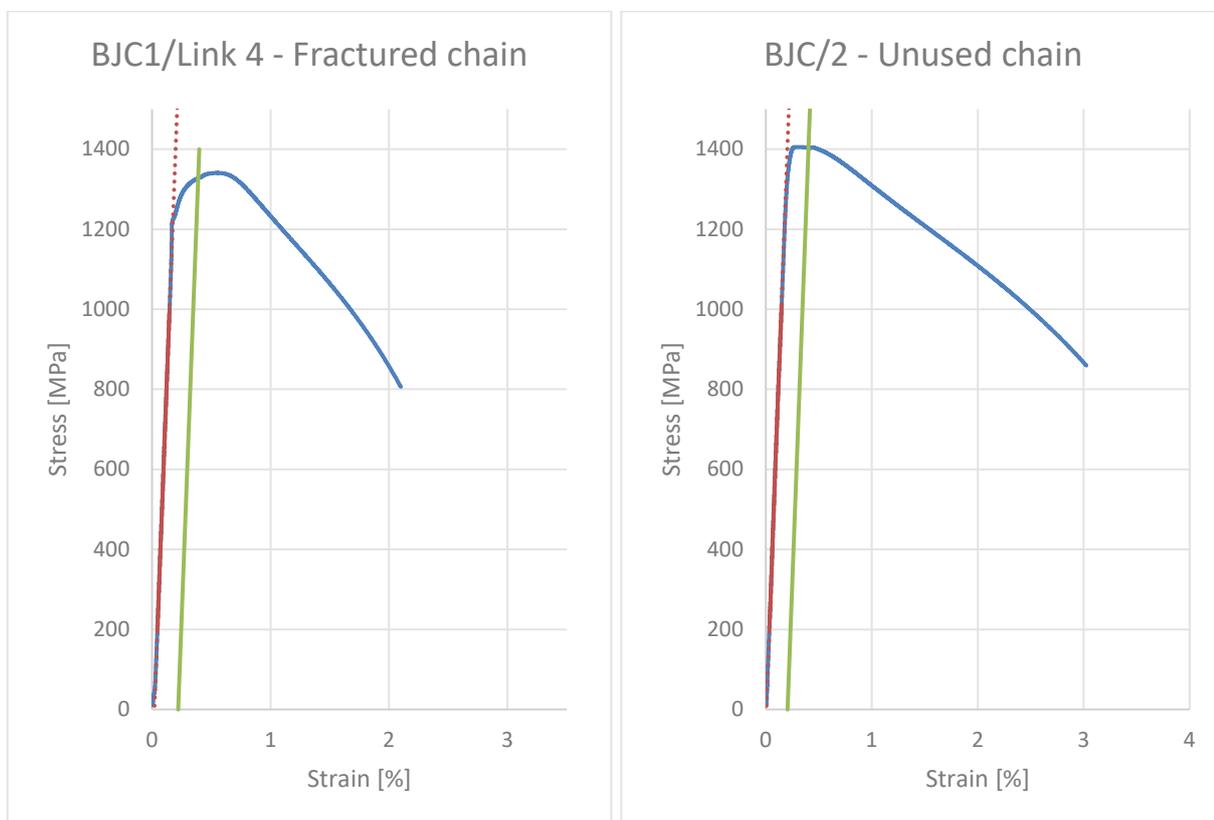
Figure 4-50 Stress-strain plots from tensile testing. The red and green lines are used for determination of the 0.2% yield strength.

The test results show small difference between the yield strength and the tensile strength for both samples. The test results show higher tensile strength and yield strength of the reference chain, and correspondingly lower elongation (based on $L_0 = 32$ mm) and contraction.

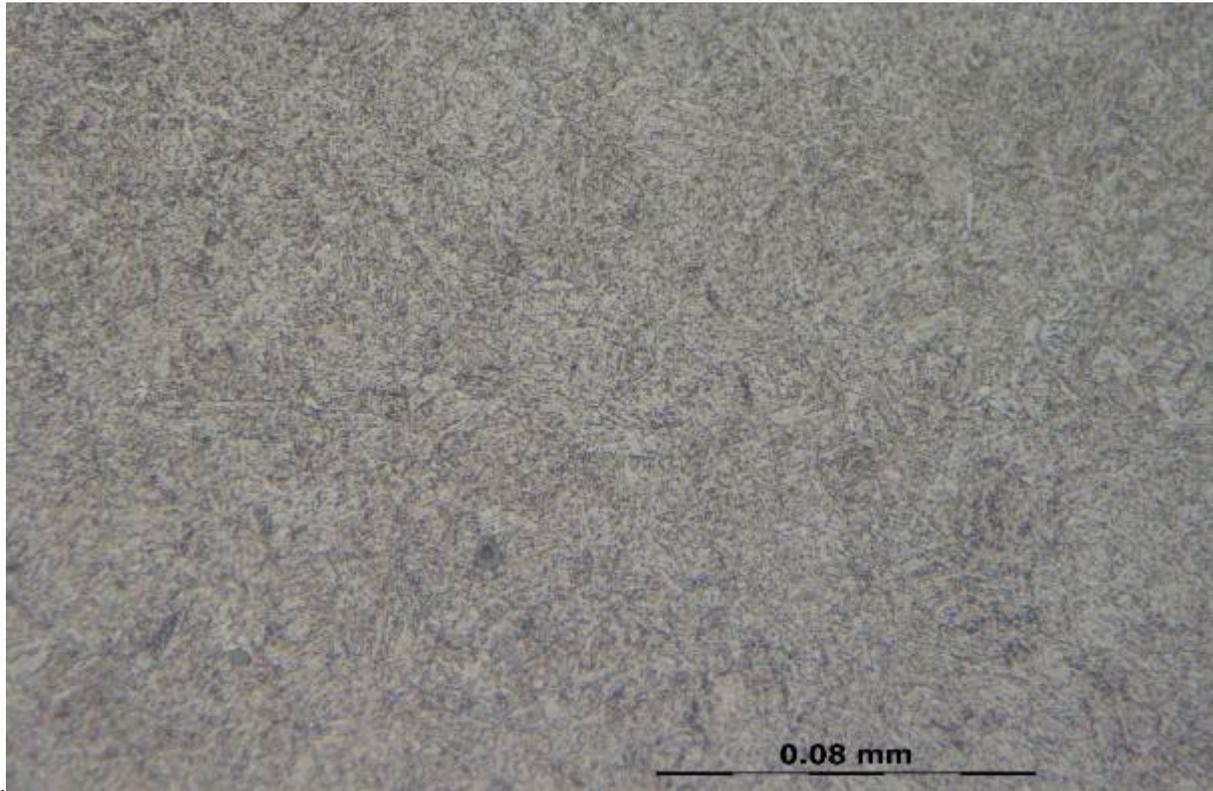
The examined cross sections from the pin material had a quenched and tempered microstructure, while the cross section from the cheek plate material had a ferritic-pearlitic microstructure.

Figure 4-51 Cross section, pin material of derrick head (MPH/CM/SB/1). Quenched and tempered microstructure.

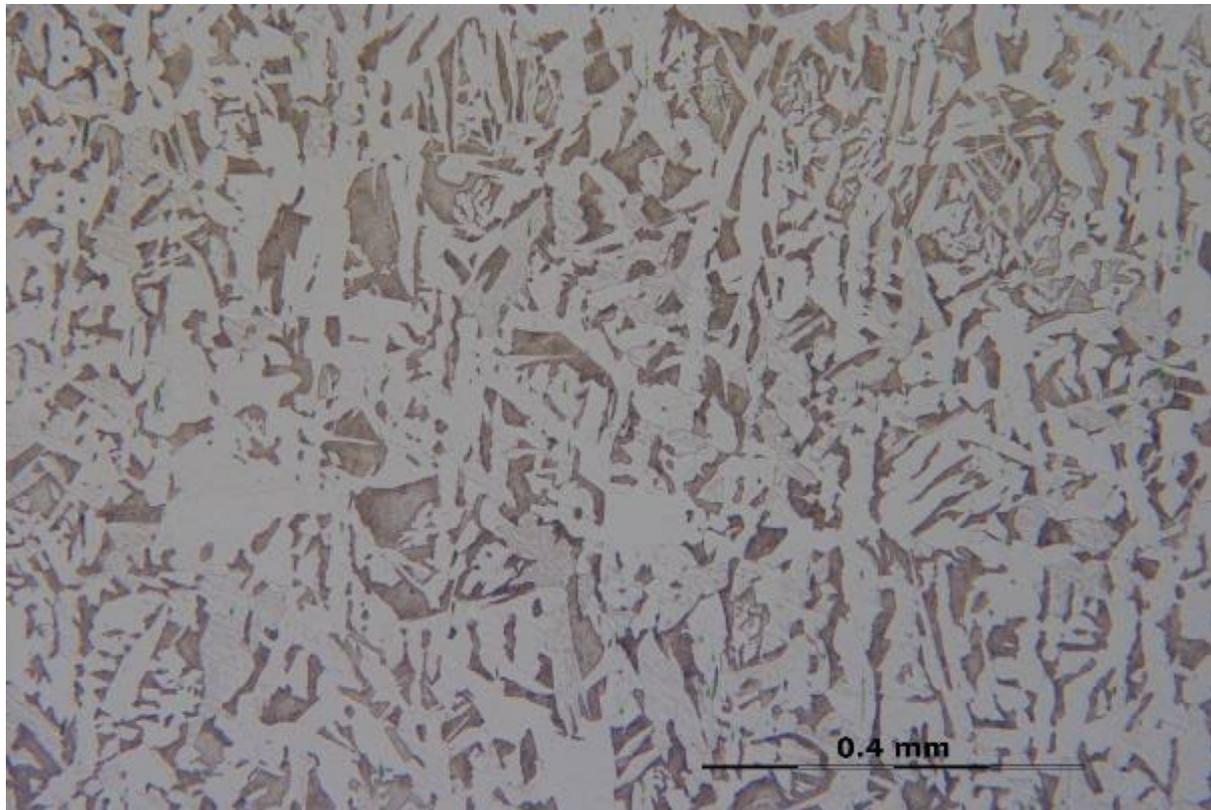
Figure 4-52 Cross section, cheek plate material of derrick head (MPH/CM/PORT/3). Ferrite-pearlite microstructure.

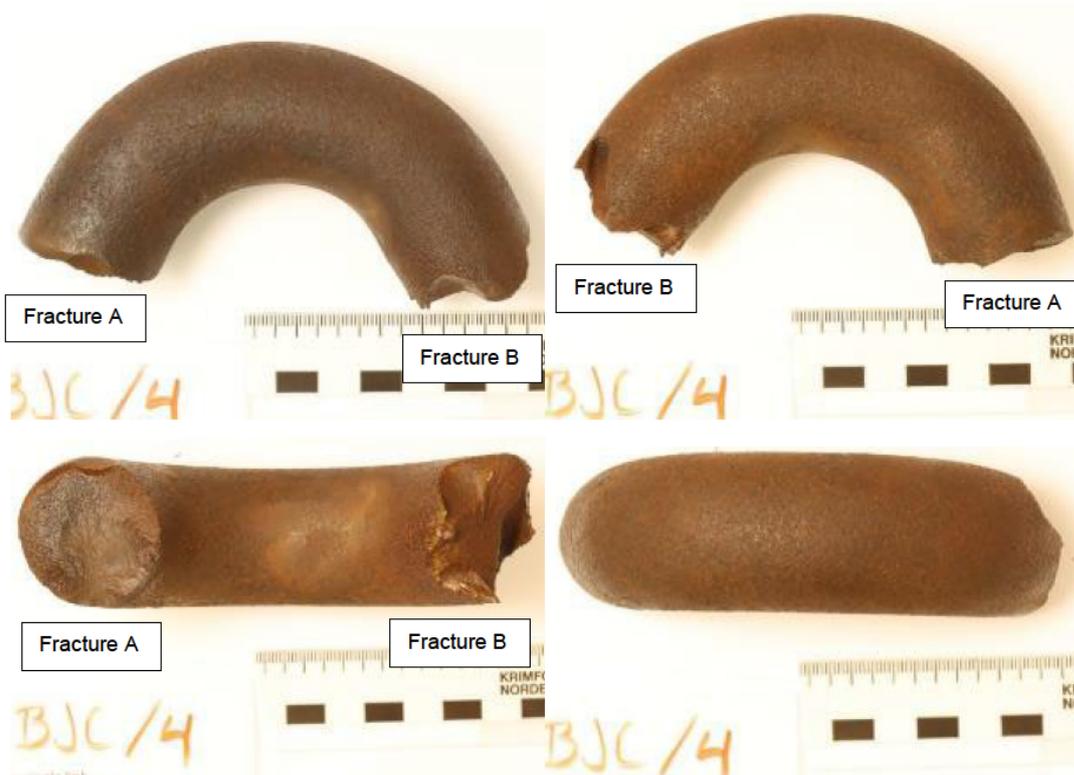
Figure 5-2 Overview images showing the fractured link after cleaning using cotton rags and ethanol.

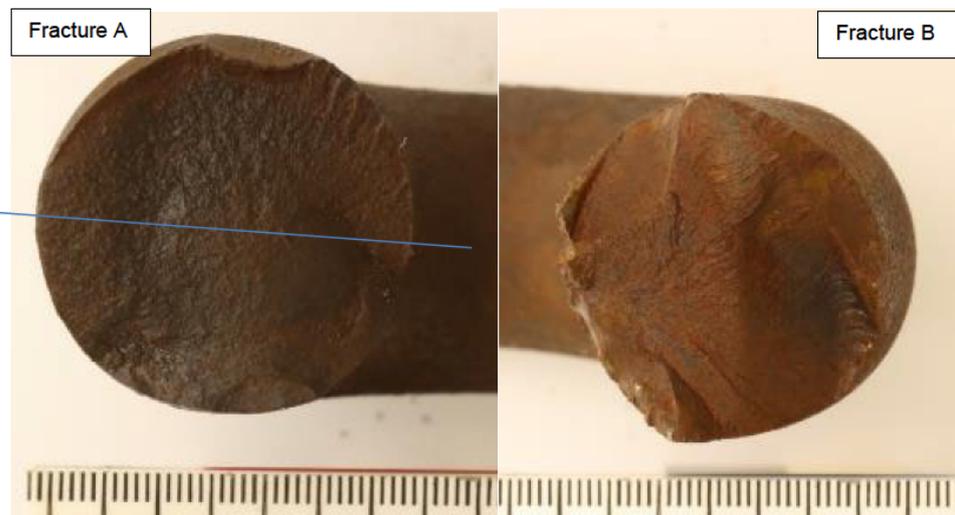
Figure 5-3 Overview images of the two fracture surfaces, after cleaning using cotton rags and ethanol.

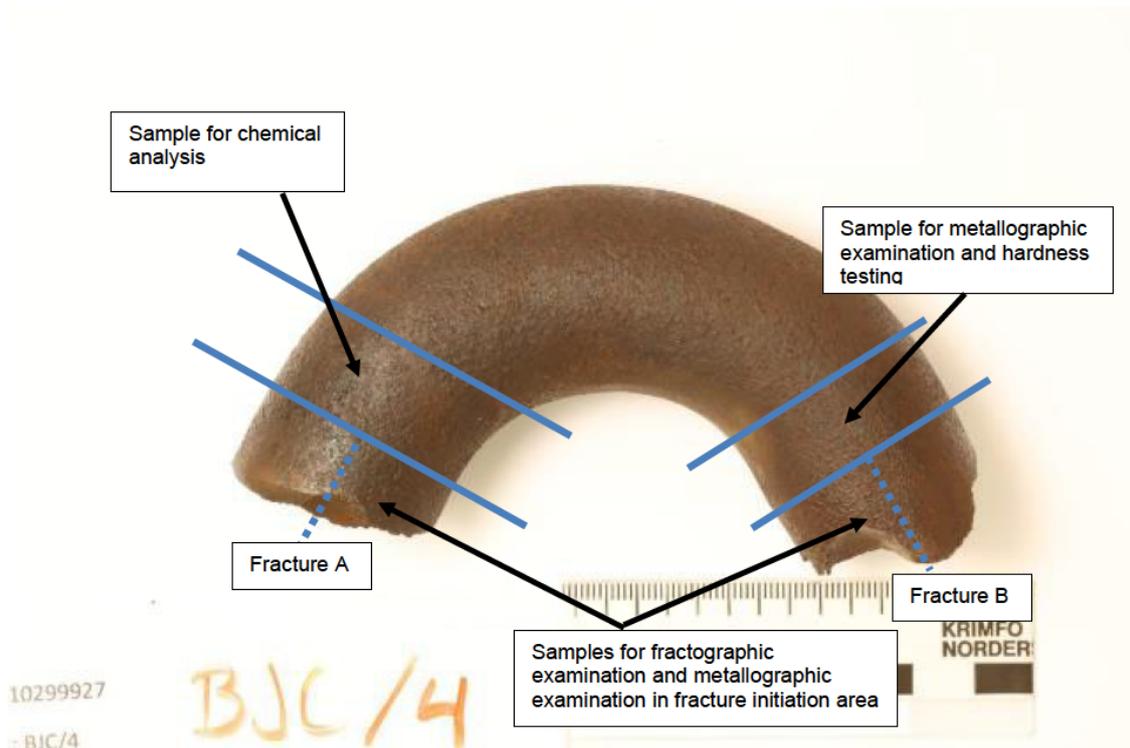
The fractured link part was further cleaned using inhibited hydrochloric acid to remove corrosion products. The two fractures were cut from the link part as shown in Figure 5-4 for easier handling and examination using a scanning electron microscope.

Figure 5-4 Cutting of fractured chain link.

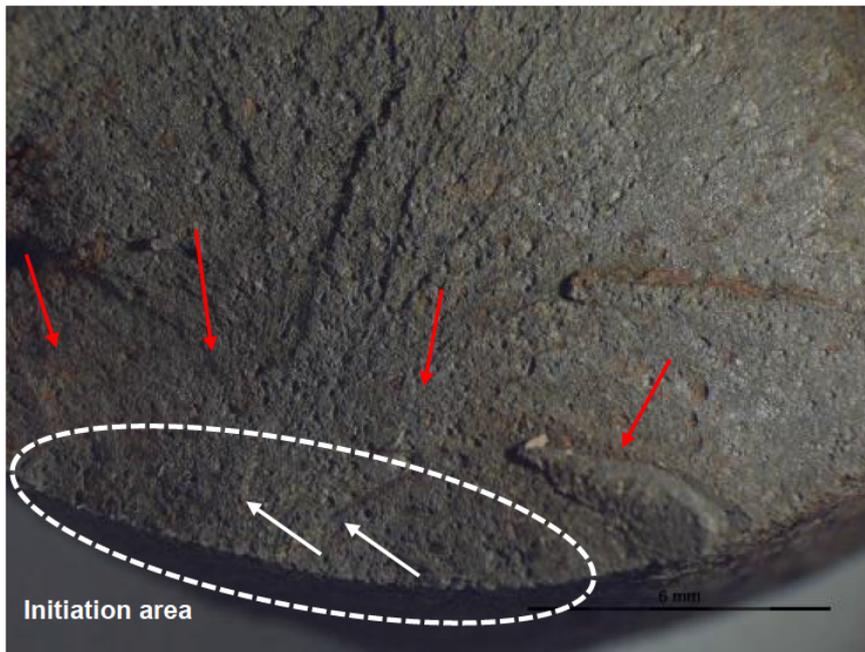
The fracture surface has a likely fracture initiation area as is indicated in Figure 5-5. In this area ratchet marks / breakover lines are seen, and weak indication arc-shaped features radiating outwards from the initiation area. This indicates crack growth from multiple initiation points. Ratchet marks / Breakover lines form when two (or more) cracks from different initiation points meet and grows together into one crack. The initiation area is seen along the edge of the fracture surface, approximately 90° from the interior/exterior curve of the link (i.e. 90° from the intrados/extrados). An image showing the initiation area at higher magnification is given in Figure 5-6.

Figure 5-6 Fracture A: Fracture initiation area. Break-over lines and indication of arc-shaped features radiating outwards from the initiation area is seen, and marked by white and red arrows, respectively.

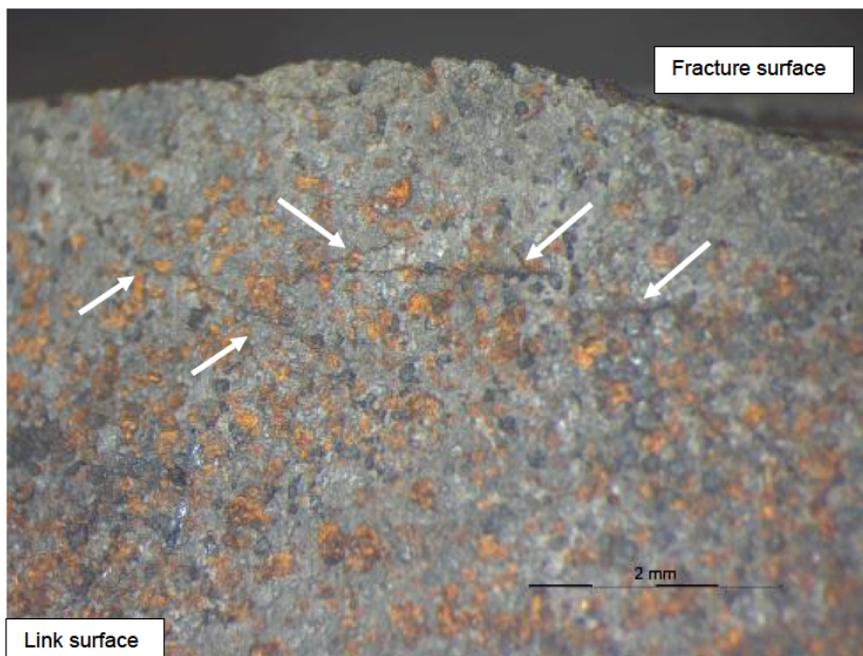
Examining the link surface close to the initiation area, a number of small cracks were found close to the fracture initiation area, as shown in Figure 5-7. These are believed to be similar cracks that have initiated in parallel with the main crack, however has not propagated further.

Figure 5-7 Fracture A: Cracks on the link surface, more or less parallel to the main crack, close to the initiation area. Cracks shown by arrows.

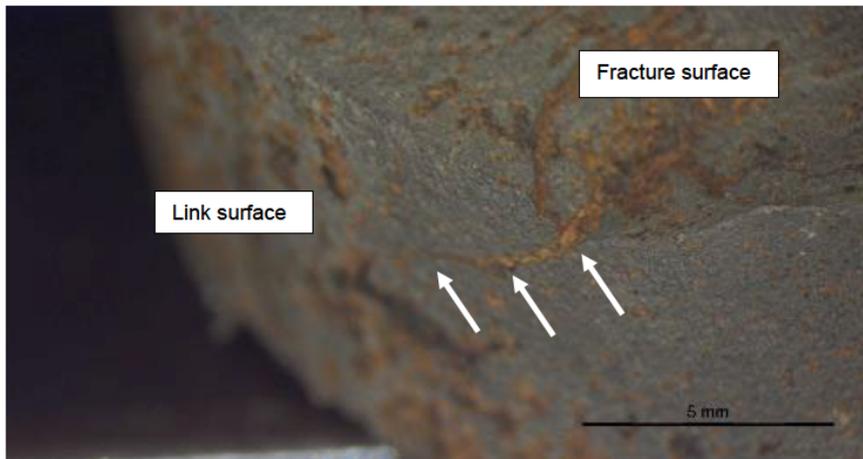
Figure 5-8 shows a crack branching from the main fracture.

Figure 5-8 Fracture A: Crack branching from the fracture surface, indicated by arrows

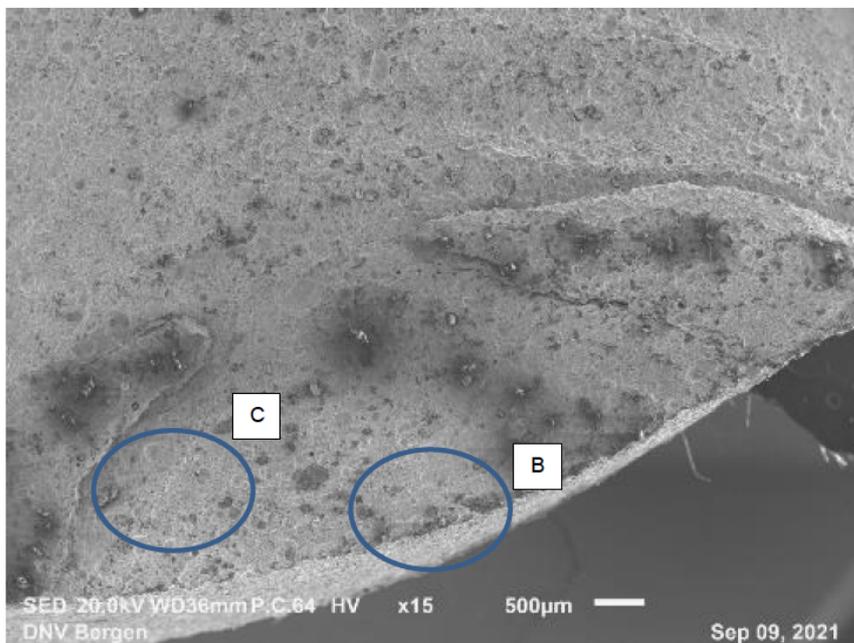
Figure 5-10 and Figure 5-11 shows the initiation area at low magnification. Some indication of possible beach marks are seen; however the fracture topography is mainly disturbed by corrosion. This is also shown in the close-up images showing representative features from the fracture topography, shown in Figure 5-13 to Figure 5-16.

Figure 5-10 Fracture A: Initiation area, right part.

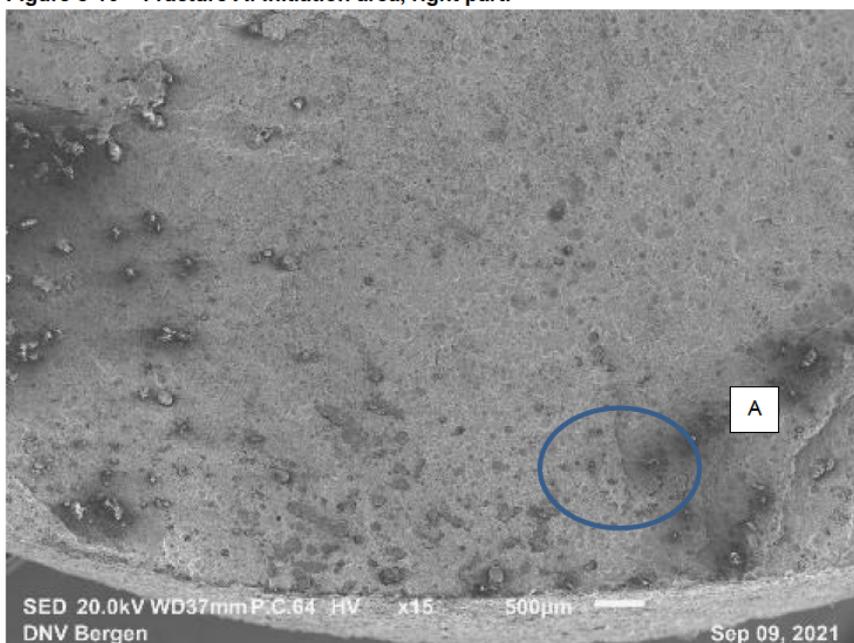
Figure 5-11 Fracture A: Initiation area, left part.
