Failure of chain link investigation on board *Cornishman* report no. 2021-5360

FAILURE OF CHAIN LINK ONBOARD CORNISHMAN

Failure investigation

Report No.: 2021-5360, Rev. 0

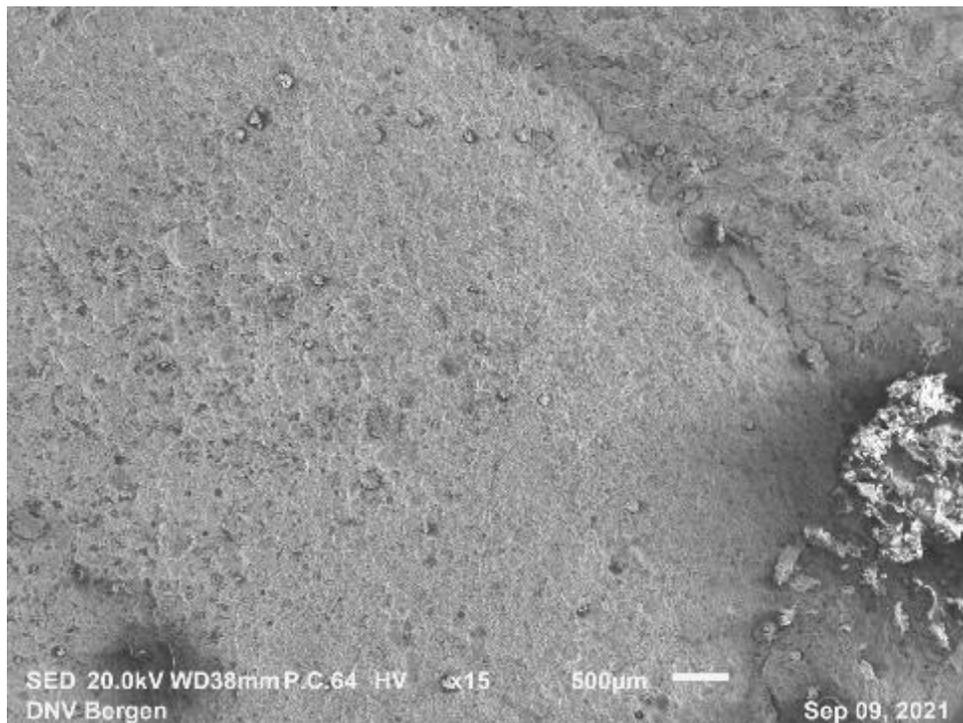
Figure 5-12 shows the clear change from the more even inner fracture surface, to the outer and rougher surface.

Figure 5-12 Fracture A: Transition between mid part of fracture surface and outer part with rougher topography. Mainly corrosion is observed.

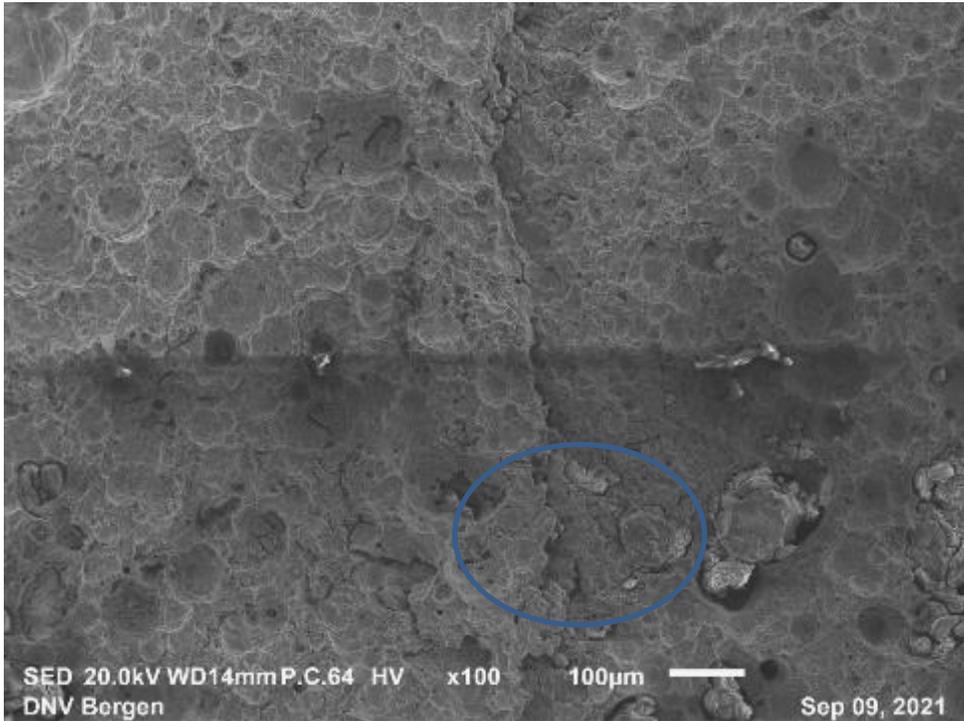
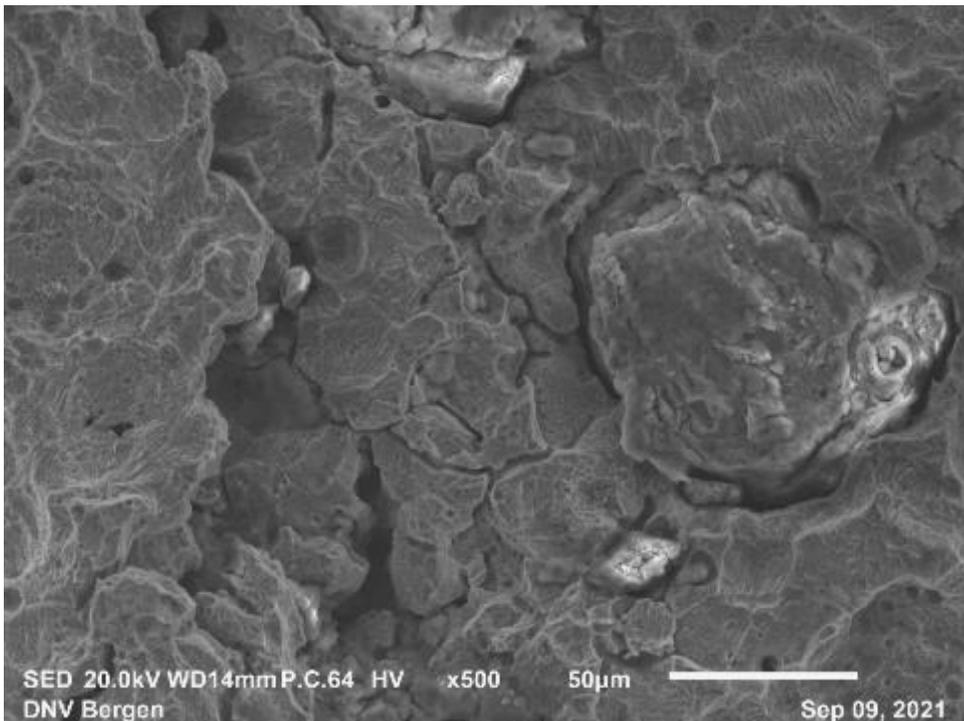
In several of the close-up images, areas of intergranular cracking is observed.

Figure 5-13 Fracture surface A, area A: Intergranular cracks in fracture surface, along breakover line in initiation area. Corrosion and intergranular cracking are observed. The blue eclipse in the upper image shows the position of the lower image.

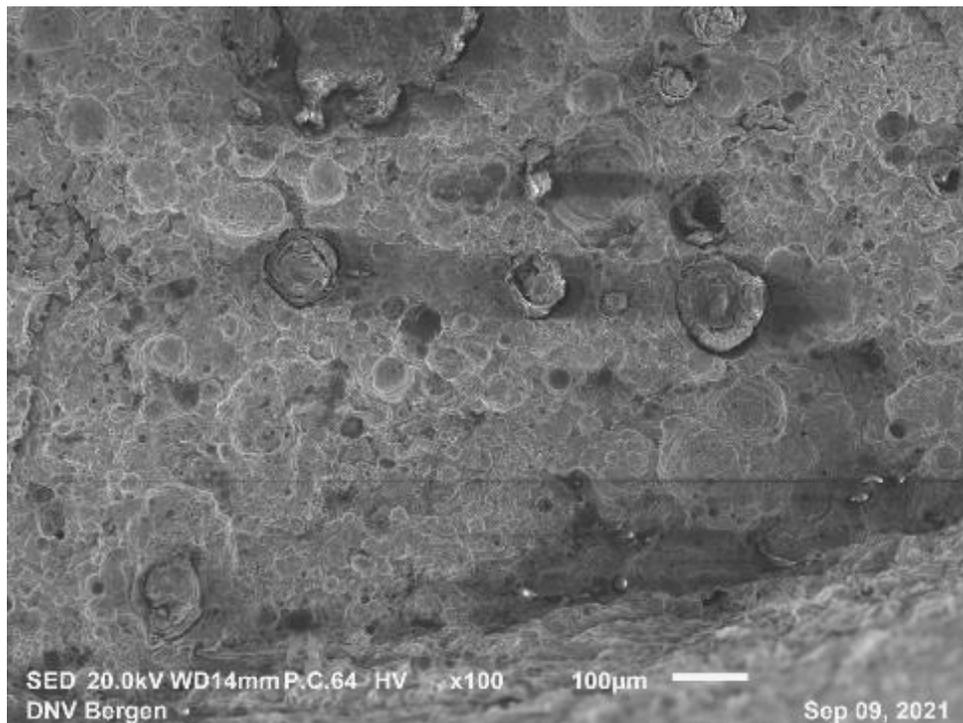
Figure 5-14 Fracture A, area B: Crack topography at edge of initiation area. Dimples/corrosion is seen.

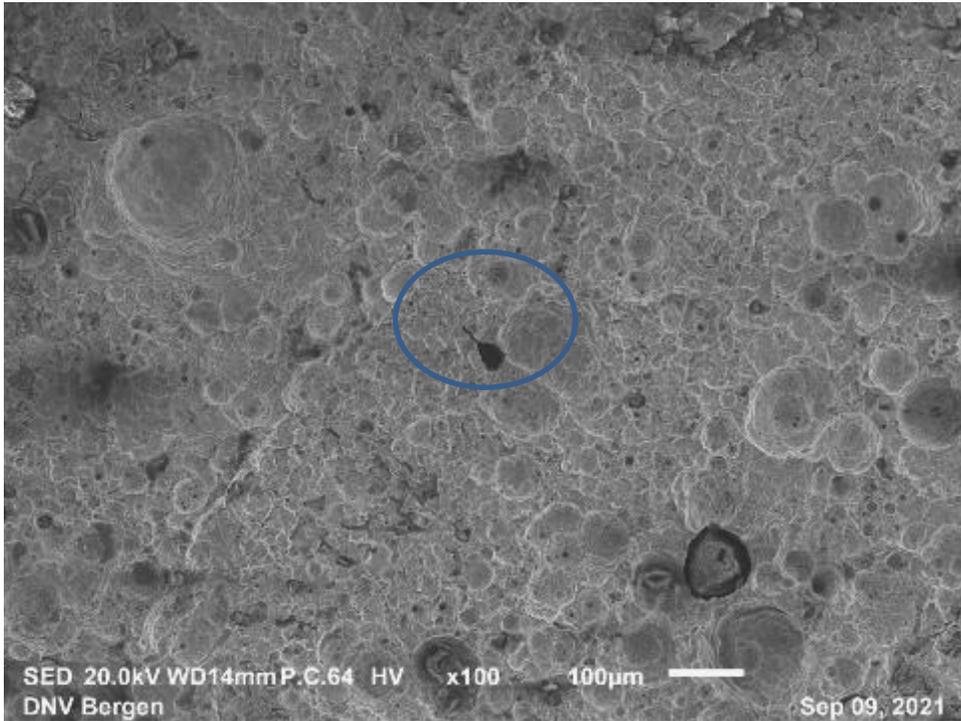
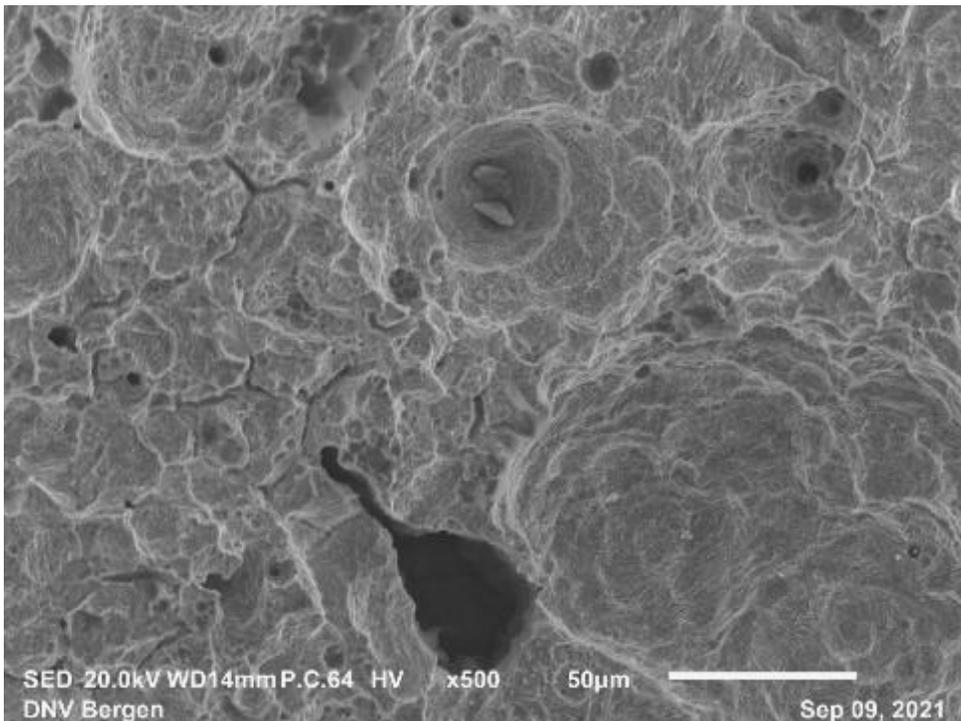
Figure 5-15 Fracture A, area C: Possible beach mark in fracture initiation area. The blue eclipse in the upper image shows the position of the lower image.

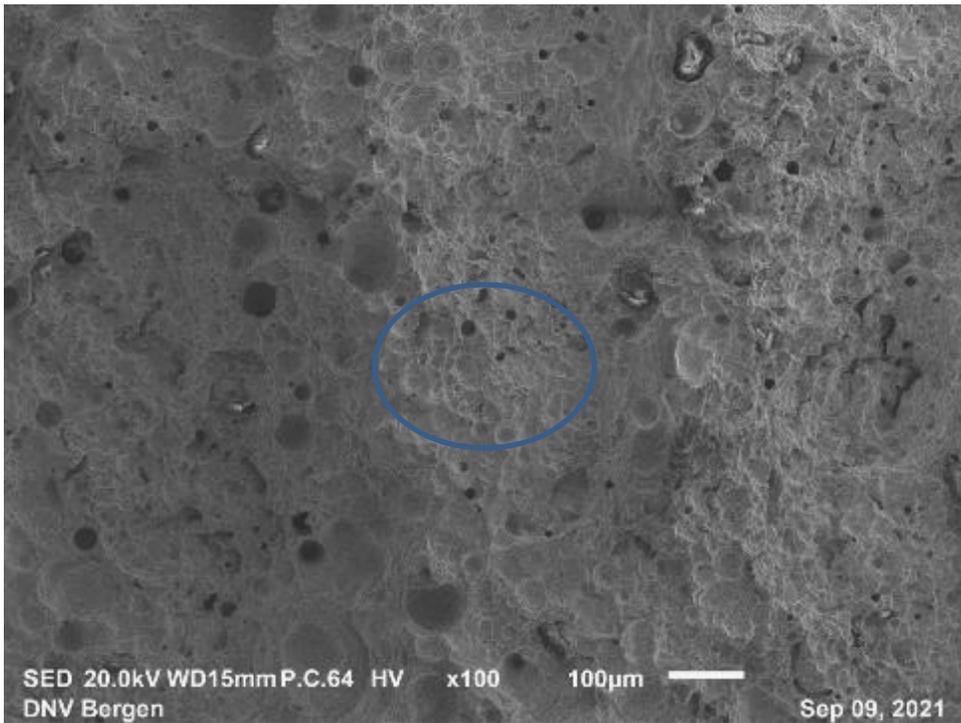
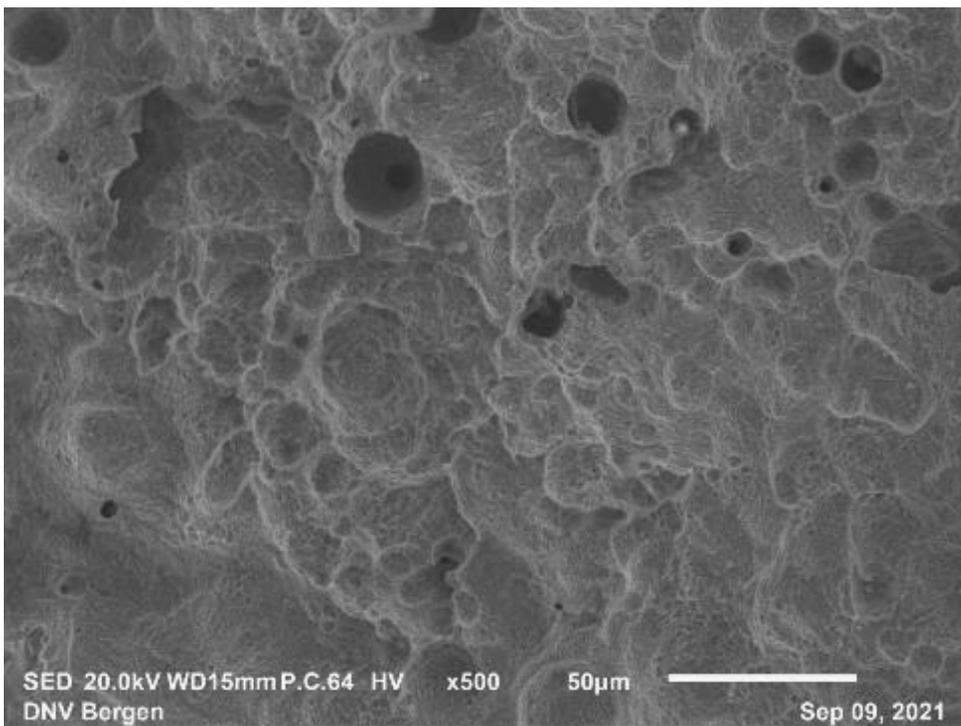
Figure 5-16 Fracture A, area D: Outer part of fracture surface. See Figure 5-5 for position in overview image. The blue eclipse in the upper image shows the position of the lower image.

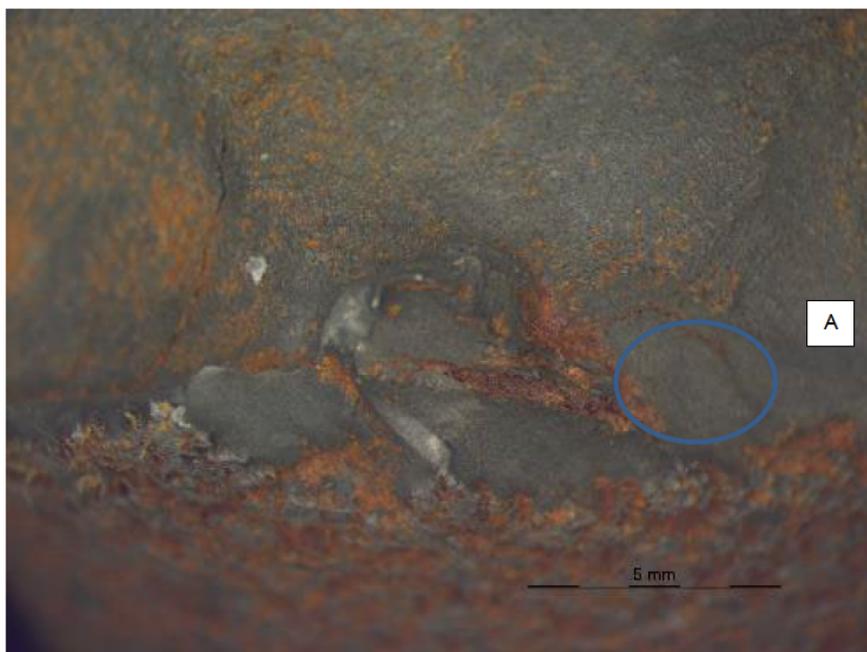
An overview image showing fracture B after careful cleaning using inhibited hydrochloric acid, is shown in Figure 5-17. This fracture surface has a rather rough initiation area, as is indicated in Figure 5-17 and at higher magnification in Figure 5-18. The main part of the fracture surface has a typical river-pattern, as is shown at higher magnification in Figure 5-19. This crack has initiated approximately from the intrados (inner curve) of the chain. A shear lip is observed ca 90-180° from the initiation area, see Figure 5-20, and this is the last part of the chain link to have fractured.

Figure 5-18 Fracture B: Fracture initiation area. Several cracks observed. The marked area A refers to position of a SEM image.

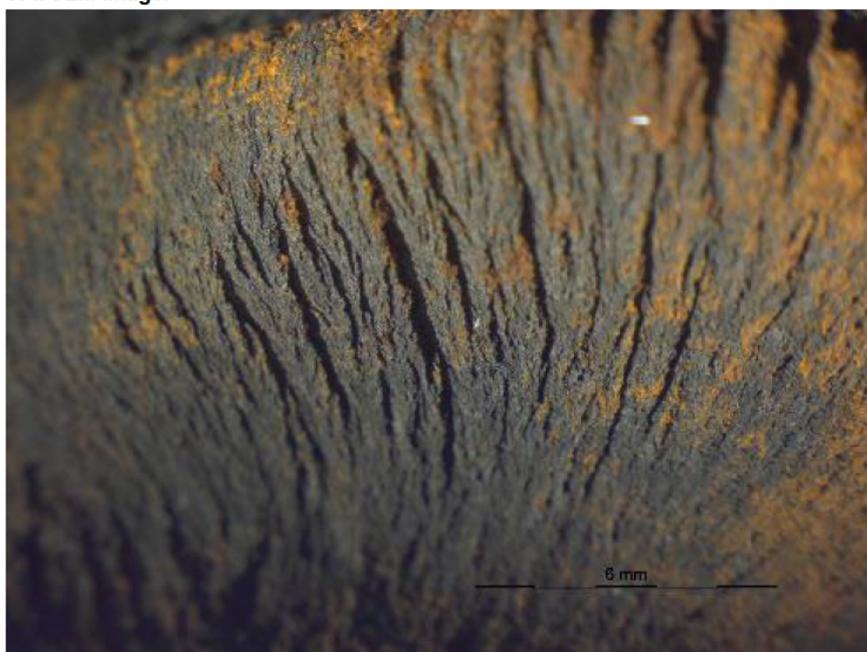
Figure 5-19 Fracture B: Close-up of river pattern in main part of fracture.

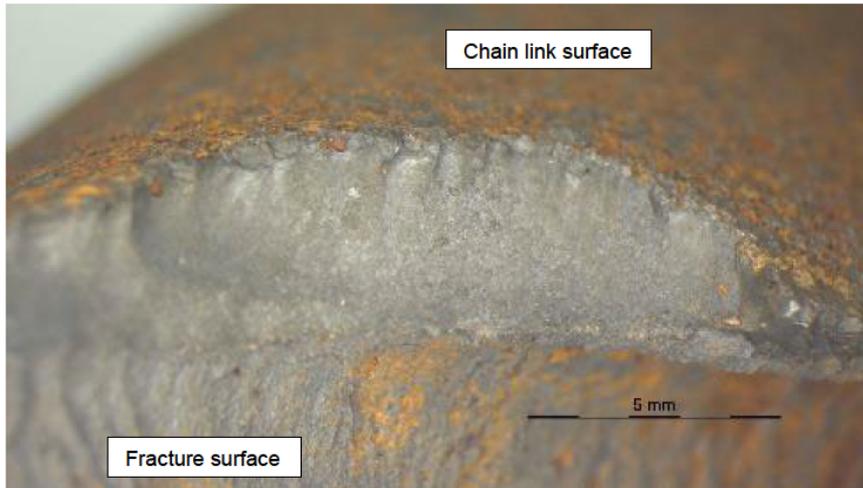
Figure 5-20 Fracture B: Close-up of shear lip.

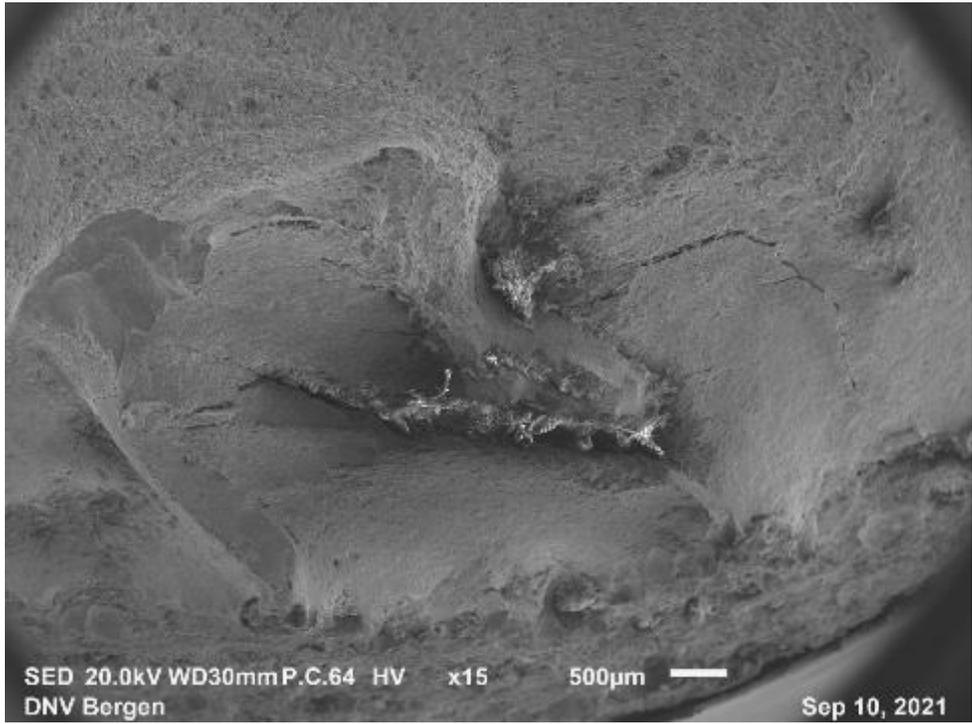
Overview images showing the initiation area and part of the main area with river pattern, is shown in Figure 5-21 and Figure 5-22, respectively. Cracks are seen in the initiation area, and to the left, there is an area with more cracks, Area C, as shown in Figure 5-23.

Figure 5-21 Fracture B: Fracture initiation area.

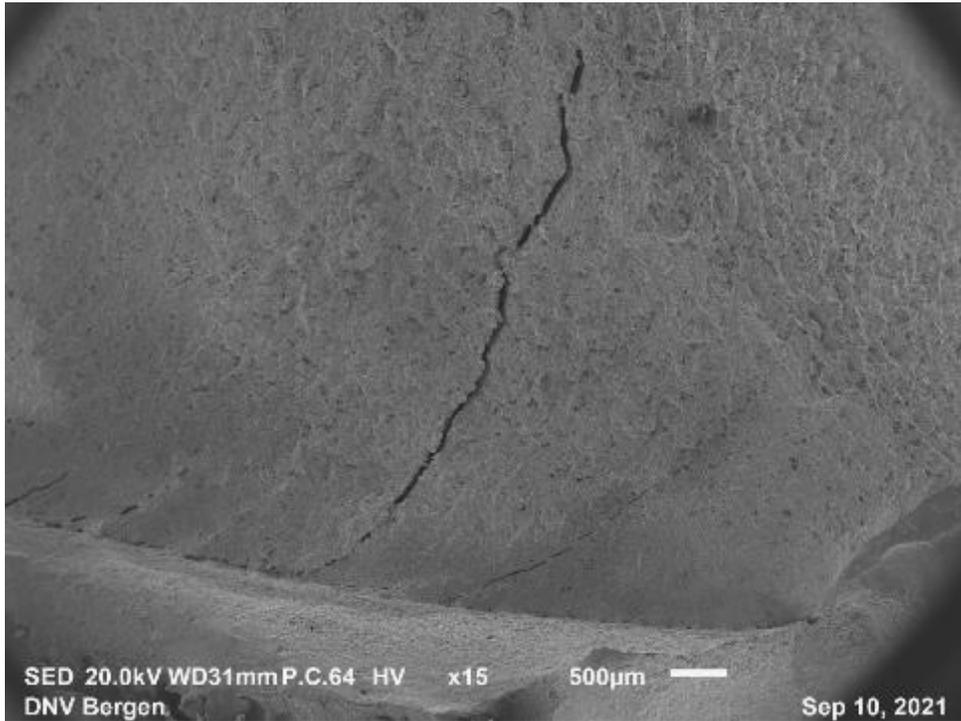
Figure 5-23 Fracture B, area C: Area with multiple cracks, to the left of the initiation area.

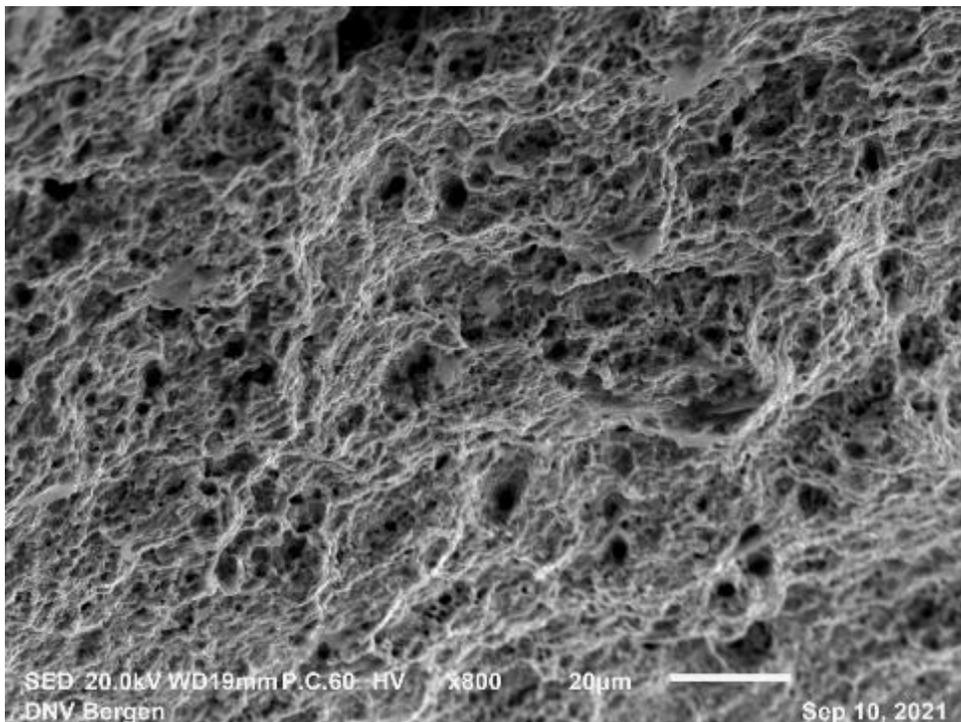
Close-up images from different representative areas are shown in Figure 5-24 to Figure 5-27. The fracture topography is a mixture of corrosion, and most likely a ductile fracture topography with dimples.

Figure 5-24 Fracture B, area A: Right part of fracture initiation area. Corrosion and/or dimple fracture topography.

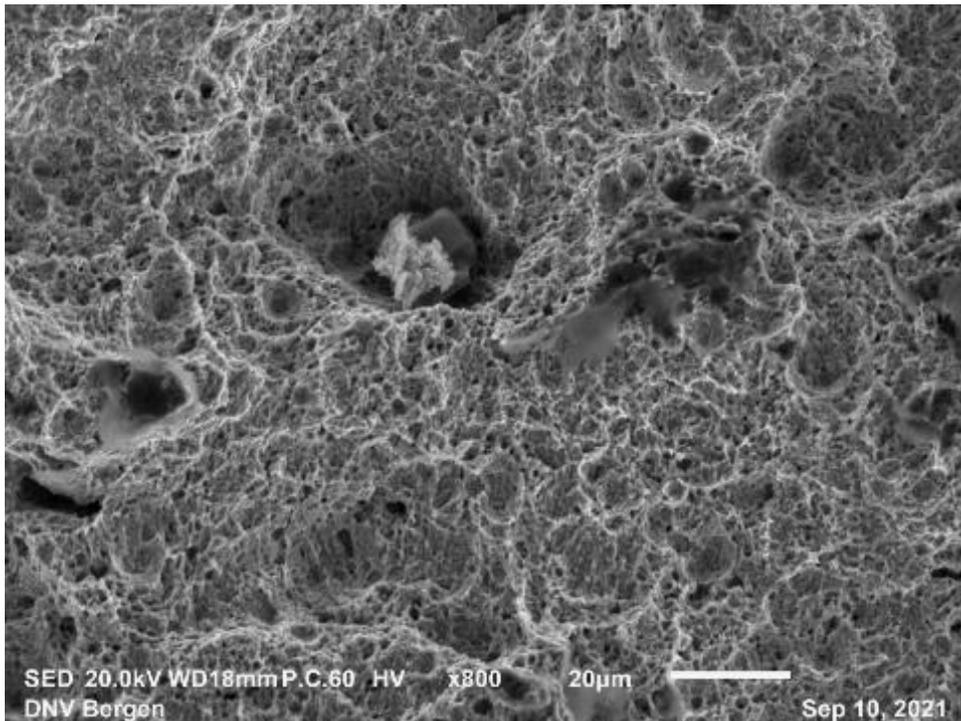
Figure 5-25 Fracture B, area B: Main part of fracture surface, close to initiation area. Corrosion and/or dimple fracture topography.

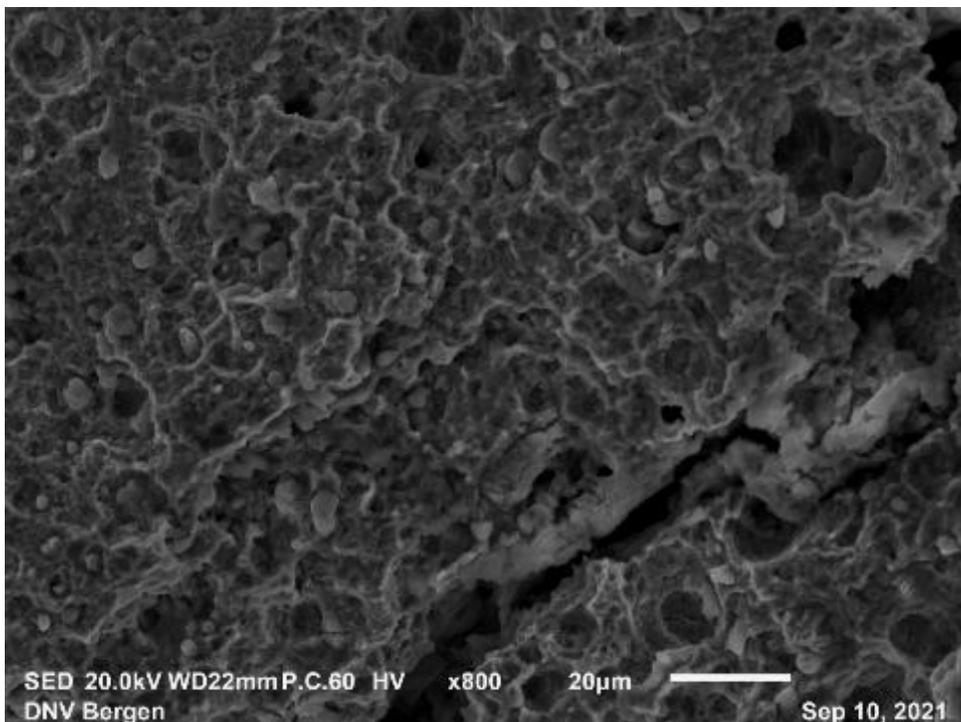
Figure 5-26 Fracture B, area C: Area with multiple cracks, to the left of the initiation area. Corrosion and/or dimple fracture topography.

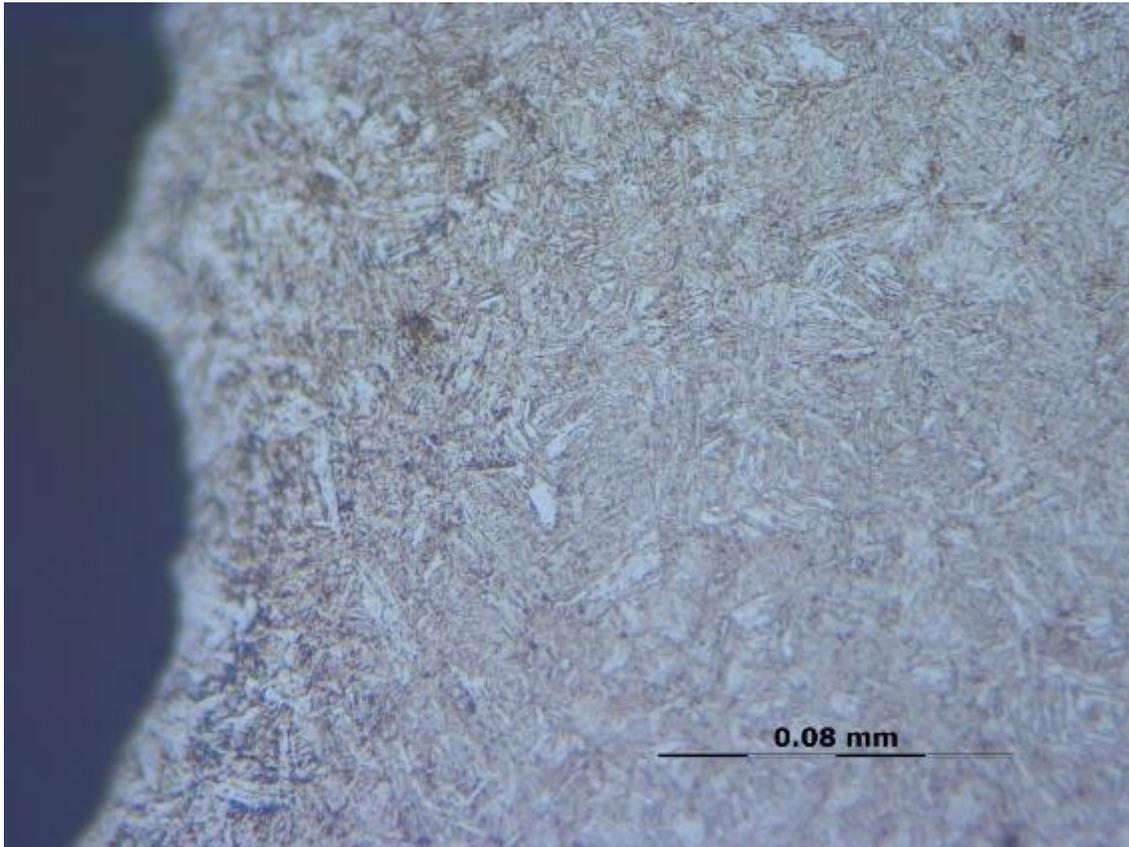
Figure B-8-9 Cross section, fractured link: Quenched and tempered microstructure close to outer surface.

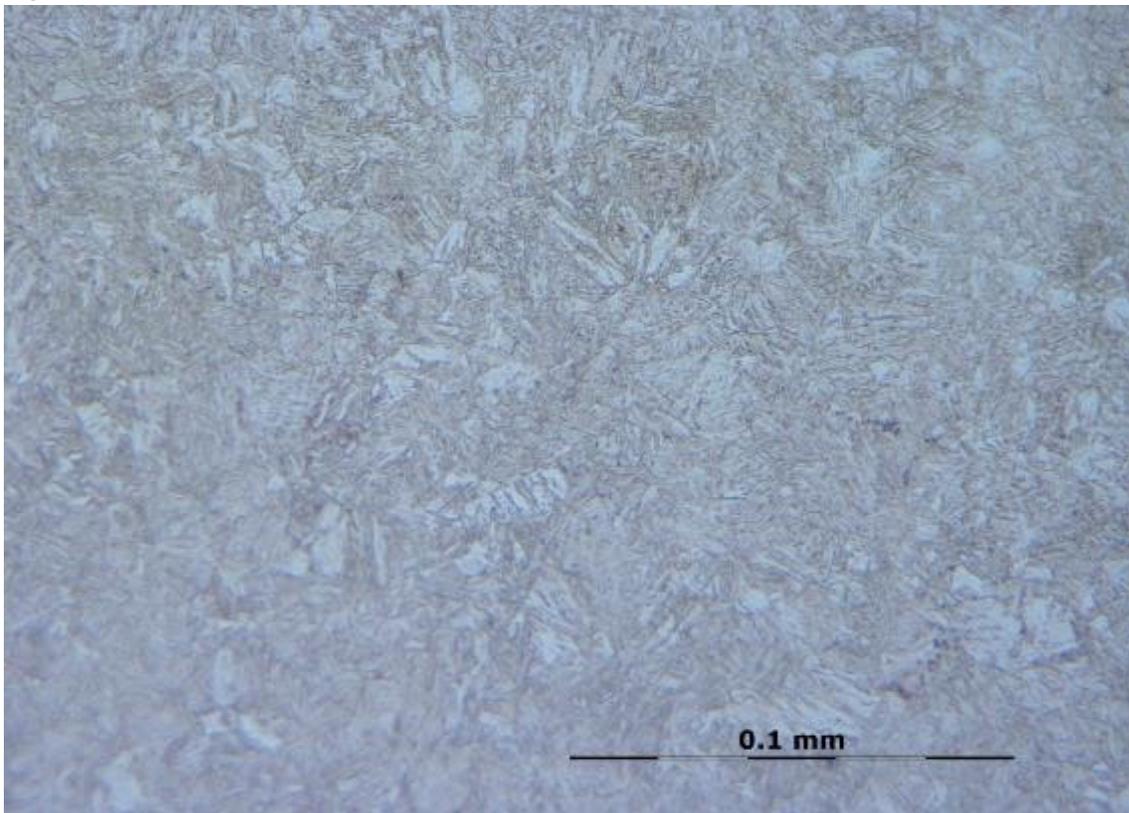
Figure B-8-10 Cross section, fractured link: Quenched and tempered microstructure ca 10 mm from outer surface.

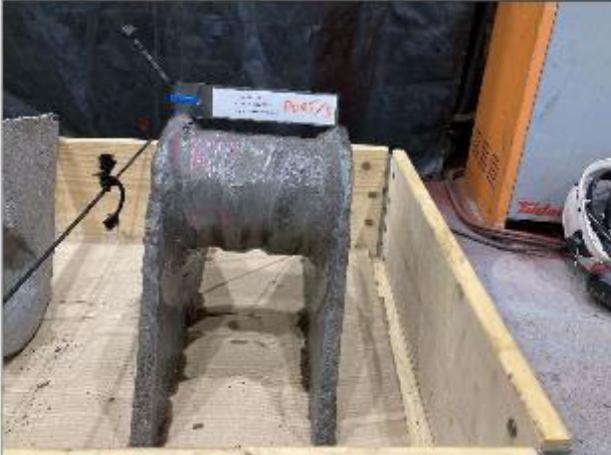
<p>Fi navn / Filename: PORT_3.jpeg</p> <p>Beskrivelse / Description: PORT_3. Indications 3 places</p>

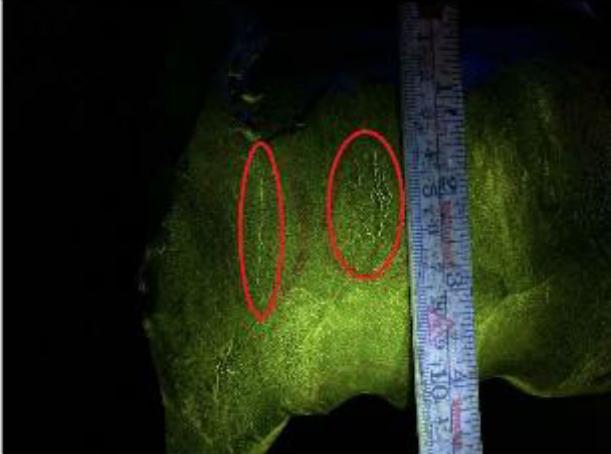
<p>Fi navn / Filename: Head1.jpg</p> <p>Beskrivelse / Description: Indication 1&2</p>

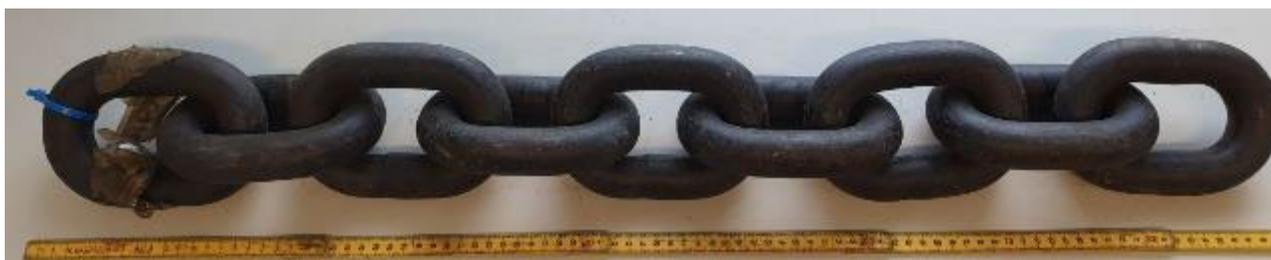
Figure 4-2 Sample BJC/2, unused (reference) section of chain.

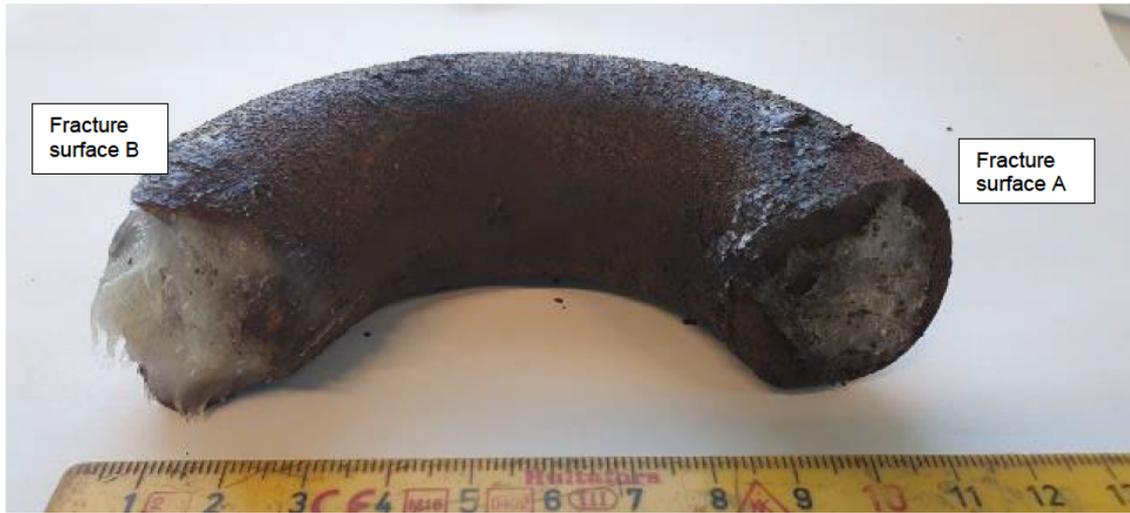
Figure 4-4 Sample BJC/4, part of fractured link, portside chain. The letters A and B is used further for identification of the two fracture surfaces.

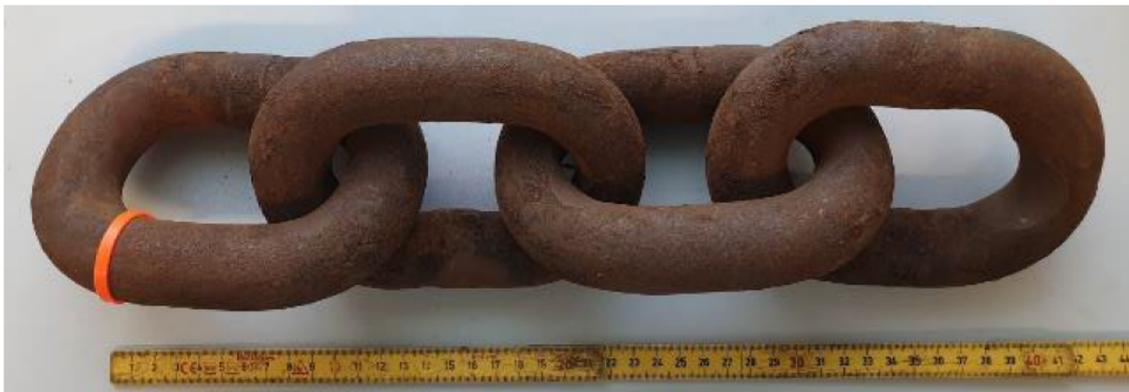
Figure 4-5 Sample BJC/5, part of portside chain, towards trawl.

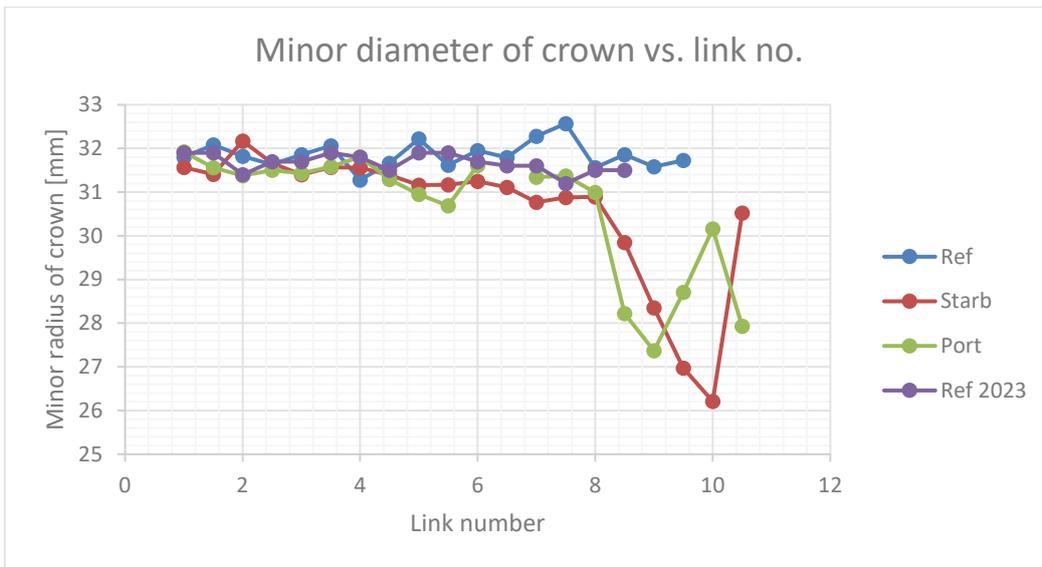
No significant dimensional difference between the currently examined chain links and the previously examined chain links is seen, except for the measurements in the crown indicating interlink wear on the used chain segments /1/.

Figure 3-10 Measured minor crown diameter plotted versus link number for all examined chain segments.

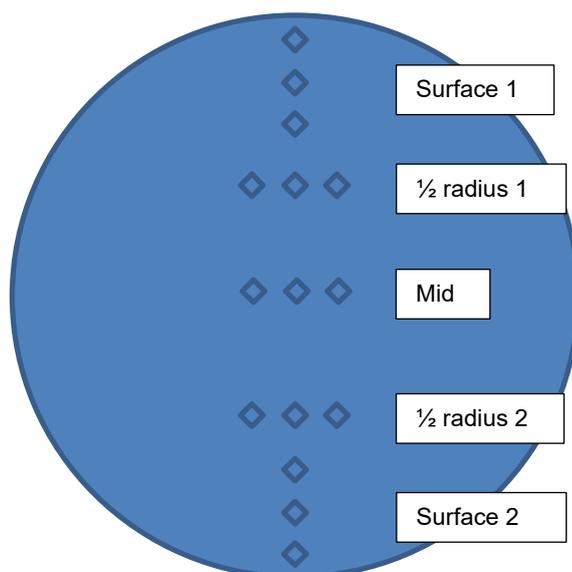
The obtained hardness results are lower compared to the previously performed testing, total average value of 406 HV10 compared to values in the range of 426-431 HV10 in previous testing. The same trend is seen through the survey, a higher hardness is measured in the core compared to the surface for all hardness surveys.

According to a test certificate from the manufacturer, forwarded by the client (given in Appendix B), the expected hardness is 375 HB, corresponding to 380 HV10, according to NS-EN ISO 18265 /7/. Brinell hardness cannot be compared directly to Vickers hardness, however an estimated converted value for Vickers hardness is found, using NS-EN ISO 18265 /7/. The obtained results are significantly above this value.

Figure 3-12 Drawing showing the schematic position of the hardness measurements. Note that the drawing is not to scale. The distance between the measurements in each group is 1 mm.

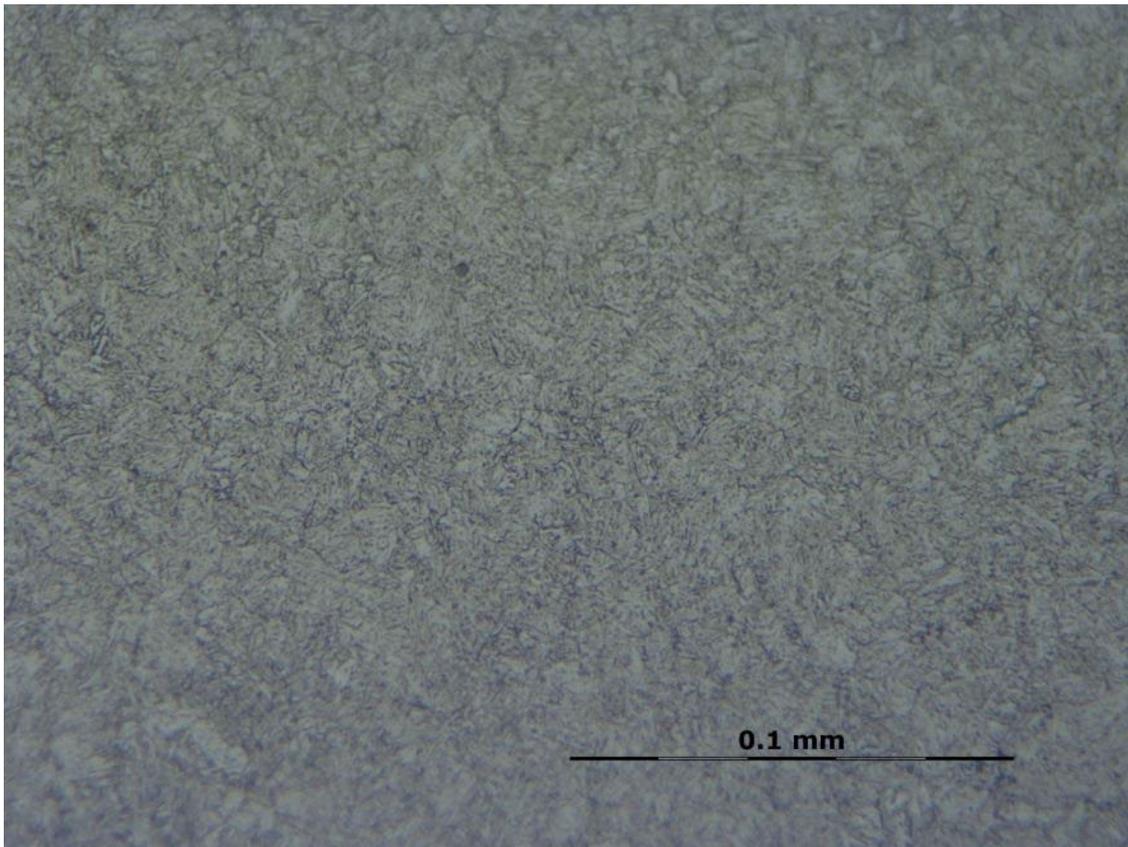
The examined cross section had a quenched and tempered microstructure, as expected. This is also as specified both in NS-EN ISO 818-2 and ASTM A391 /2-3/. No significant differences are observed between different areas of the cross section. Also, no significant difference was observed between the examined link and the links from chain segments examined previously /1/.

Figure 3-13 MJA/4, link 1. Representative quenched and tempered microstructure.

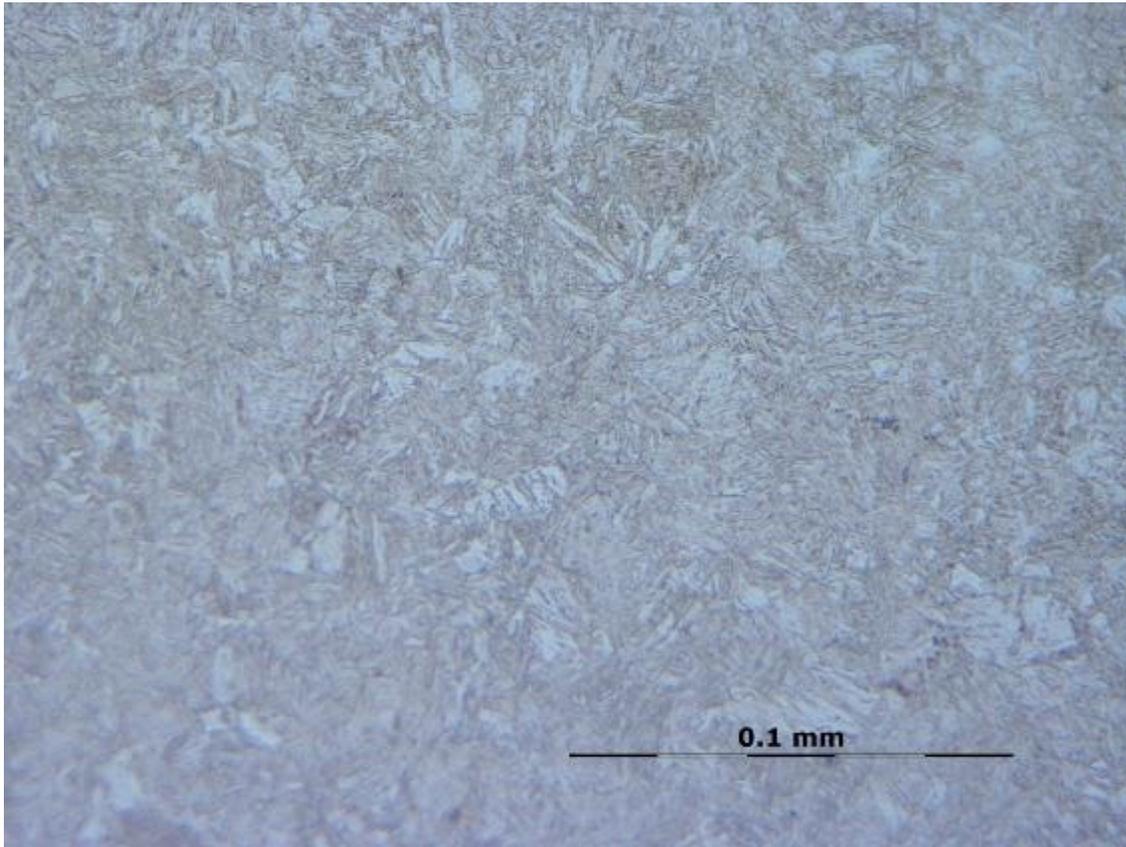
Figure 3-14 Sample BJC/4 (Fractured link). Representative quenched and tempered microstructure.

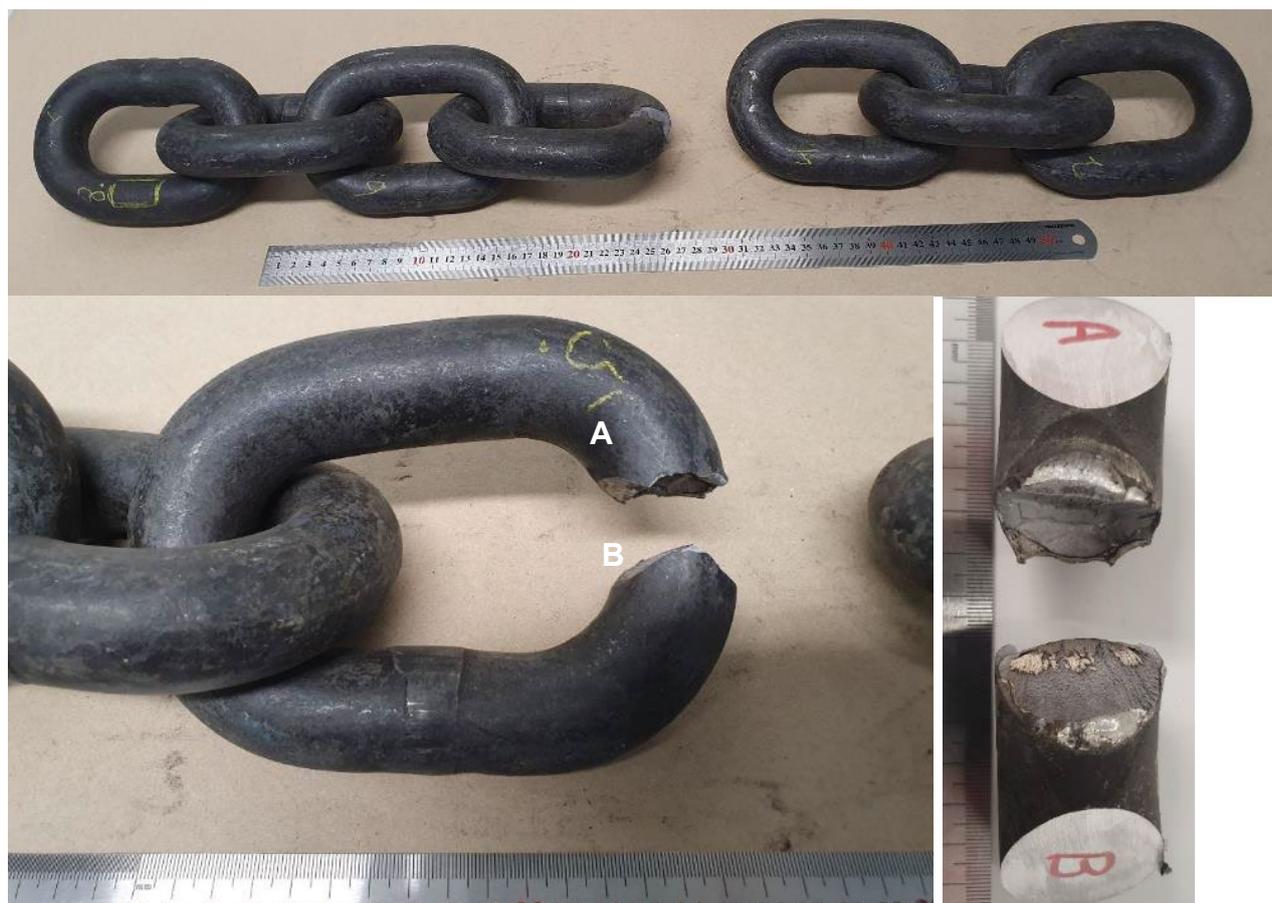
Compared to the previous testing, the position of the fracture, the break load and the overview of the fracture appears similar to what was obtained for Part BJC/2, unused reference chain. Images showing this are presented in Figure 3-17 and Figure 3-18.

Figure 3-17 Part MJA/4: Sample after break load testing.

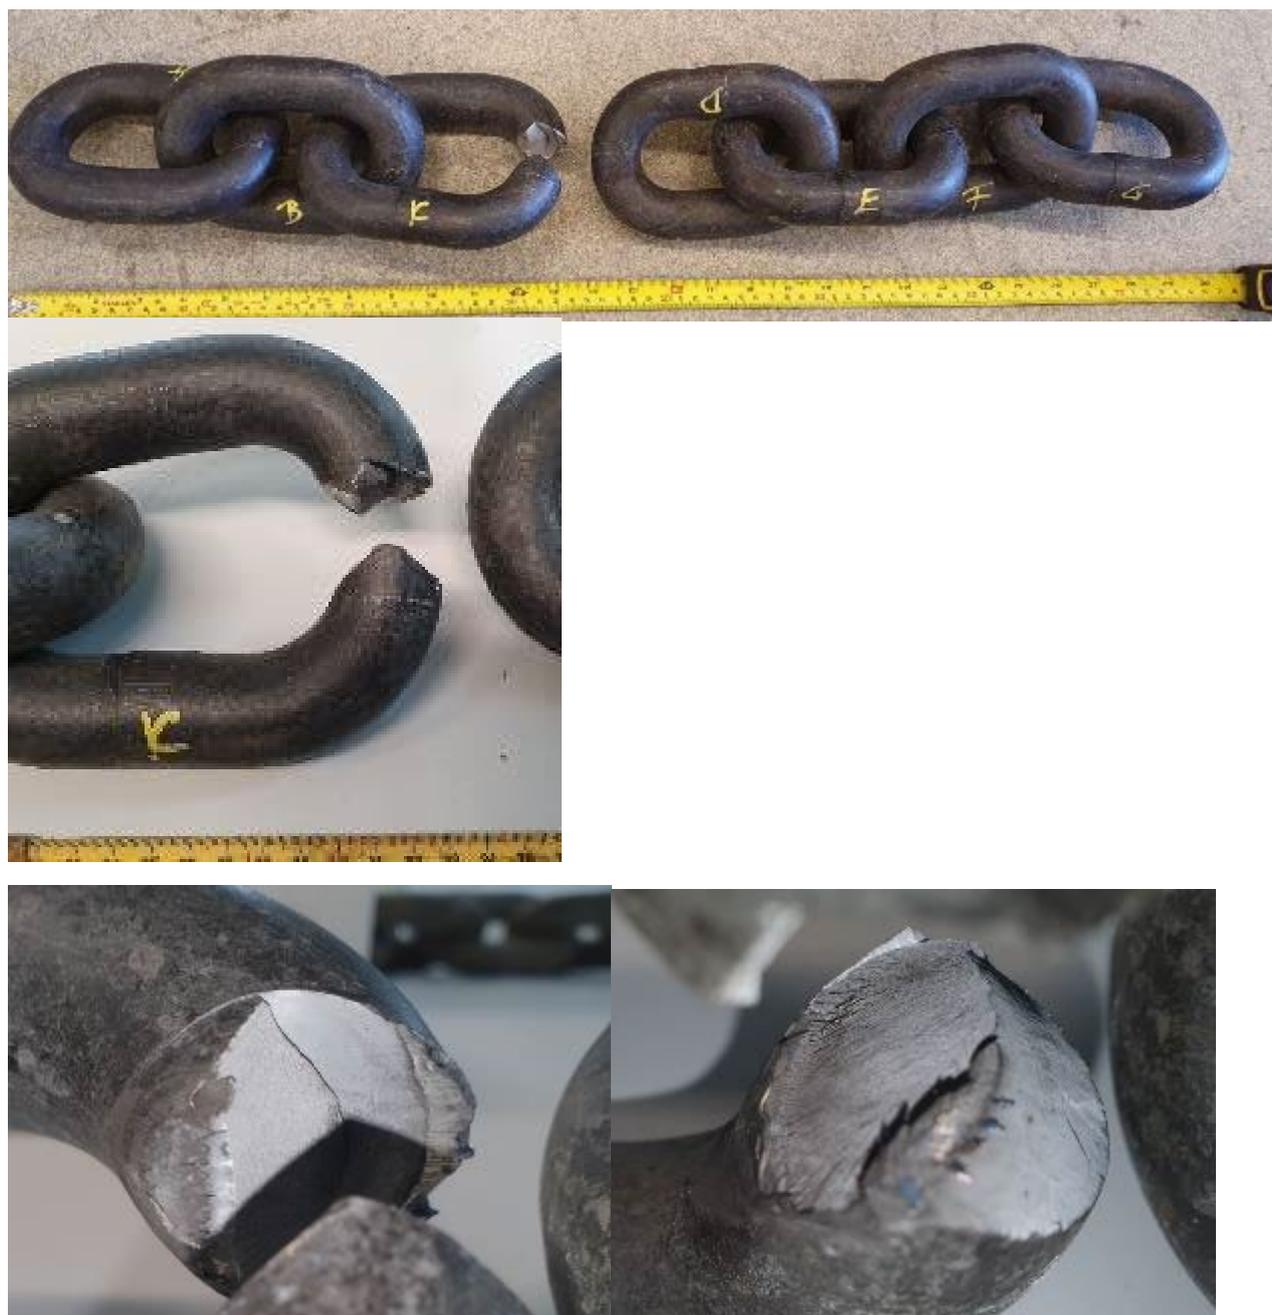
Figure 3-18 Part BJC/2: Sample after break load testing.

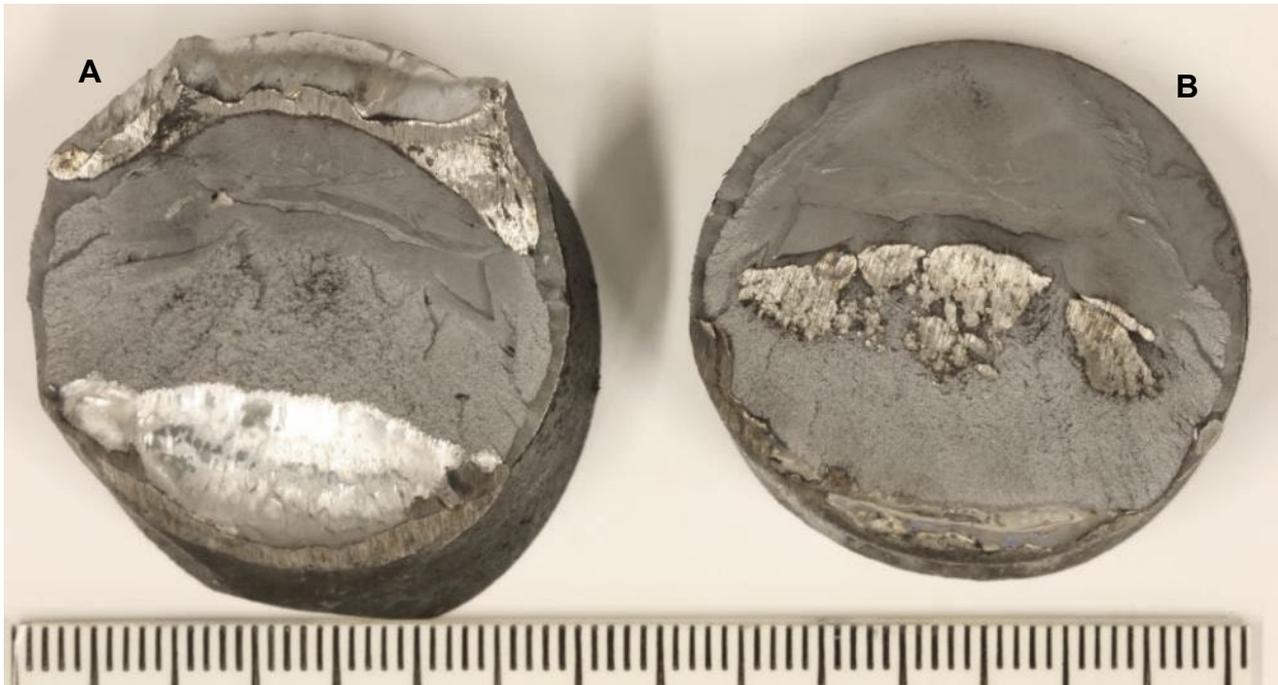
Overview images showing the two fracture surfaces from break load testing are presented in Figure 3-19. Parts of the fracture surfaces are deformed as the neighbouring chain link was pulled through the opening, seen as shiny areas in Figure 3-19. Fracture surface B was chosen for further examination due to less post-fracture deformation.

Figure 3-19 Part MJA/4: Overview images showing the fracture surfaces from break load testing. The inner part of the crown (intrados) is shown downwards.
