Failure of chain link investigation on board *Cornishman* report no. 2021-5360

FAILURE OF CHAIN LINK ONBOARD CORNISHMAN

Failure investigation

Report No.: 2021-5360, Rev. 0

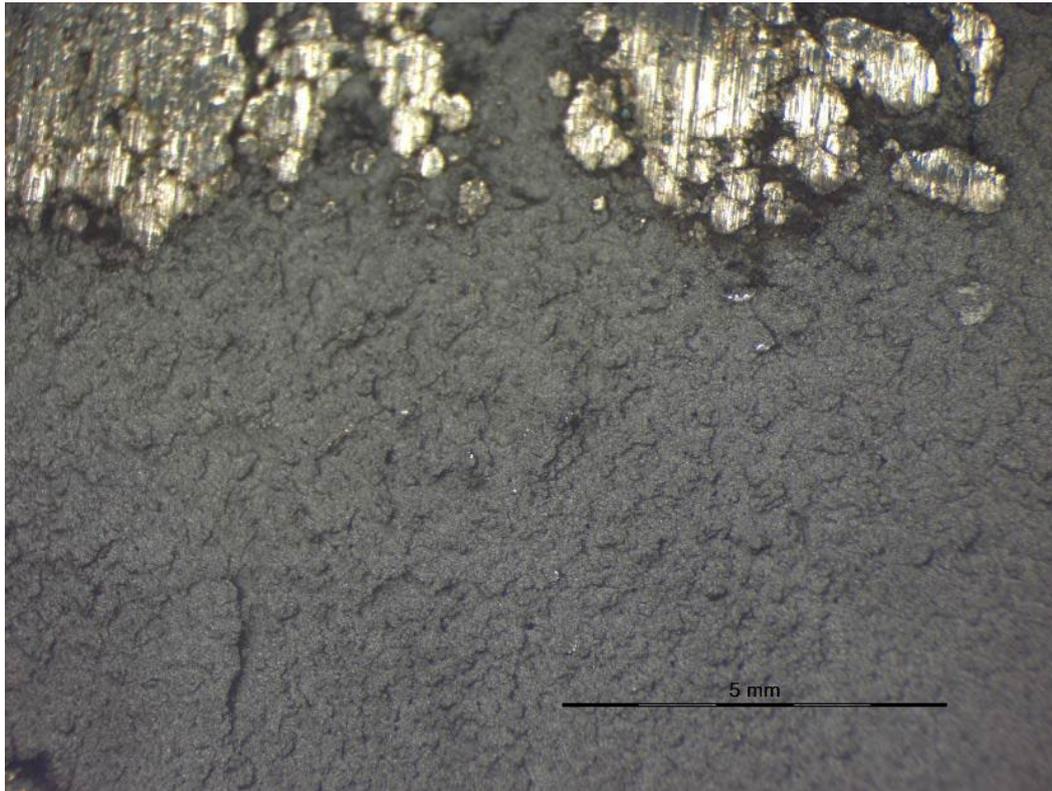
Fracture surface B has two main areas, separated by a deformed area across the mid-height of the surface. Typical low magnification fracture topography of the two different areas is shown in Figure 3-20 and Figure 3-21. The inner part of the fracture surface has a rougher appearance compared to the outer part. Somewhat above (outside) of the deformed area, a stripe pattern is observed, as shown in Figure 3-22.

Figure 3-20 Part MJA/4: Typical appearance of the inner (lower) part of fracture surface B from break load testing.

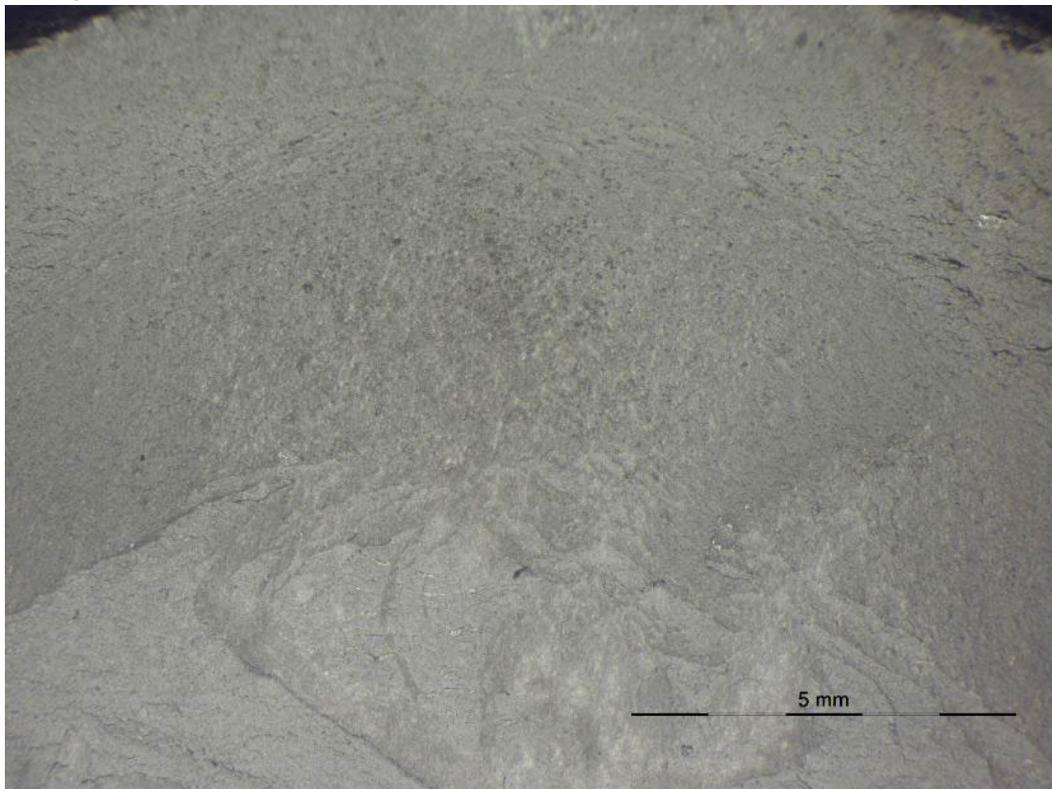
Figure 3-21 Part MJA/4: Typical appearance of the outer (upper) part of fracture surface B from break load testing.

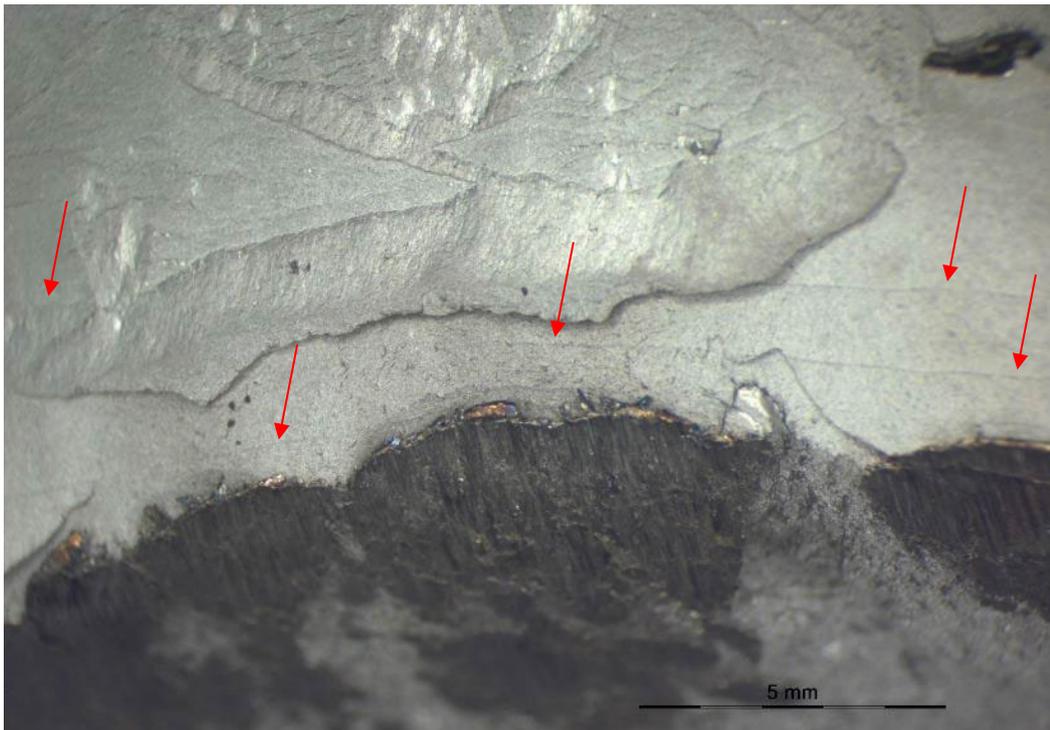
Figure 3-22 Part MJA/4: Stripe pattern observed in the mid part of fracture surface B from break load testing.

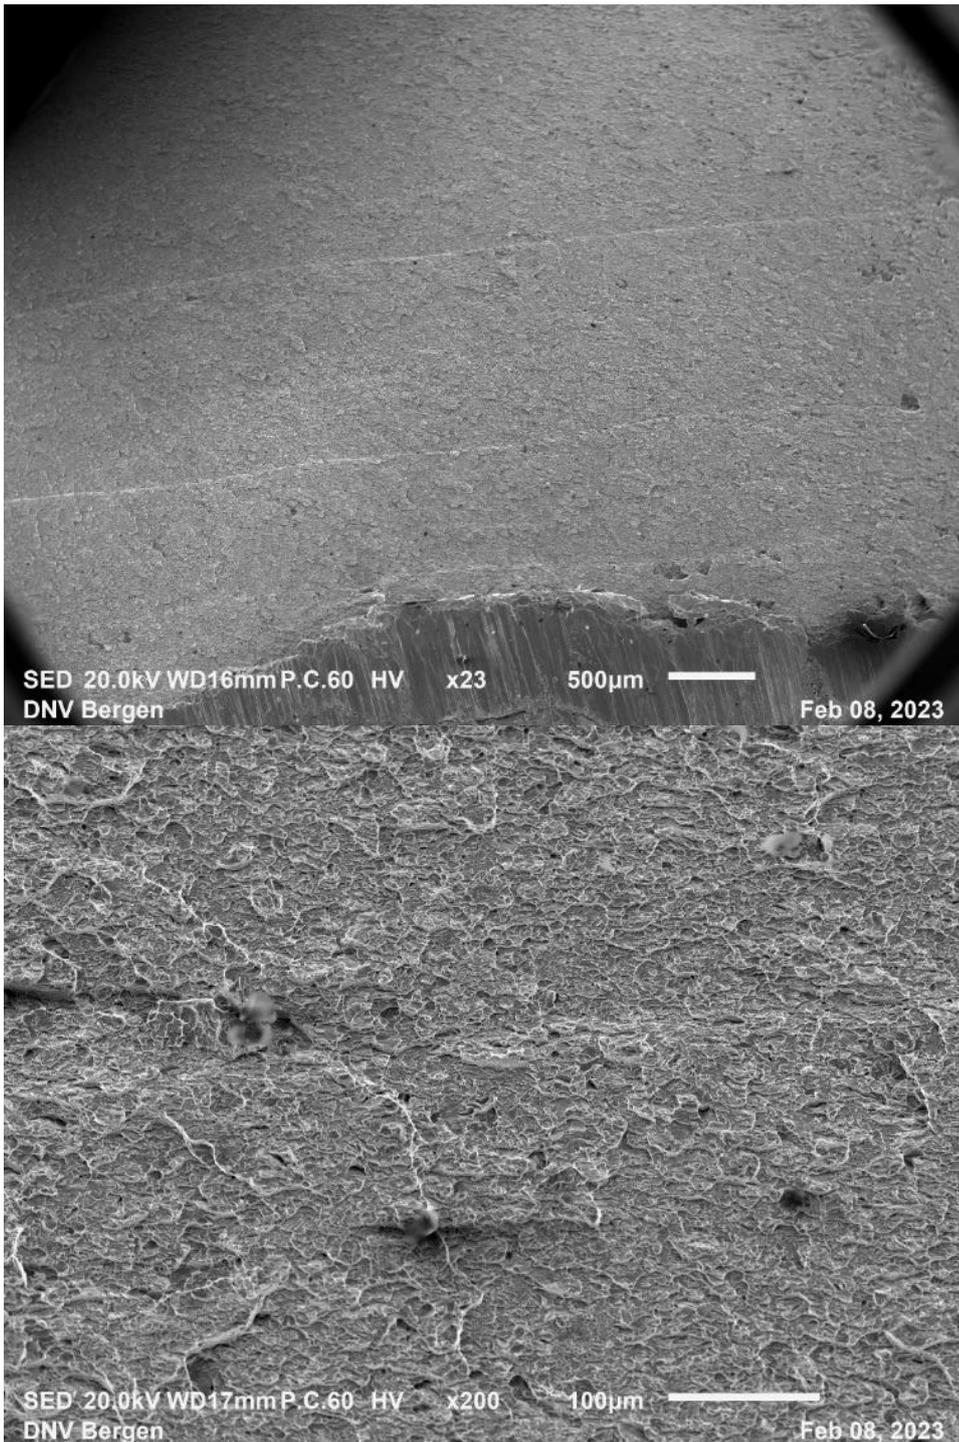
Figure 3-24 shows the stripe pattern observed at lower magnification, see Figure 3-22. The high magnification images shows that the stripes are not cracks, only unevenness in the fracture surface, most likely formed due to propagation of the crack front.

Figure 3-24 Part MJA/4, area 1: Observed stripe pattern does not indicate cracks, however only unevenness in fracture surface.

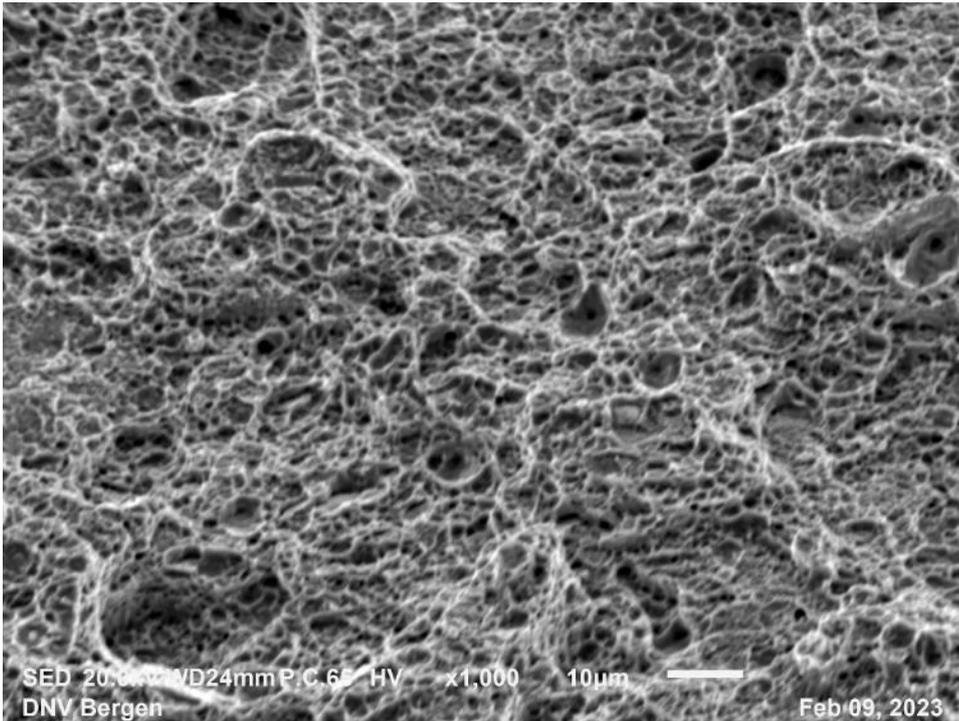
Images from the outer (upper) part of the fracture surface are given in Figure 3-25 and Figure 3-26. Figure 3-25 shows a dimple topography typical for ductile overload in the mid of the upper area. Figure 3-26 shows a mixture of ductile and brittle area a bit to the side of the fracture surface.

Figure 3-25 Part MJA/4, area 2: Dimple topography typical for ductile overload, in the middle of the upper area.

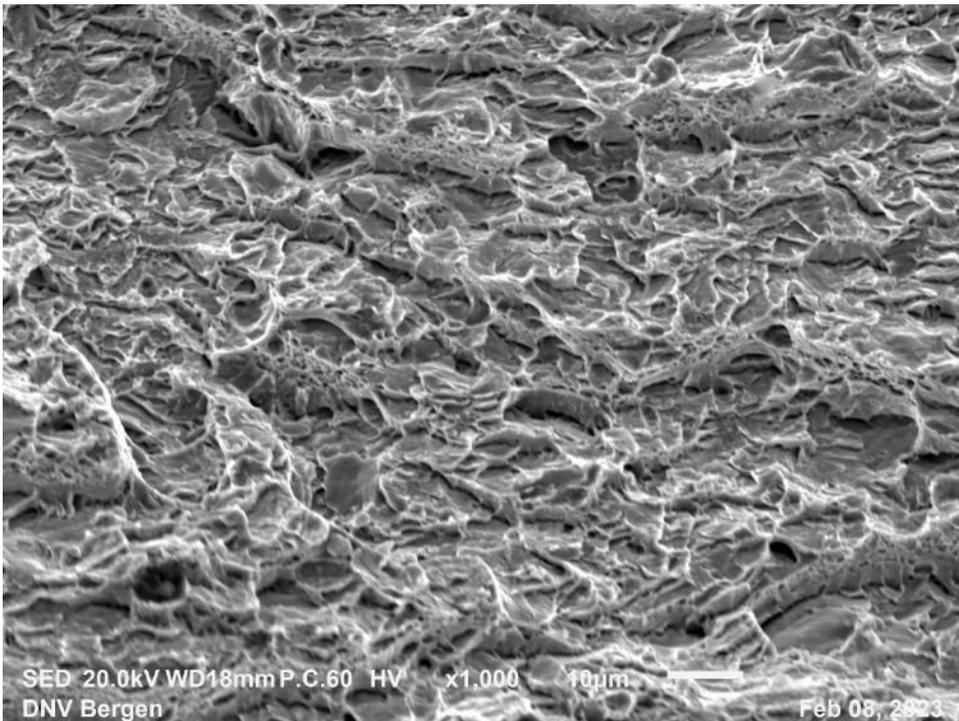
Figure 3-26 Part MJA/4, area 3: Mixture of dimple topography and cleavage fracture.

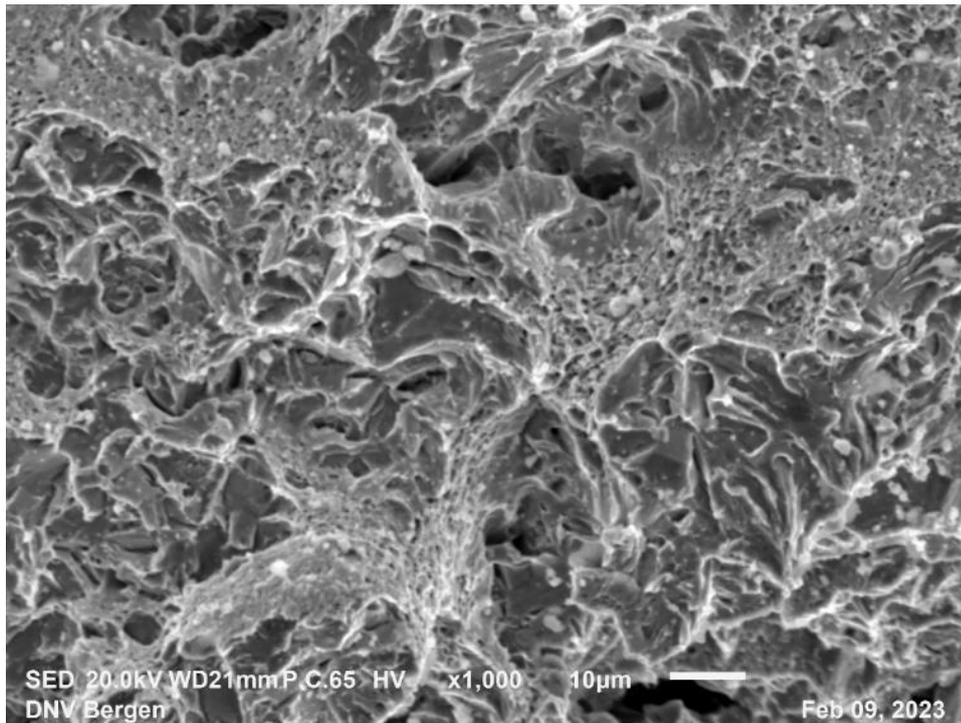
Images from the inner (lower) part of the fracture surface are given in Figure 3-27 to Figure 3-30. The fracture surface has a mainly brittle appearance, with a large portion of cleavage fracture, however areas of dimple topography is seen in between the more brittle areas.

Figure 3-28 Part MJA/4, area 5: Mixture of dimple topography and cleavage fracture.

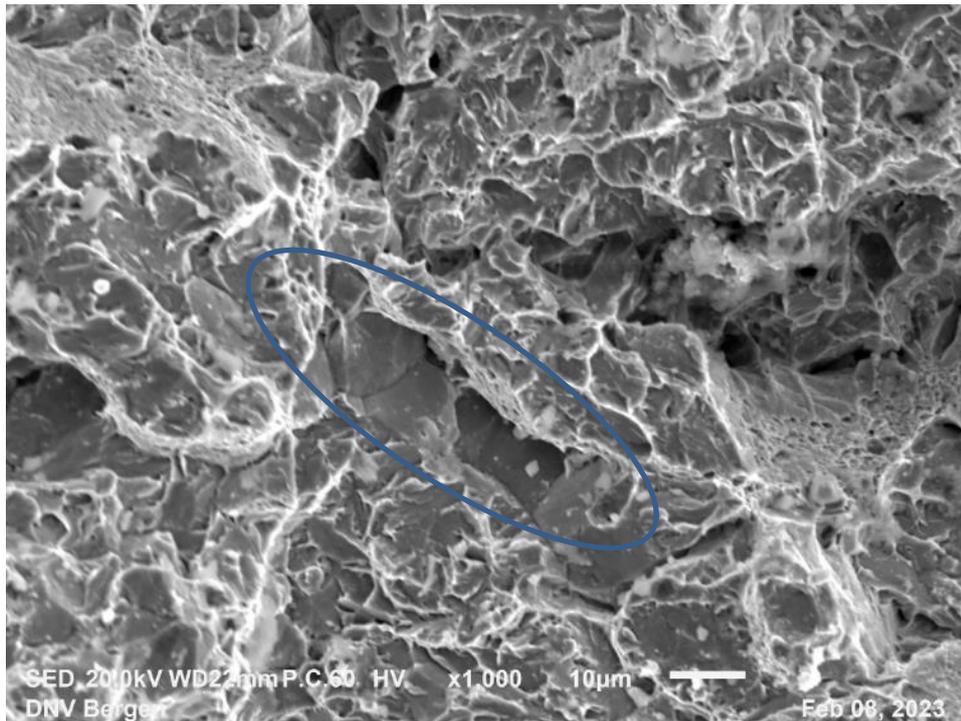
Figure 3-29 Part MJA/4, area 6: Mixture of intergranular cracking (encircled area), cleavage fracture and dimple topography.

Based on the finding of areas of intergranular cracking on the fracture surface from break load testing, hydrogen should be discussed as a possible contributing cause, as intergranular cracking is a typical observation in hydrogen-related crack growth. Hydrogen-related cracking is generally dependent on a combination of three different factors /9/: Presence of hydrogen, tensile stress and a susceptible material. Based on the high hardness of the material in all the examined chain samples, the material is considered susceptible to hydrogen embrittlement and/or hydrogen-assisted cracking, see also assessment of hardness of chain material in previous report /1/. Potential sources of hydrogen are limited to production, as no damage of the coating or corrosion has been seen visually, excluding potential external sources. The chain samples (both reference chain from 2021, BJC/2 and current sample MJA/4) are also stored in relatively dry conditions, hence not exposed to significant corrosion giving potential hydrogen formation. As the chain segment has not been in use, it has not been loaded after production (proof loading at manufacturer), apart from potential residual stress. During cutting of the chain links, compressive residual stresses were noted, as the saw blade got caught in the chain link, as soon as the link was cut through. Based on an assessment of all the three factors, it is not very likely that hydrogen is a contributing cause for the low actual break load. The areas of intergranular crack growth can also be a direct result of the high strength material.

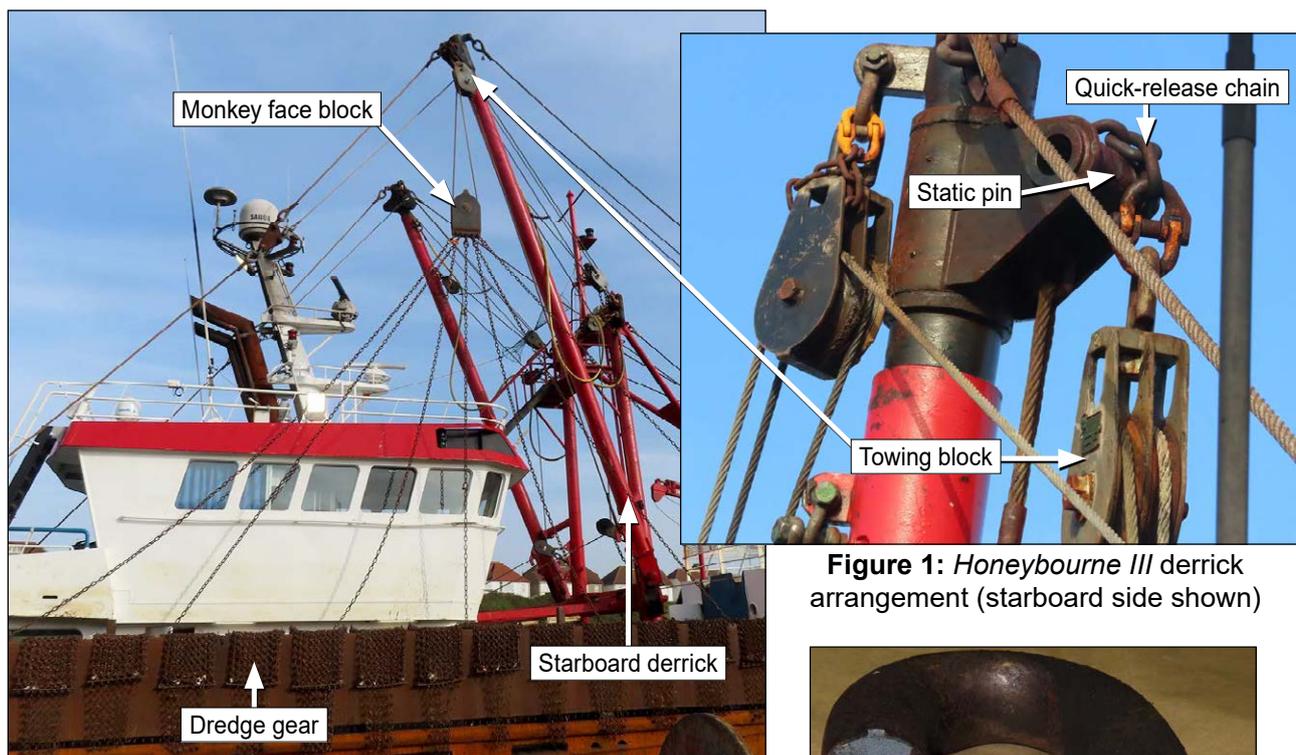
The ongoing MAIB investigation has found that a section of chain in the port dredging gear quick-release assembly failed as the gear was being retrieved. A 32mm chain link, which was led over a static steel pin at the derrick head (**Figure 1**), parted (**Figure 2**) and allowed the towing block, monkey face block and associated gear to fall to the deck below.

Figure 1: *Honeybourne III* derrick arrangement (starboard side shown)

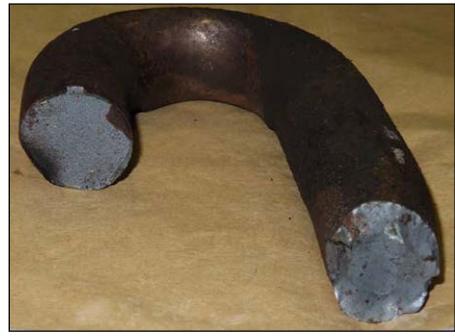
Figure 2: Failed chain link on *Honeybourne III*

It is therefore imperative in the short-term that these types of release mechanisms and derrick head pins are subject to regular inspection and replaced at the earliest sign of wear.

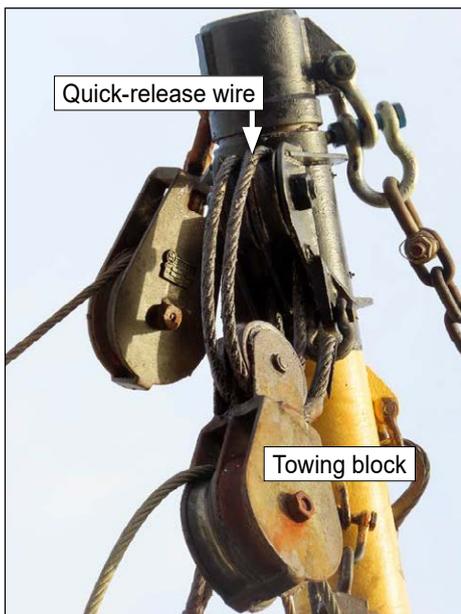
Figure 4: Quick-release arrangement with derrick head quick-release wire and sheave

Alternative arrangements for the quick-release mechanisms at the derrick head that either do not include a chain passing over a static pin, or remove the risk of the gear falling in the event of a failure, have been fitted to vessels to mitigate the risk of gear falling from height in the event of a failure of the chain arrangement. The alternative configurations observed by the MAIB have included the use of wire and sheave arrangements (**Figure 4**), the replacement of the derrick head arrangement with a swinging arm mechanism (**Figure 5**), and the provision of warp tension monitoring and release systems. Options have also been suggested for a secondary means of retaining the gear, in addition to the chain, to prevent the gear from falling in the event of a chain failure while still allowing the release of the gear in an emergency (**Figure 6**).

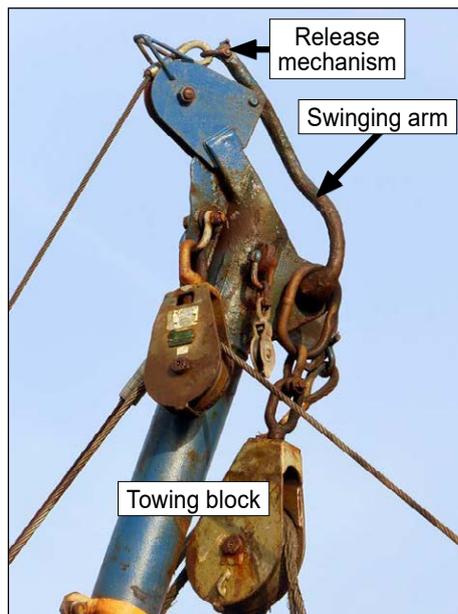
Figure 5: Quick-release arrangement with derrick head swinging arm

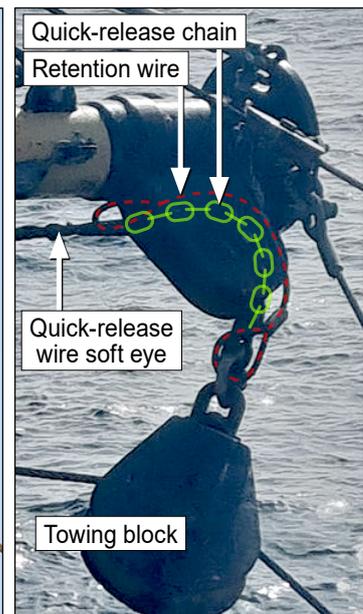
Figure 6: Quick-release arrangement with secondary means of gear retention

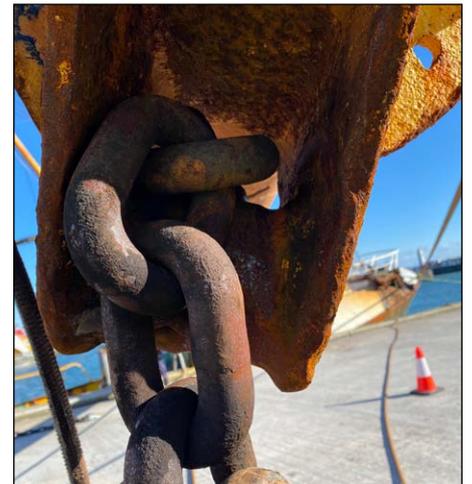
The investigation established that a 32mm Grade 8 chain link forming part of the port trawl gear's quick-release mechanism supporting the port beam had fractured and allowed the beam to fall. The chain was operated over a 150mm diameter fixed steel pin (**Figure 1**) at the top of the derrick; both the chain and its links were found to be corroded, heavily worn, and cracked.

Figure 1: Quick-release chain over fixed steel pin
