Report on the investigation of  
the fatal accident to a deckhand on board the  
beam trawler

***Cornishman (PZ 512)***

44 nautical miles south-south-west of the Isles of  
Scilly, England

on 6 February 2021

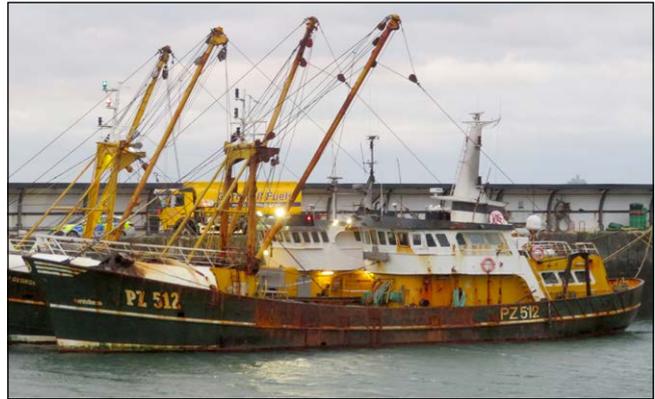
**Figure 1:** *Cornishman*

At 1830 on 31 January 2021, the beam trawler *Cornishman* (**Figure 1**) departed Newlyn, England and proceeded to its fishing grounds approximately 44 nautical miles south-south-west of the Isles of Scilly, England. The six crew on board experienced heavy weather for the first 3 days, but conditions gradually improved towards the end of the week and, by 6 February, the weather was clear and dry and the sea was calm with a slight swell.

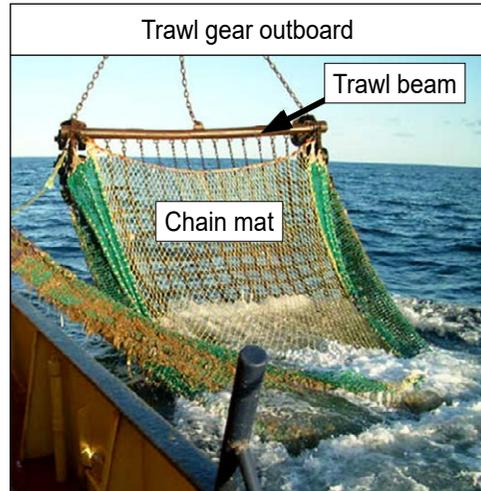
**Figure 2:** Cornishman's net arrangement

The head of the fishing net mouth was attached directly to the beam. The bottom of the fishing net mouth was attached to a chain mat via the footrope, the ends of which were also then attached to the beam. The chain mat was a series of linked chains connected by further chain links and shackles (see **Figure 2**).

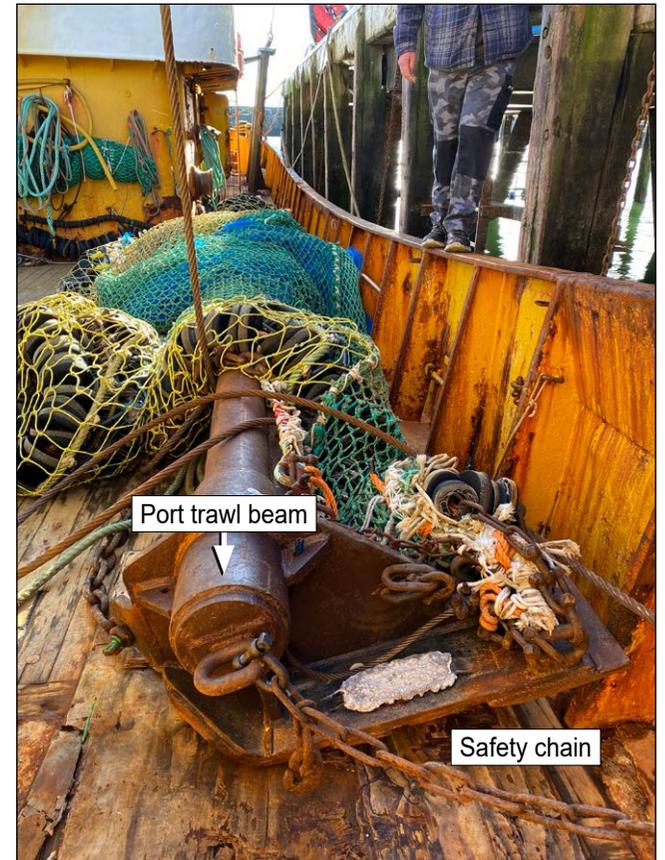
**Figure 3:** Port trawl beam and forward safety chain

At 0545 on 6 February, the four deckhands started hauling in the nets. The mate had just taken over the watch in the wheelhouse and the skipper was resting at the back of the wheelhouse. Two deckhands worked on each side of the vessel and the starboard net was emptied. The rest of the starboard gear, including the beam but excluding the cod end, remained in the hauling position with the derrick suspended at about 45°. When the port trawl gear was retrieved, one of the deckhands (deckhand 1) noticed that a shackle was missing on the third row of the chain mat below the beam (**Figure 2**). Deckhand 1 discussed it with the mate and, having been instructed to replace the shackle, was assisted by two other deckhands to secure the port trawl beam using the safety chains at either end of it (**Figure 3**).

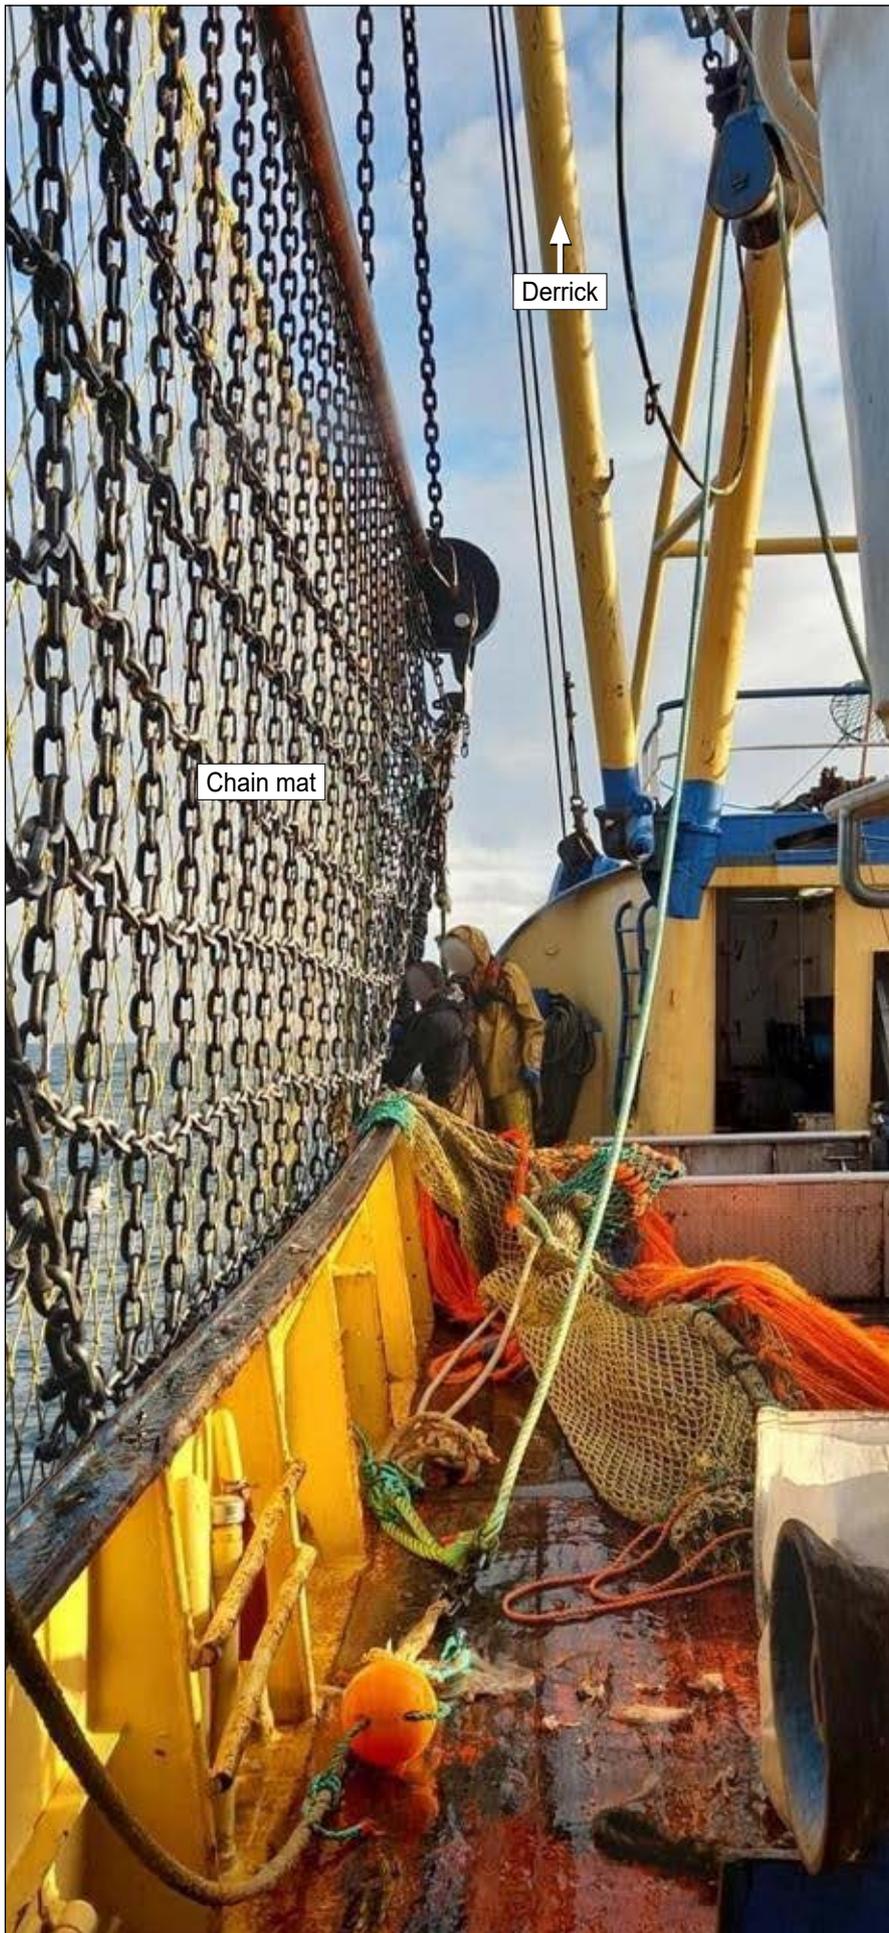
**Figure 4: Port chain mat suspended outboard**

At about 0620, the mate raised the port derrick to ensure the safety chains held the trawl beam taut alongside the vessel at between 3m to 3.5m above the deck and about 10° from the vertical so that the trawl gear, including the chain mat, was hanging slightly outboard (**Figure 4**). The third row of the chain mat was positioned at about bulwark level. One of the deckhands collected a pneumatic spanner (air gun) from the engine room and handed it to deckhand 1 while the other deckhand brought the compressed airline from forward of the gantry. The vessel was rolling steadily in the sea conditions.

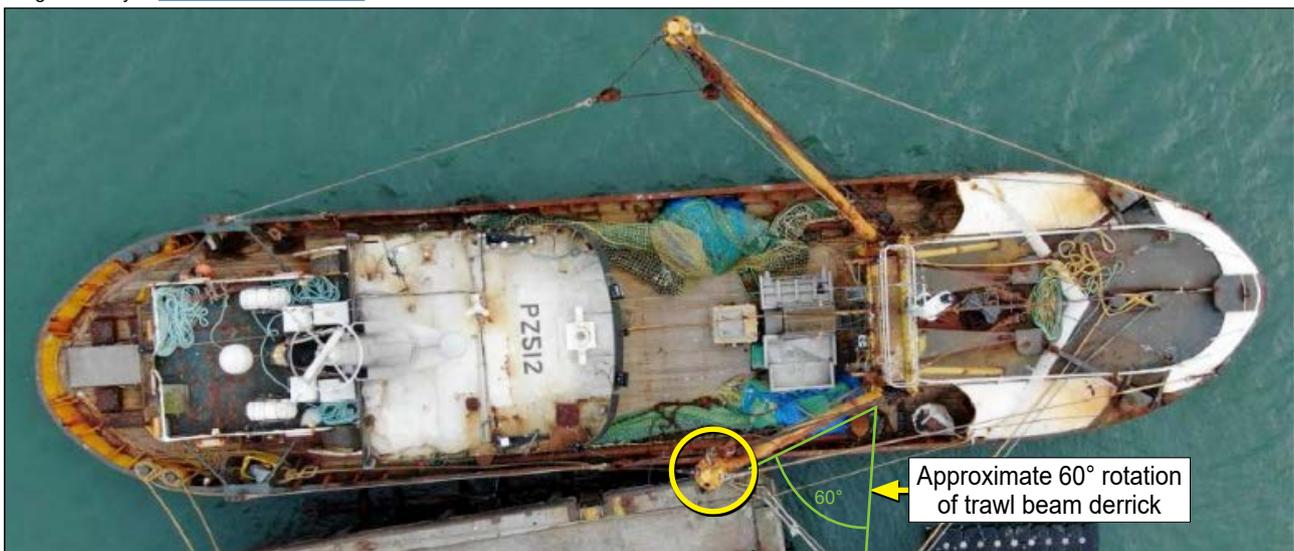
**Figure 7:** Overhead view of *Cornishman*'s derricks

*Cornishman* was a twin beam trawler that used port and starboard derricks to operate the vessel's trawl beams and fishing nets. The derrick heads were free to rotate by approximately 60° in the horizontal plane to accommodate the movements of the trawl gear (**Figure 7**). Both derricks were lowered to a near horizontal position just above sea level during trawling, when it was normal for the top portion of the derricks, including the chain of the quick-release gear, pulley block, shackles and fixed pin, to frequently dip into the water as the vessel rolled to either side (**Figure 8**).

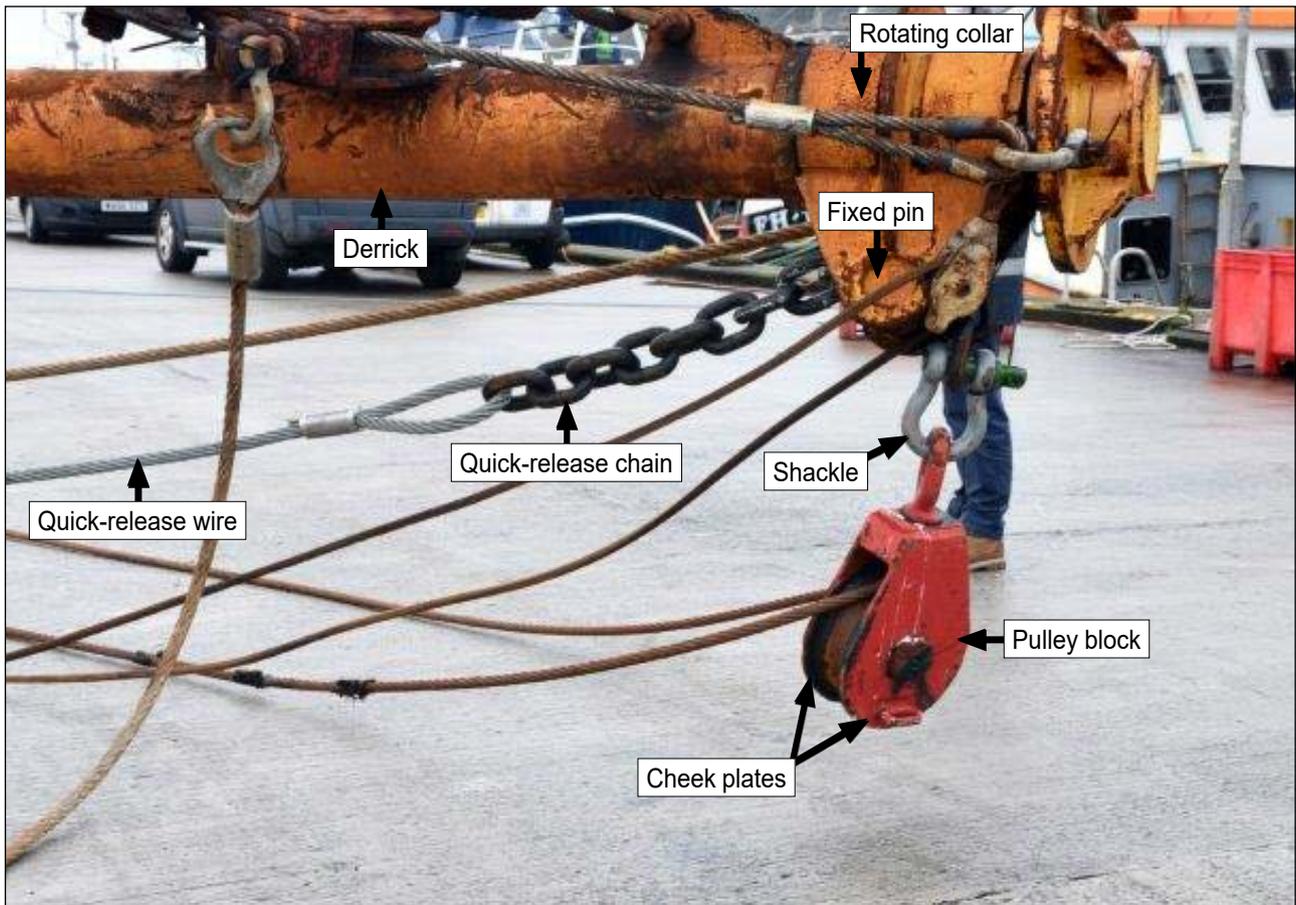
**Figure 8:** *Cornishman's* starboard quick-release gear in lowered position

The pulley blocks were routinely greased before starting a fishing trip when a general appreciation of the condition of the quick-release chain could be achieved. A thorough assessment of either the section of the chain that went around the derrick head's fixed pin or the condition of the derrick head fixed pin with the chain in place was impractical (**Figures 11 and 14**). Close inspection of the quick-release gear required *Cornishman* to be berthed alongside and for the derrick on the vessel's shore side to be lowered until the component parts rested on the quayside; the vessel was then turned and the inspection process repeated for the quick-release gear on the opposite side (see **Figure 8**).

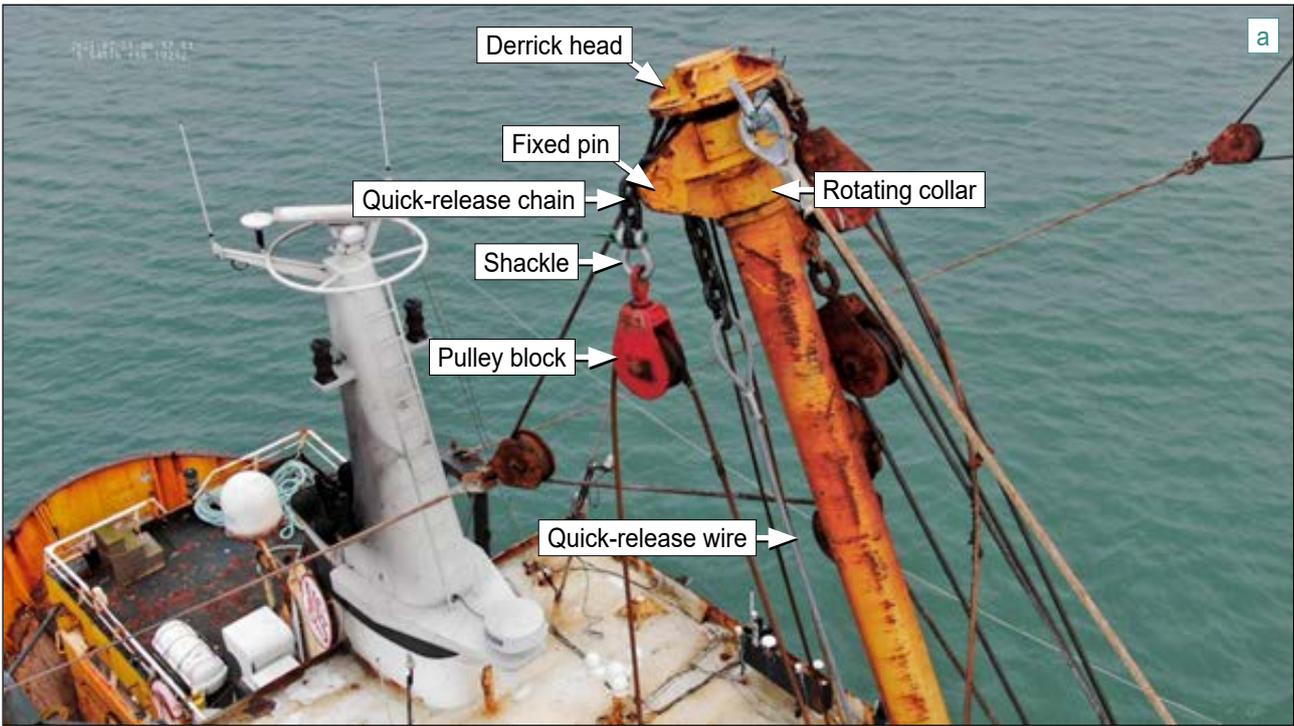
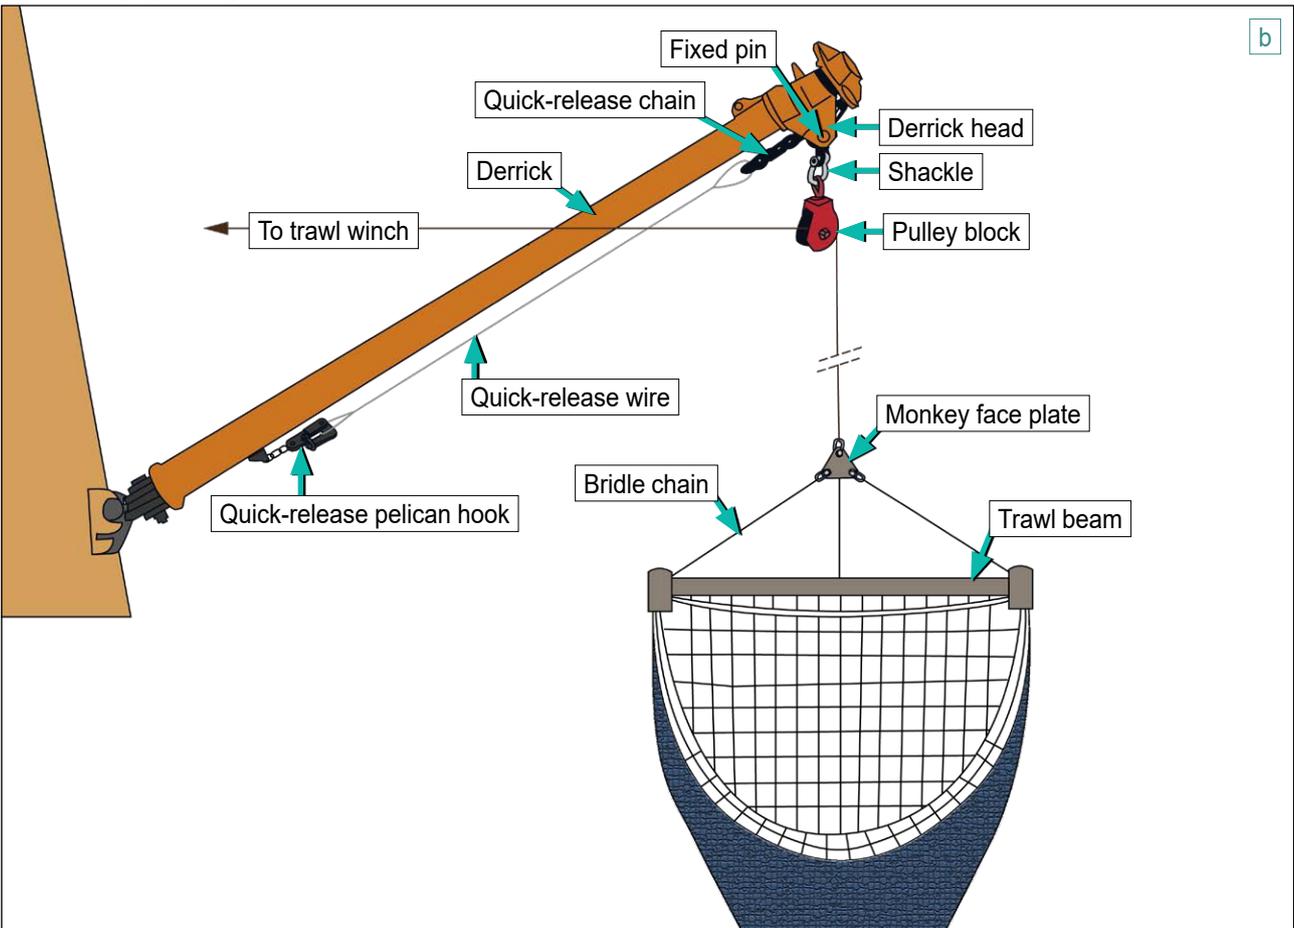
**Figure 9:** *Cornishman's* starboard quick-release system, showing the derrick head (a) and illustration of the quick-release mechanism (b)

*Cornishman's* port and starboard fishing arrangement (**Figure 9**) consisted of a trawl beam suspended from a pulley block, which was connected by a shackle to the quick-release chain passed over the derrick head<sup>6</sup> fixed pin. The trawl warp was fed from the trawl winch through the pulley block to the monkey face plate, which was in turn connected to the trawl beam with bridle chains. The trawl winch enabled the beam to be lowered into the sea so that the trawl gear could be payed out to the required trawling length on the seabed.

between the steel cheek plates of the derrick head and connected to the shackle at the top of the pulley block to support the trawl beam. The D/d ratio<sup>7</sup> of the 150mm fixed pin (D) and 32mm 10-link chain (d) was 4.68 (150/32) when new.

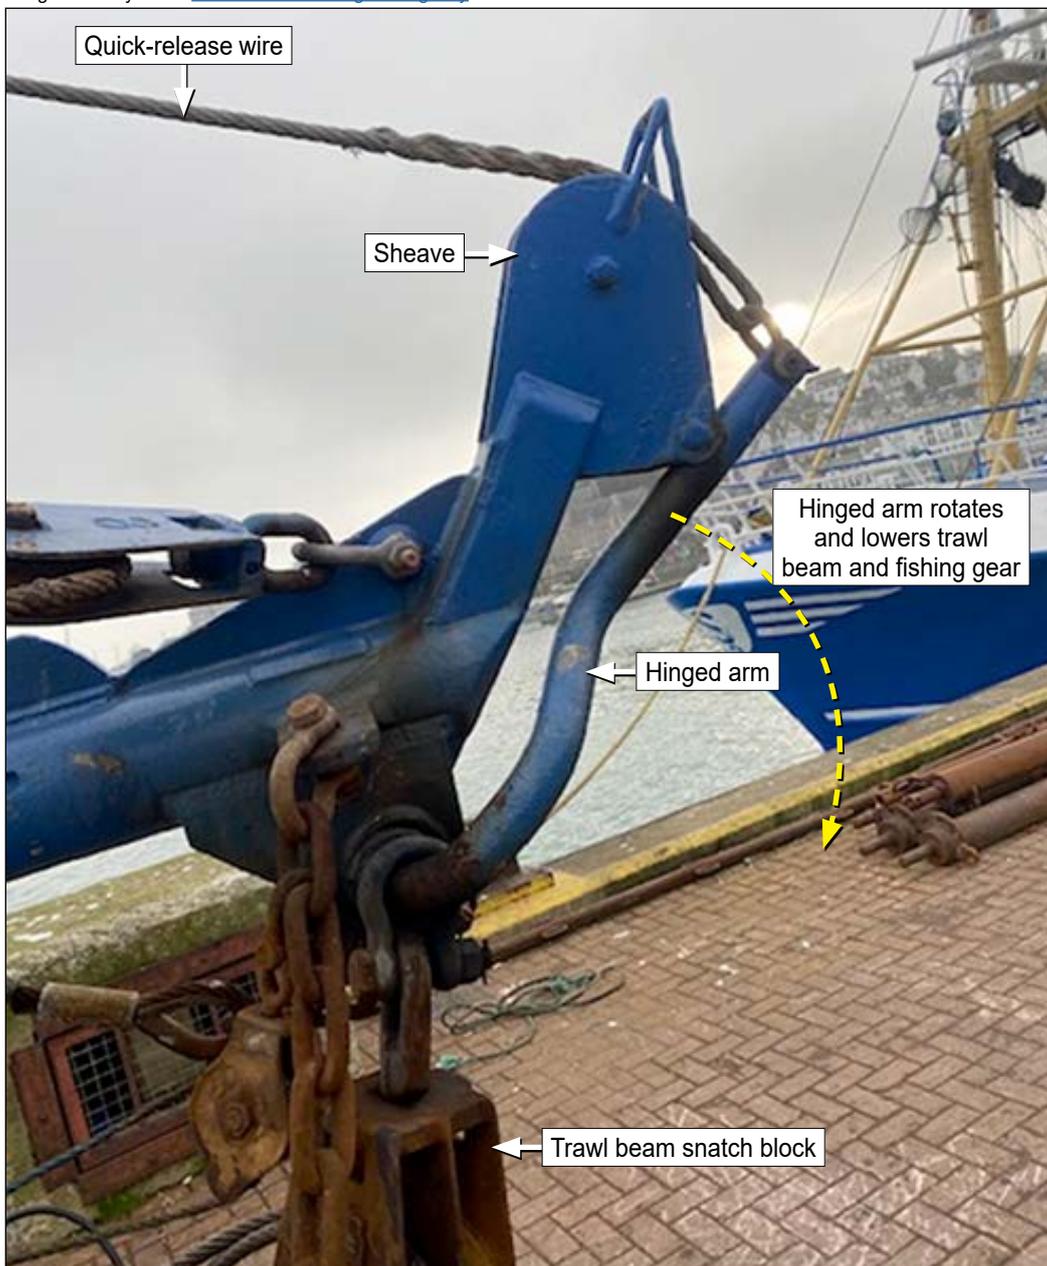
**Figure 15:** Van Damme quick-release arrangement

Other methods of quickly releasing the towing point from the derrick head if the fishing gear became fouled had been developed. These included the Van Damme quick-release system (**Figure 15**). This arrangement used a wire running over a sheave instead of a chain over a pin and worked on a swivel system on the end of the derrick. The release wire connected to a hinged arm at the derrick head and, when released, enabled the trawl beam and fishing gear to move inboard, reducing the capsize forces.

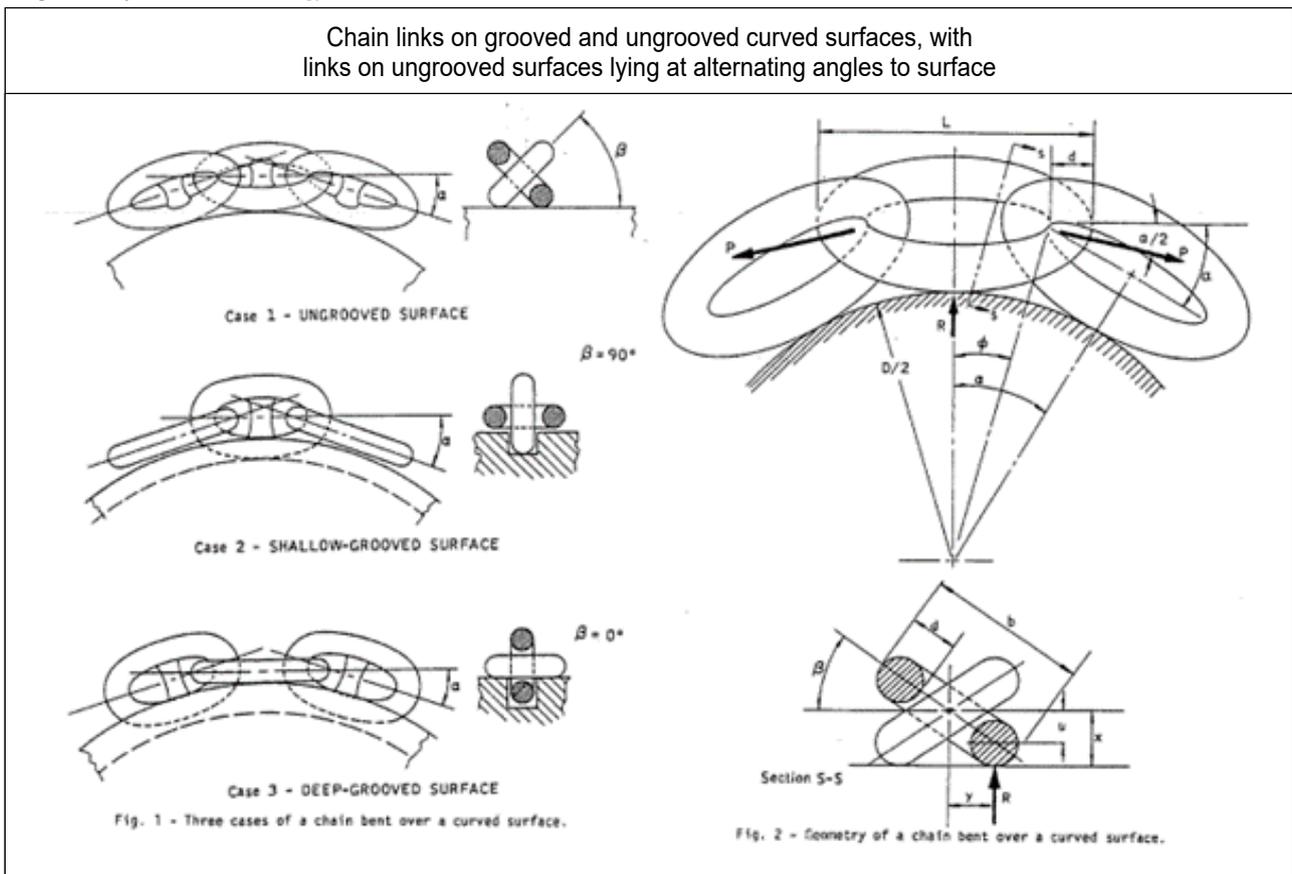
**Figure 19:** Extract from the Offshore Technology Conference technical paper

Analysis of the stresses under different conditions highlighted their complexity: when operating on an ungrooved curved surface with a larger diameter, the chain links were lying at alternating angles to the surface; when the chain was operating over an ungrooved surface with a smaller diameter and only one or several of its links were in contact, the alternating links might lie flat and upright to the surface (**Figure 19**). On surfaces with a very small diameter, only one chain link might be in contact.

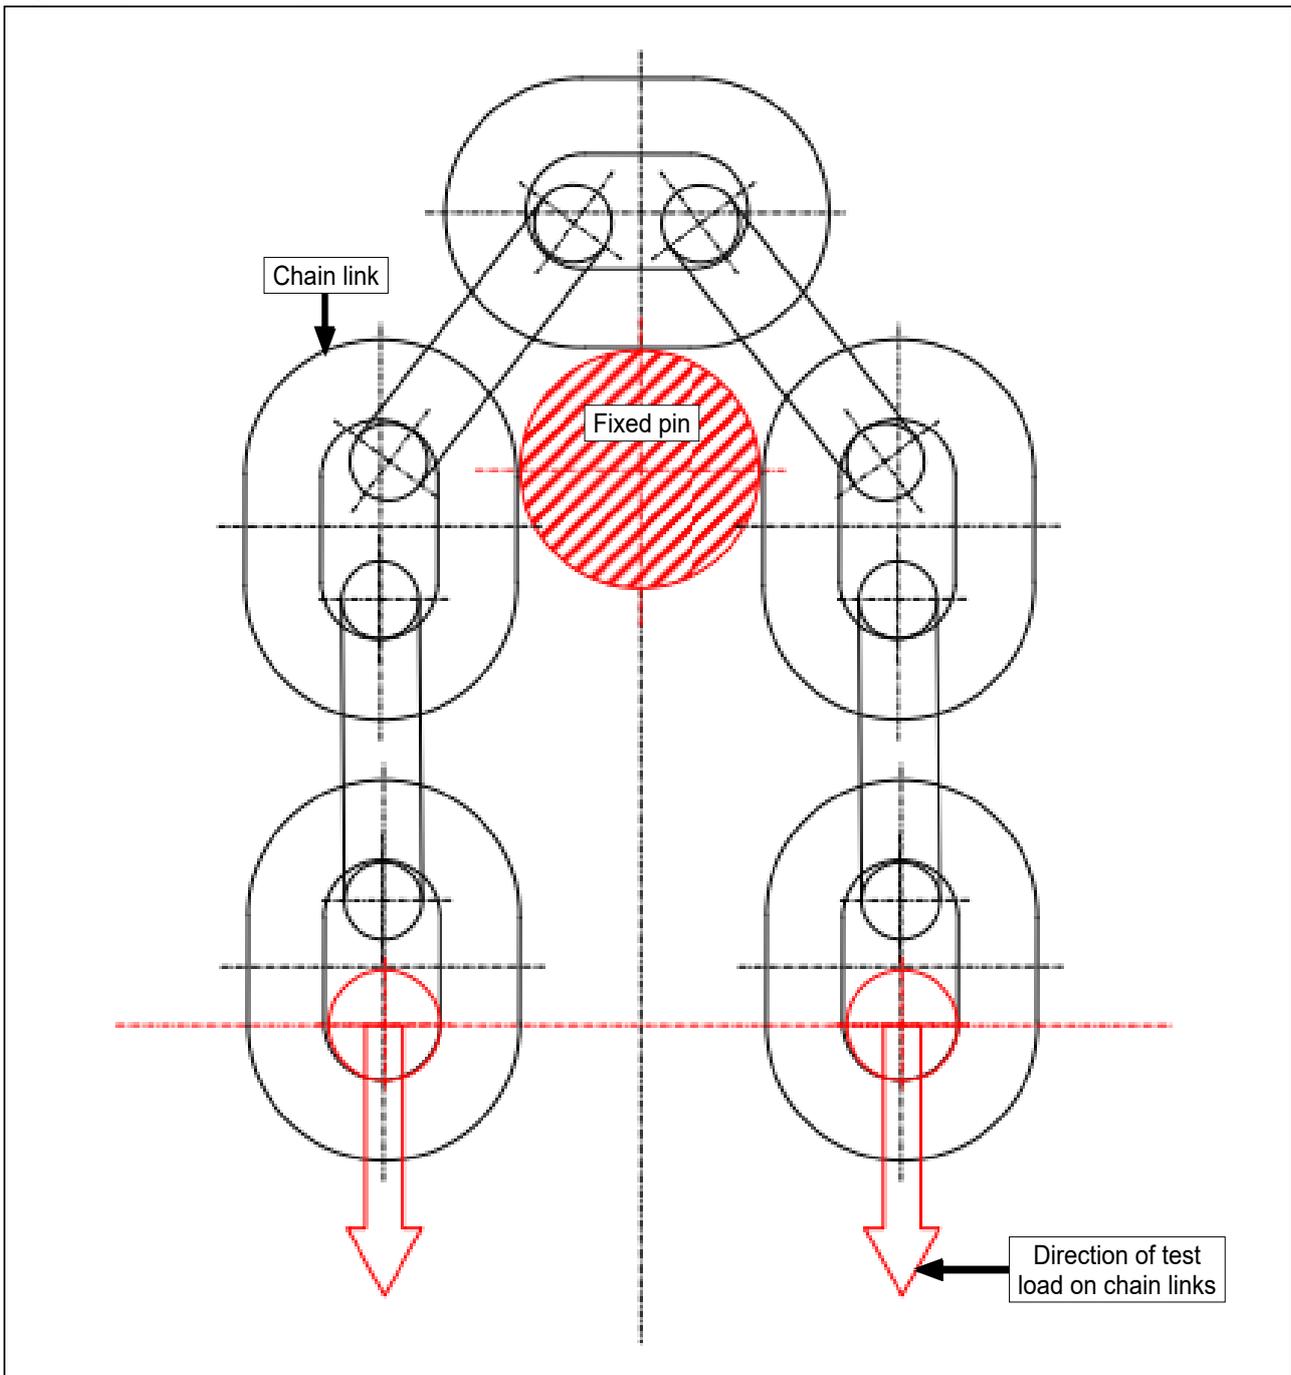
**Figure 22:** Extract from the *Llandwyn Island* chain failure test report

The parted steel chain was recovered and sent to Tension Technology International Ltd for inspection and testing. The test report identified that, around the pad eye at the chain connection, there was a 25% reduction in strength of the doubling up of the chain (**Figure 22**) compared to a straight chain length. This had significantly reduced the chain's breaking load and ability to absorb energy.
