February 6, 2025

MIR-25-08

# Collapse of Chalmette Refinery Dock Section During Docking of *Ovide J* Tow

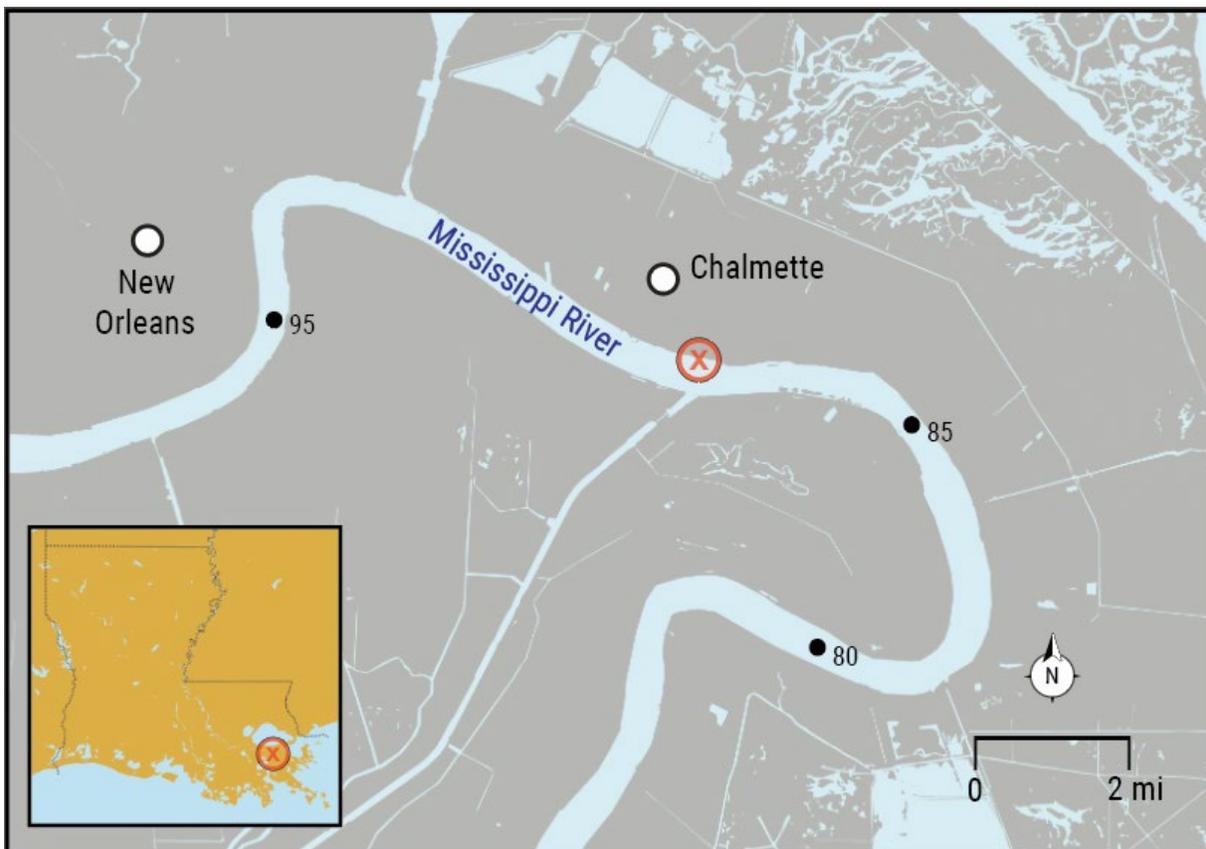
**Figure 2.** Area where the Chalmette Refinery crude oil dock section collapsed, as indicated by a circled X. (Background source: Google Maps)

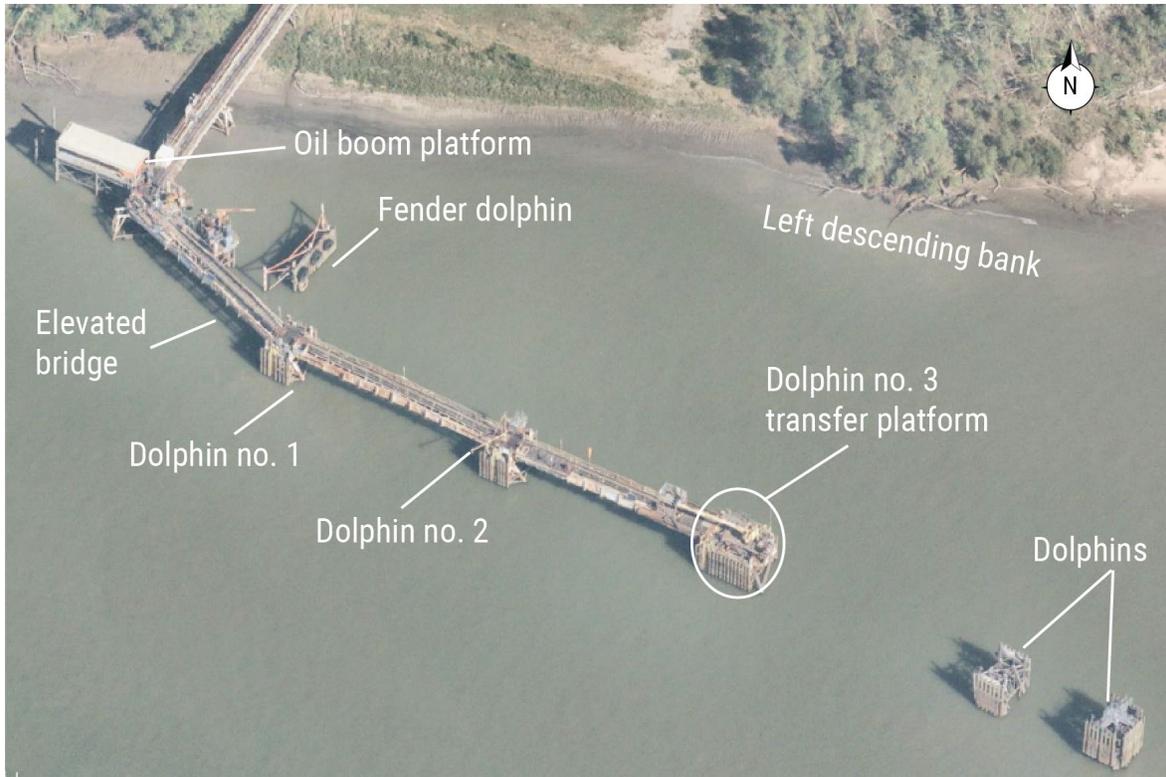
The Chalmette Refinery crude oil dock, constructed in 1967, was located on the left descending bank of the Lower Mississippi River and consisted of wood and steel pilings, dolphins, and elevated bridges (see figure 3).<sup>3</sup> The elevated bridges were connected in series to a transfer platform located on dolphin no. 3. Three 16-inch crude oil pipelines ran the length of the dock to the transfer platform on dolphin no. 3, which contained a boom crane, an associated pipe manifold, and shore-provided hose connections. The dock had two berths: one inshore berthing with a forward fendering dolphin and one offshore berth.

**Figure 3.** The Chalmette Refinery crude oil dock. (Background source: Nearmap)

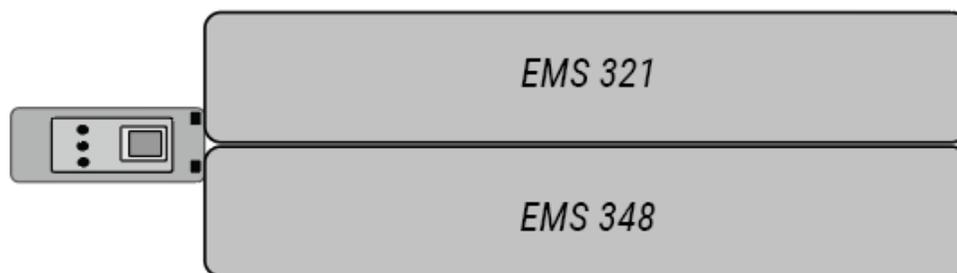
**Figure 4.** *Ovide J* tow arrangement (scale approximate).
