March 24, 2025

MIR-25-11

## Contact of Tank Vessel *Hafnia Amessi* with Pier

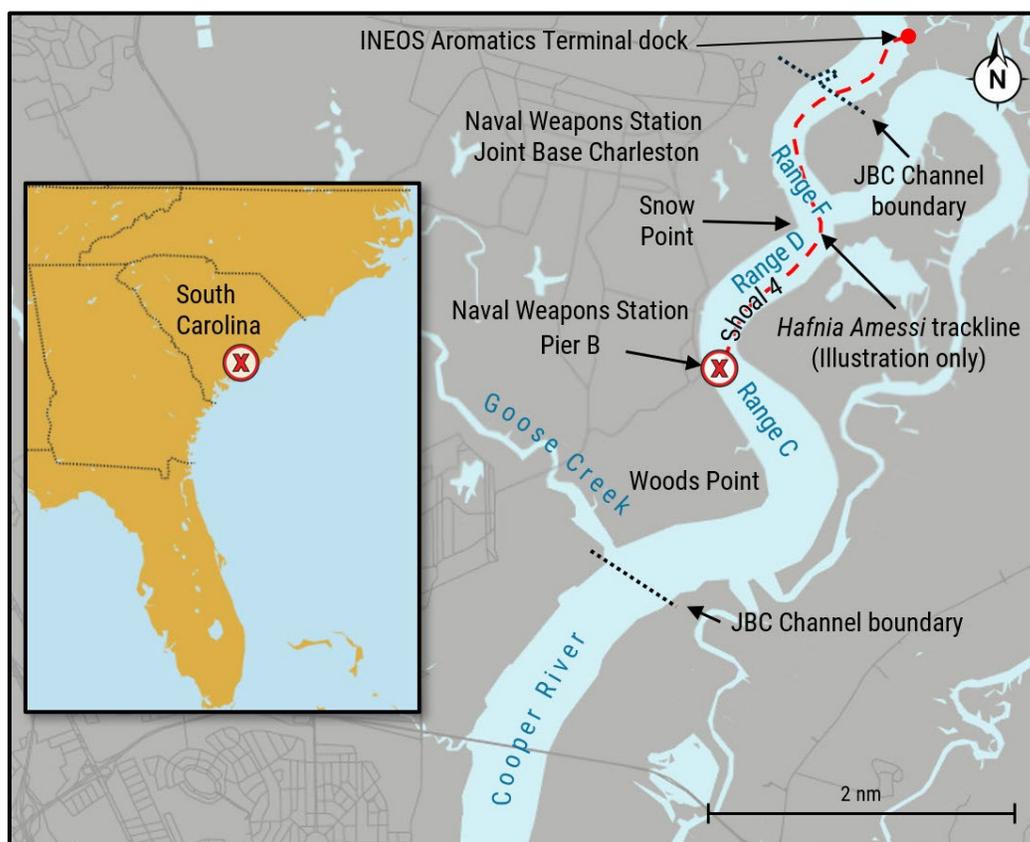
**Figure 2.** Area where the *Hafnia Amessi* contacted the Naval Weapons Station Pier B, as indicated by a circled X. (Background source: Google Maps)

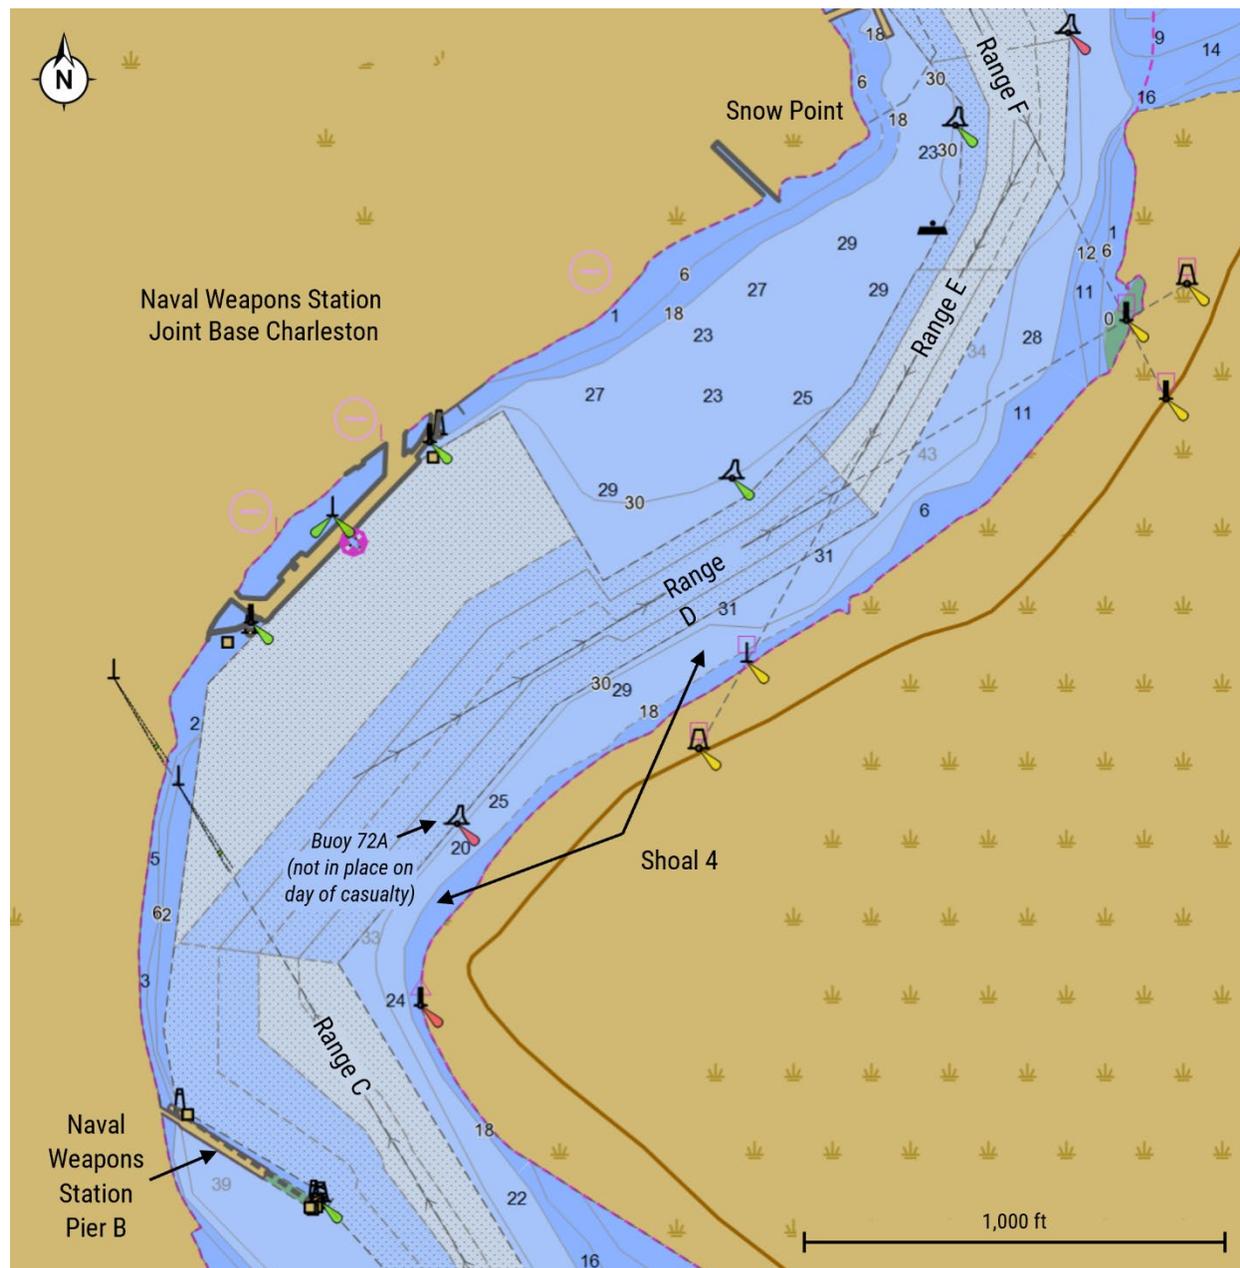
After Range F, the river made a bend to starboard onto Range E and then Range D (see figure 3). After passing through the bend, the pilot continued to issue rudder commands to steer the ship toward the next bend, a port turn onto the stretch of the river containing Range C and Naval Weapons Station Pier B. On the eastern

side of the river, near the bend toward Range C, was an area designated as “Shoal 4” that was known to silt up following periodic dredging operations.

**Figure 3.** National Oceanic and Atmospheric Administration (NOAA) electronic navigation chart (ENC) US5SC1LO, accessed on January 30, 2025, showing the area of the Cooper River where the *Hafnia Amessi* would eventually strike Pier B.

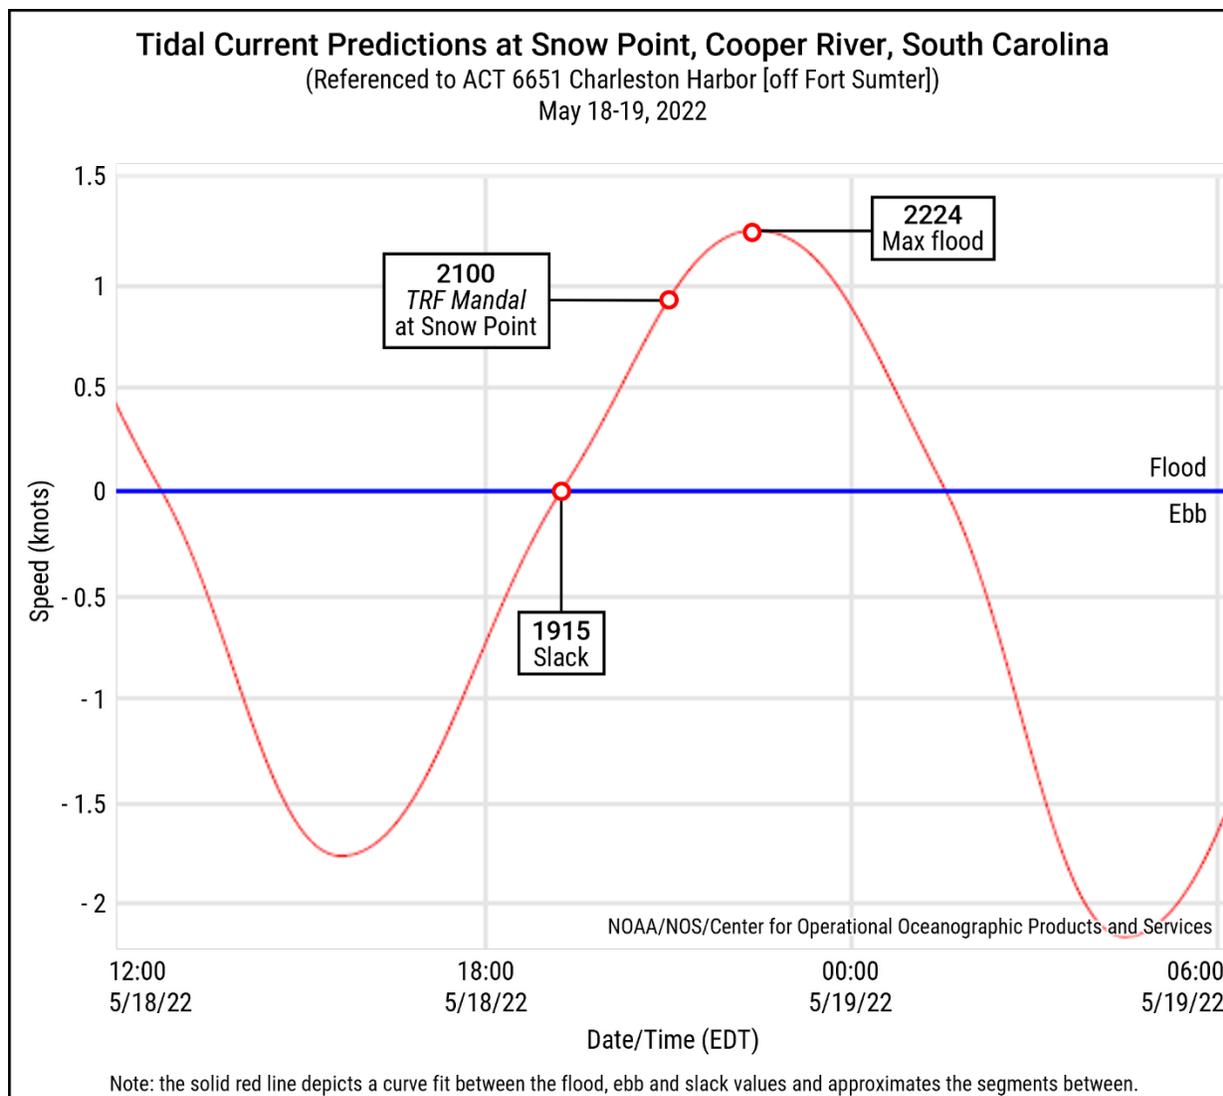
During the *TRF Mandal* transit on the evening of May 18, 2022, the predicted time of slack water at Snow Point (the point in the JBC Channel that forms the turn from Range F onto Ranges E and D; see figure 3) was 1915. The predicted maximum for the next flood current was 1.25 knots at 2224. The *TRF Mandal* passed Snow Point at 2100 that evening, 1 hour 24 minutes before the maximum tidal current. Based on the times of slack water and maximum flood tide, the predicted tidal current at the time the *TRF Mandal* passed Snow Point—about 10 minutes before it passed Pier B—was just under 1 knot (see figure 8).

**Figure 8.** Tidal current predictions for Snow Point, Cooper River, South Carolina, on May 18, 2022. (Background source: NOAA)

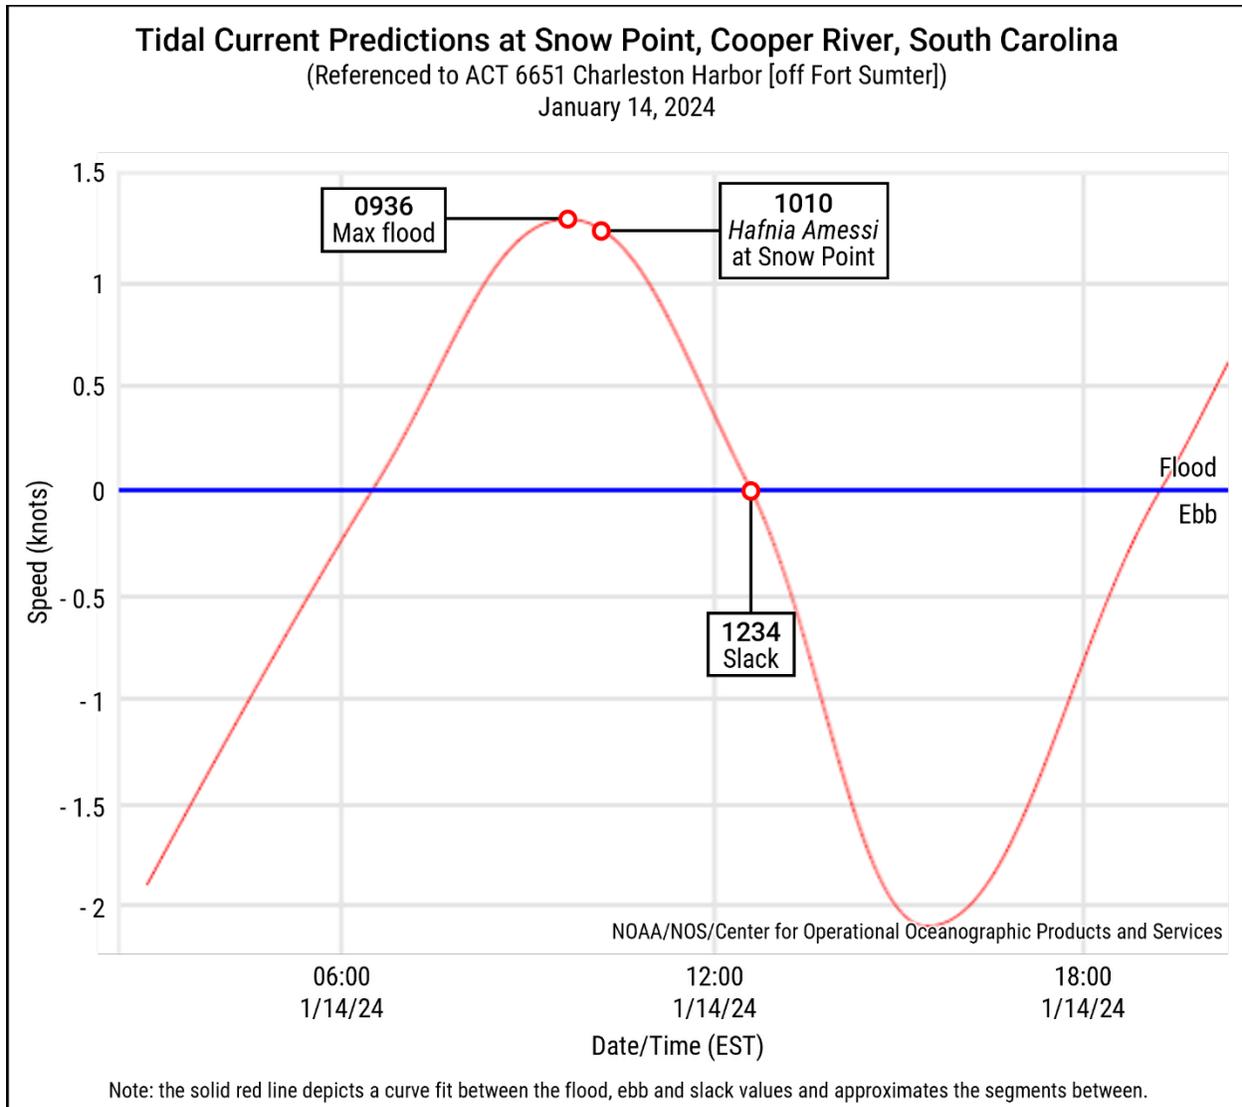
During the *Hafnia Amessi* transit on the morning of January 14, 2024, the predicted maximum flood current at Snow Point was 1.29 knots at 0936. The next slack water was at 1234. The *Hafnia Amessi* passed Snow Point at 1010, 34 minutes after maximum tidal flood current. Based on the times of maximum flood tide and slack water, the predicted tidal current at the time the *Hafnia Amessi* passed Snow Point—about 9 minutes before it struck Pier B—was 1.2 knots (see figure 9).

**Figure 9.** Tidal current predictions for Snow Point, Cooper River, South Carolina, on January 14, 2024. (Background source: NOAA)
