April 22, 2025

MIR-25-17

Contact of Towing Vessel *Cocodrie* with Valero St. Charles Refinery Walkway

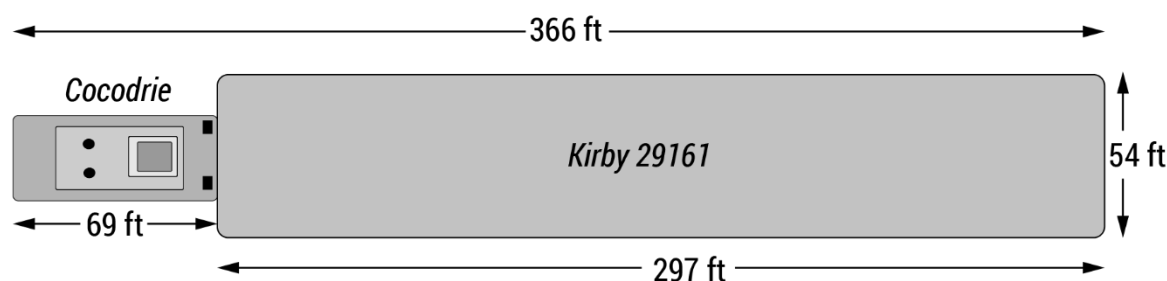
On March 15, 2024, about 0236, the 2,000-hp, twin screw, 69-foot-long, steel-hulled *Cocodrie* and its tow, the 297-foot-long, 54-foot-wide tank barge *Kirby 29161*, moored starboard side to dock no. 5 at the Valero St. Charles Refinery at mile 125 on the Lower Mississippi River near Norco, Louisiana, to discharge petroleum product. Five crewmembers were aboard, including a pilot, relief captain, deckhand, and two tankermen.³ The *Cocodrie* was faced up to the barge, and the total length of the tow was 366 feet (see figure 3).

Figure 3. *Cocodrie* towing arrangement.
