April 29, 2025

MIR-25-18

Contact of Bulk Carrier *American Mariner* with Munuscong Channel Junction Light

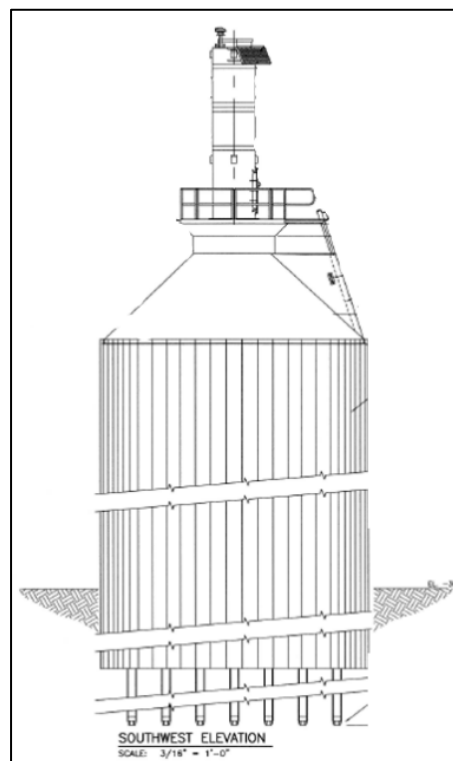
Figure 3. Munuscong Channel Junction Light. (Source: Coast Guard)

Initial underwater scans performed by the US Army Corps of Engineers indicated damage to the seabed foundation and underwater structure of the Munuscong Channel Junction Light, which caused the structure to lean from its originally constructed orientation (see figure 7). According to the Coast Guard Civil Engineering Unit, the estimated cost for repairs was \$1.25 million, and the cost for replacement was estimated at \$2.2 million due to the remote location of this ATON and mobilization costs for in-water work. As of the date of this report, repairs have not been made to the Munuscong Channel Junction Light.

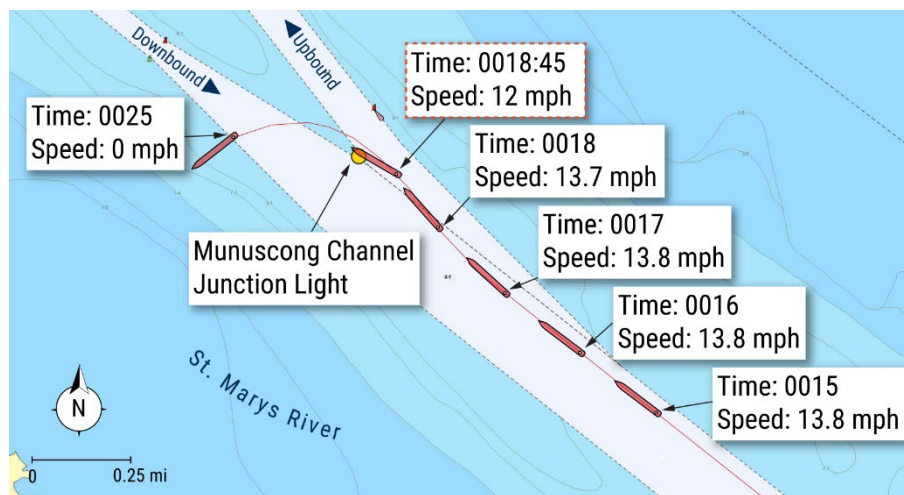
Just after midnight on March 28, the *American Mariner* was transiting upbound in the St. Marys River in Munuscong Lake and approaching the Munuscong Channel Junction Light. According to the captain, they were transiting “below the 14 mph speed limit,” with the captain, second mate, and wheelsman on the bridge (see figure 5). To maneuver around the Munuscong Channel Junction Light and into the upbound channel, the wheelsman used about 20–30° of right rudder to “start the jog”

around the light, and once he saw the vessel begin to swing to starboard, he counter steered to port using about 20–25° of left rudder.

Figure 5. *American Mariner*'s automatic identification system trackline and upbound transit in St. Marys River on March 28, 2024. Munuscong Channel Junction Light is not to scale. (Background source: MadeSmart)

About 0018, the wheelsman alerted the captain and second mate that the rudder was stuck about 20° left and he had lost steering control. No alarms were activated at the time of the loss of steering control. The captain directed the wheelsman to switch to NFU steering mode to manually control the rudder, but changing to NFU had no effect. The vessel began to veer to port, and the captain ordered the second mate to drop the stern anchor. The captain brought the main engine throttle to full astern to reduce the vessel's speed and its rate of turn. The second mate ran down to the stern, released the brake on the anchor, and let out an estimated one shot of anchor chain (90 feet).

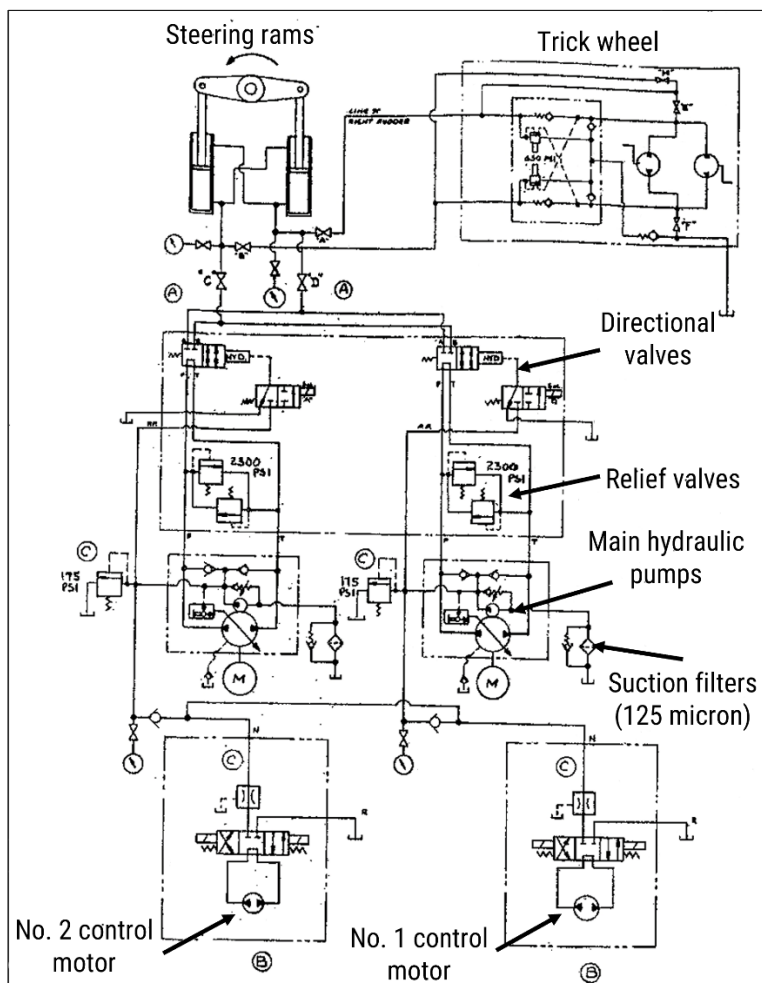
The steering system of the *American Mariner* consisted of two electrically driven, variable displacement hydraulic pumps that took suction of hydraulic oil from a sump through a 125-micron suction filter (see figure 8).⁴ The system was equipped with directional valves and system relief valves, set at 2,300 pounds per square inch. A control motor, via mechanical linkages, mechanically adjusted the stroke of each of the main hydraulic pumps. Per the third-party technician, the control motor would move the mechanical linkages to “put oil through the cylinders to move the rudder to a specific degree.”

Figure 8. Diagram of hydraulic piping and components for the steering system aboard the *American Mariner*. (Background source: Grand River Navigation, Inc.)

During a postcasualty inspection of the hydraulic sump, technicians noted a "fair amount of contamination of unknown materials, both ferrous and non" within the hydraulic oil. The suction filters were rated at 125 microns, meaning that particles larger than 0.125 millimeters (0.005 inches) would be captured in the mesh of the suction filter elements. The debris found inside the no. 1 control motor ranged from about 2–4 millimeters (0.08–0.16 inches) in length. Therefore, since the debris was

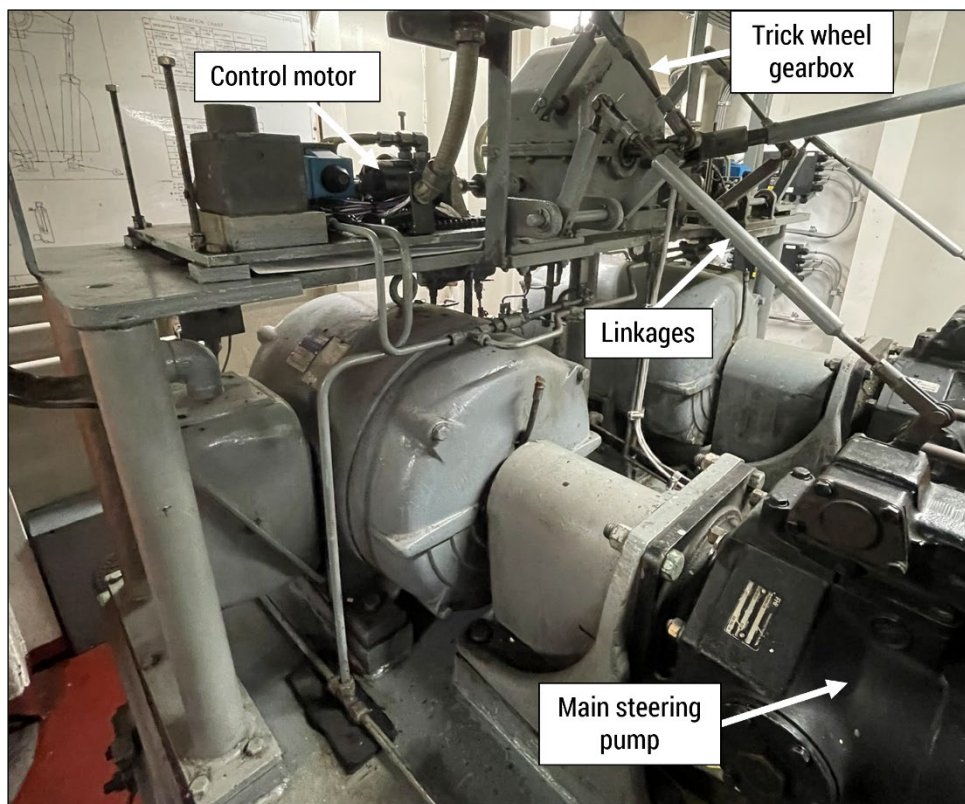
The output shafts of both control motors connected to input shafts in the trick wheel gear box assembly via couplings. The output shafts from the trick wheel gearbox were connected to the swash plate of the main steering pump via mechanical linkages to control the stroke and adjust the output flow of the main pumps to the main hydraulic steering rams, which rotated the rudder to a desired angle (see figure 9).

Figure 9. Steering gear arrangement aboard *American Mariner*.

Immediately after the casualty, crewmembers inspected the steering system and determined that the no. 1 control motor (which controlled the stroke of the main hydraulic pump) within the vessel's steering system had failed. The motor was disassembled, and a piece of black, pliable debris was found to be lodged in between the rotating gears of the control motor, preventing it from rotating properly. Once seized, the control motor's corresponding linkages to the main steering pump remained stationary, preventing the main steering pump from changing output pressure and locking the rudder in its last ordered position at 20° left. Once a replacement control motor was installed, the steering system responded properly to steering commands from the bridge.
