June 11, 2025

MIR-25-23

Grounding of Towing Vessel *Tom Frazier*

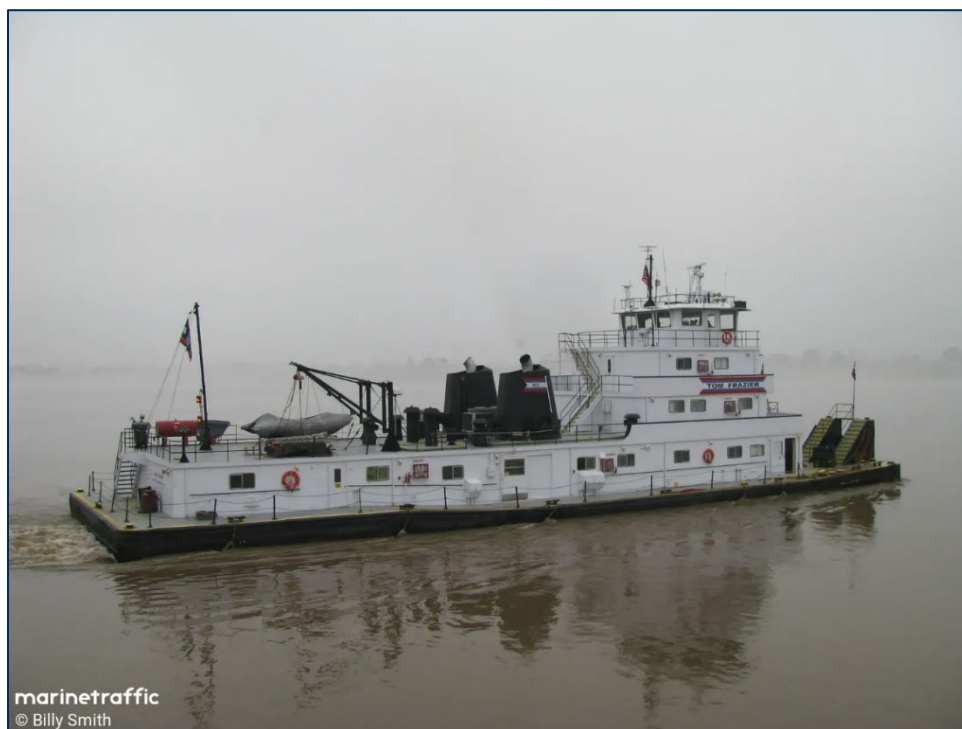
Figure 1. The *Tom Frazier* underway in 2008. (Source: Billy Smith)

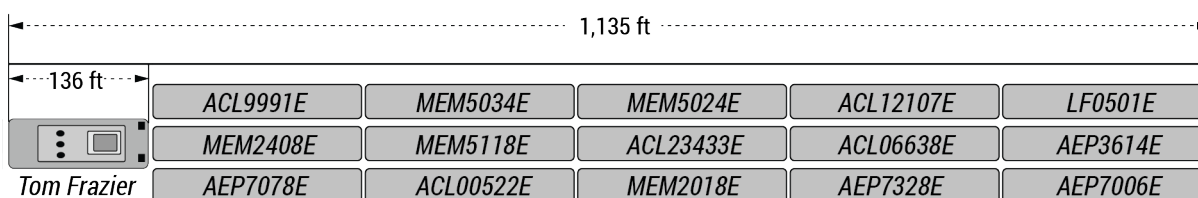
On February 2, 2024, the towing vessel *Tom Frazier* departed Cairo, Illinois, pushing 15 empty hopper barges—arranged in three strings of five barges each—en route to South Point, Ohio, upbound on the Ohio River.³ The tow's total length was 1,135 feet, and its width was 112 feet (see figure 3). The draft of the *Tom Frazier* was 11.2 feet, while the draft of the barges ranged from 1.5 to 2 feet. The vessel had a crew of nine.

Figure 3. *Tom Frazier* towing arrangement (scale approximate).
