June 24, 2025

MIR-25-26

Collision of *William B Klunk* Tow with Moored Barges

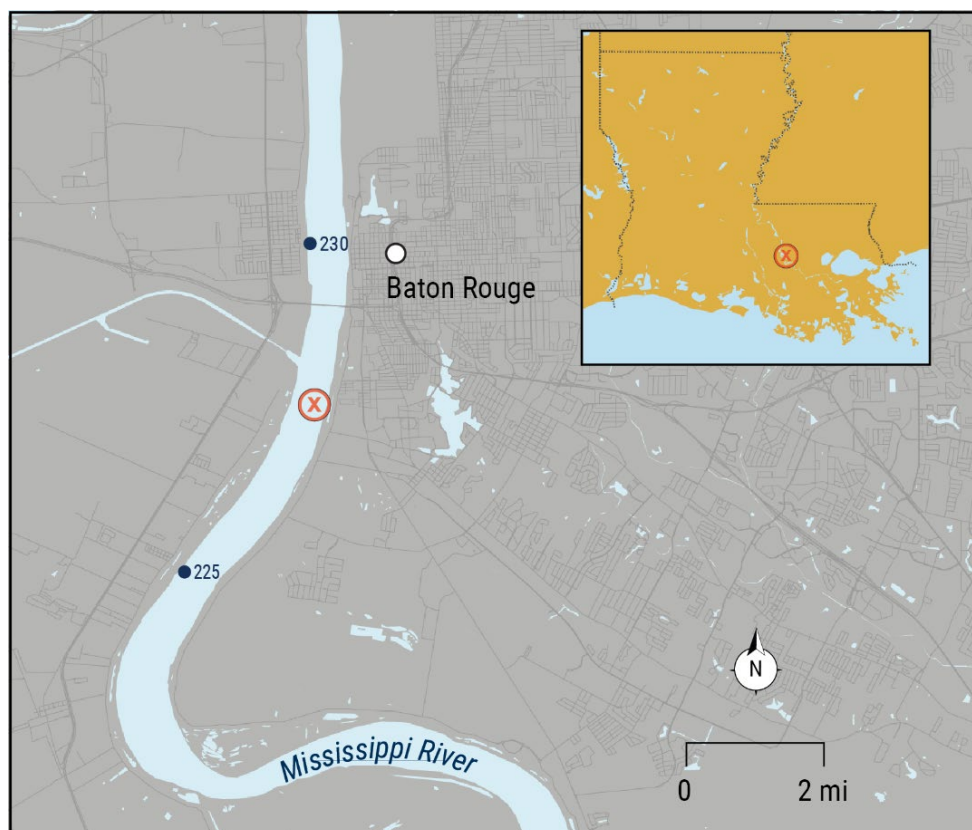
Figure 2. Area where the *William B Klunk* and tow collided with moored barges, as indicated by a circled X. (Background source: Google Maps)

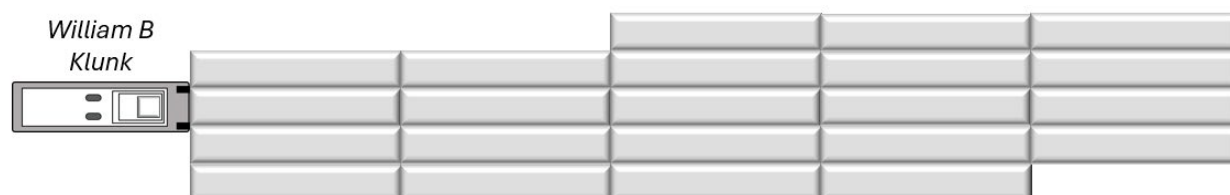
Figure 3. *William B Klunk* tow arrangement on the day of the collision (scale approximate).
