MARINE TRANSPORTATION SAFETY INVESTIGATION REPORT M21A0041

CATASTROPHIC FAILURE OF MACHINERY, SUBSEQUENT FIRE, AND SINKING

Fishing vessel *Atlantic Destiny*

02 March 2021

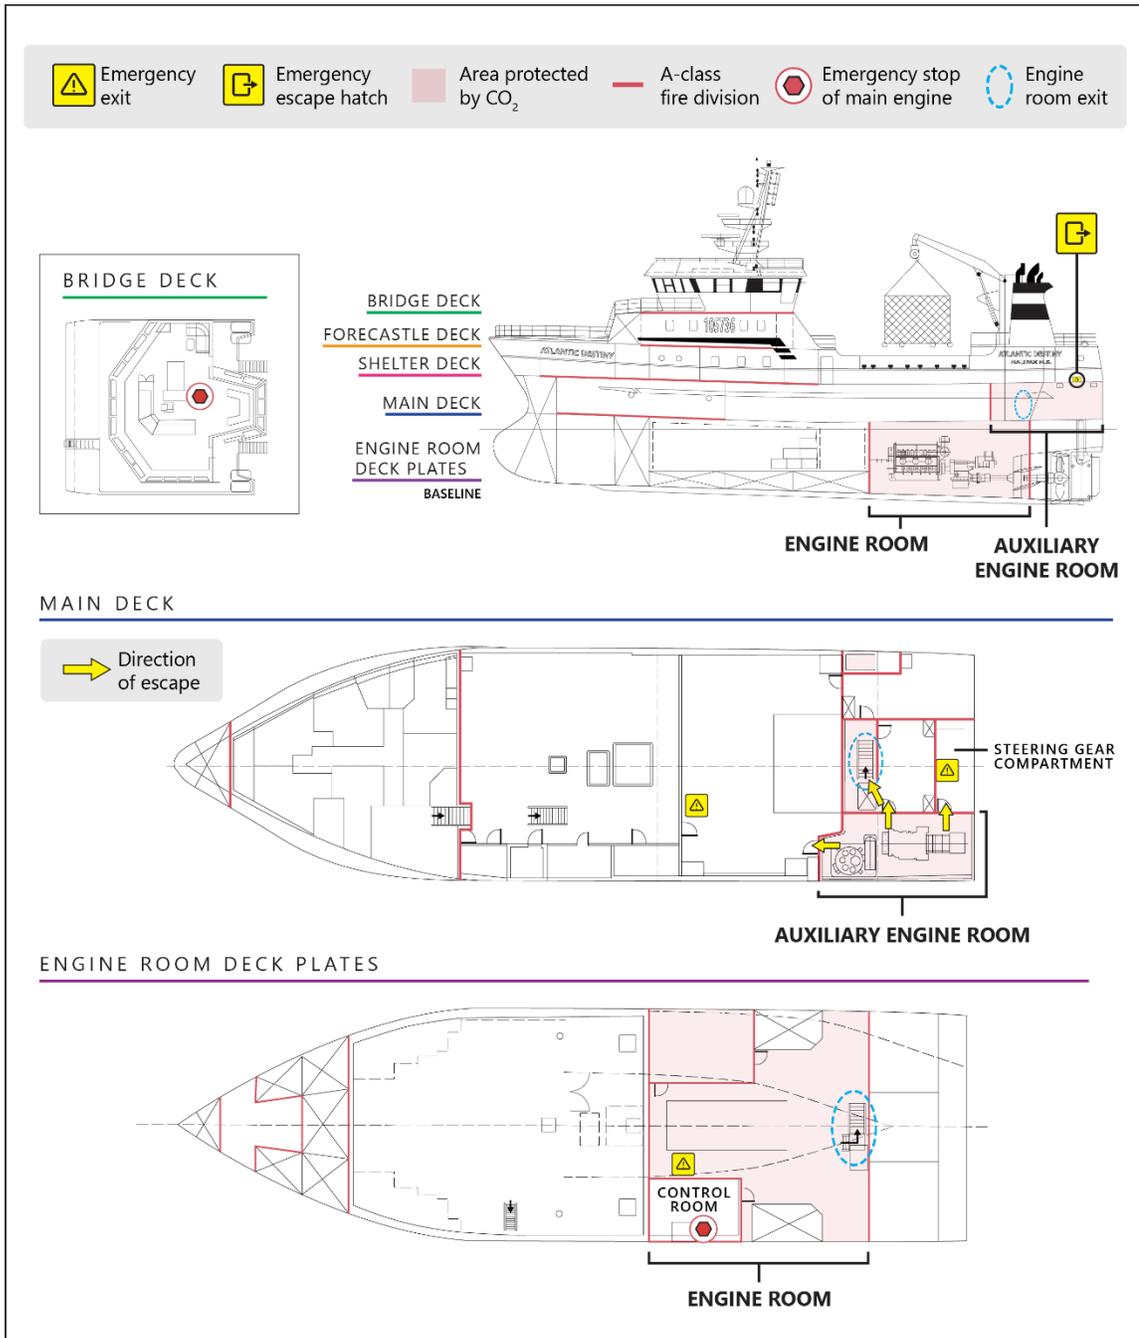
deck of the auxiliary engine room had an opening around the exhaust stack, making the 2 rooms into a single category A space. The engine control room (ECR) was located on the forward port side of the engine room and was accessed from the engine room but was in its own category A space. The steering gear compartment was on the main deck and accessed from the auxiliary engine room or from a hatch on the shelter deck but was in a different category A space (Figure 2).

Figure 2. Port-side cross-section view and top view of the main deck and engine room deck plates of the vessel showing that the engine room and auxiliary engine room formed a single category A space on 2 levels (Source: TSB, based on the Atlantic Destiny fire and safety plan)

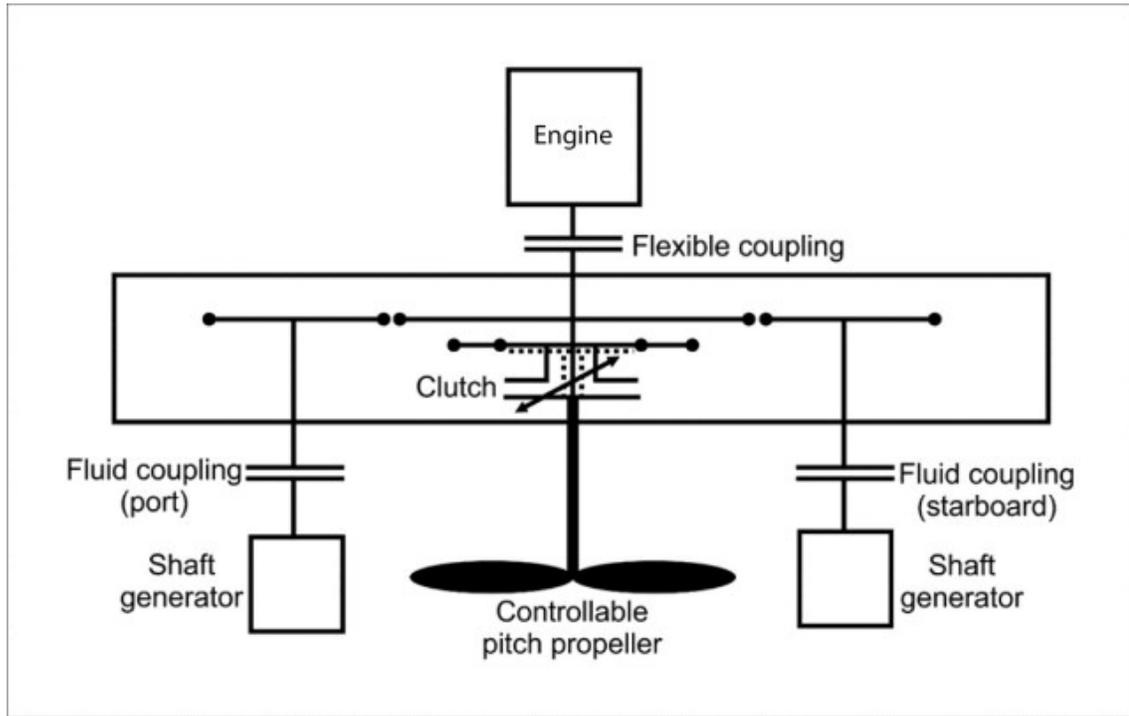
The engine was connected to a combination gearbox via a flexible coupling (Figure 4). There were 3 output shafts from the combination gearbox: the lower output shaft at a 5.52:1 reduction for the propeller shaft, and 2 upper output shafts with fluid couplings, at a 1:2 increase, to drive the shaft generators. The design limit for the fluid couplings was 1800 rpm. At the normal engine operating speed of 900 rpm, the propeller shaft turned at 163 rpm and the generators turned at 1800 rpm.

Figure 4. The configuration of the engine, shaft generators, and controllable-pitch propeller (Source: TSB)
