# NORD MAGIC

Marine accident report on occupational accident

17 JUNE 2022

**MARINE ACCIDENT REPORT ON OCCUPATIONAL ACCIDENT  
ON NORD MAGIC ON 17 JUNE 2022**

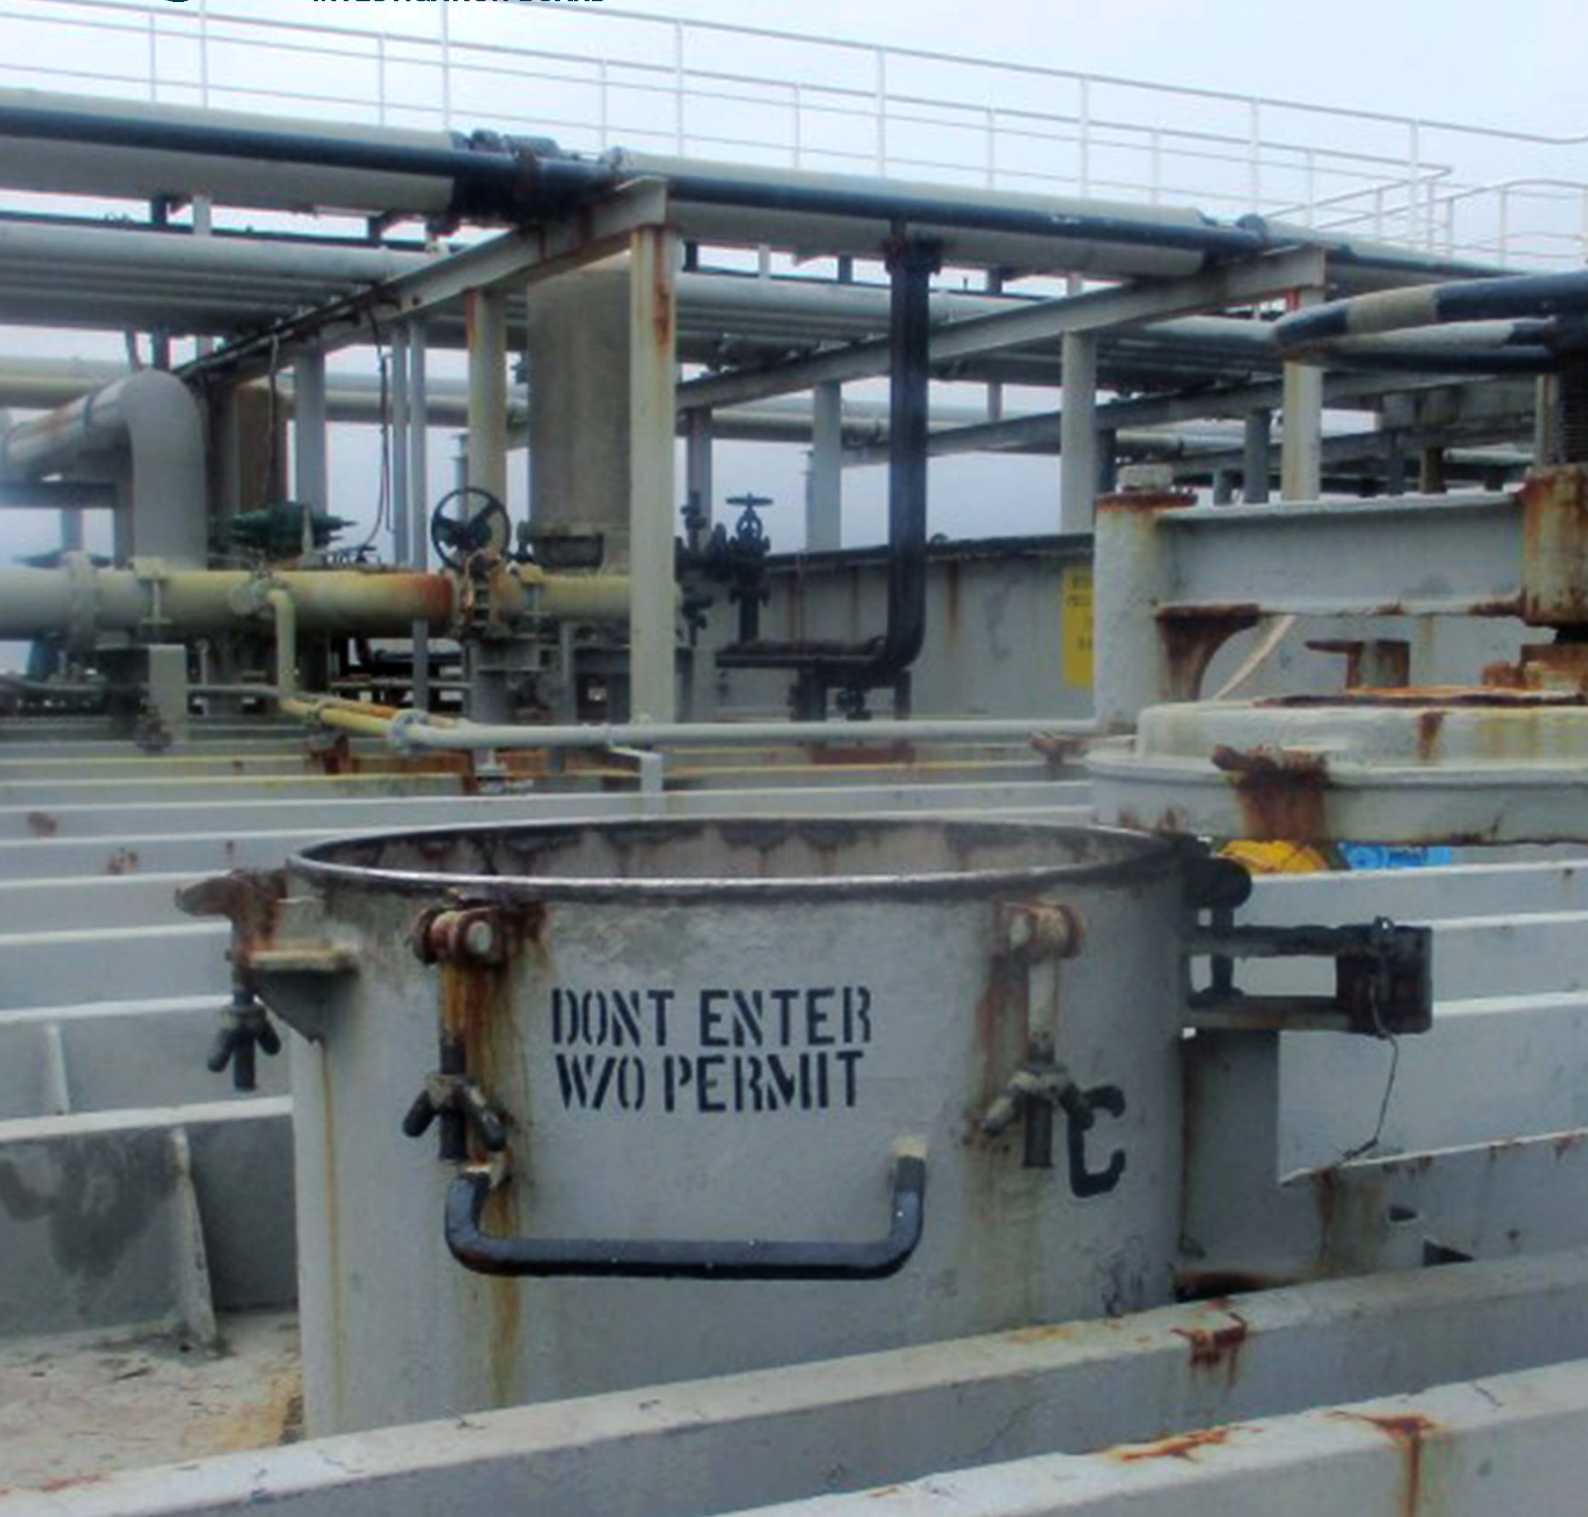
Photo: Hatch no. 2 COT (S) on NORD MAGIC  
Source: Norden Synergy Ship Management A/S

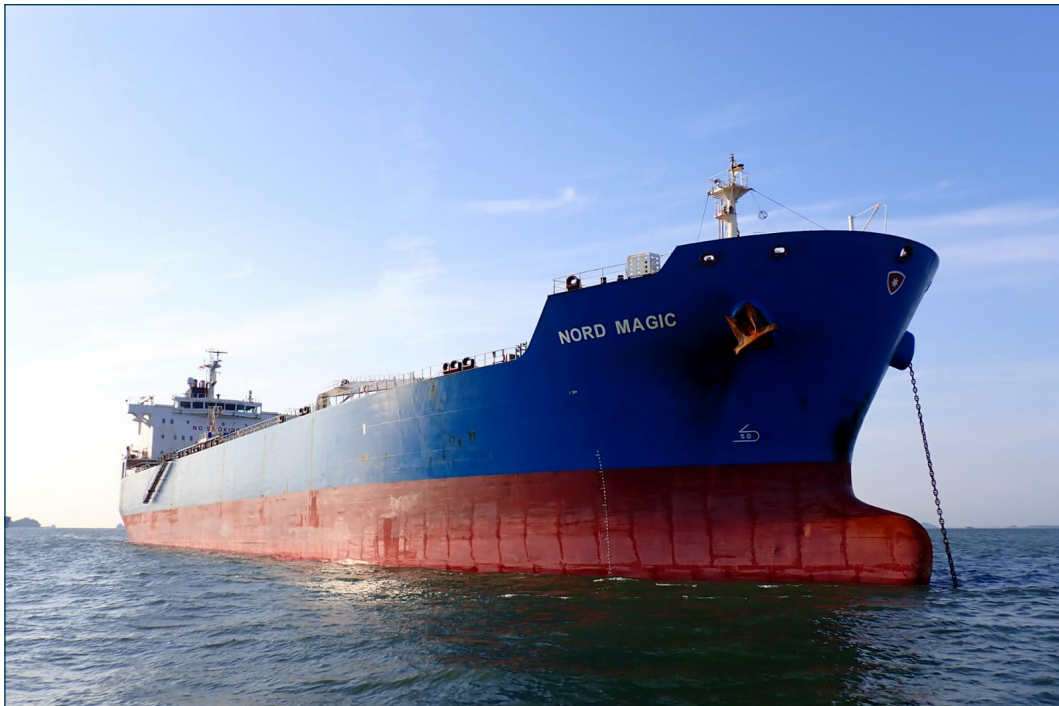
Figure 1: NORD MAGIC  
Source: Norden Synergy Ship Management A/S

NORD MAGIC (Figure 1 and appendix) was a product tanker in worldwide tramp service carrying a variety of chemical and oil products. At the time of the accident, the ship carried soybean oil loaded in San Lorenzo, Argentina, some of which had already been discharged in ports in Madagascar and Mozambique, with the remainder to be discharged in India and Bangladesh.

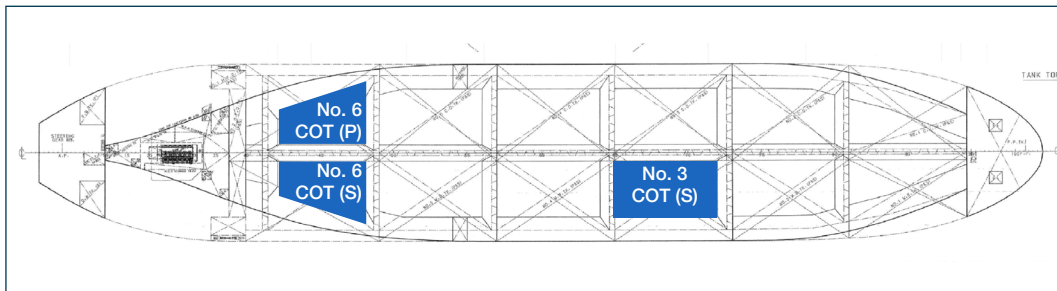
Figure 2: Overview of cargo oil tanks.

On 17 June, NORD MAGIC was at anchor off Chittagong, Bangladesh, and at 0354, a cargo barge arrived alongside to receive a parcel of soybean oil. After the meeting between the ship's crew and the cargo surveyors, and when the sounding of the tanks was completed, the discharge operation from three cargo oil tanks (COT): no.6 COT port (P), no. 6 COT starboard (S) and no. 3 COT (S) began (Figure 2). The cargo discharge operation was planned to be completed at noontime.
