Report on the investigation of the collision  
between the general cargo vessel  
***Scot Carrier***  
and the split hopper barge  
***Karin Høj***  
resulting in the capsize of the barge with two fatalities  
in the Bornholmsgat traffic separation scheme, Sweden  
on 13 December 2021

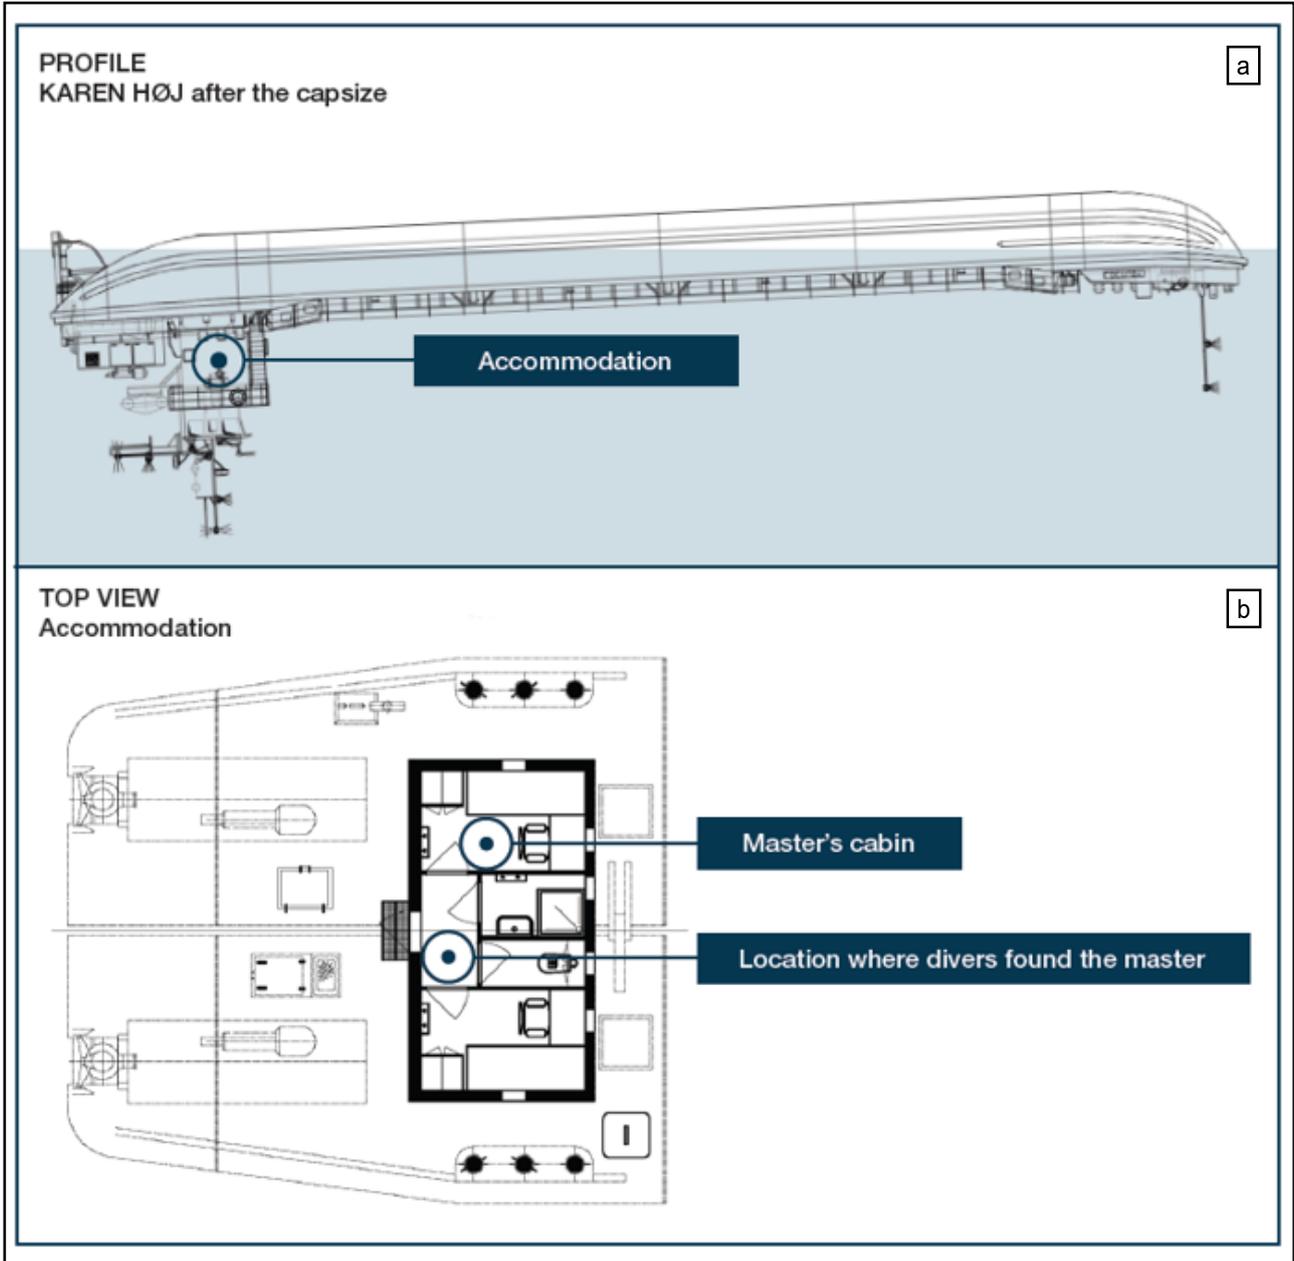
Figure 14: Karin Høj's accommodation (a) and cabin layout (b)

At 1340, Swedish rescue divers entered *Karin Høj*’s submerged accommodation and, 10 minutes later, found one partially clothed person in the accommodation hallway outside the starboard cabin (**Figure 14**). The person was later declared deceased and identified as the vessel’s master.

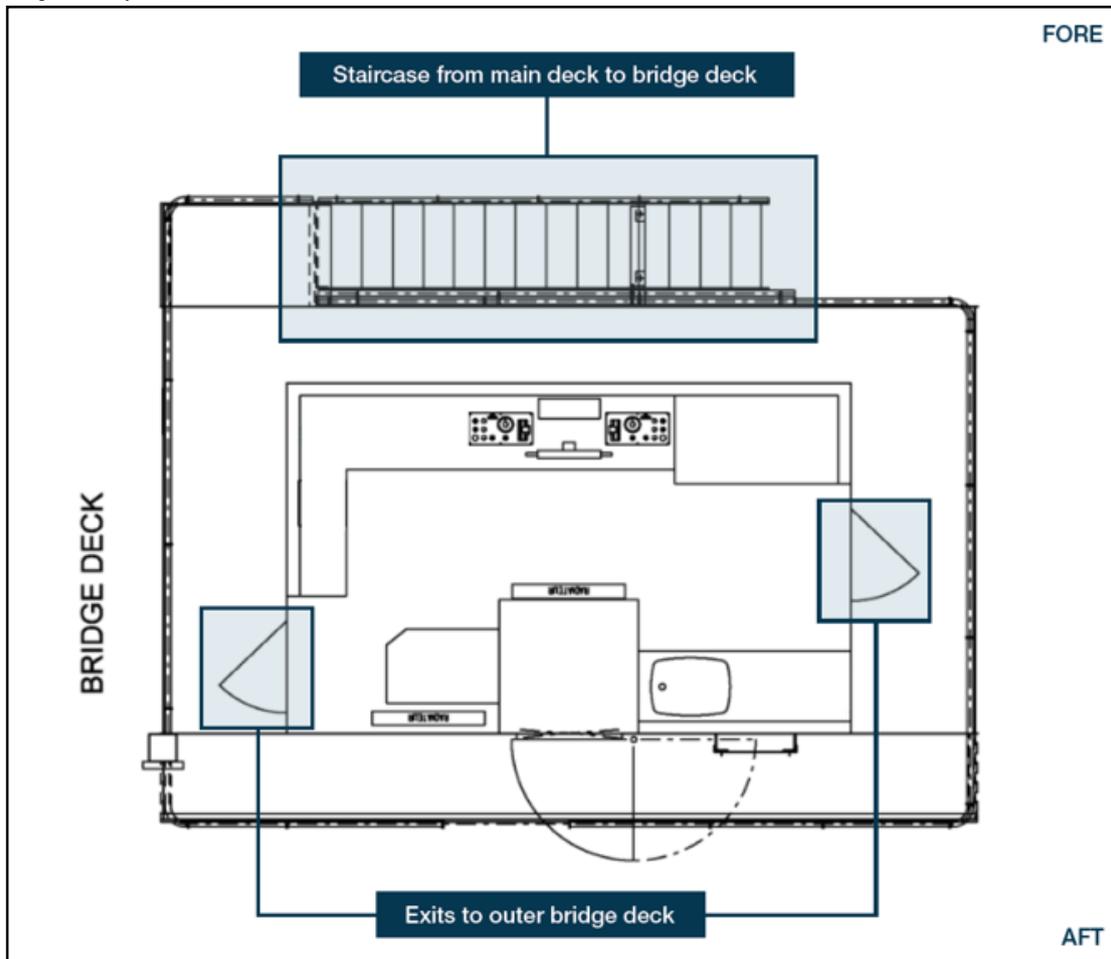
Figure 22: Karin Høj's bridge arrangement, modified from the fire plan

*Karin Høj's* bridge was accessed from the main deck by an external staircase to doors on the port and starboard side (**Figure 22**). It was not possible to enter the bridge directly from the accommodation. The bridge was fitted with windows on all sides.

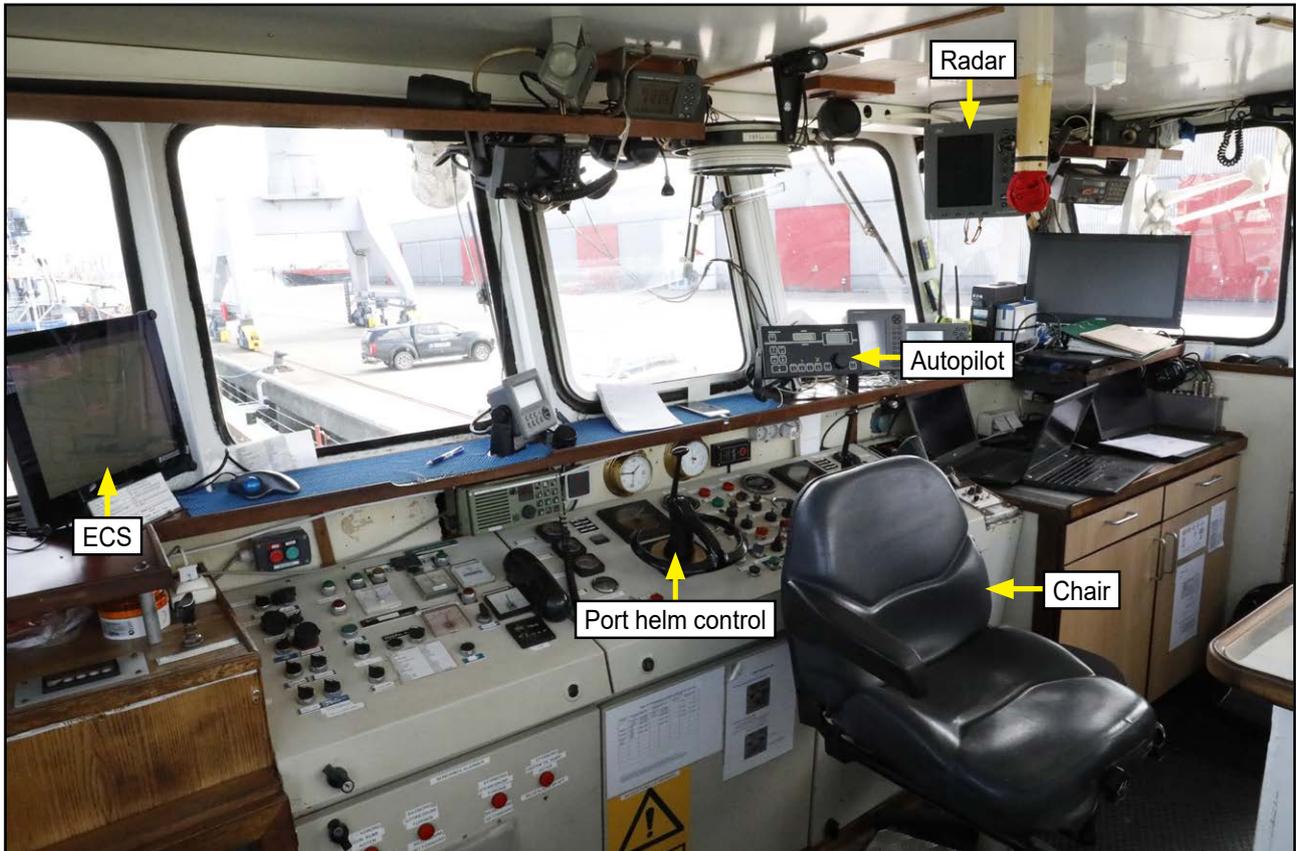
Figure 23: Karin Høj's bridge (2019)

A single fully rotating helm chair was mounted to the deck at the centre of the bridge. Monitors for electronic navigational equipment were mounted on the forward windowsill and suspended from the deckhead (**Figure 23**). The chart table was aft of the helm chair and a small adjustable lamp was fitted above it.

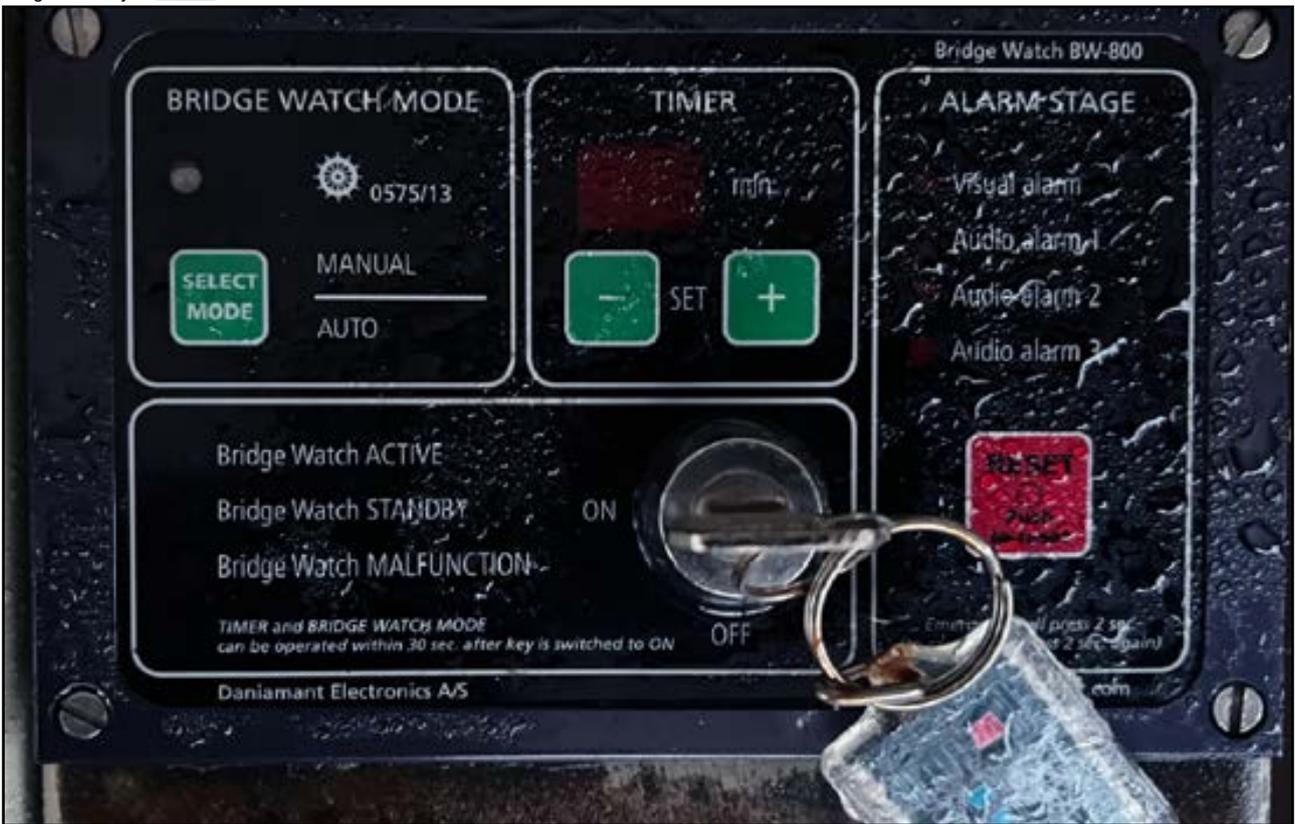
Figure 26: Karin Høj's BNWAS control panel

The switches to the masthead lights, port and starboard sidelights and stern light were in the *on* position (**Figure 25**). The key in the BNWAS control panel was in the *on* position (**Figure 26**). It was not possible to determine the BNWAS alarm interval setting selected.

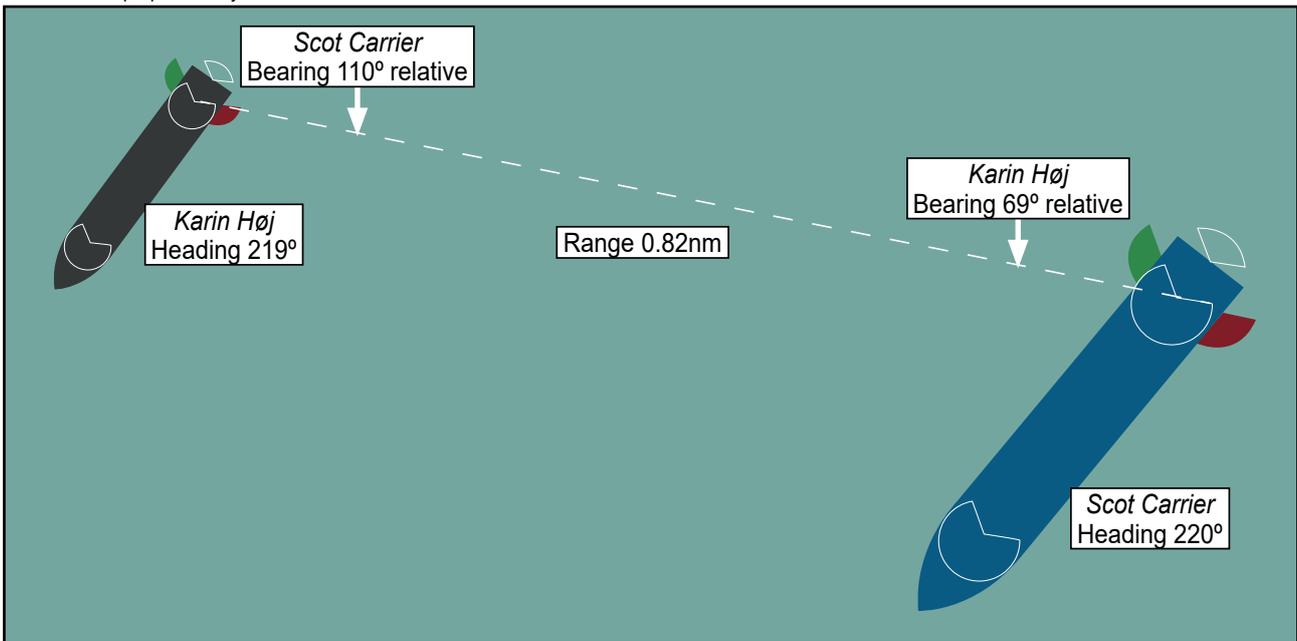
**Figure 30:** Relative positions of both ships at 0321, shortly before *Scot Carrier* altered course from 220° to 270°

Prudent seamanship required early and substantial action to be taken in order to make any intentions clear. The alteration of *Scot Carrier*'s course close to *Karin Høj* left barely 3 minutes for its watchkeeper to identify the collision risk and take action, assuming that he was actively monitoring the situation.
