Summary report on occupational accident

2 NOVEMBER 2021

SUMMARY REPORT ON OCCUPATIONAL ACCIDENT ON BB ON 2 NOVEMBER 2021

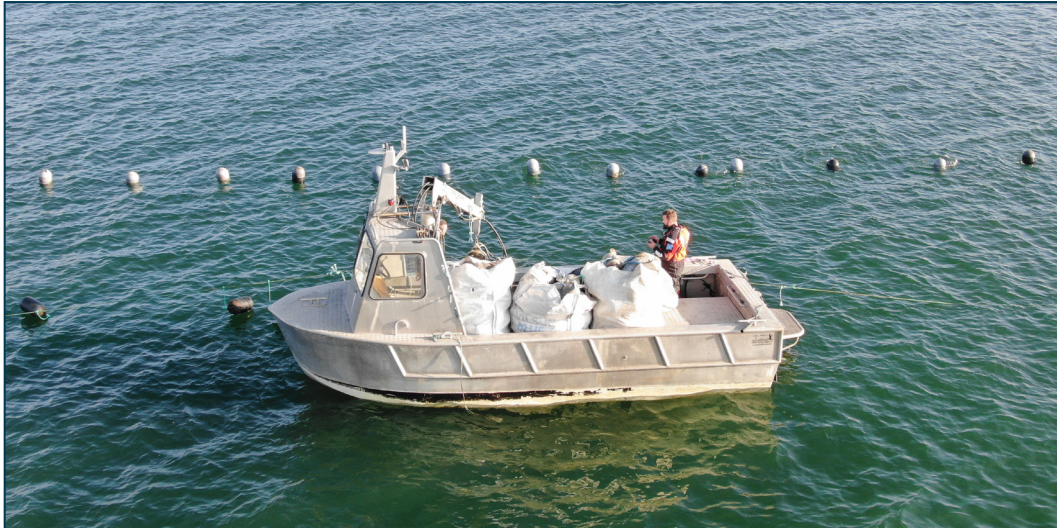
Figure 1: BB
Source: DMAIB

The work boat was found tied to the mussel farm longline. On the boat's starboard side, the worker was found wearing bib trousers, but his rubber boots and bib waterproof trousers, which he was usually wearing, were missing. Presumably, the boots and bib waterproof trousers were weighing him down in the water, and he therefore took them off. When the owner lifted the worker from the water, he was found clutching a rope in his left hand which was tied to the boat.

The ladder was fitted in an upward position and could be released by a person in the water pulling a string. Once pulled down, part of the ladder was submerged, making it easier to climb onto the platform. When the boat was found, the ladder had not been released.

On the boat's deck four full bags and two empty bags with buoys were found occupying most of the deck area (figure 5). According to the owner's statement nothing unusual was observed on the boat when he arrived and saw the worker in the water, i.e. there were no lines or buoys unusually positioned, and the crane was in its usual place.

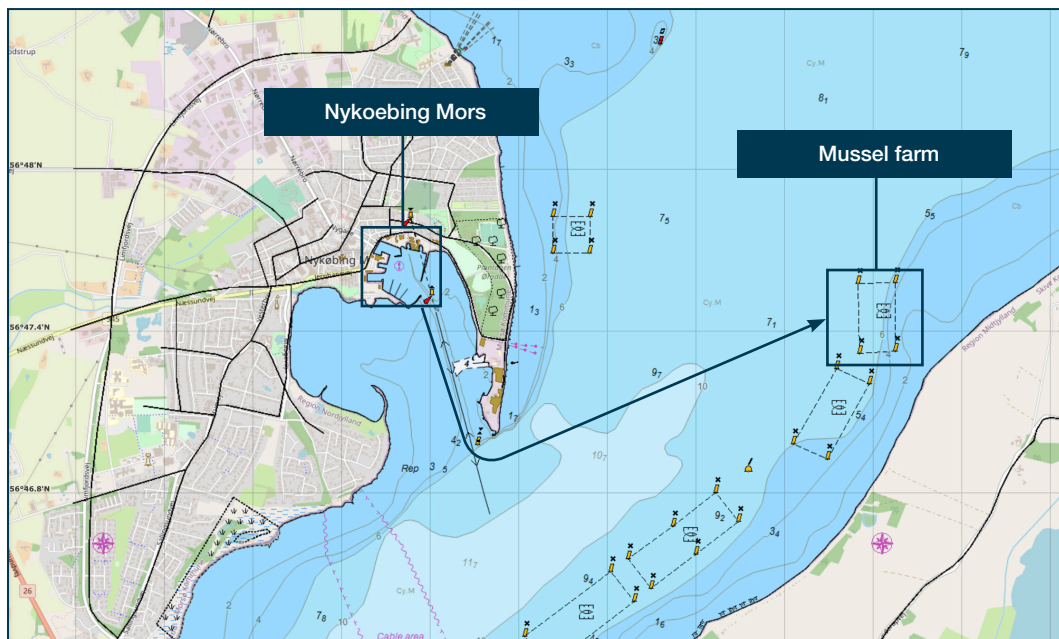
Figure 2: Mussel farm location and BB approximate route
Source:© Made Smart Group BV 2021 © i4 Insight / DMAIB

The two empty bags found on the deck indicated that the worker had completed fitting 1/3 of the buoys. On the day of the accident the work entailed fastening the boat to the longline (see figure 2), shortening the longline by lifting it out of the sea using the crane and cutting off a section. The longline tended to become stretched and thus longer after having been in the sea for a prolonged period. Once the longline had been shortened, the buoys were attached.
