Marine accident report on occupational accident

16 FEBRUARY 2022

**MARINE ACCIDENT REPORT ON OCCUPATIONAL
ACCIDENT ON DANMARK ON FEBRUARY 2022**

DMAIB
Danish Maritime Accident Investigation Board
Batterivej 9
DK-4220 Korsoer
Denmark

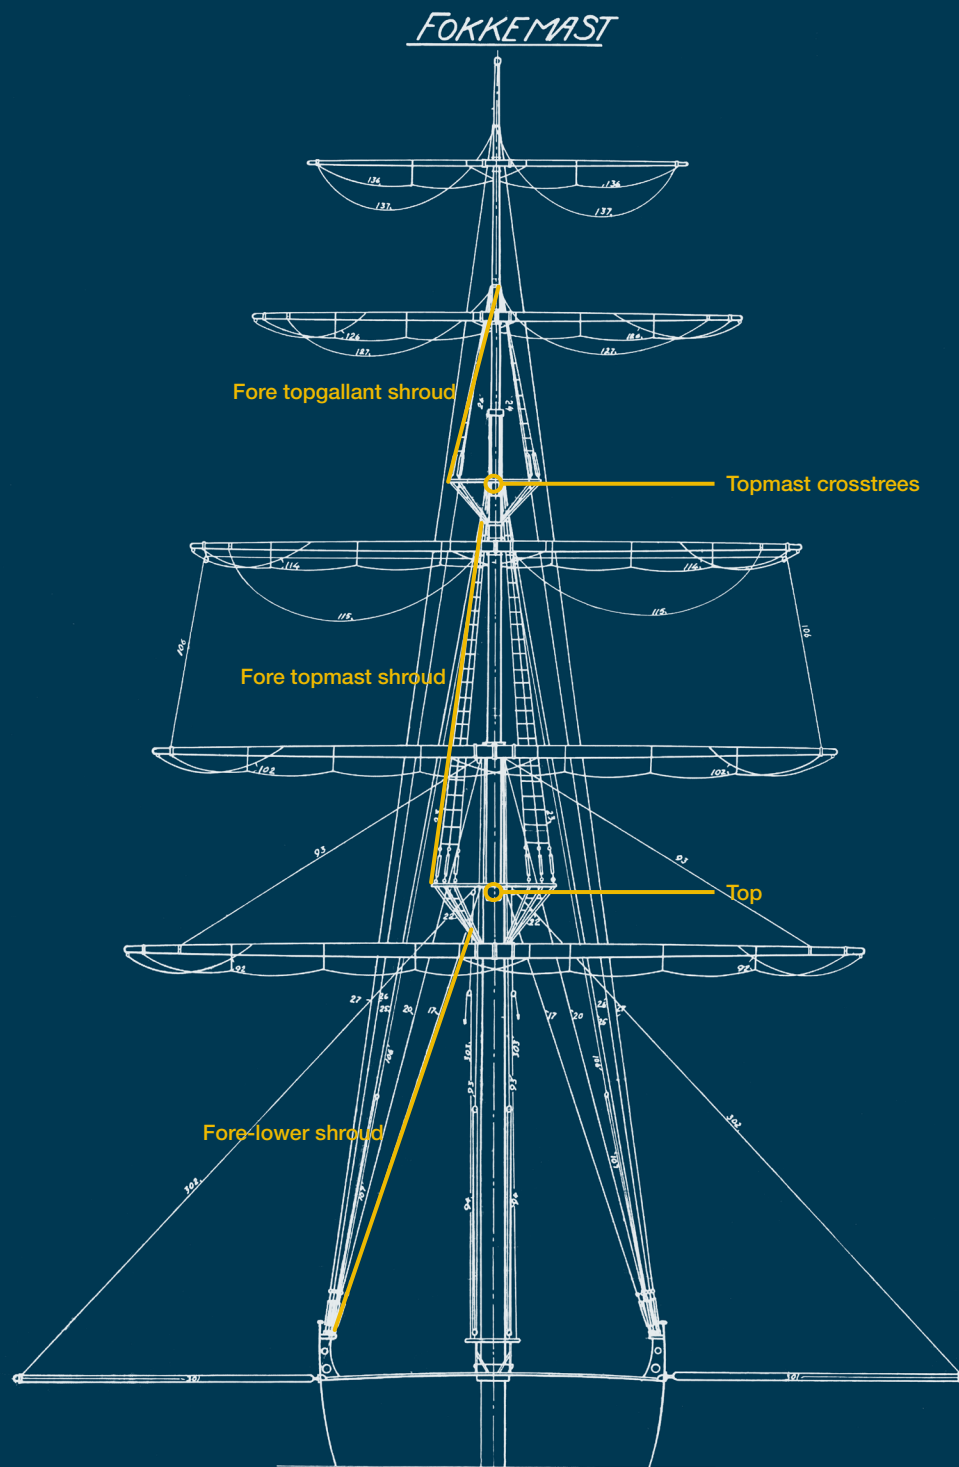
The foremast consisted of three parts: foremast, top mast and gallant mast. These were joined at the top and the topmast crosstrees and connected by three steel wire rope shrouds (fore-lower shroud, topmast shroud and topgallant shroud) with ratlines of rope, which afforded access from the deck up to the yards (figure 4). The fore-topgallant mast had five yards: Fore-yard, lower topsail yard, upper topsail yard, topgallant yard and royal yard.

Figure 4: Fore-topgallant mast on DANMARK
Source: Nakskov Shipyard/DANMARK, modified by DMAIB

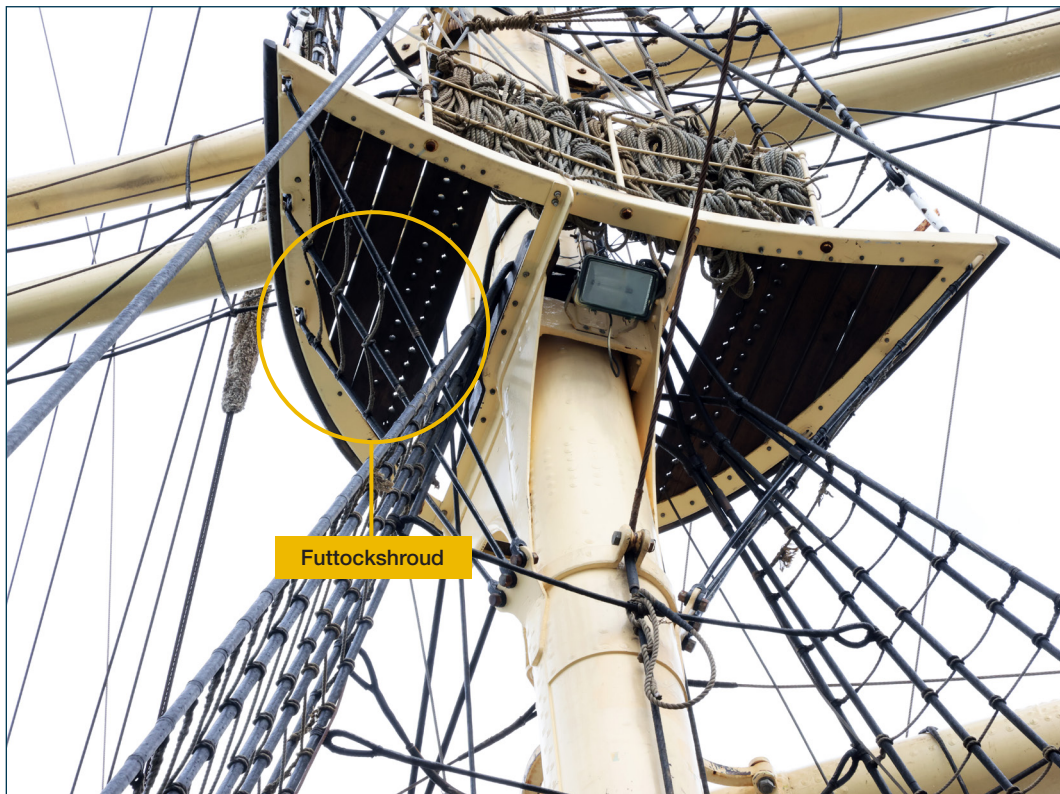
The upper part of the rigging was attached on the underside of the top and the topmast crosstrees. On the underside of the top and the topmast crosstrees, respectively, were a futtockshroud and a topmast futtockshroud of round iron with ratlines of rope mounted to ensure a foothold when climbing from the shroud onto the top or the topmast crosstrees (figure 5). The shrouds were attached at the bottom with a shackle and a rigging screw on the platform made up by the top and the topmast crosstrees, respectively (figure 6).

Figure 5: The underside of the top in the fore-topgallant mast.
Source: DMAIB

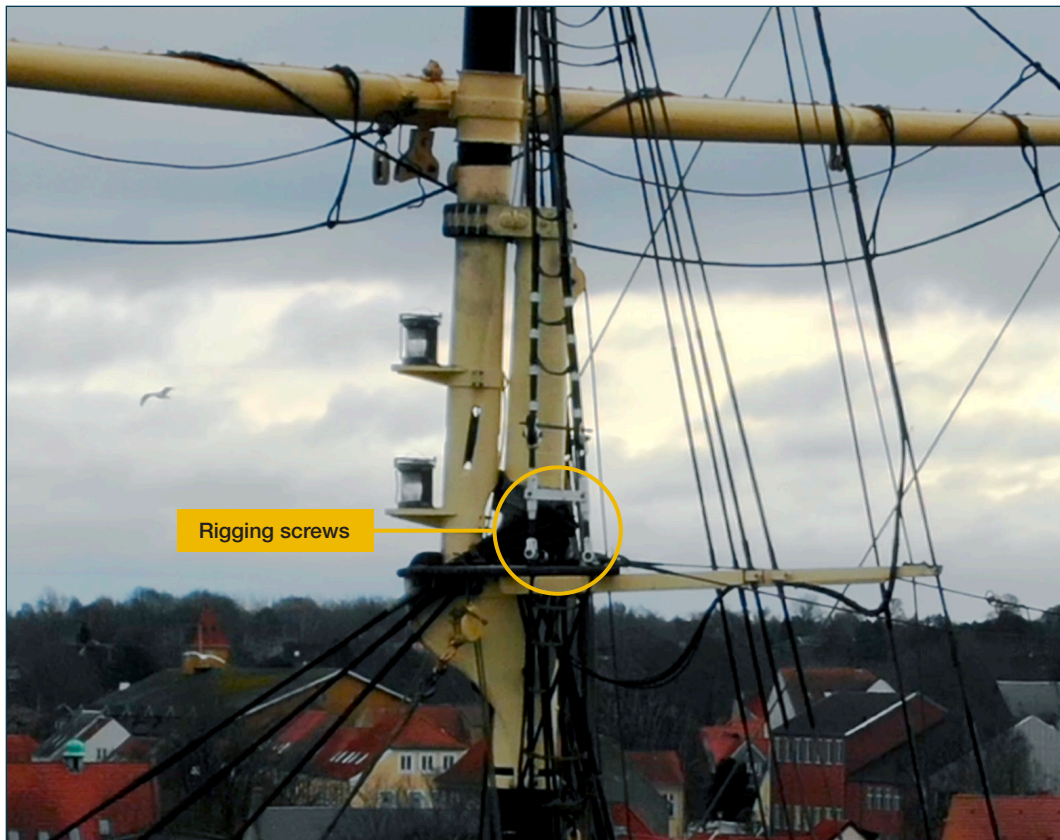
Figure 6: Rigging screw at the topgallant shroud.
Source: DMAIB

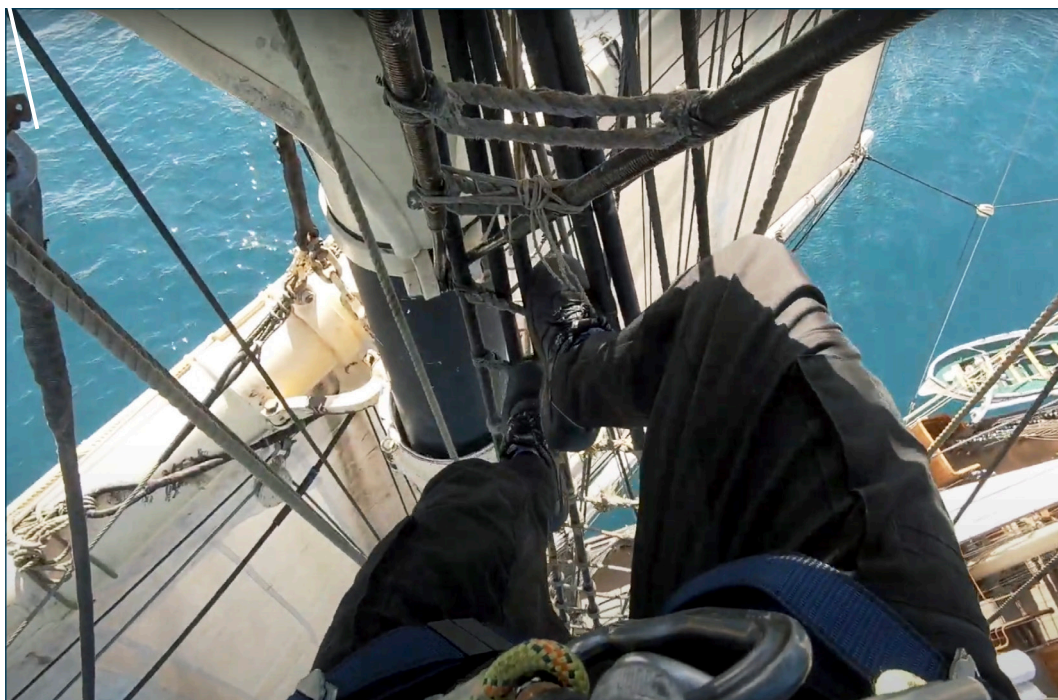
Traversing the top and topmast crosstrees had to be carried out with caution. When ascending, a person had to lean backwards to negotiate the overhangs. In addition, the ratlines under the crosstrees were very narrow and required the feet to be angled a particular way to enable a person to push/lift themselves onto the crosstrees (figures 9 and 10).

*Figure 10: Feet in ratlines under the topmast crosstrees (in the mainmast).
Source: Kasper Feder, YouTube (dk), 2021*
